NATIONAL TRANSPORTATION SAFETY BOARD
Office of Aviation Safety
Washington, D.C. 20594

Airworthiness Group Chairman's Factual Report of Investigation

A. ACCIDENT **CEN13FA196**

Location: South Bend, Indiana
Date: March 17, 2013
Time: 1623 Eastern Daylight Time
Aircraft: Hawker Beechcraft Corporation Model 390 Premier 1A,
 N26DK

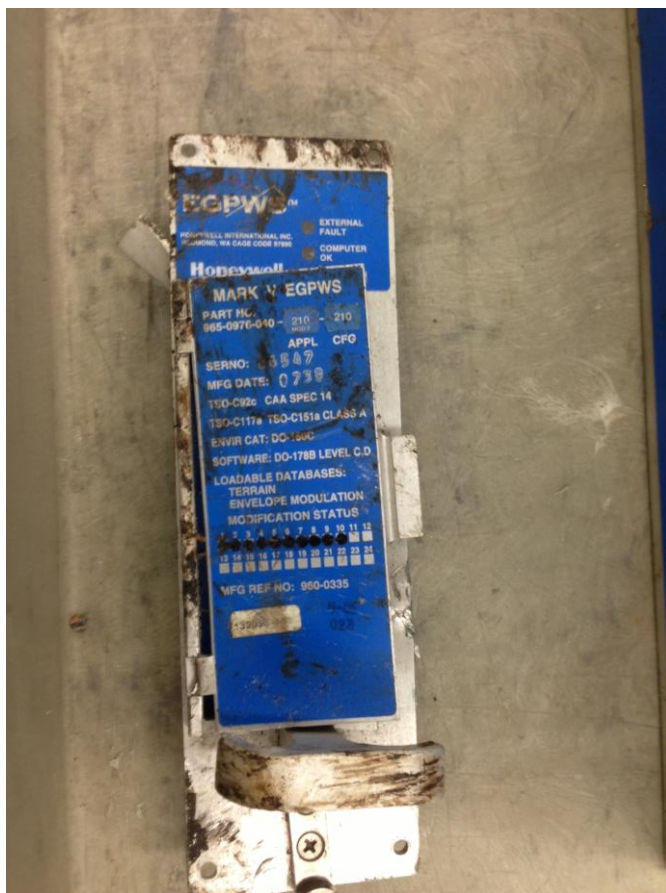
The EGPWS was damaged by impact forces and the front door/panel was separated from the unit. See Figure 1.

Figure 1 - EGPWS front panel, separated from unit.

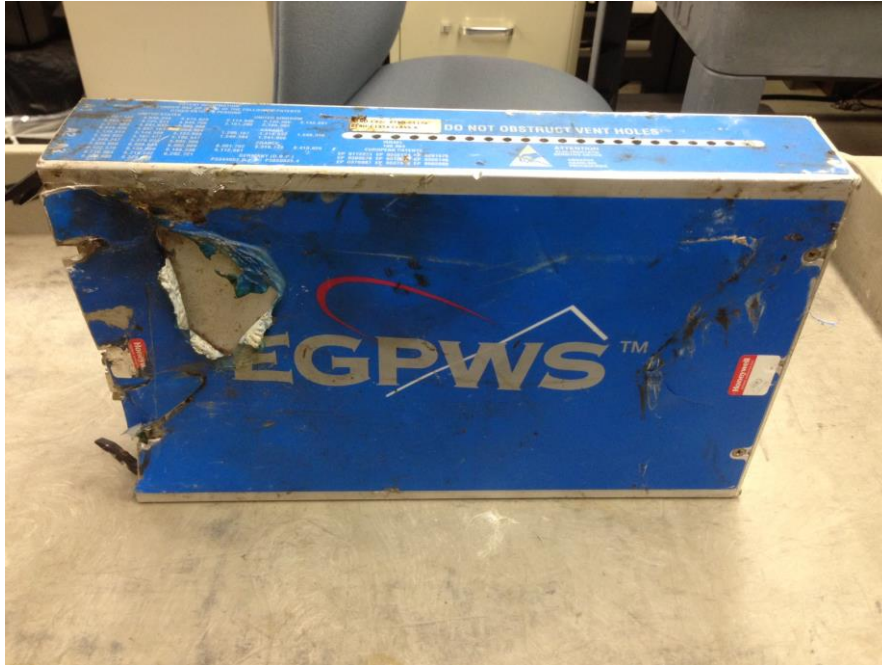
Due to accident impact damage, the EGPWS was unable to receive power for examination and data download (See Figure 2). Therefore, the unit's outer case/dust cover was opened and the relevant circuit card, with flash memory chips attached, examined.

Figure 2 - EGPWS unit, as received at Honeywell, prior to examination.

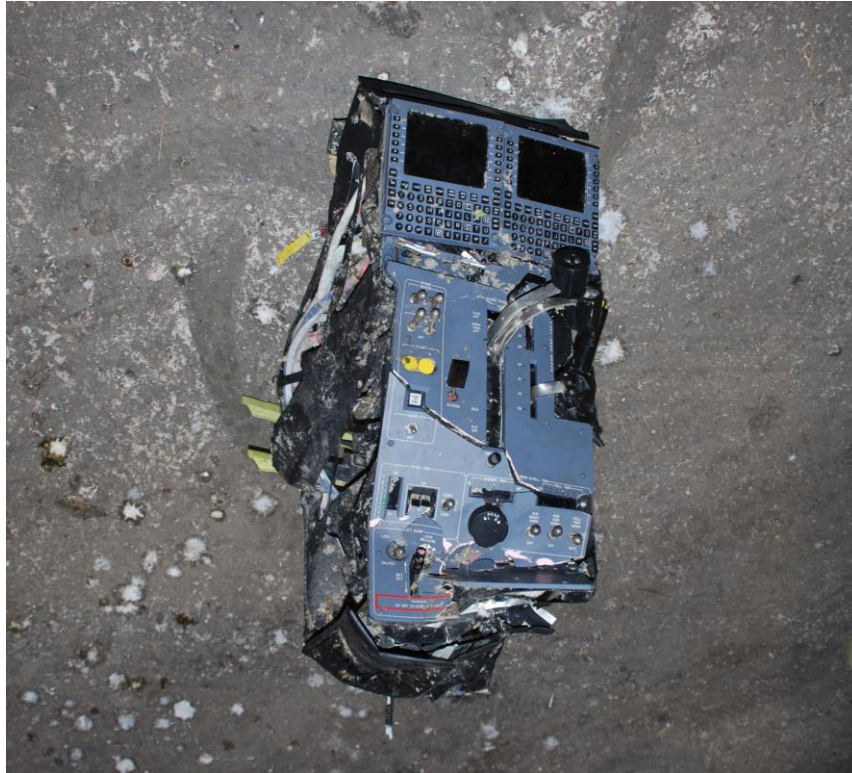
The throttle quadrant assembly was removed from the airplane wreckage and retained for further examination (See Figure 3). The assembly was shipped to the Federal Aviation Administration's Wichita Aircraft Certification Office (ACO) and placed in secure storage.

Figure 3 - Center Pedestal, including throttle quadrant, at hangar, prior to shipment to manufacturer.

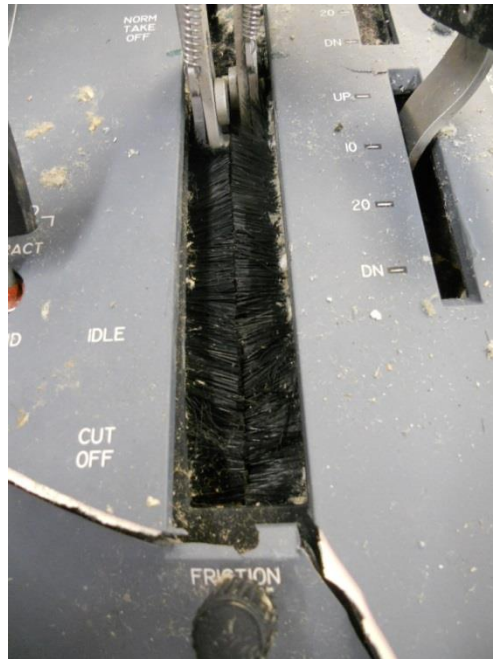
The FOD brushes were trimmed in the area of the idle stop to accommodate visual examination and further testing. A visual examination of the idle stops by the group did not reveal any physical damage. According to Harlow, the idle stops appeared undamaged and per design. See Figures 4 and 5.

Figure 4 - FOD brushes near the Idle/Cut Off area, before the brushes were cut.

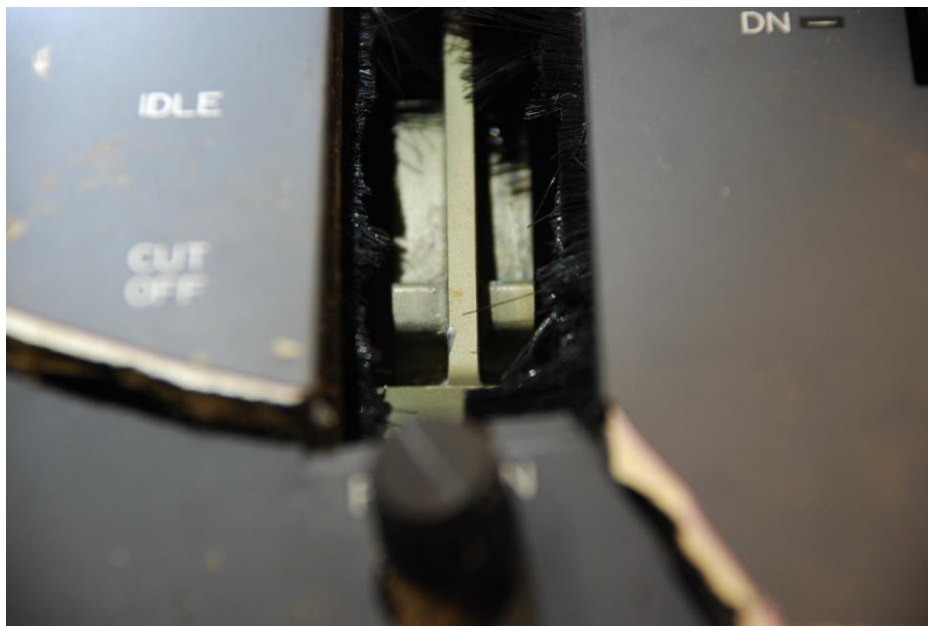
Figure 5 - Area of the Cut Off gates, after the FOD brushes were cut.
