NATIONAL TRANSPORTATION SAFETY BOARD

Group Chairman's Factual Report of Investigation – Airworthiness

DCA17IA020

Location: LaGuardia Airport, Flushing, New York
Date: October 27, 2016
Time: 1942 Local Time
Aircraft: Eastern Air Lines flight 3452, a Boeing 737-7L9, registration N278EA

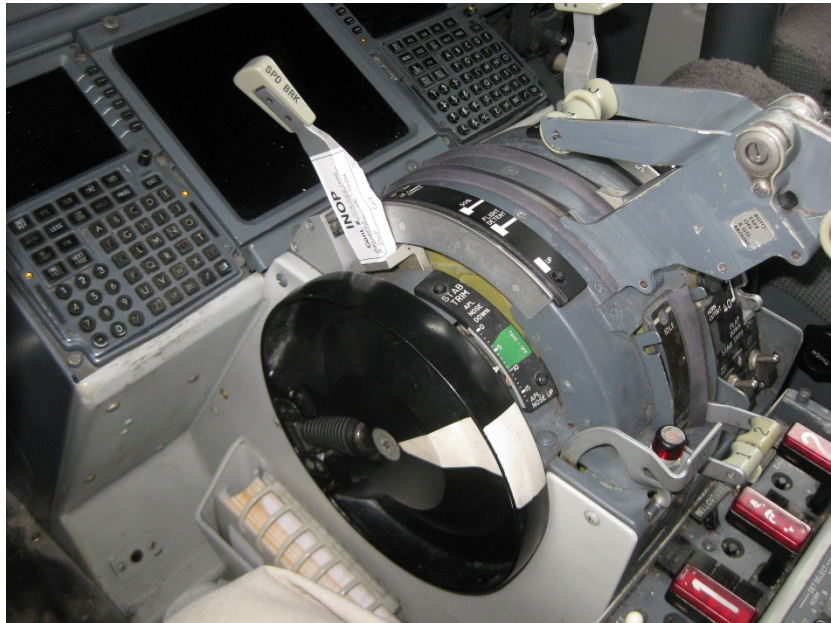
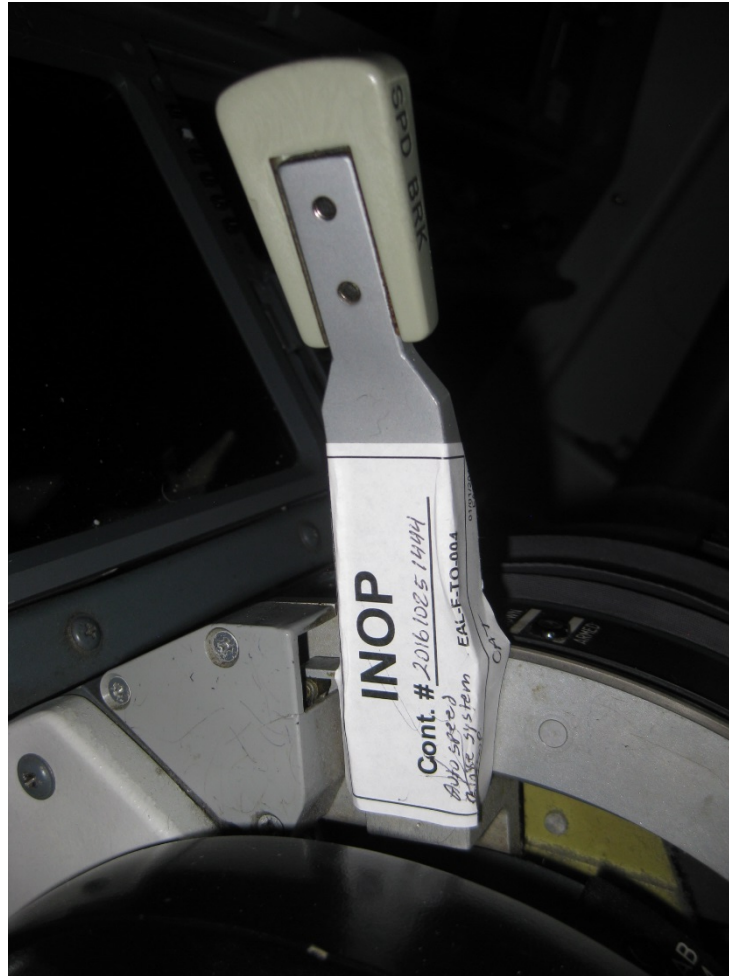
The flightdeck speedbrake control components were examined. The speedbrake handle was noted in the full forward position, with a paper sticker wrapped around the base of the handle. The sticker indicated the system was inoperative (See Figures 1 and 2). All spoiler panels, including the ground spoilers, were found in the down or retracted position. No damage was noted to any of the ground spoilers.

Figure 1 - Overview of the Center Pedestal in Flightdeck.

Figure 2 - Close Up of the Speedbrake Handle and INOP Sticker.

The white sticker wrapped around the speedbrake handle was marked INOP due to a maintenance procedure conducted on the auto speedbrake system. For additional information regarding the maintenance activity, please see Section 4.0, Airplane Maintenance Records.

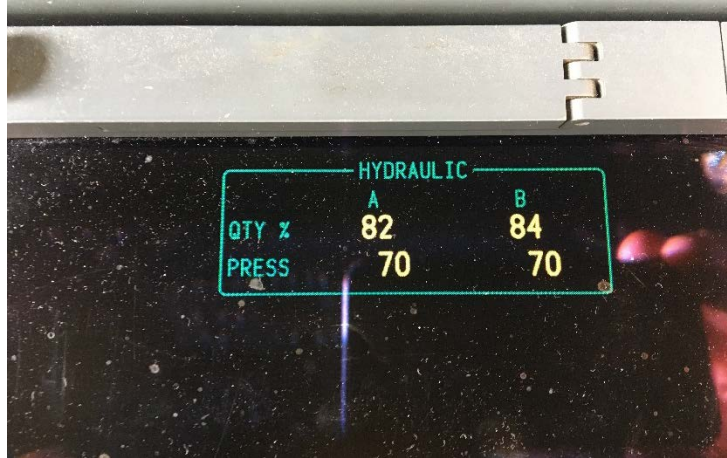
Hydraulic System A: 82%
Hydraulic System B: 84%

Figure 3- Hydraulic Quantity and Pressure (Hydraulic Systems Not Powered)

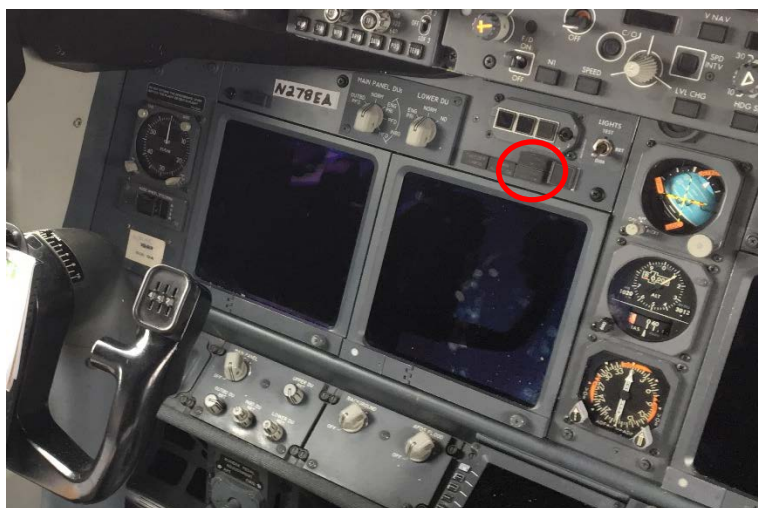
- P1 Left Forward Instrument Panel: The “SPEEDBRAKE DO NOT ARM” and the “SPEEDBRAKE ARMED” lights were noted. See Figure 4.

Figure 4 - The "SPEEDBRAKE ARMED" and "SPEEDBRAKE DO NOT ARM" lights on the P1 Panel (circled).

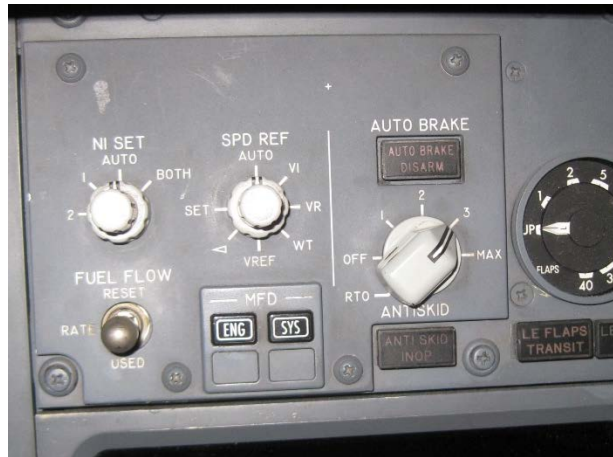
- P2 Center Instrument Panel: The Auto Brake Rotary Switch – Position 3 (See Figure 5).

Figure 5 - Autobrake Control Panel with Position 3 Selected

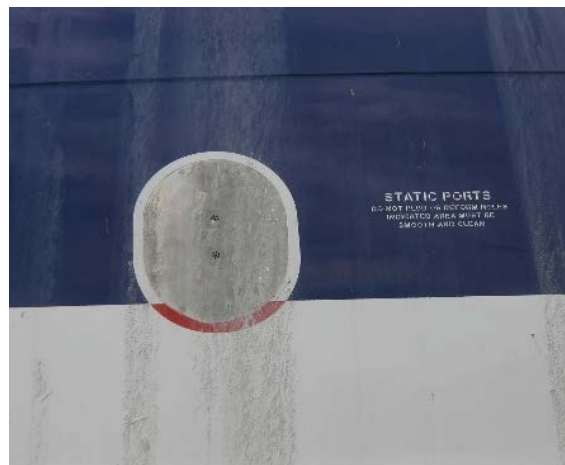
The airplane’s external probes and ports exhibited EMAS debris accumulation. The static ports and ram air probes also accumulated debris. See Figures 6, 7, and 8.

Figure 6 - Example of EMAS debris on Static Port

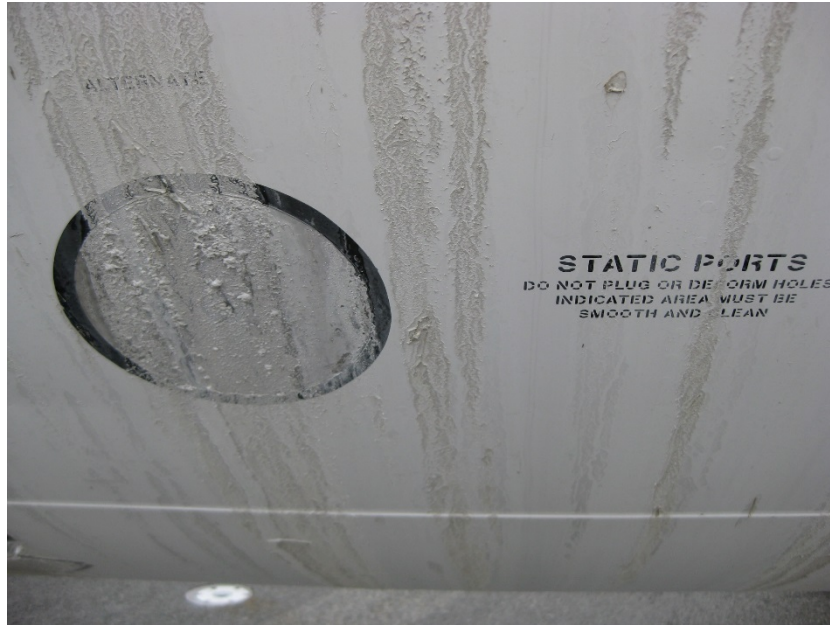
Figure 7 - Example of EMAS debris on Static Port.

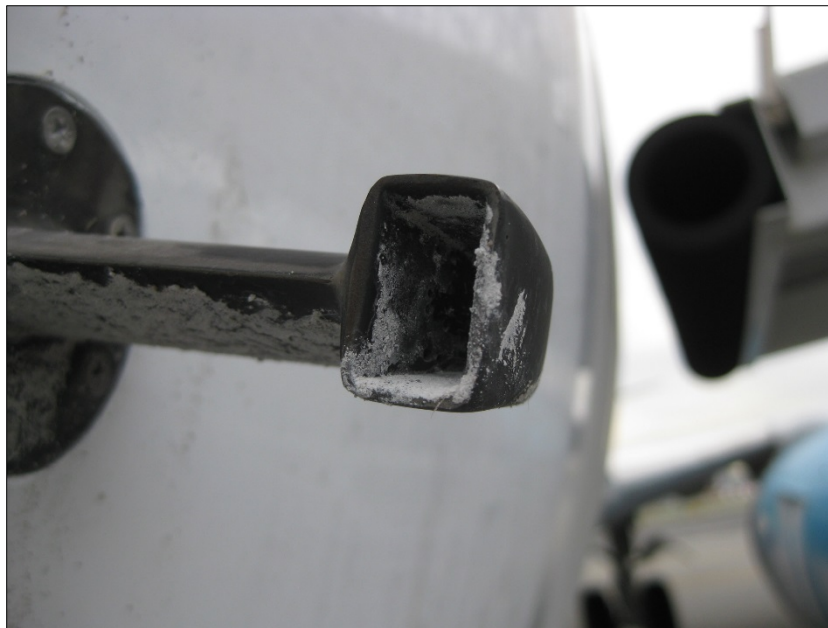
Figure 8 - Example of EMAS debris on External Port.

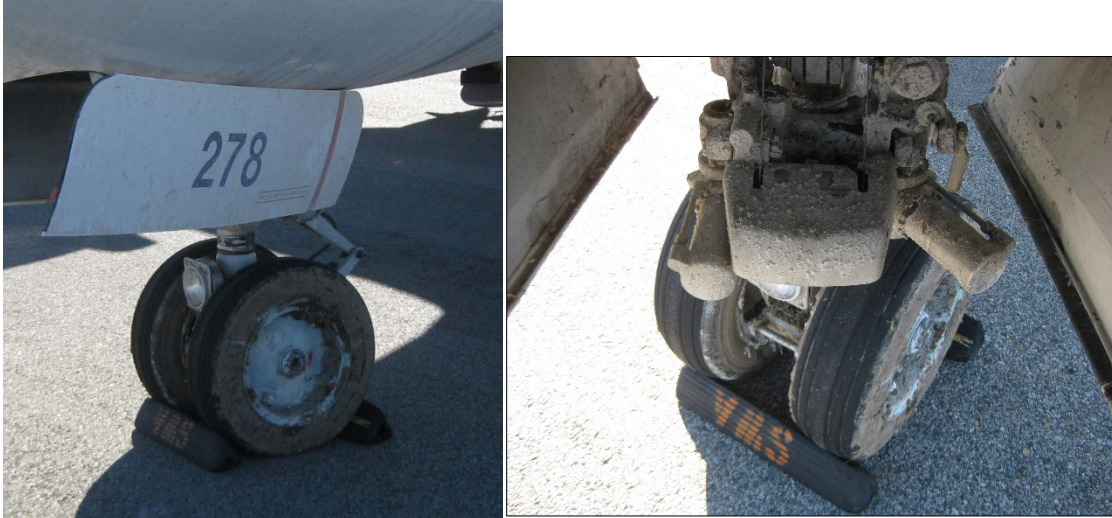
The nose wheel assembly and tires were coated with dried EMAS material and mud. Portions of the nose wheel well were also covered with dried EMAS material. The left and right nose wheel tires showed cut damage.

The nose wheel landing gear and associated assemblies were examined, with no visible damage or malfunction noted. See Figures 9A and 9B.

Figure 9A/B - Nose Landing Gear and EMAS debris.

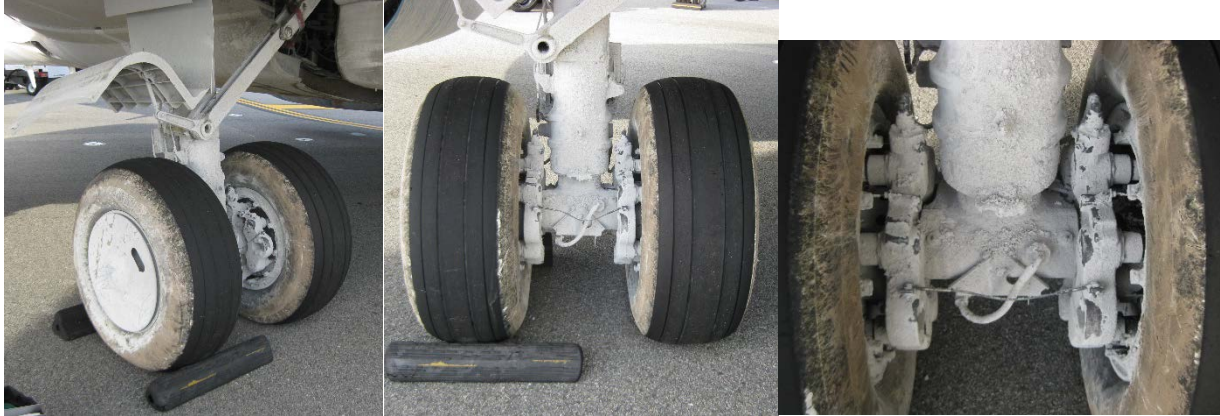
Both two main landing gear assemblies were coated with dried EMAS material. Pieces of the EMAS matting material were also noted in the landing gear assemblies. Portions of the wheel wells and adjacent areas were also covered with the EMAS materials. See Figures 10A/B/C and 11A/B/C.

Figure 10A, B, and C - Left Main Landing Gear and EMAS Debris

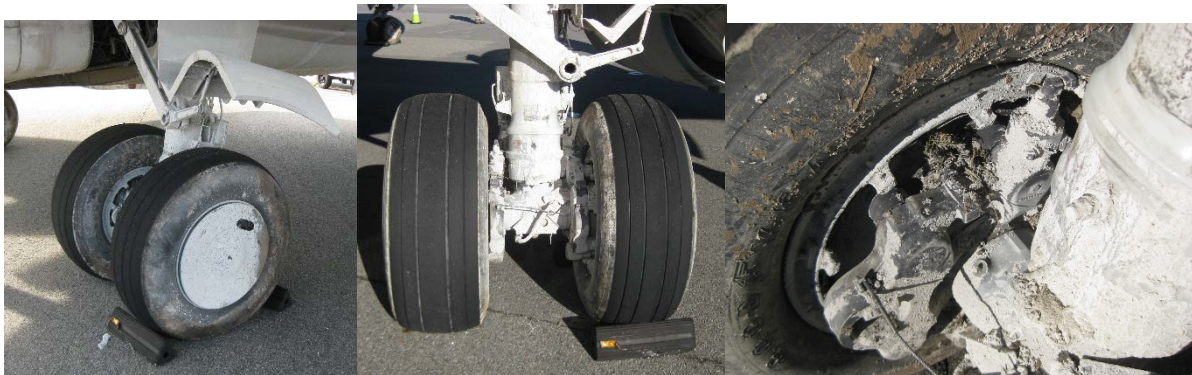
Figure 11A, B, and C - Right Main Landing Gear and EMAS Debris

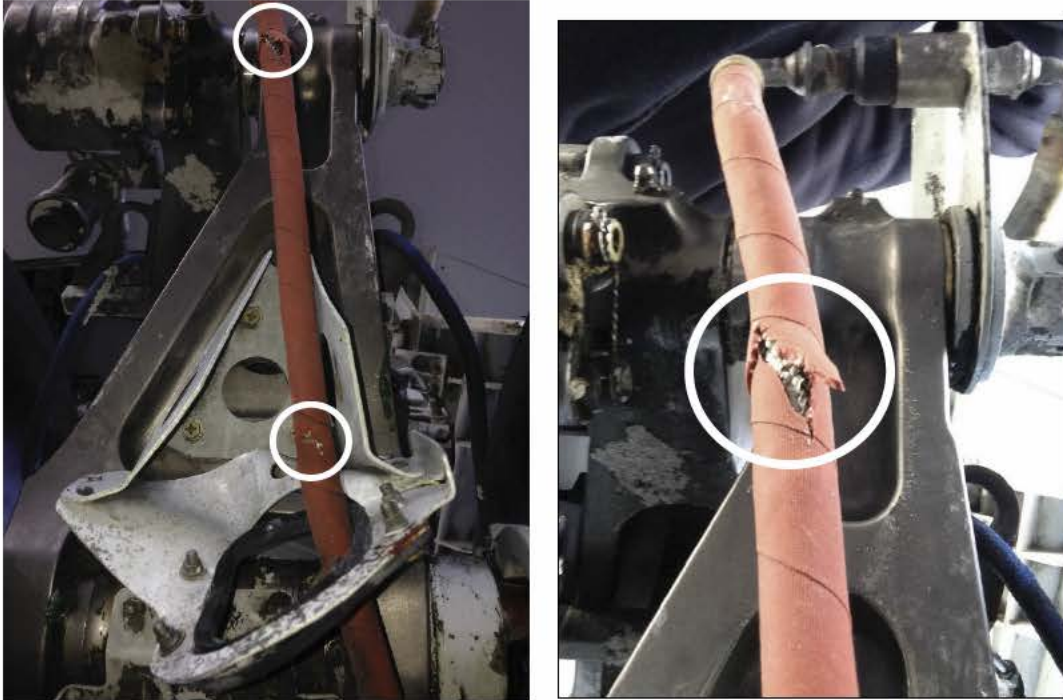
A preliminary visual examination of the main landing gear strut, doors, assemblies, associated hydraulic lines, and antiskid components did not reveal evidence of physical damage. However, after the airplane was cleaned of EMAS debris and the main landing gears retracted, physical damage was noted on the underside of each gear strut. Eastern Airlines indicated that the Left and Right Main Landing Gear Lower Wire Bundle Support Bracket were each damaged. In addition, on the Left Main Landing Gear, the wire conduit sleeve was damaged as well. See Figures 12A and B (Left Main Gear) and 13 (Right Main Gear).

Figure 12A and B - Damage to underside of Left Main Landing Gear Lower Wire Bundle Bracket and damage to wire conduit. Damaged areas of conduit are circled.

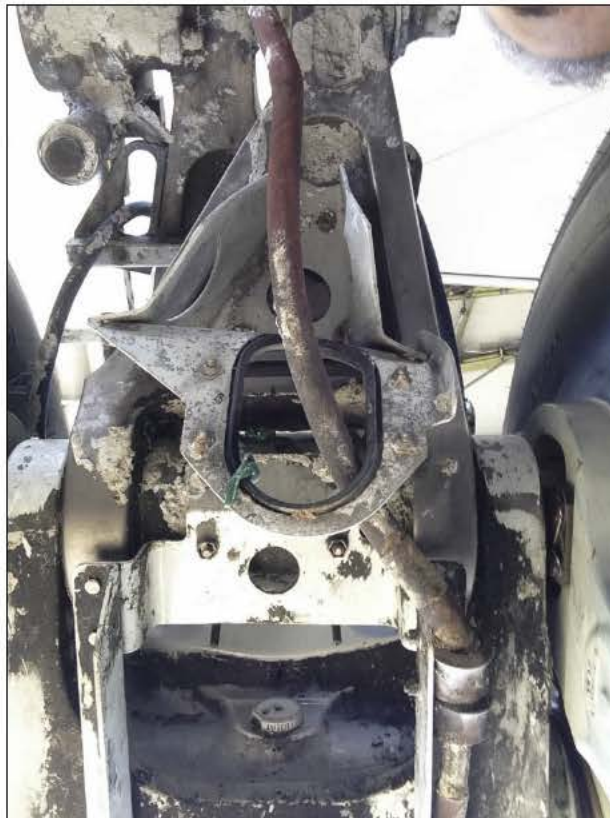
Figure 13- Damage to underside of Right Main Landing Gear Lower Wire Bundle Bracket.

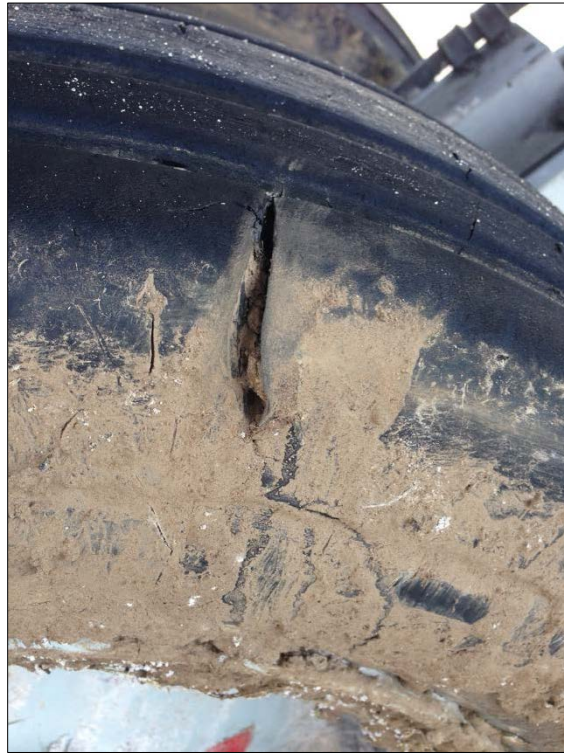
Each of the four main wheel tires (numbers 1 and 2 on left main landing gear, numbers 3 and 4 on right main landing gear) showed cut damage in addition to normal wear. For example, the outboard sidewall of tire number 1 had a cut (See Figure 14) and tire number 3 had a cut with a piece of clear glass imbedded in it. None of the observed cuts were deep enough to reach the tire treads.

Figure 14 - Cut on the outboard sidewall of Tire Number 1.

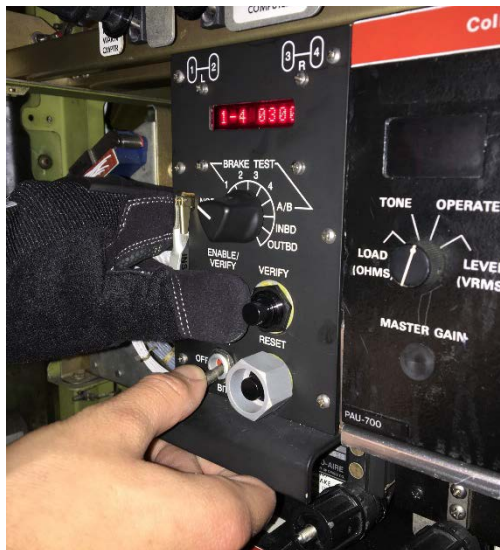
With power applied to the airplane, the autobrake and antiskid systems were examined via the Antiskid/Autobrake Control Unit (AACU). For the test, the Boeing 737-600/700/800/900 Fault Isolation Manual (dated June 15, 2013), Section 32-42, Task 801” Antiskid/Autobrake Control Unit Built In Test (BITE) Procedure was conducted. The BITE function was initiated via the front panel of the AACU. The BITE functions were completed with no faults found. In addition, no pre-existing faults were recorded in the AACU. The following messages, determined to be Software Revision Display Messages⁴, were noted on the AACU screen during the tests:

Figure 15 - Testing the Antiskid/Autobrake Control Unit (AACU) Using the BITE Function. A Software Revision Display Message is shown on the AACU Display.

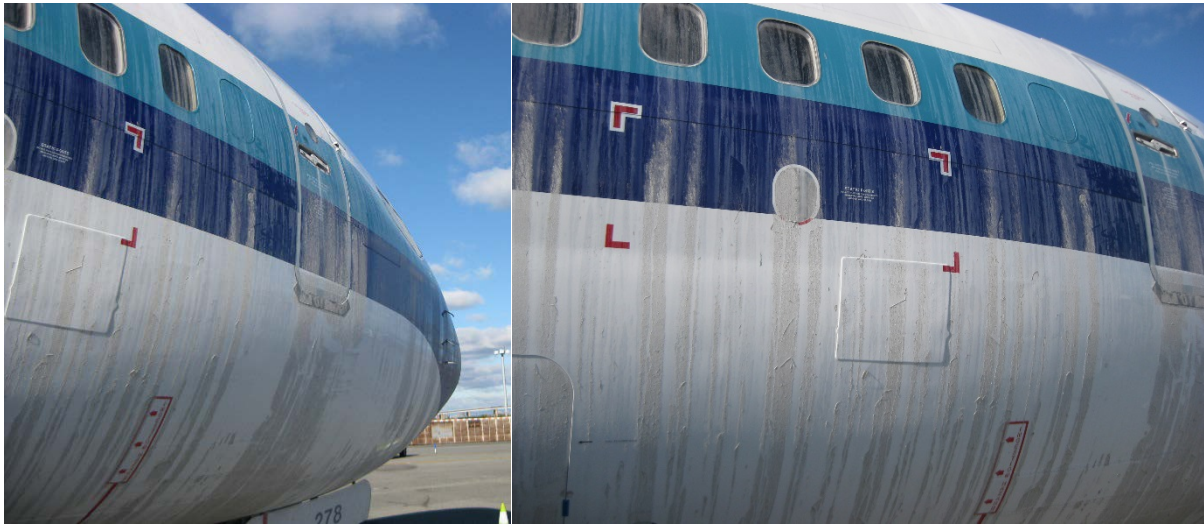
The runway barrier debris (EMAS material) was noted on the lower fuselage surfaces and inside all of the wheel wells. See Figures 16A/B and 17.

Figure 16A/B - Dried EMAS Material and Grass on Right Hand Side of Fuselage

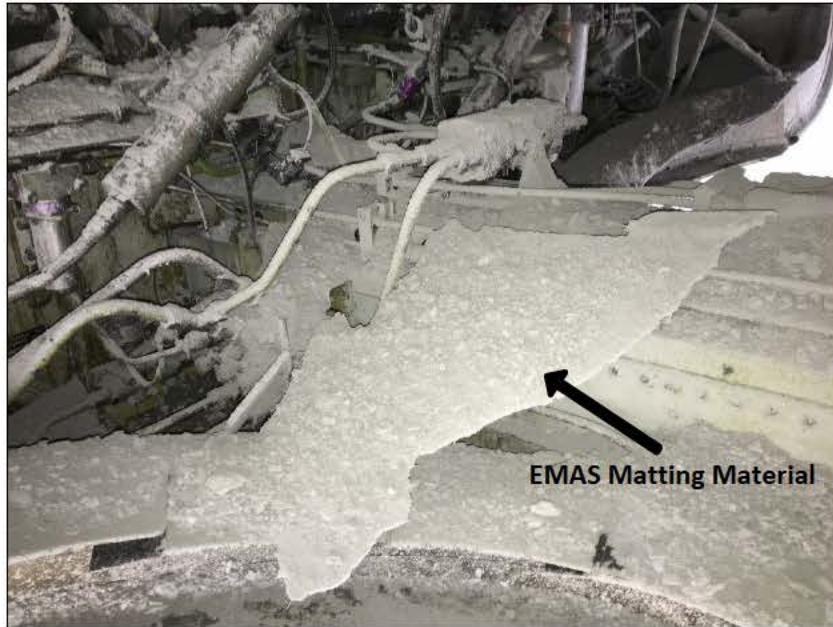
Figure 17 - EMAS Material and Matting in the Left Main Wheel Well

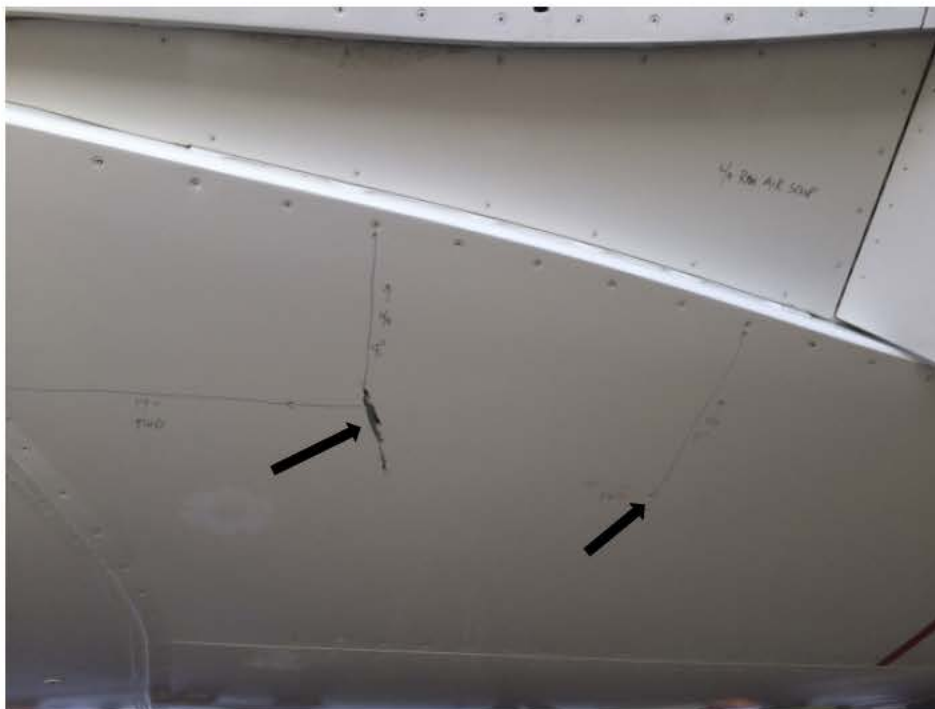
After the airplane was cleaned, damage was found on the Left Hand Forward Wing to Body Fairing (Panel 191CL). See Figure 18.

Figure 18 - Damage Found on Left Hand Forward Wing to Body Fairing.

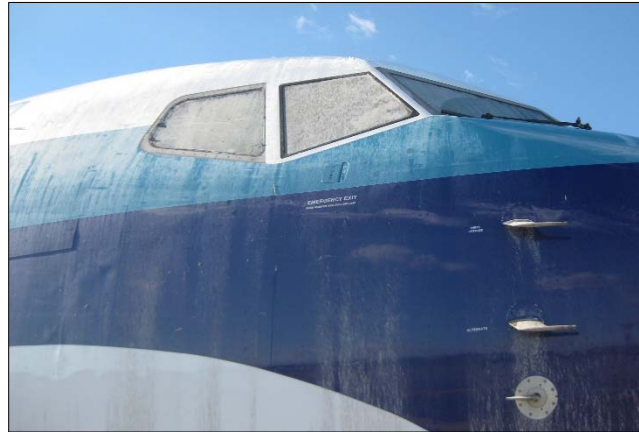
The flight deck windows were coated with dried EMAS material. See Figure 19.

Figure 19 - Right Side Flight Deck Windows with EMAS

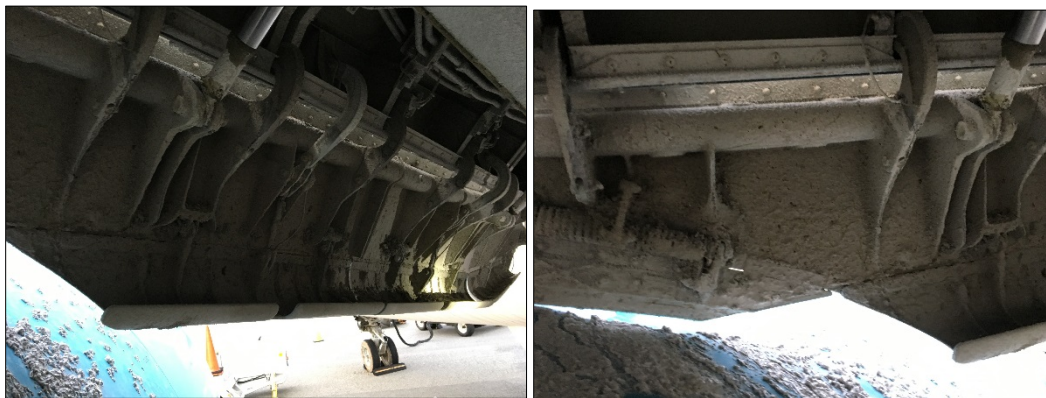
The leading edge interior exhibited accumulation of EMAS material and matting. See Figures 20A and B.

Figure 20 A/B - EMAS debris on the underside and interior of wing leading edge.

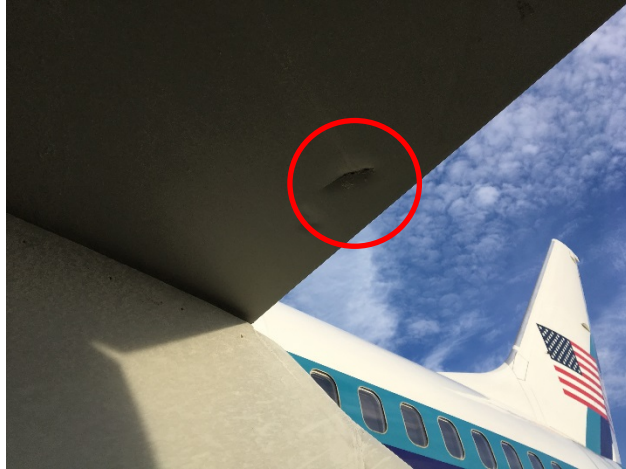
The left hand trailing edge flap exhibited impact damage at the lower, underside surface area. The damage was noted in the area near the outboard section of the number 3 flap “canoe” fairing. The damage was noted as a gouge of approximately 2” long and 1/16” wide that penetrated the flap skin. See Figure 21.

Figure 21 - Impact Damage Noted on Underside of Number 3 Trailing Edge Flap Surface

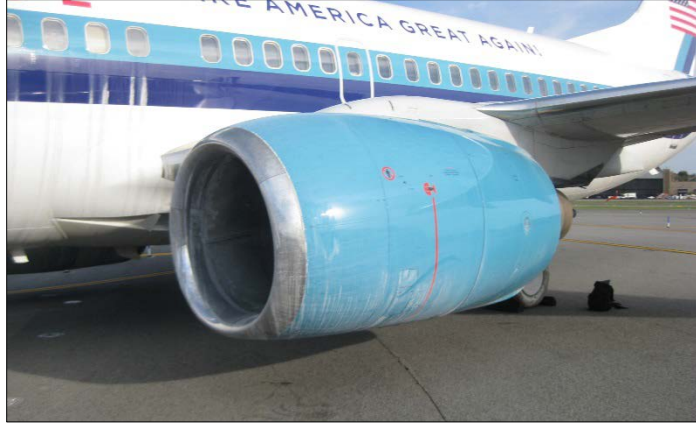
Engine Number 1 showed evidence of EMAS material and matting on the engine inlet and internal components. See Figures 22 and 23.

Figure 22- Overview of Left Engine (Engine #1).

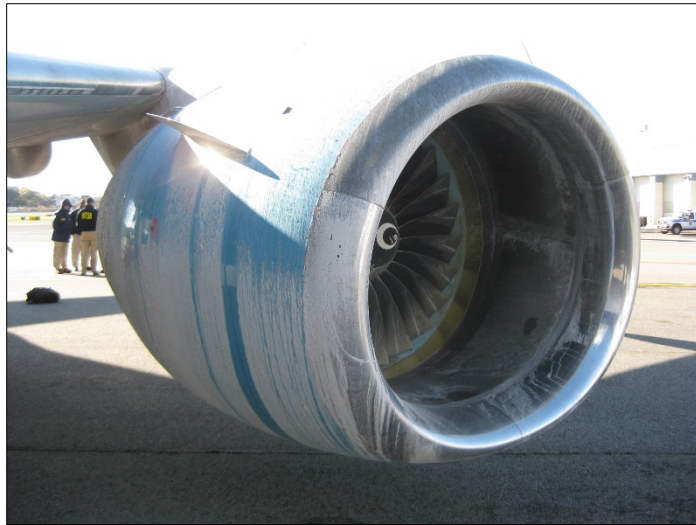
Figure 23 - Inboard side of Left (Number 1) Engine

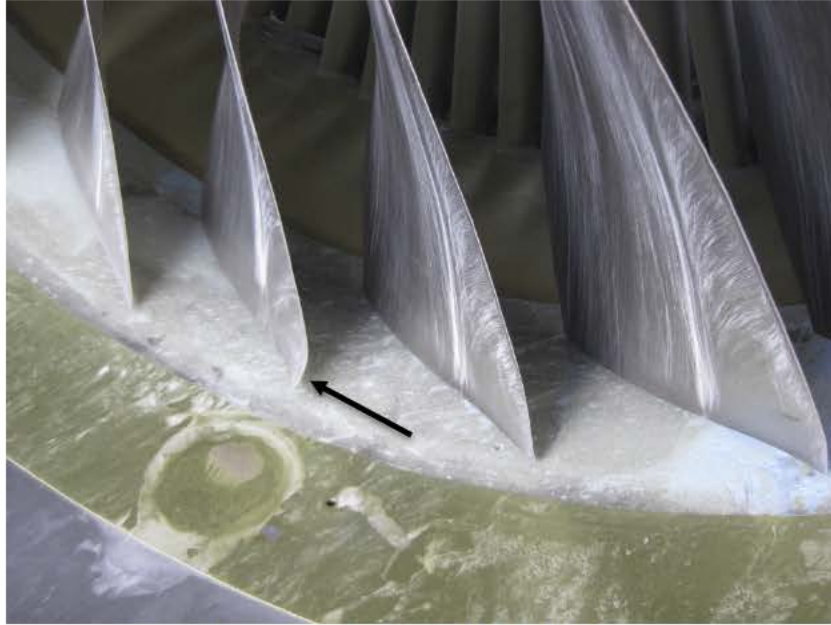
The left engine sustained fan blade damage, including four blades bent in the direction opposite of rotation, at the tip corner. See Figure 24.

Figure 24 - Left Engine Debris and Blade Damage

Eastern Airlines indicated that the left engine was removed from the airplane (while still parked at LaGuardia Airport) on December 1, 2016.

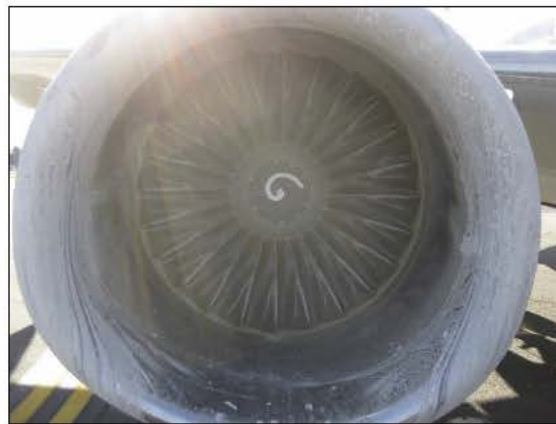
Engine Number 2 (right hand) showed evidence of EMAS material and matting on the engine inlet and internal components. See Figures 25, 26, and 27.

Figure 25 - Number 2 (right) engine intake

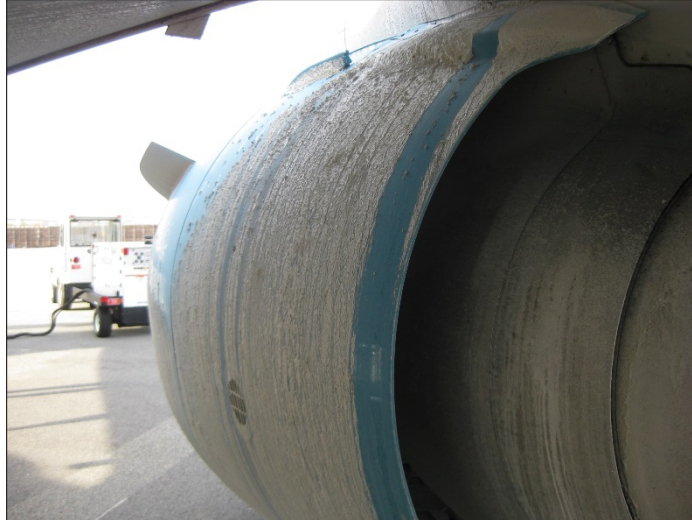
Figure 26 – Inboard (left) side of Engine 2 with EMAS debris

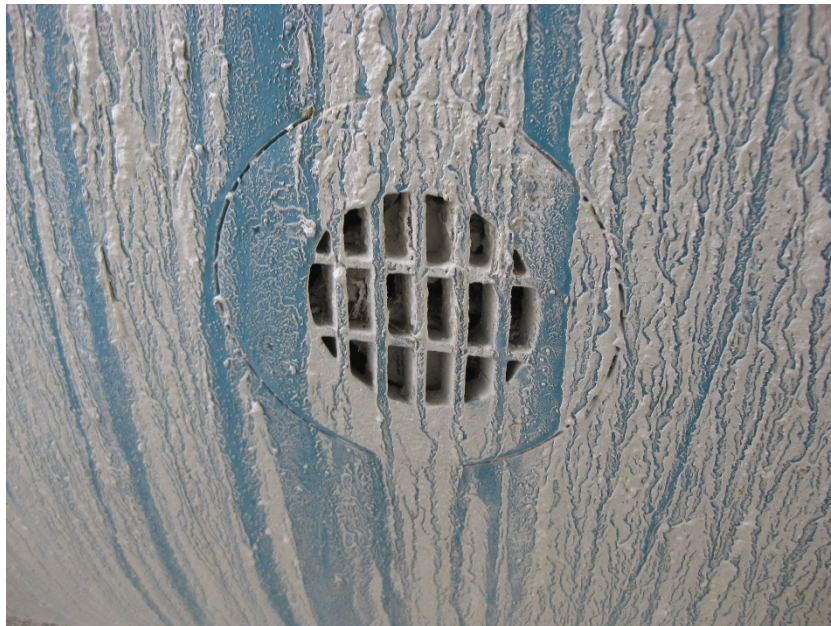
Figure 27 - Port with EMAS debris on inboard Number 2 (right) Engine.

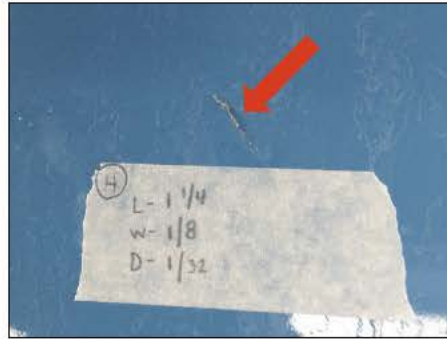
Eastern Airlines indicated that, after cleaning and deploying the thrust reversers, damage was found on the inboard thrust reverser sleeves and blocker doors for both engines.

The left engine inboard thrust reverser sleeve (Figure 28):

Figure 28- Damage to the inboard thrust reverser sleeve, left engine.

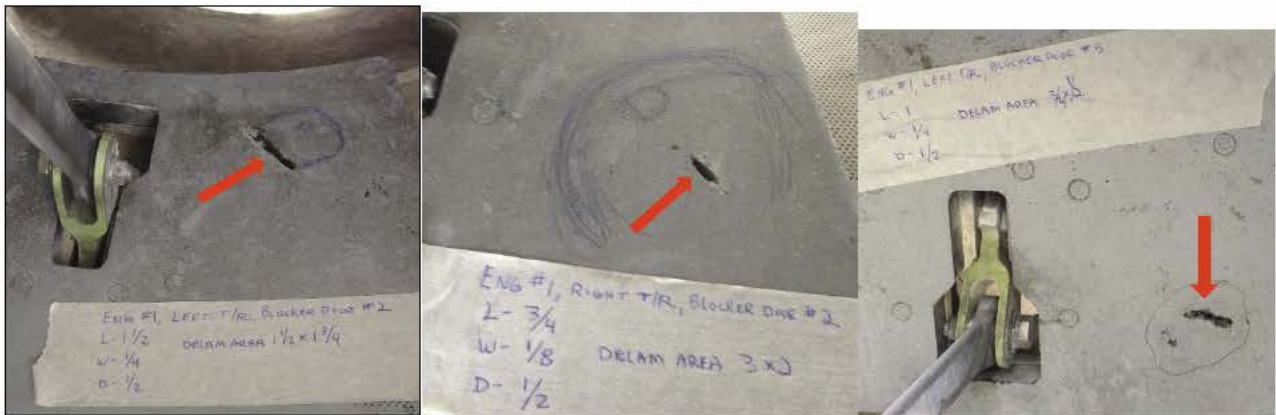
Damage to the left engine blocker doors number 2 and 5 (see Figures 29A, B, and C):

Figure 29A, B, C - Damage to Left Engine Blocker Doors

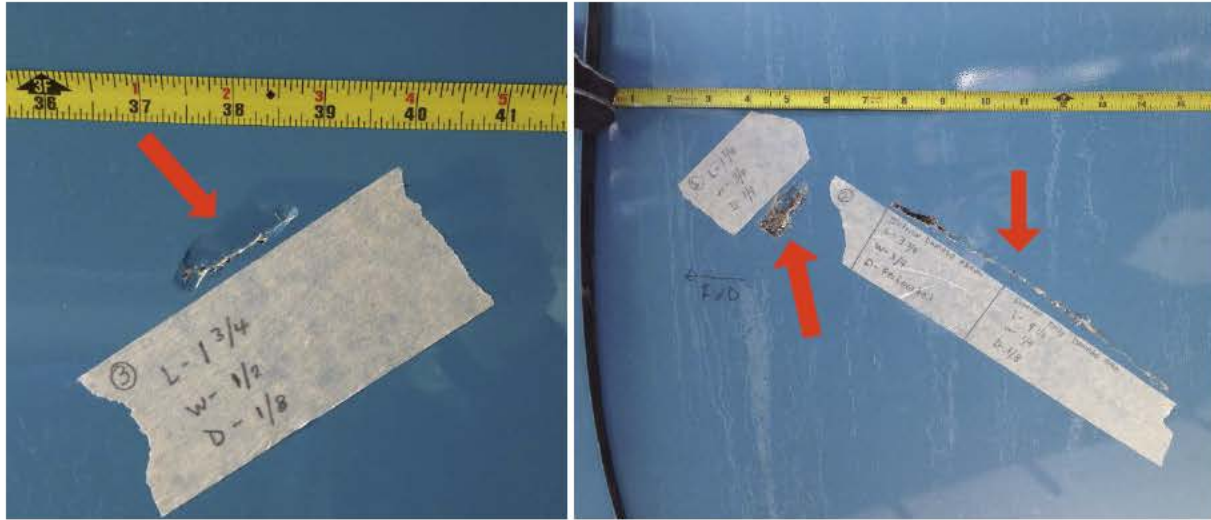
Damage to the right engine inboard thrust reverser sleeve (see Figures 30A and B):

Figure 30A and B - Damage to right engine inboard thrust reverser sleeve.

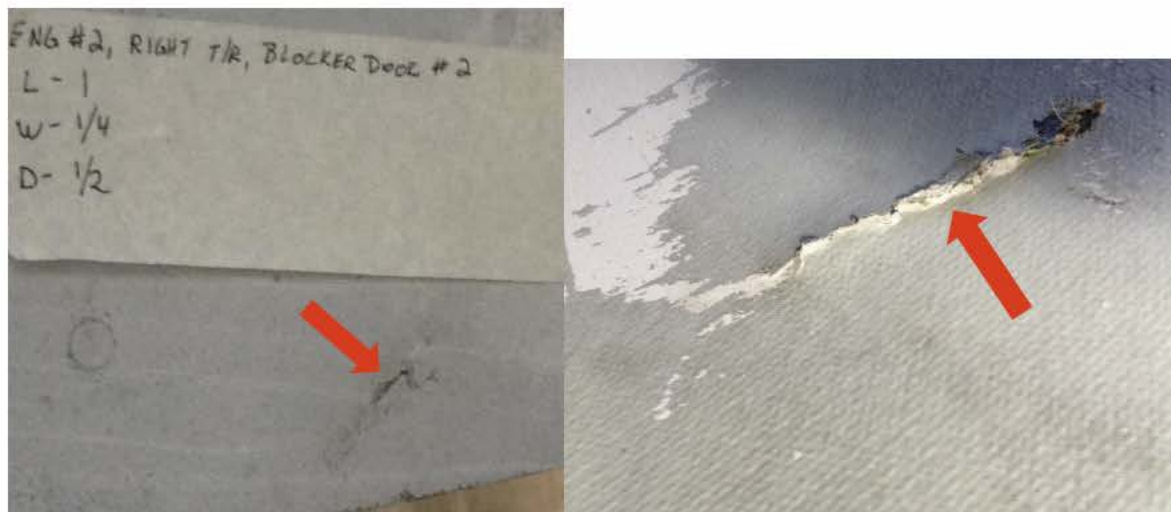
Damage to the right engine blocker door number 2 (Figures 31A and B)

Figure 31A and B - Damage to right engine blocker doors.
