## **National Transportation Safety Board**

### **Group Chairman's Factual Report**

# **AIRWORTHINESS**

CEN17MA183

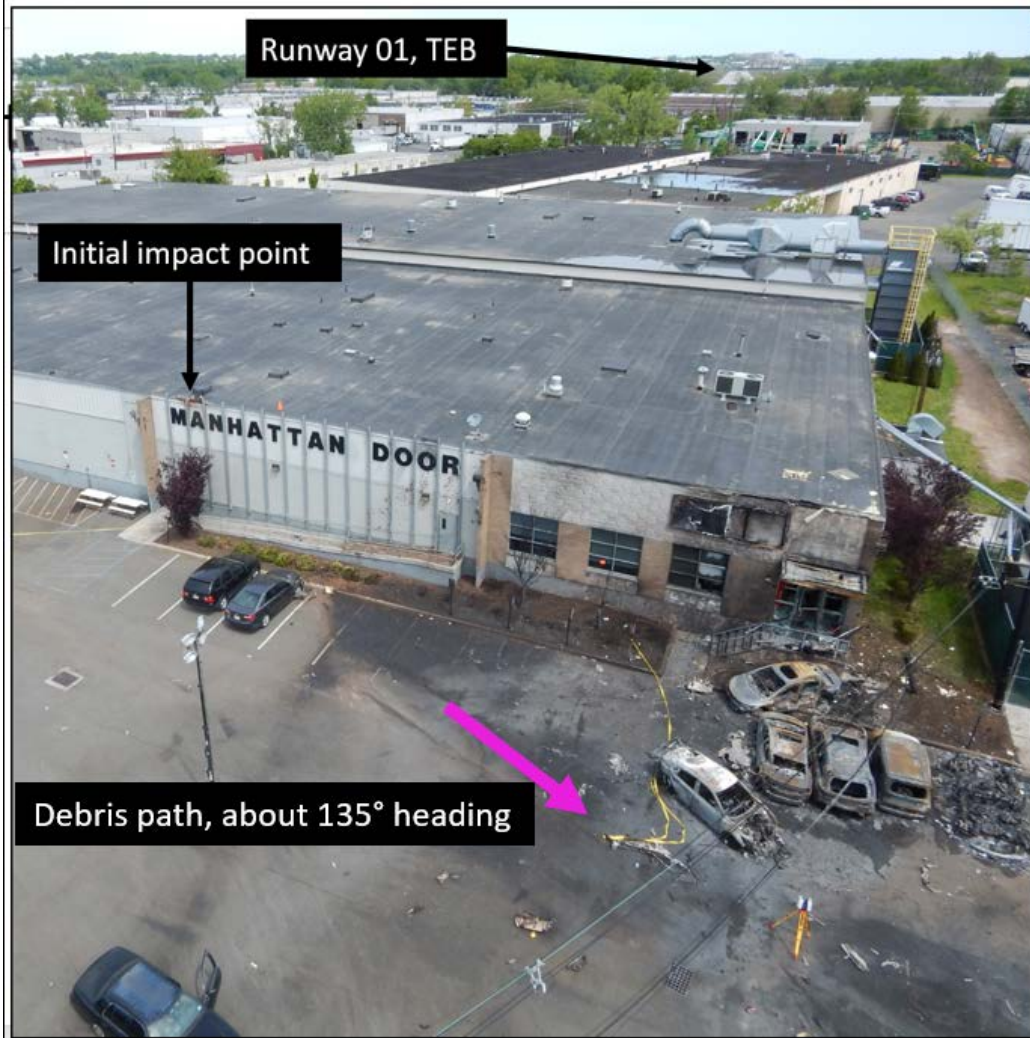
**Figure 2: Overhead view looking north at initial impact point and runway 01 at TEB**

The first point of impact was near the “M” on the roof of the Manhattan Door Office Building, about 30 ft. above ground. The items found were the right tip tank access panel and a fragment of what appeared to be the green navigation light.

The first ground impact point: There were three ground scars located near the initial impact point below the roof of the Manhattan Door building. The first ground scar was about 6 ft. by 32” and various fragments of the right wing tip tank were located.

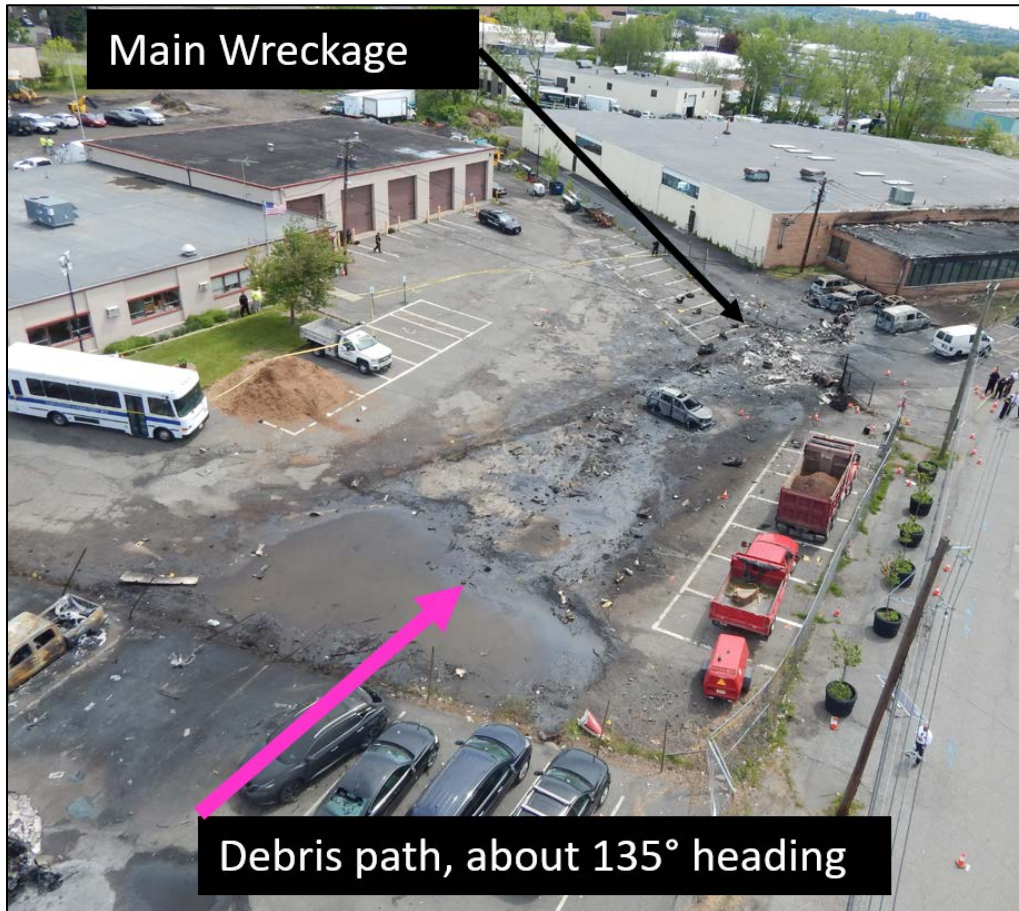
**Figure 3: Overhead view looking southeast at the debris path and main wreckage**

Forward of the main wreckage: The forward portion of the right wing tip tank was located. Both engines were fragmented, separated from the empennage and located near the furthest points of the debris field.

The engines' installation positions were identified based on the mainframe mount locations. The left engine (item #8, 9) was approximately 25 ft. further down the debris field as compared to the right engine. Compressor section stator vanes and fractured fan blades were located about one third of the way into the debris field indicating that at least one of the engines began to separate early into the impact sequence.

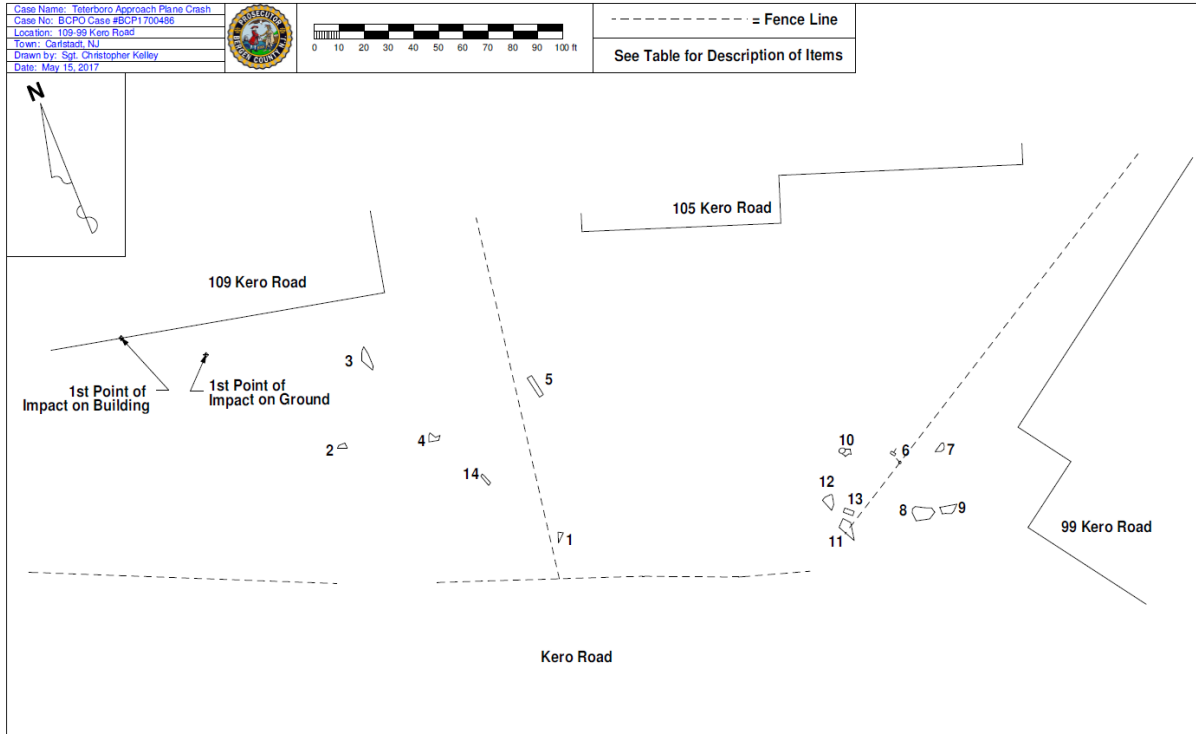
**Figure 4: Station laser scan of the accident site**

Inboard right wing (item # 3) and right main landing gear: The right main landing gear was tucked into the wing. The right flap (item #5) was separated from the wing, and located in the debris field. Seven feet and 9 inches of the inboard right wing was located. Five crushed right-wing spars were located near the inboard right wing.

Right aileron (item #2): The right aileron and balance tab remained attached. The cap at the top of the vertical stabilizer was found nearby. The right aileron was crushed inward, about 38” were measured. Fragments of the right-wing tip tank were also located. An aft portion of the right tip tank was located in the debris field (item #4).

Left elevator (item #14): A portion of the elevator separated from its attach points, about 5 ft. was measured. One hinge remained attached.

Aft section of left wing tip tank (item #1): The tip tank was separated from the wing and fragmented. The aft 5 ft. portion were located.

Core of the right engine (item #11): Located and separated from the fan section of the engine.

Lower portion of vertical stabilizer (item #12): 4 ft. of the flight control cable pulleys were located. The torque tube and control cables were observed running forward about 6

ft. from the rudder flight control surface. The horizontal stabilizer trim actuator was found attached to its attach points.

Horizontal stabilizer (item #13): The horizontal stabilizer was located upside down within the debris field. Near the horizontal stabilizer, the left wing root was located. The cockpit voice recorder was separated from its attach points and was located under the left wing.

Right engine core section (item #10): The right engine core section was separated from the fan section.

Left main landing gear (item #6): The left main landing gear was separated and the lower torque link was fractured. Near the left main landing gear, the nose gear was also located and found separated from its attach point.

Right rudder pedal control linkages (item #7): The right rudder pedal control linkages were separated from the main wreckage. The passenger door was located near this point.

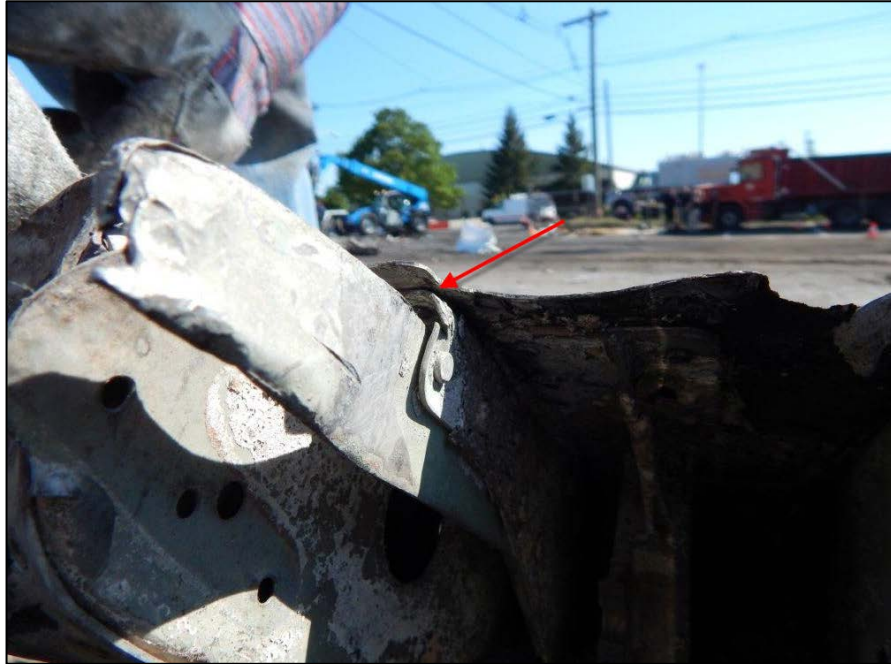
**Figure 6: Right flap track**

The flap tracks were all found intact.

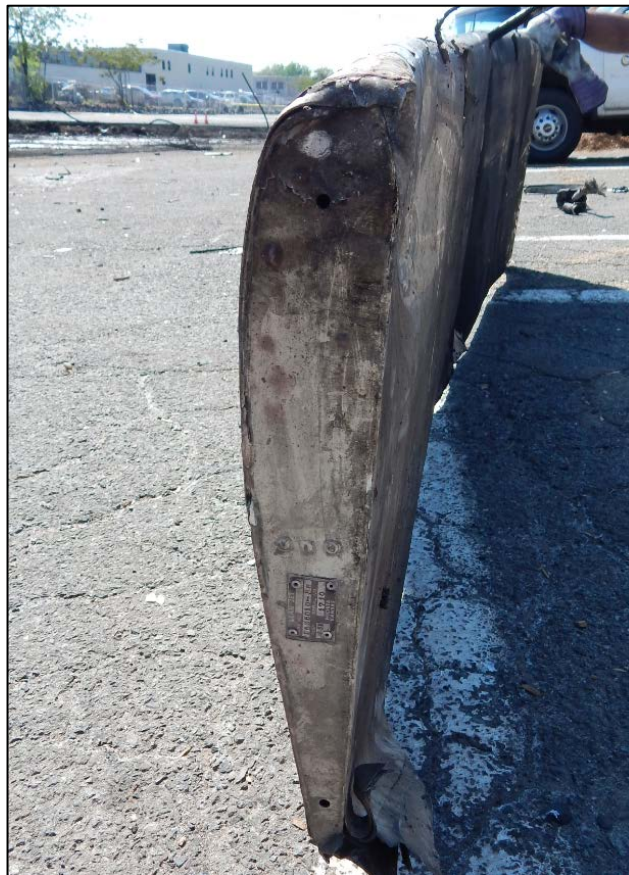
**Figure 7: Right wing flap**

The outboard edge of the right wing flap did not exhibit signs of damage consistent with aileron interference. The outboard edge of the left wing flap was crushed during the impact.

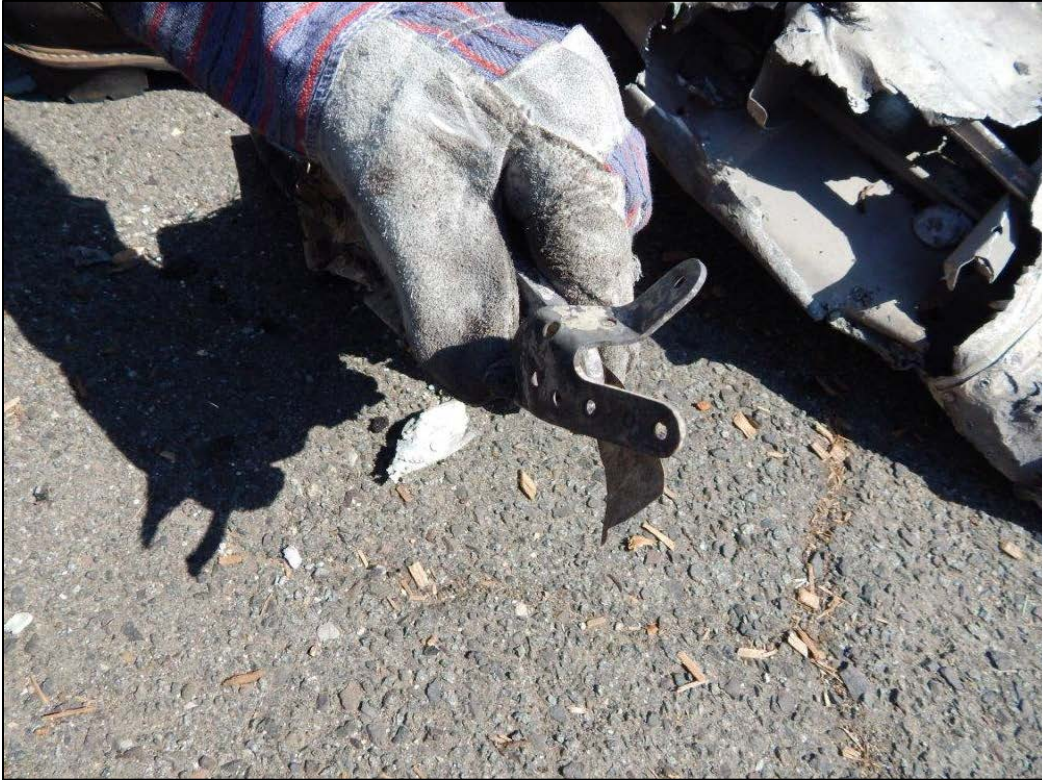
**Figure 8: Right flap inboard nose roller bracket**

The right flap inboard nose roller bracket was bent and no cracks were observed. The right flap inboard flap track bracket was inspected for cracks in the radius and none were observed.

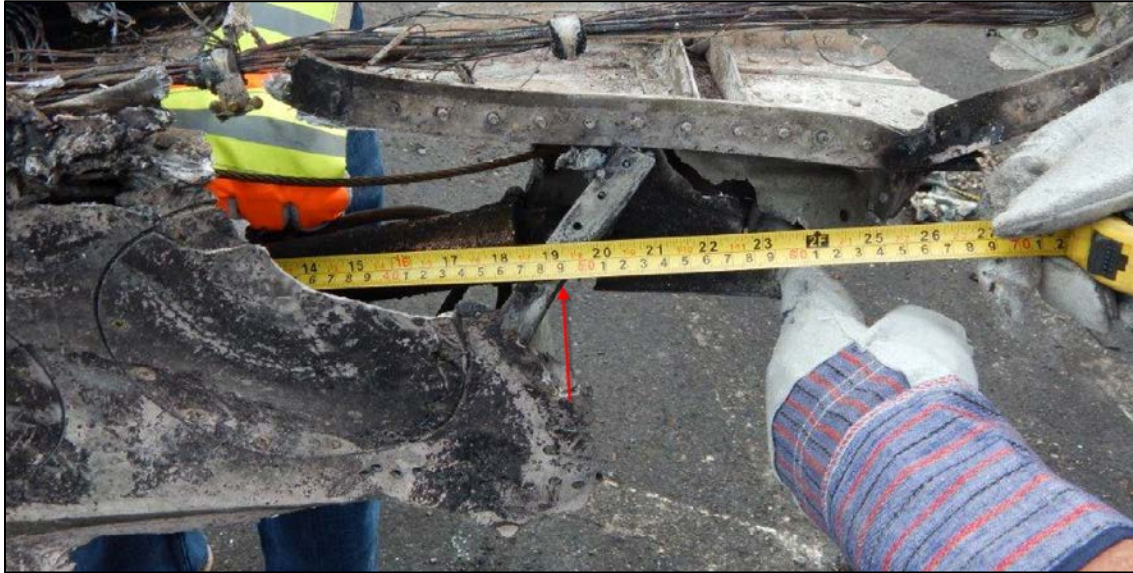
**Figure 9: Flap measurement**

The left flap actuator extension was measured and was about 19". According to the airplane manufacturer document, the fully retracted dimensions are 12.950 and the fully extended position is 19.140, as per engineering drawings. The dimensions taken indicate the actuator, as found in the wreckage, was in the fully extended position (flaps 40°).

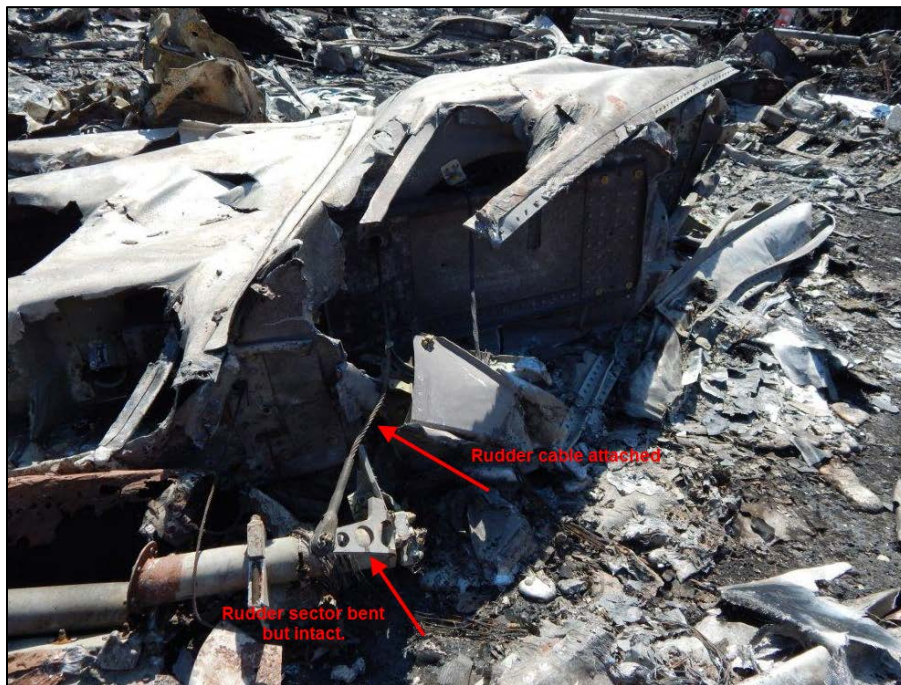
**Figure 10: Rudder section**

The rudder sector was bent, but intact. The rudder control cable remained attached to the rudder sector.

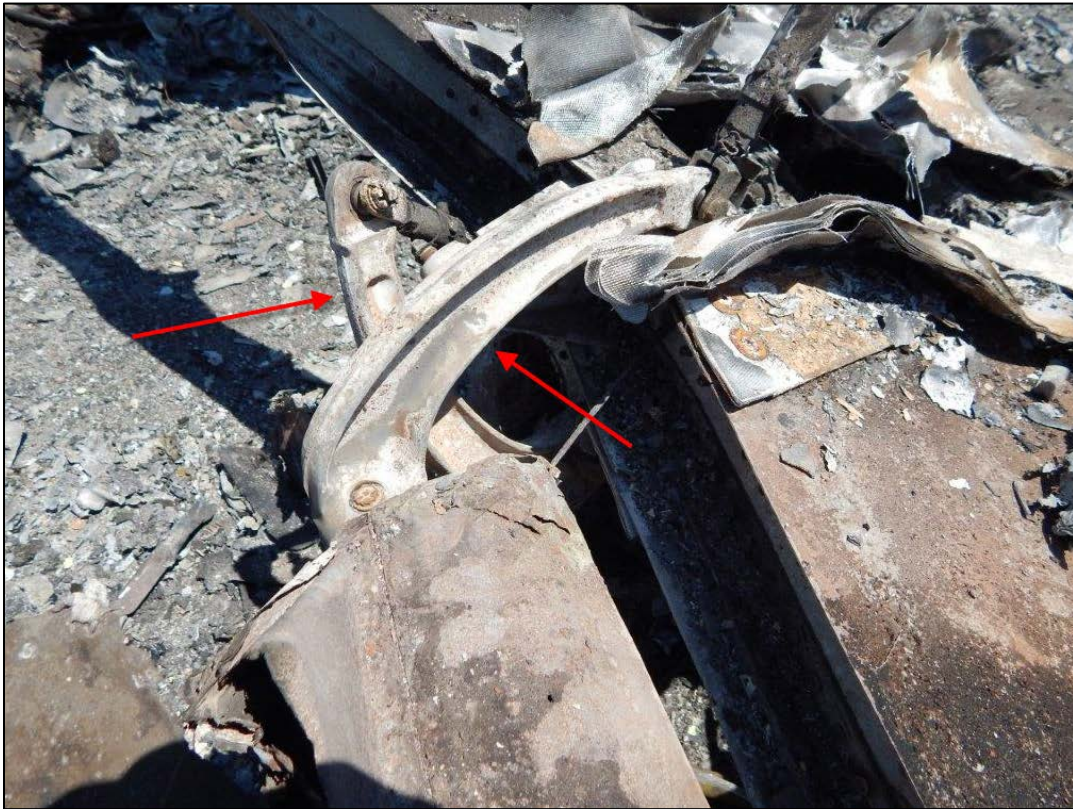
**Figure 11: Right elevator section**

The right elevator control horn remained attached to the horizontal stabilizer and the elevator. The left elevator control horn remained attached to the horizontal stabilizer.

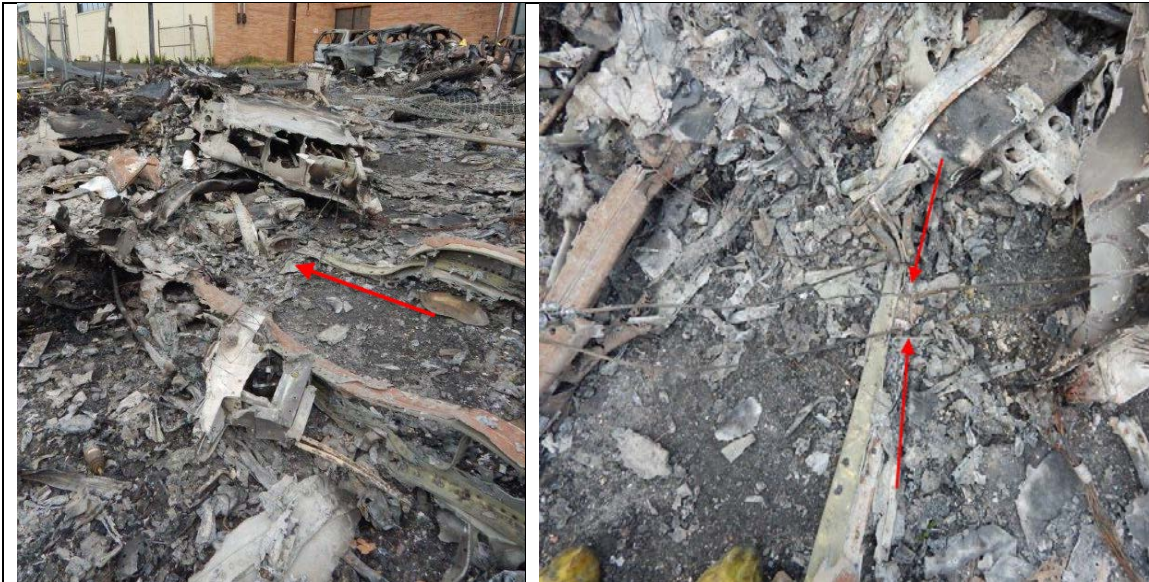
**Figure 12: Ailerons**

The left aileron cable continuity ran through the left wing section to what remained of the left aileron. The break in aileron cables were consistent with disruption from impact forces.

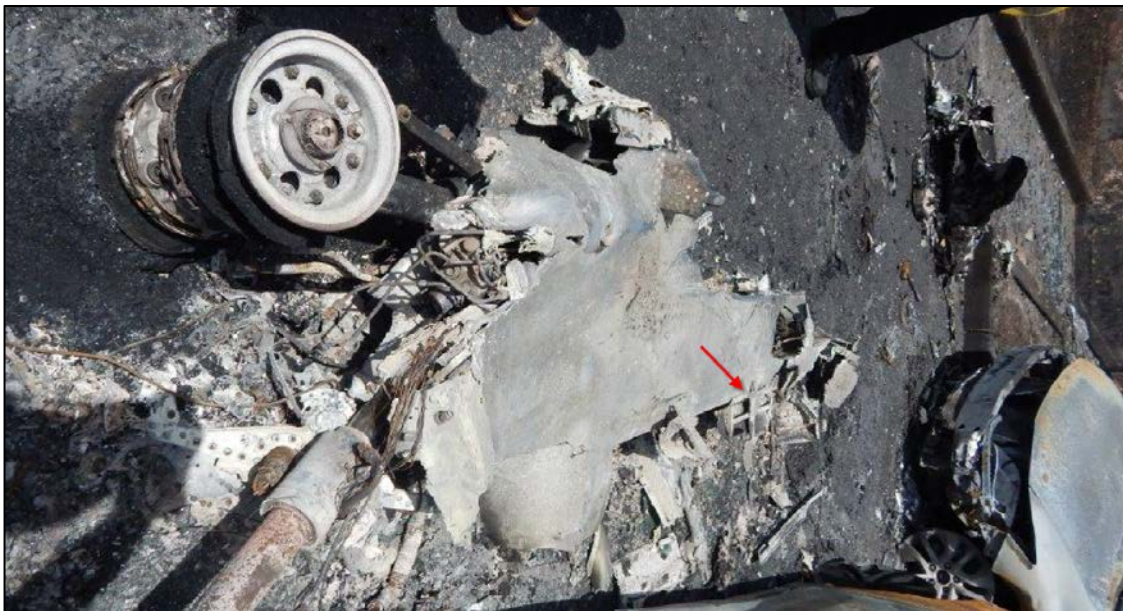
**Figure 13: Right spoiler**

The right spoiler was found down and locked.

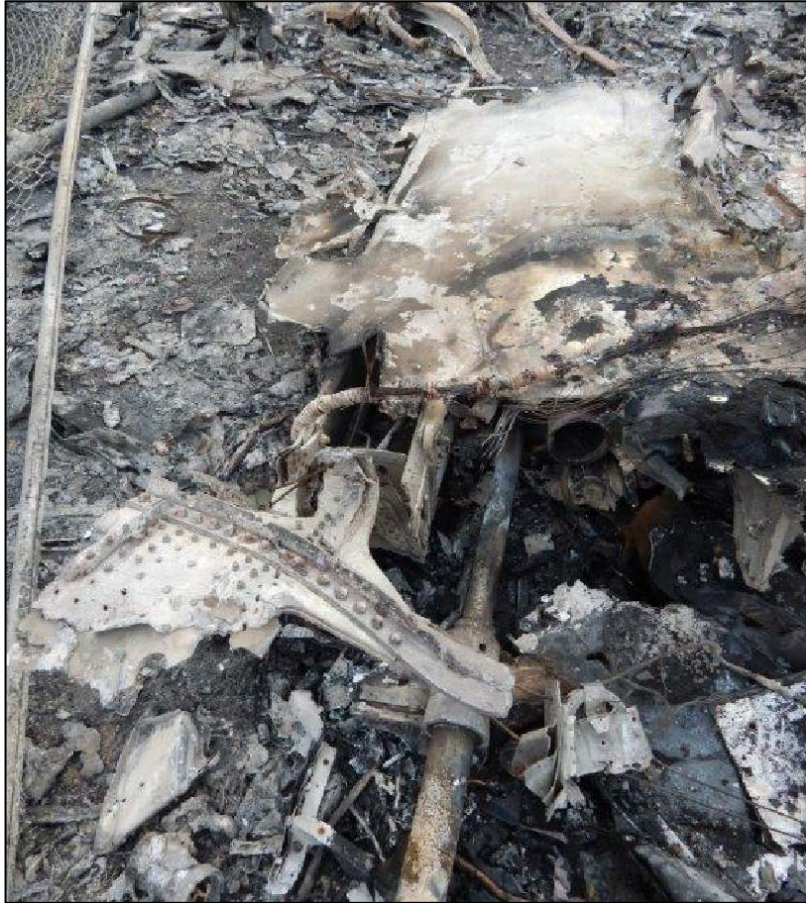
**Figure 14: Left spoiler**

The left spoiler was found down and locked.

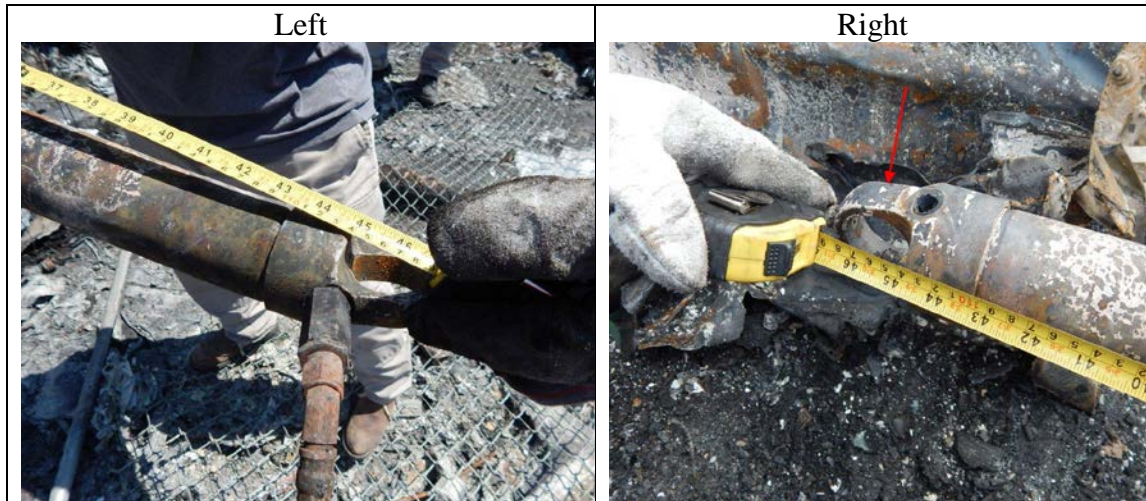
**Figure 15: Landing gear actuators**

According to the airplane manufacturer document, the main landing gear actuator extension dimensions in the down and locked position is 45.79" reference. Measurements indicated that the left and right main landing gear actuators were fully extended.

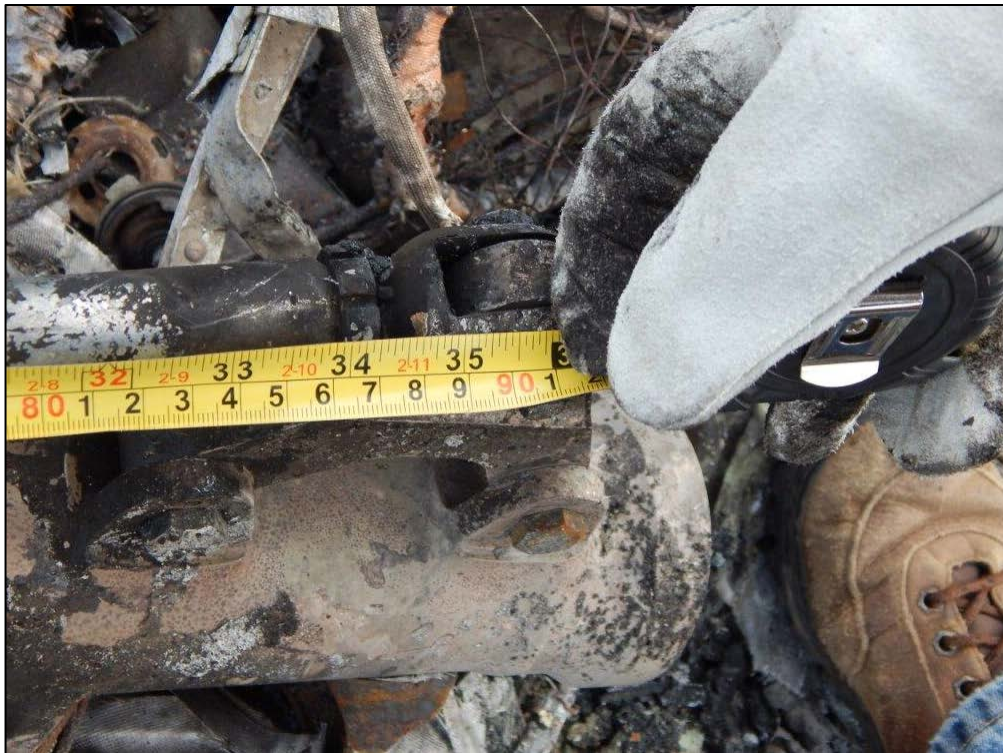
**Figure 16: Nose gear actuator**

According to the airplane manufacturer document, the nose gear actuator extension dimensions in the down and locked position is 33.79". Measurements indicated that the nose gear actuator was fully extended.

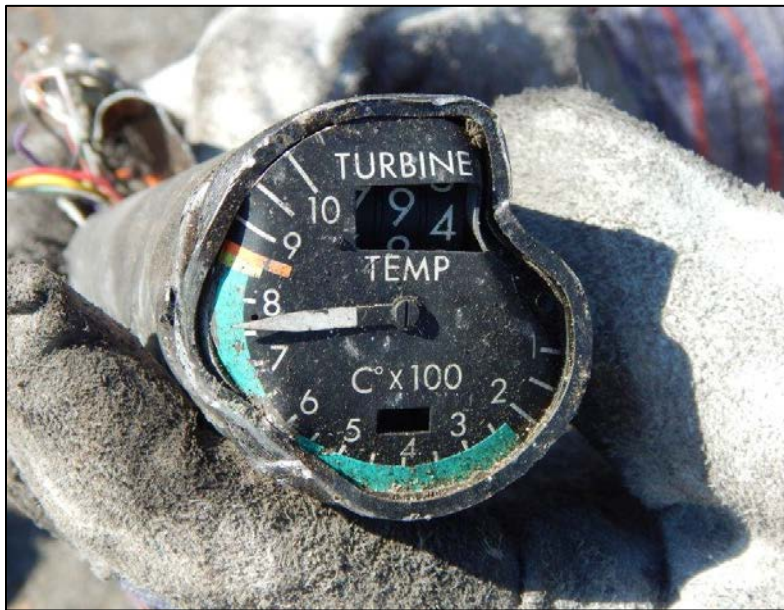
**Figure 17: Inlet turbine temperature gauge**

The inlet turbine temperature (ITT) gauge reading 794° C was noted on the gauge. Both thrust levers were found together about  $\frac{3}{4}$  of the way forward (toward max thrust).

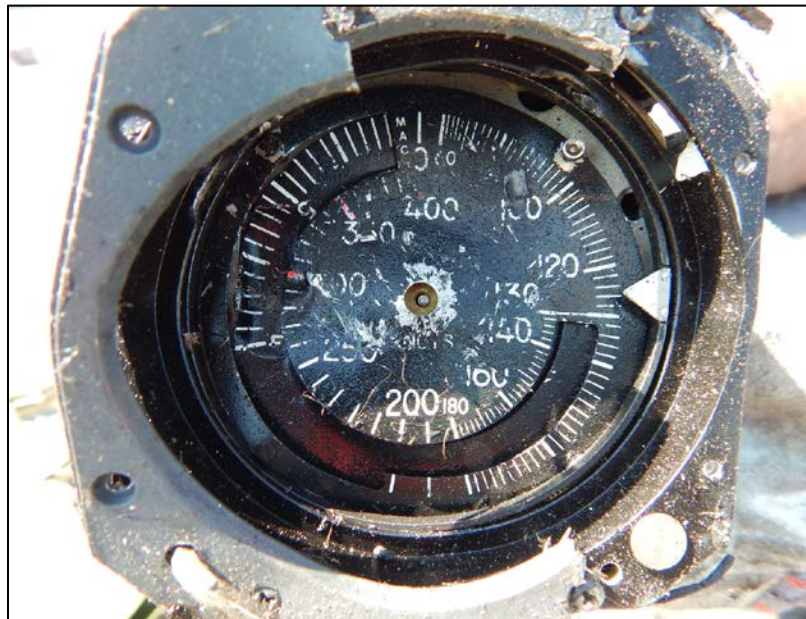
**Figure 18: Airspeed indicator**

The airspeed indicator landing reference bug was found set to 126 Knots.

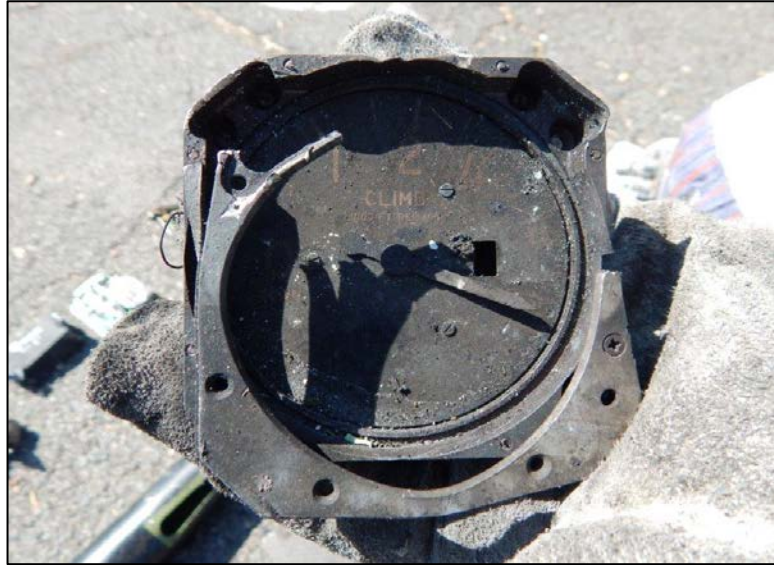
**Figure 19: Vertical speed indicator**

The vertical speed indicator pointer was found indicating a decent rate about 6000-8000 ft. per minute.

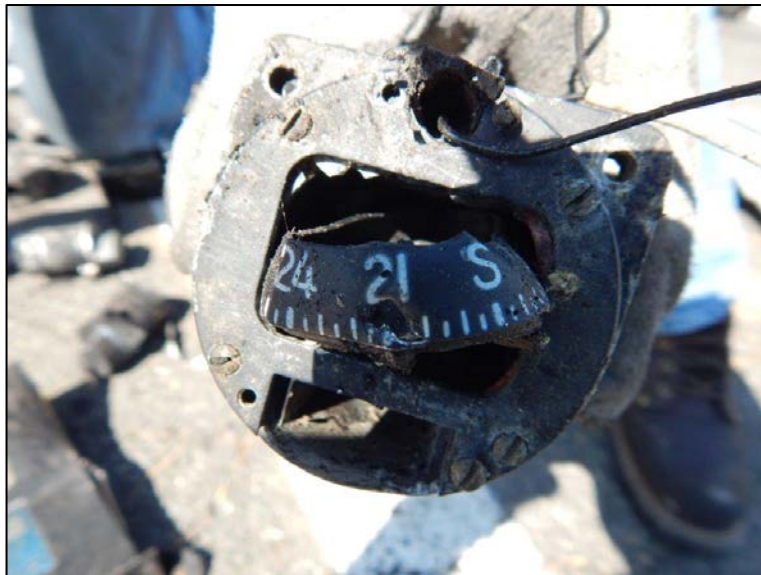
**Figure 20: Compass**

The standby compass was found indicating 210 degrees.

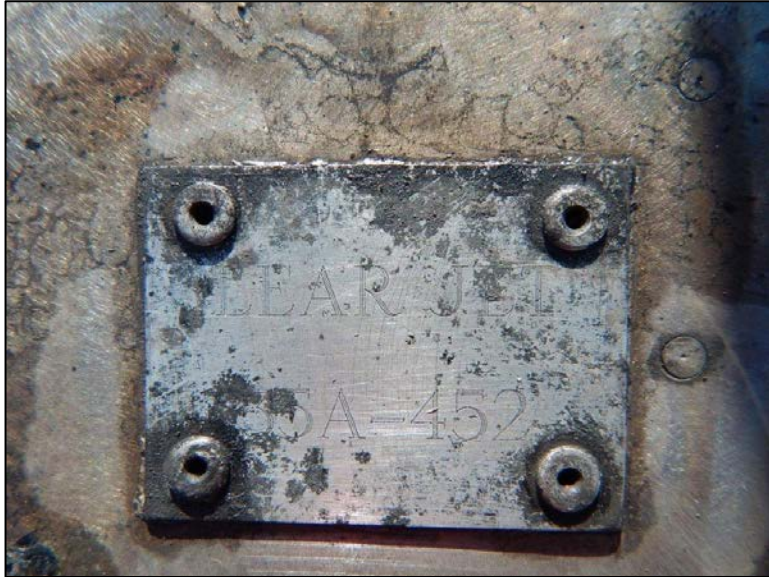
**Figure 21: Data Plate**

The data plate was found, indicating serial number 35A-452.

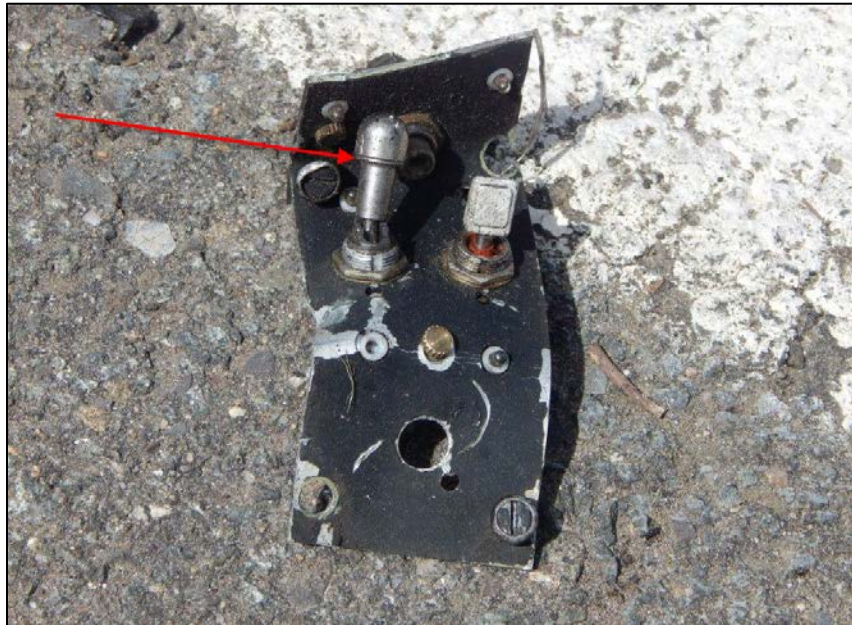
**Figure 22: Pitch trim panel switch**

The pitch trim panel switch was found set in the primary position.

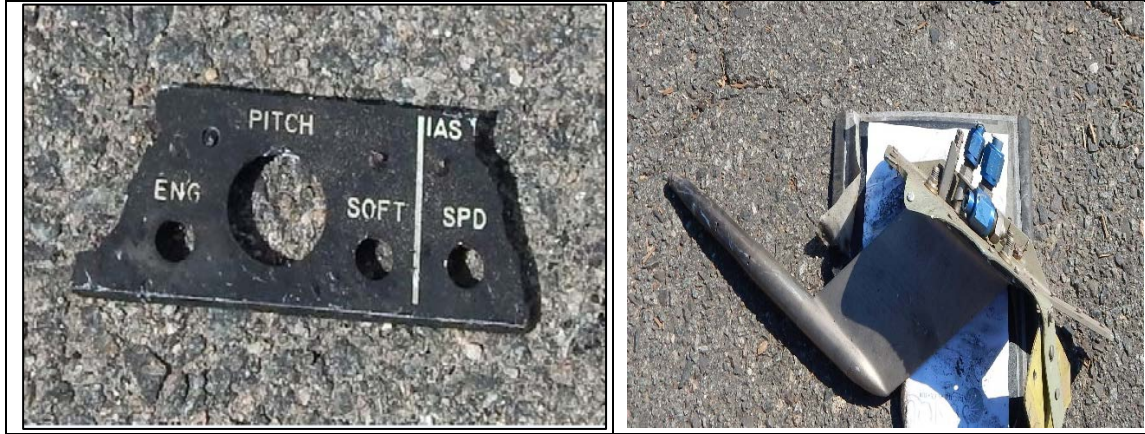
**Figure 23: Autopilot Faceplate and Pitot Probe**

A partial piece of the FC200 autopilot faceplate was located. The pitot probe was also located in the wreckage and separated from its attach point.

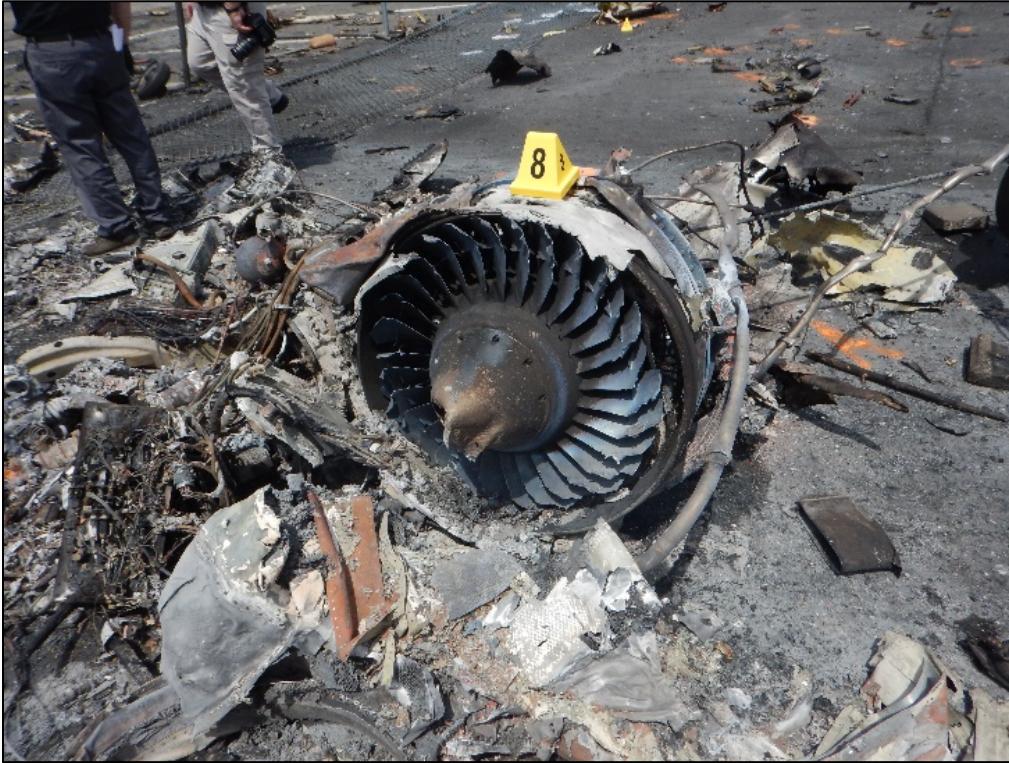
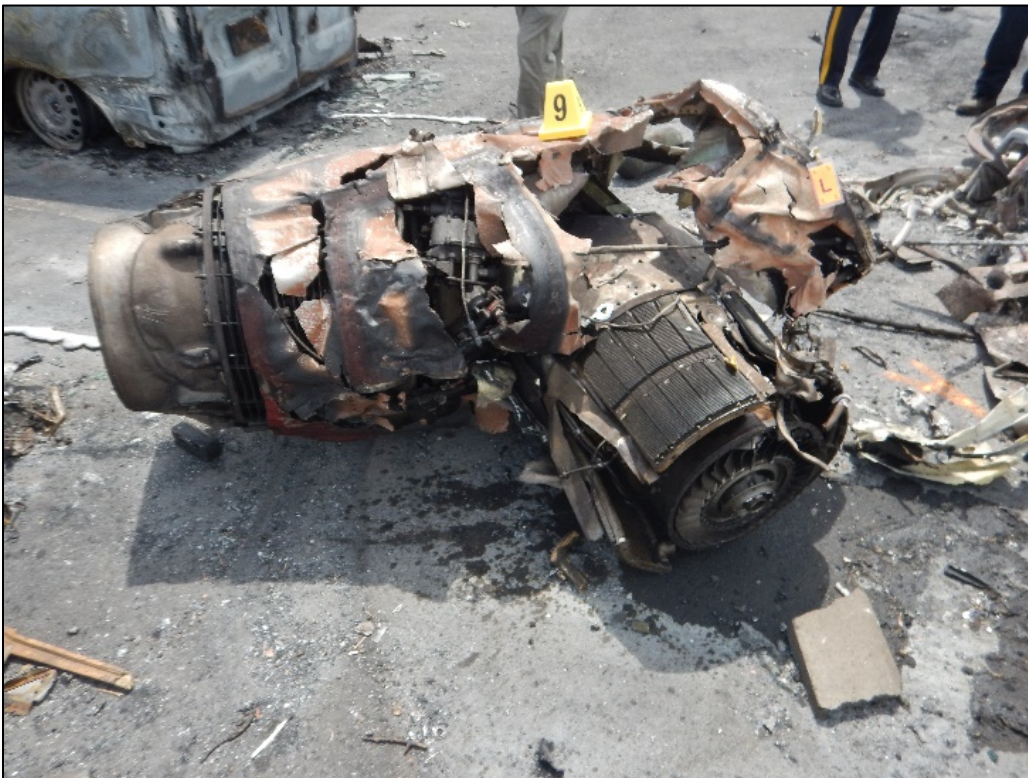
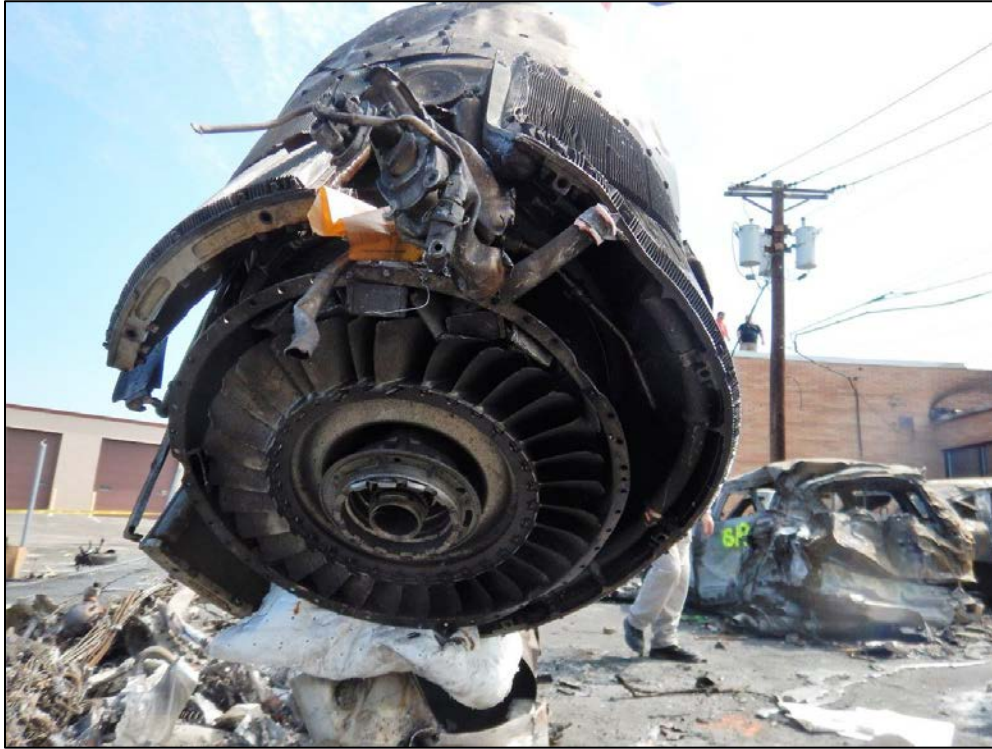
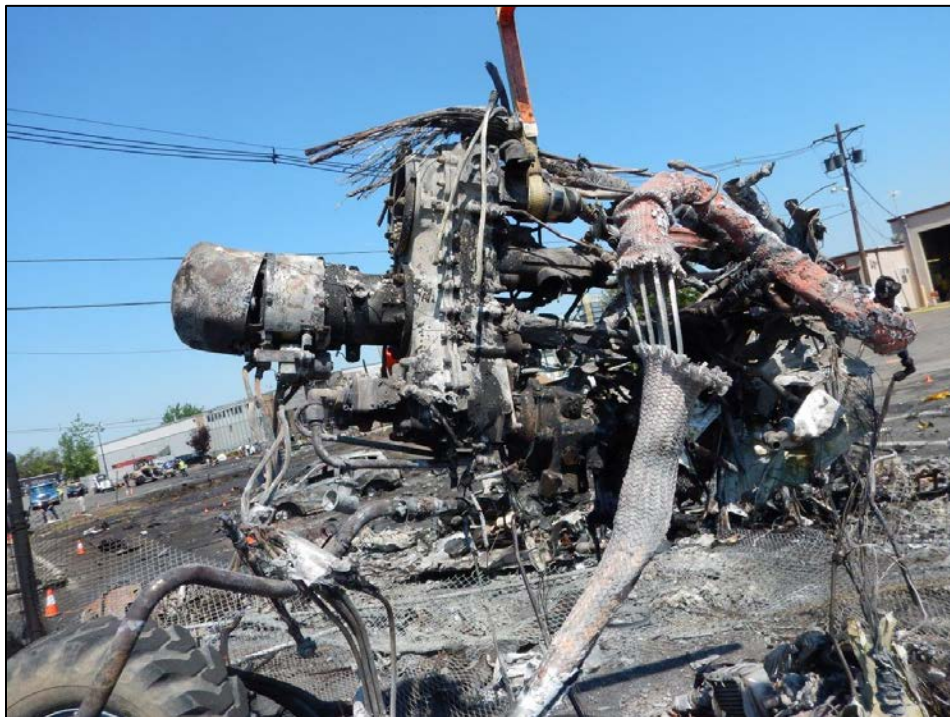
The engine was separated into two sections just aft of the engine mainframe at the low pressure compressor (LPC) case attachment split-line. The engine data plate remained attached to the engine inlet housing. The aircraft inlet was separated from the engine inlet housing. The engine inlet housing was partially consumed by the post-crash fire and was impact damaged (compression). The spinner was partially consumed by the post-crash fire. All of the fan blades were present. They exhibited tearing and battering damage and all were bent opposite the direction of rotation. All of the fan blades exhibited heat damage. The #3 bearing and housing were separated from the intermediate case. The ball bearing separator and some of the ball elements were noted in the area around the inlet and fan portion of the engine. The 1<sup>st</sup> stage LPC blade tip shroud remained with the fan section of the engine.

The accessory gearbox (AGB), transfer gearbox (TGB), fuel control unit (FCU), fuel pump and starter/generator were separated from the engine but remained loosely attached to the mainframe by plumbing and electrical wiring. The engine core (compressor and turbine sections) remained loosely connected to the engine's aircraft aft body and thrust reverser (T/R) by various plumbing lines. The Aeronca type thrust reverser (T/R) appeared to be in the stowed position. The engine core was impact damaged. The 1<sup>st</sup> and 2<sup>nd</sup> stage compressor blades exhibited tearing and battering damage and were bent opposite the direction of rotation. The stator vanes were damaged, loose in their mounts and some were missing. The N1 (LPC) was not free to rotate. When viewed through the exhaust, all of the 3<sup>rd</sup> stage turbine blades and stator vanes appeared to be intact. Both oil caps were present and in place. When the engines were moved during recovery, oil was noted to be draining from the engine fragments.

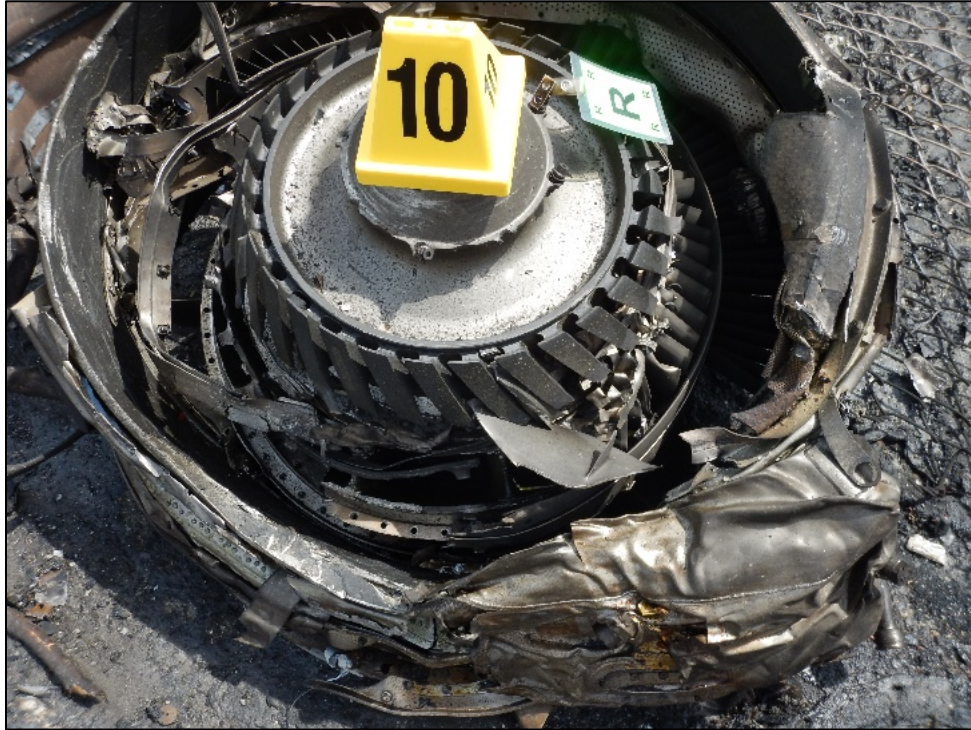
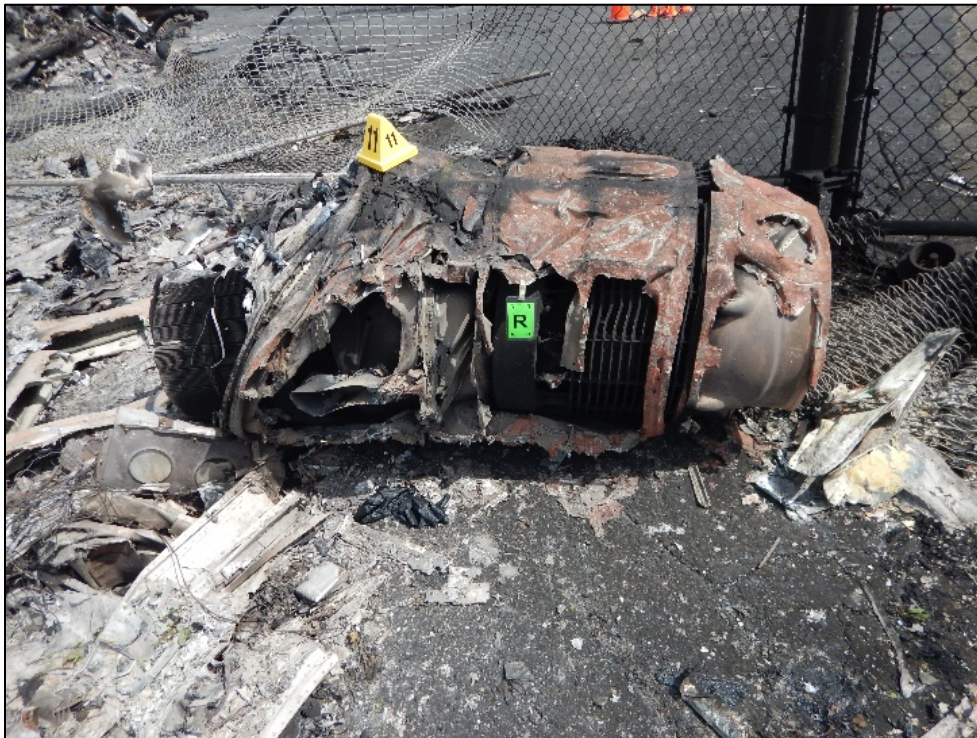
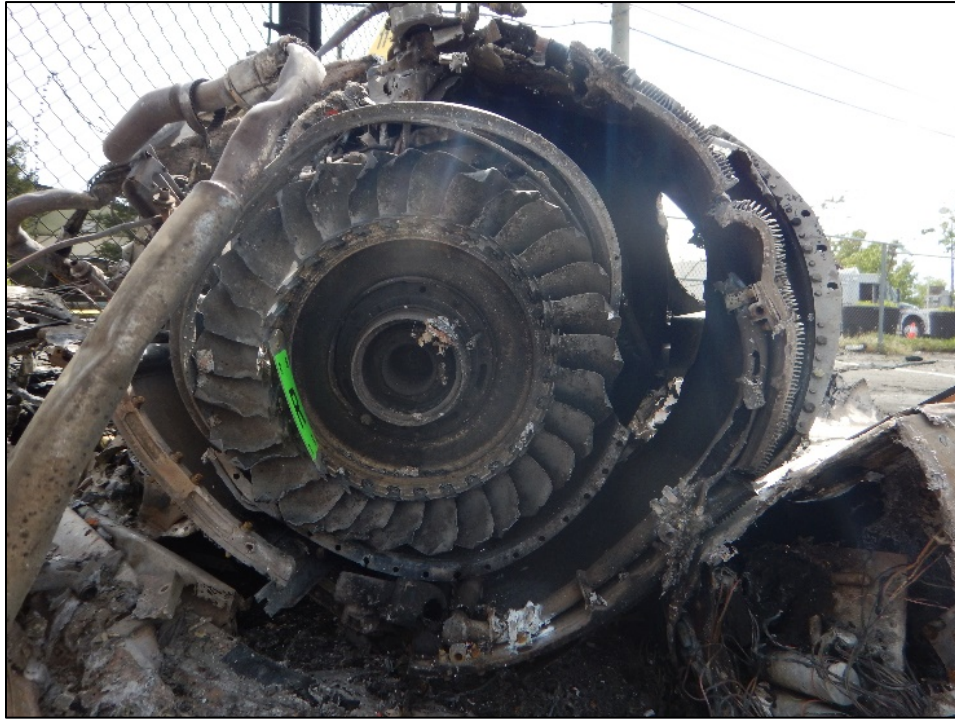
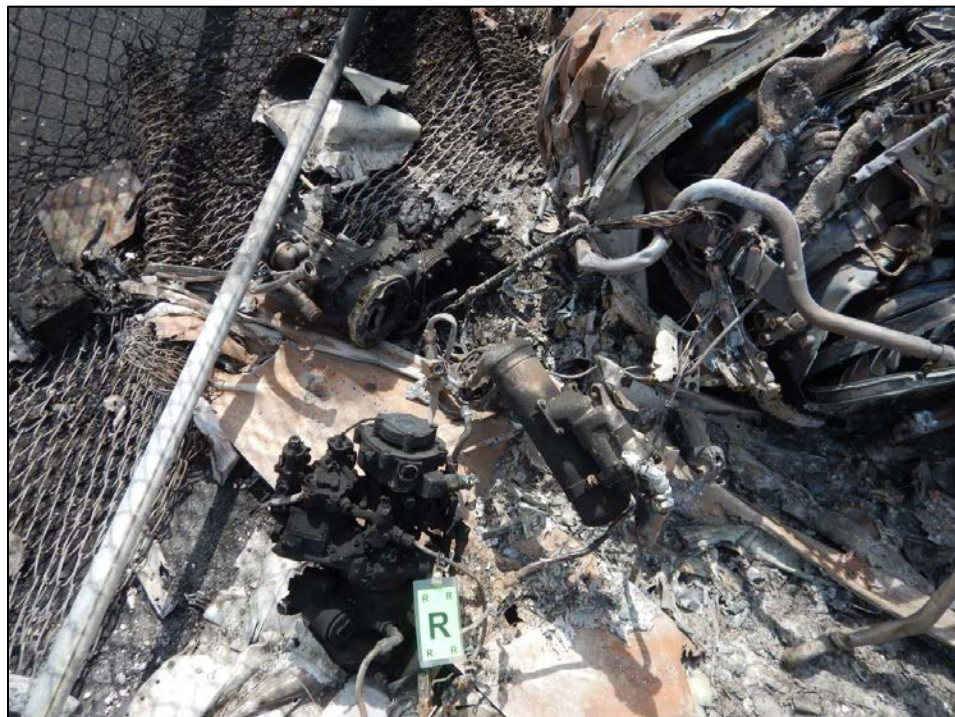
The engine was separated into two sections just aft of the engine mainframe at the low pressure compressor (LPC) case attachment split-line. The engine data plate was found loose in the debris field. The aircraft inlet was separated from the engine inlet housing. The engine inlet housing was mostly consumed by the post-crash fire and was impact damaged. The spinner was separated from the fan assembly. The remaining spinner support bolts were displaced in the opposite direction of rotation. Most of the fan blades were separated from the fan disk. Many of the remaining blades were fractured just outboard of the dovetail attachment blade platforms. The separations were in the direction opposite of the fan rotation. The located separated blades exhibited tearing and battering damage. The #3 bearing and housing remained attached to the engine core.

The accessory gearbox (AGB), transfer gearbox (TGB), fuel control unit (FCU), fuel pump and starter/generator were separated from the engine and were also separated from their respective attachment points. The engine core (compressor and turbine sections) remained within engine's aircraft aft body and thrust reverser. The Aeronca type thrust reverser (T/R) appeared to be in the stowed position. The engine core was impact damaged. The 1<sup>st</sup> and 2<sup>nd</sup> stage compressor blades exhibited tearing and battering damage and were bent opposite the direction of rotation. The stator vanes were damaged, loose in their mounts and some were missing. The N1 (LPC) was not free to rotate. When viewed through the exhaust, all of the 3<sup>rd</sup> stage turbine blades and stator vanes appeared to be intact. Metal spray deposits were adhering to the 3<sup>rd</sup> stage turbine stator vanes. Both oil caps were present and in place. When the engines were moved during recovery, oil was noted to be draining from the engine fragments.
