**NATIONAL TRANSPORTATION SAFETY BOARD
OFFICE OF AVIATION SAFETY
WASHINGTON, D.C. 20594**

AIRWORTHINESS SPECIALIST'S REPORT OF INVESTIGATION

DCA11MA076

Operator: Gulfstream Aerospace Corporation
Aircraft: GVI (G650), Serial Number 6002
Location: Roswell, NM
Date: April 2, 2011
Time: 0934 MDT

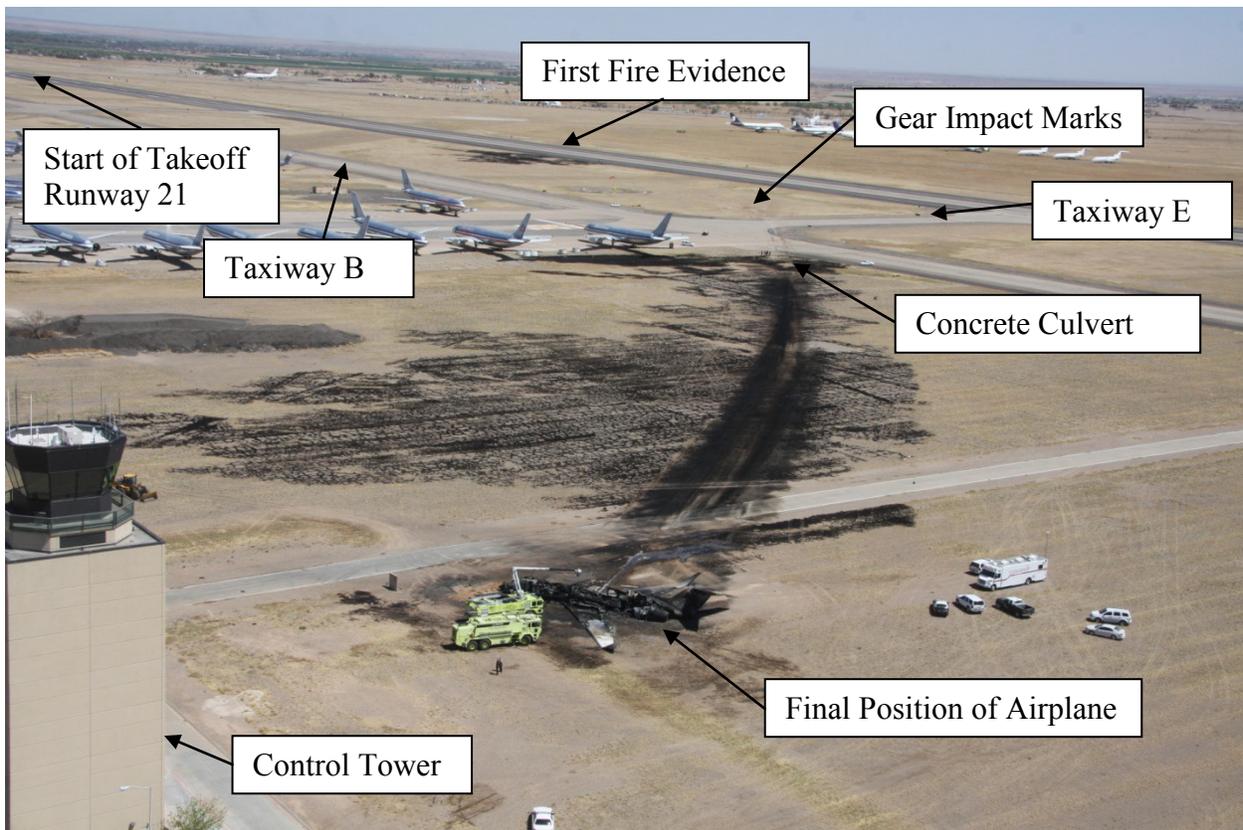
Figure 4 Overview of Wreckage Path from Final Position

Figure 4 provides an aerial view looking back over the wreckage path. There was evidence that the right wing tip first made contact with runway 21, starting about 5160 feet from the runway threshold. The right wing tip continued to touch the runway as the airplane departed the runway off the right side into the grassy area between runway 21 and taxiway B. There was evidence of a fire in the grass adjacent to the runway where the wing tip scrape marks departed the runway (Figure 5, 6). The right main gear tires contacted the ground, then the left main gear tires, then the right main gear tires (again), then the nose gear (Figure 7). The main gear separated from their attachments at the fuse separation points. The nose gear collapsed and the airplane then skid on its belly across the intersection of taxiways E and B (Figure 8). There were marks on the ground consistent with the approximate width and location of the forward and aft skags³. There were also tire marks across the intersection consistent with the right and left main landing gear. The airplane continued through the intersection and into the grass area where it impacted a runway information sign (Figure 9) and an exposed concrete culvert (used for underground electrical access)(Figures 8-10). The concrete culvert is located approximately 165 feet from the centerline of the Taxiway B, and

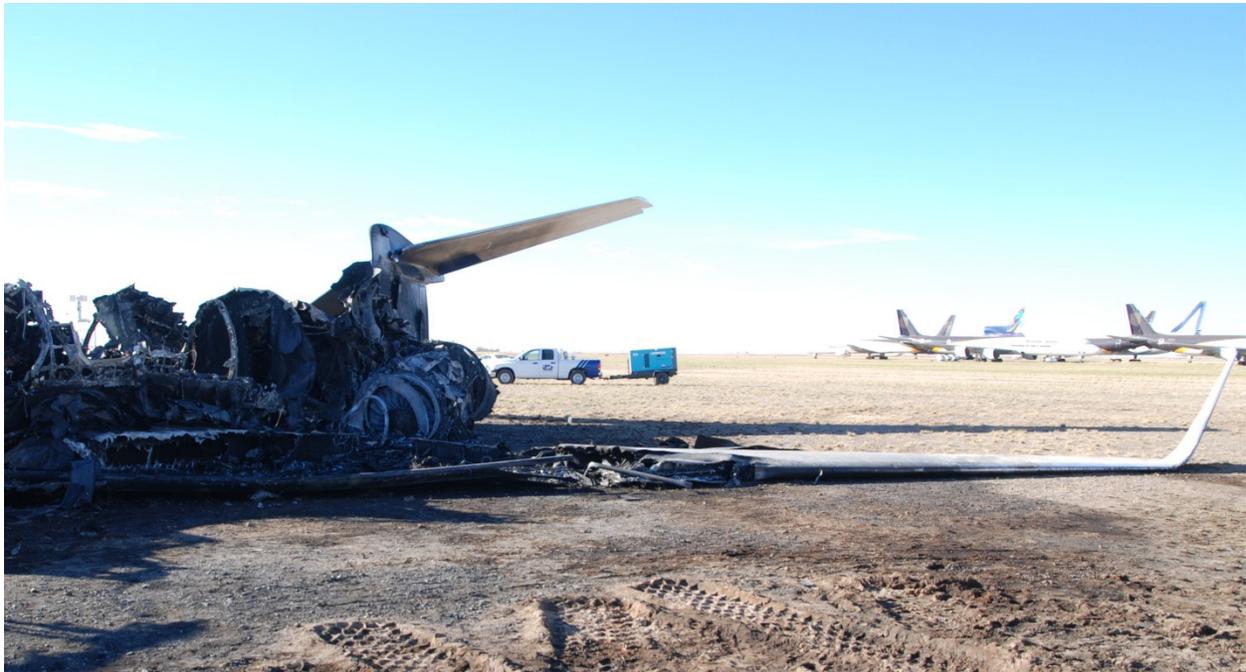
Figure 15 Left Wing Overview

The left wing experienced structural damage from impact with the weather station and substantial fire damage from the post impact fire (Figure 15). Figure 16 shows the wing station locations. The upper skin and ribs were melted from butt line (BL) 62.0 to approximately rib baffle station (RBS) 250 (Figure 17). At the leading edge (LE) there was a 24" X 46" hole centered at RBS 242 and a 10" x 12" hole centered at RBS 322. The LE had no further damage outboard to the wing tip. At the trailing edge (TE), from the wing tip in through the aileron had no damage. The aileron surface, four hinge fittings and two actuator attach fittings were all intact.

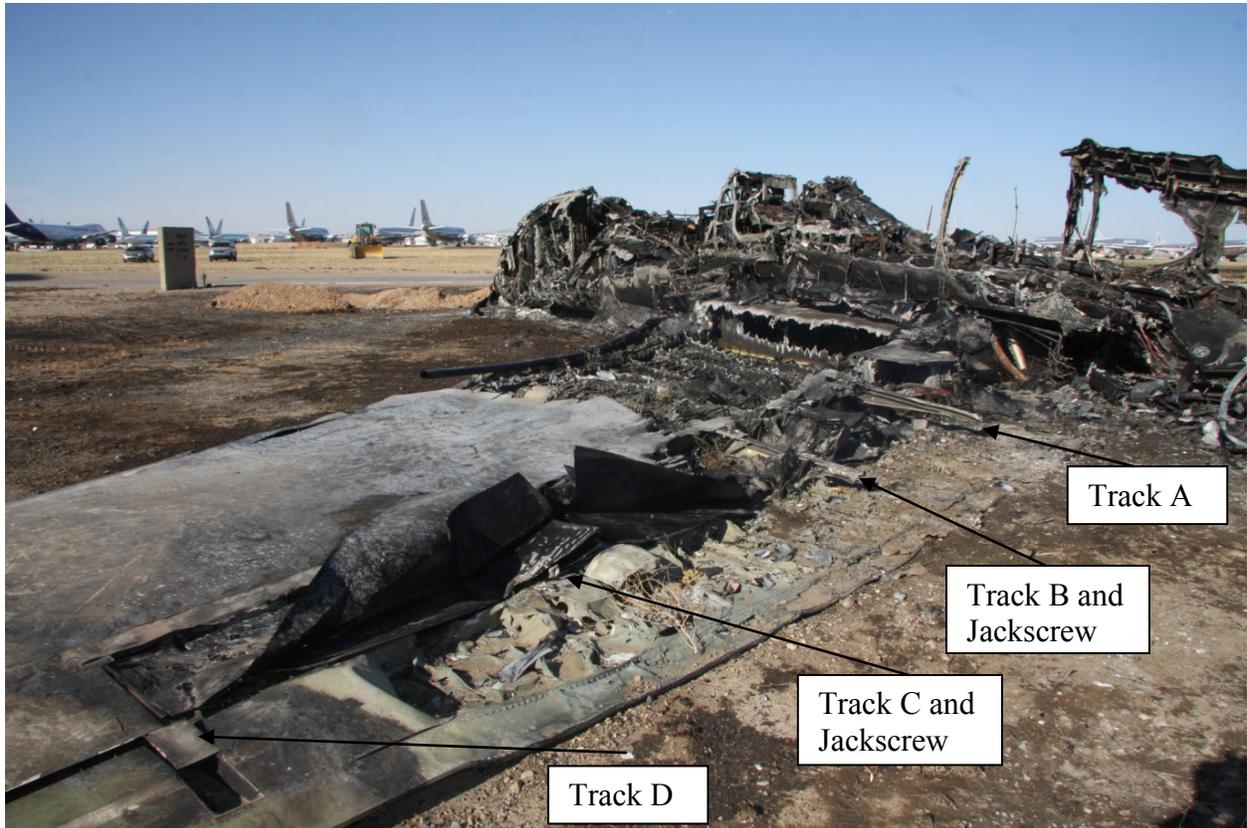
Figure 21 Left Wing Trailing Edge

The flap surface was intact from the most outboard portion to approximately 2 feet inboard of the outboard track (Track D) (Figure 21). Inboard of that point the surface and attach points were mostly melted. Flap track A was intact with flap rollers detached, but in close proximity on the ground. Flap track B was intact with the carriage still attached to the jackscrew (Figure 22). The jackscrew position was measured from the up stop to top of ballscrew – 16 5/8 inches, and the downstop to bottom of ballscrew - 12 3/4 inches. Flap track C was intact with the carriage still attached to the jackscrew (Figure 23). The jackscrew position was measured from up stop to top of ballscrew - 13 3/4 inches, and the downstop to bottom of ballscrew – 10 3/8 inches. According to Gulfstream these measurements of the jackscrew position are consistent with flaps in the 10 degree position. Flap track D structure and attach fittings all intact and connected to unmelted flap surface.

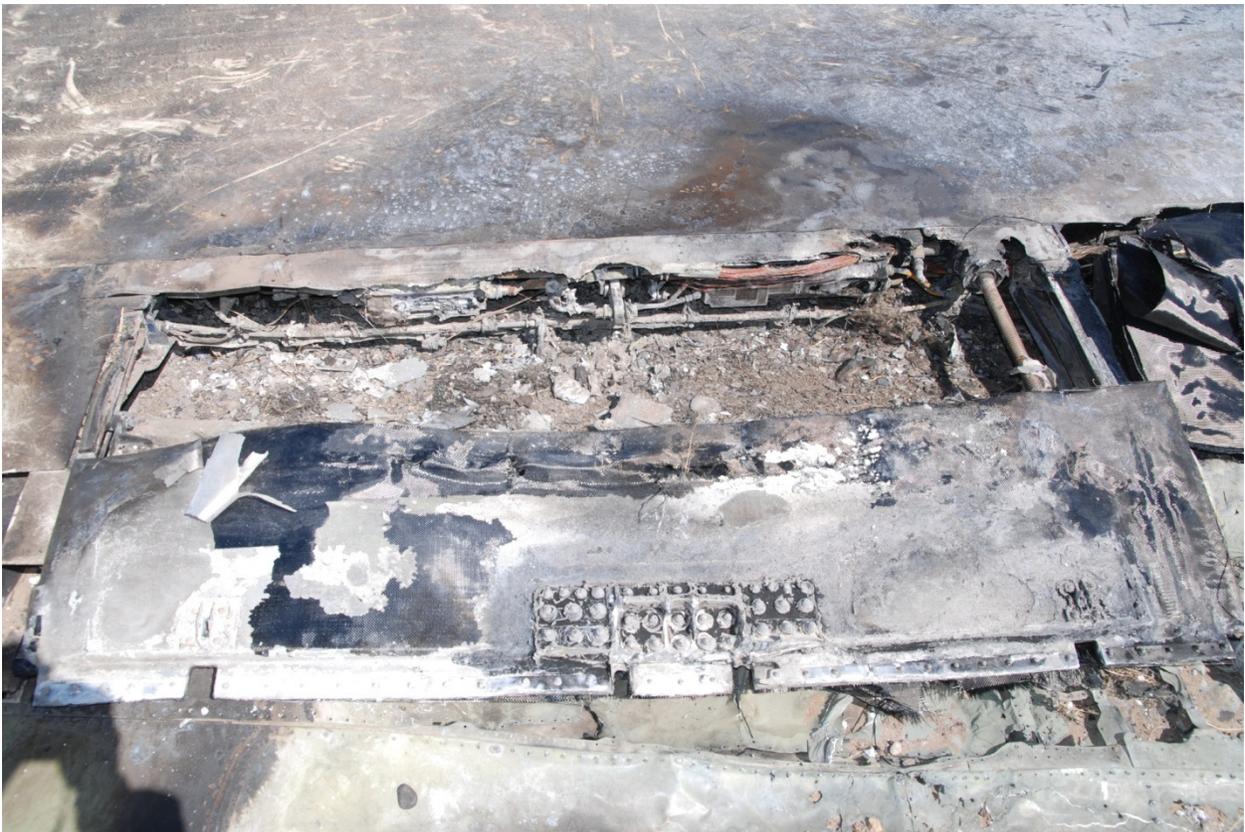
Figure 24 Left Outboard Spoiler Turned Over

The composite spoilers had extensive heat damage. The outboard spoiler was delaminated and all four hinge fittings were detached and melted (Figure 24). The actuator and connecting link (toggle link) were intact, including attachment bolts (Figure 25). The middle spoiler was delaminated (Figure 26). The two hinges nearest the actuator were present with attach fittings, but heat damaged and fractured. The most inboard hinge was melted. The actuator and connecting link (toggle link) were intact, including attachment bolts (Figure 27). The inboard spoiler was delaminated and consumed (Figure 28), with all attach fittings melted.

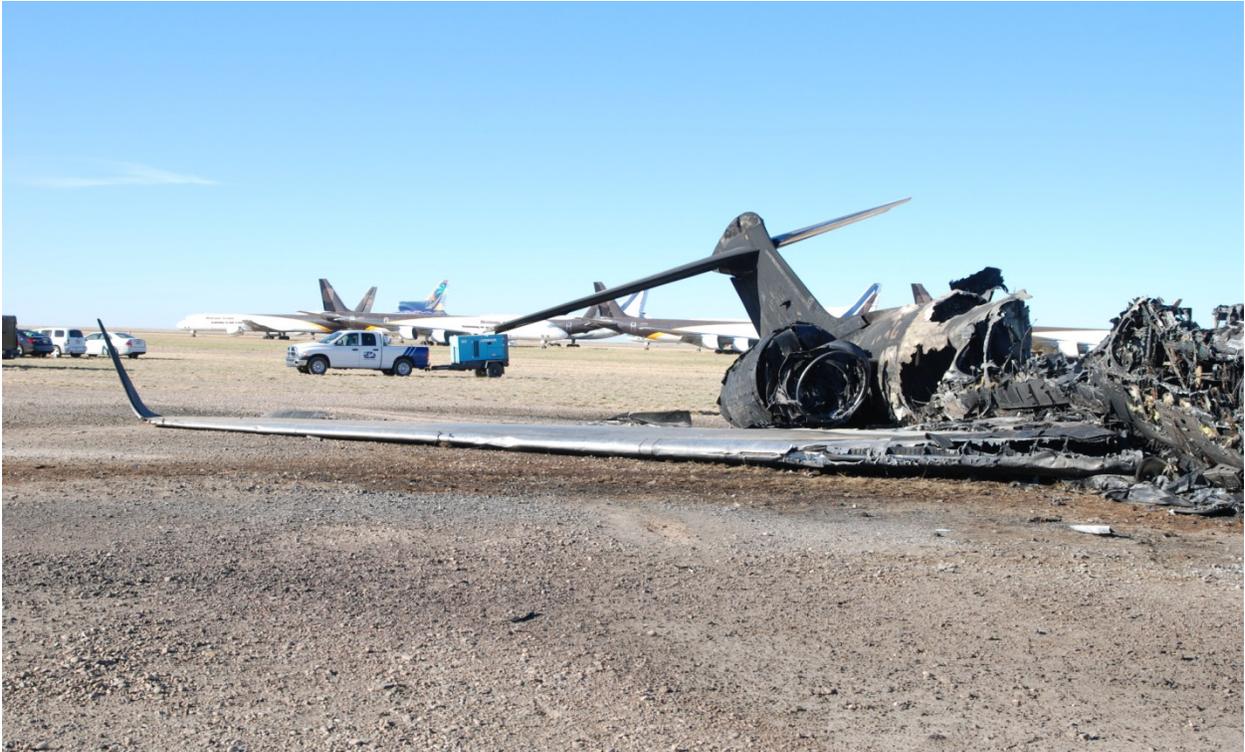
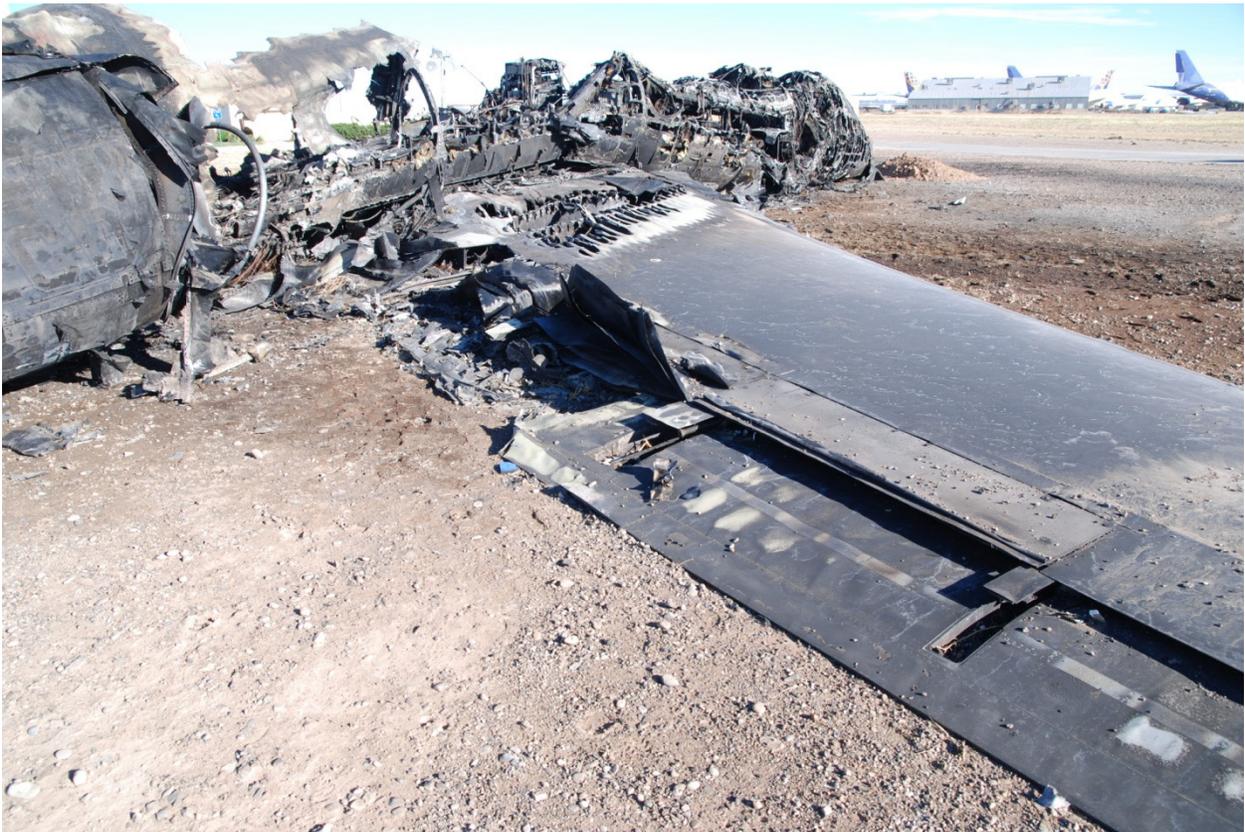
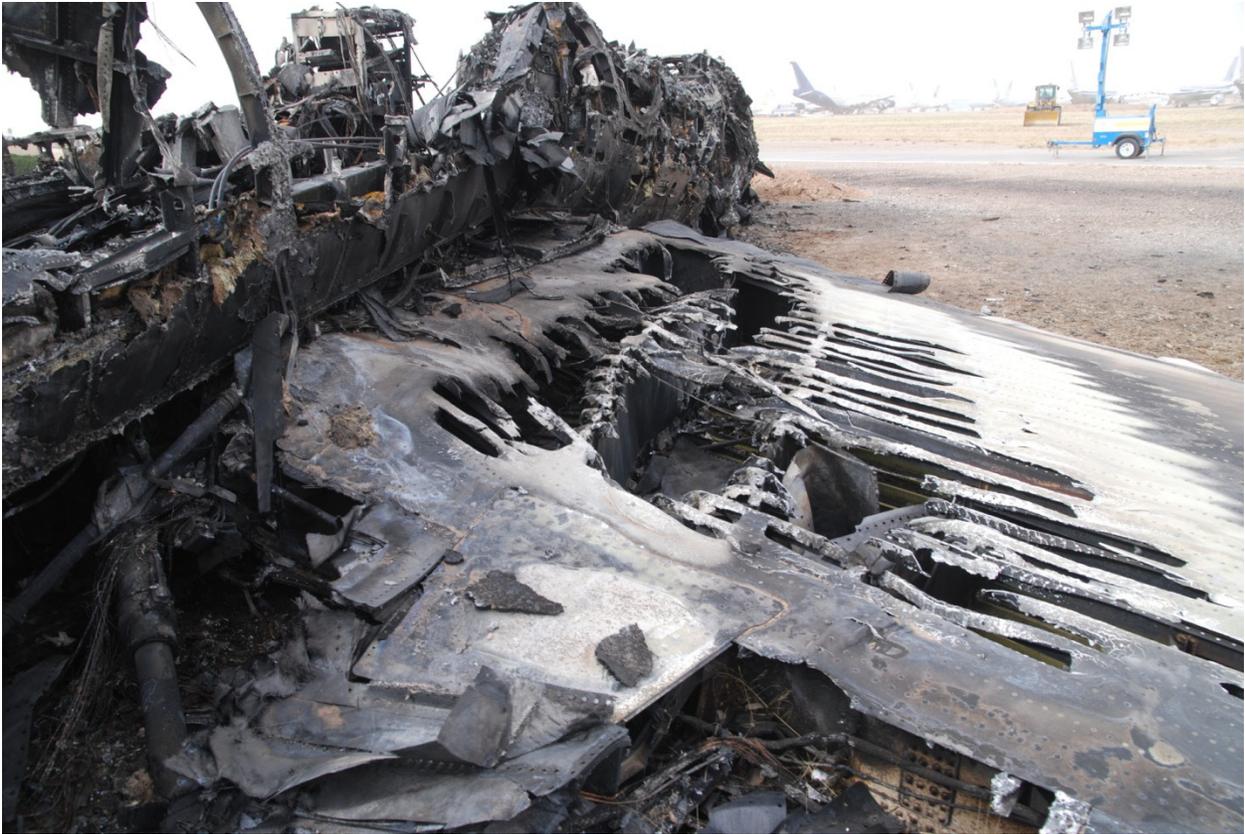
The inboard portion of the right wing experienced substantial fire damage from the post impact fire (Figures 29 - 31). The leading edge had melted out to approximately RBS180. The upper skin was melted from BL 62.0 to approximately BL143. On the trailing edge, the flap surface was melted inboard of RBS 300.

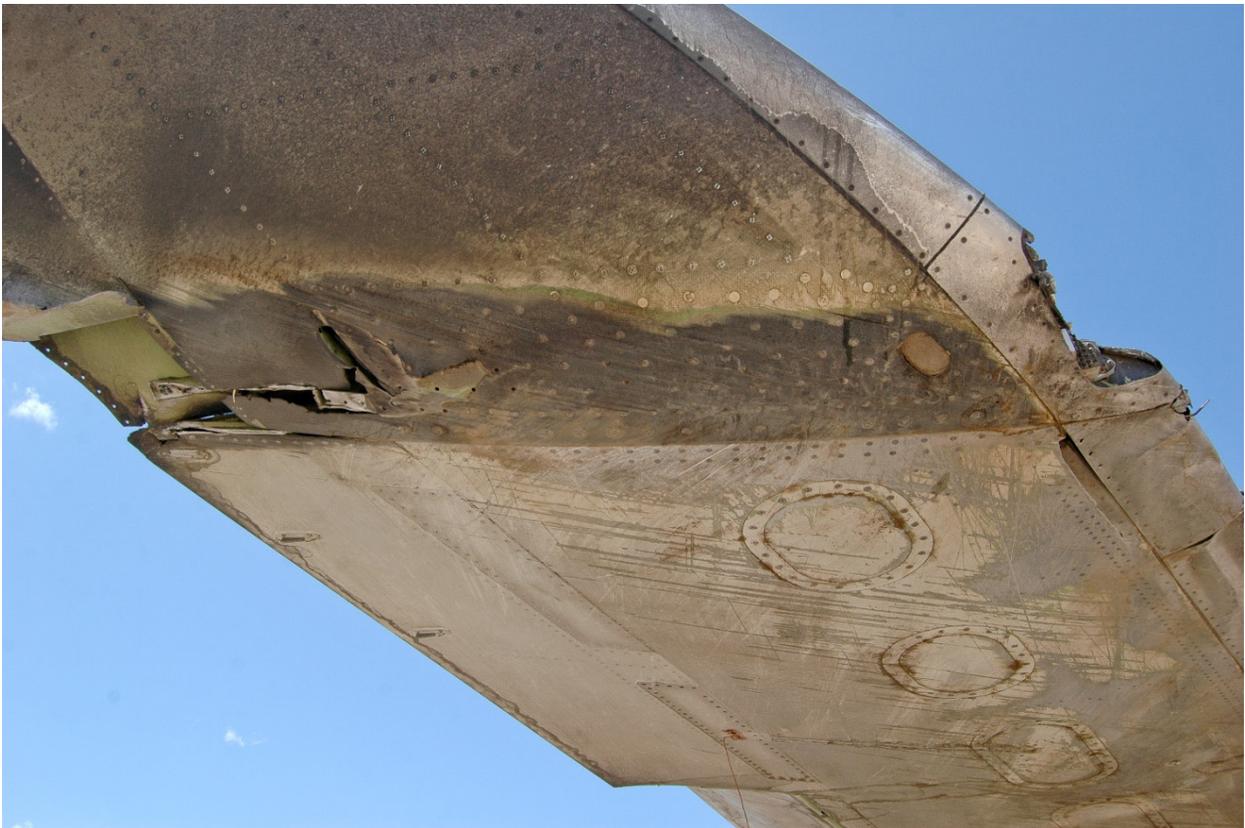
Figure 32 Right Wing Tip Scrape

Along the LE there were small dents at approximately RBS 260, RBS 325, and 585. At the bottom of the winglet there is a scrape from the LE to the TE (Figure 32).

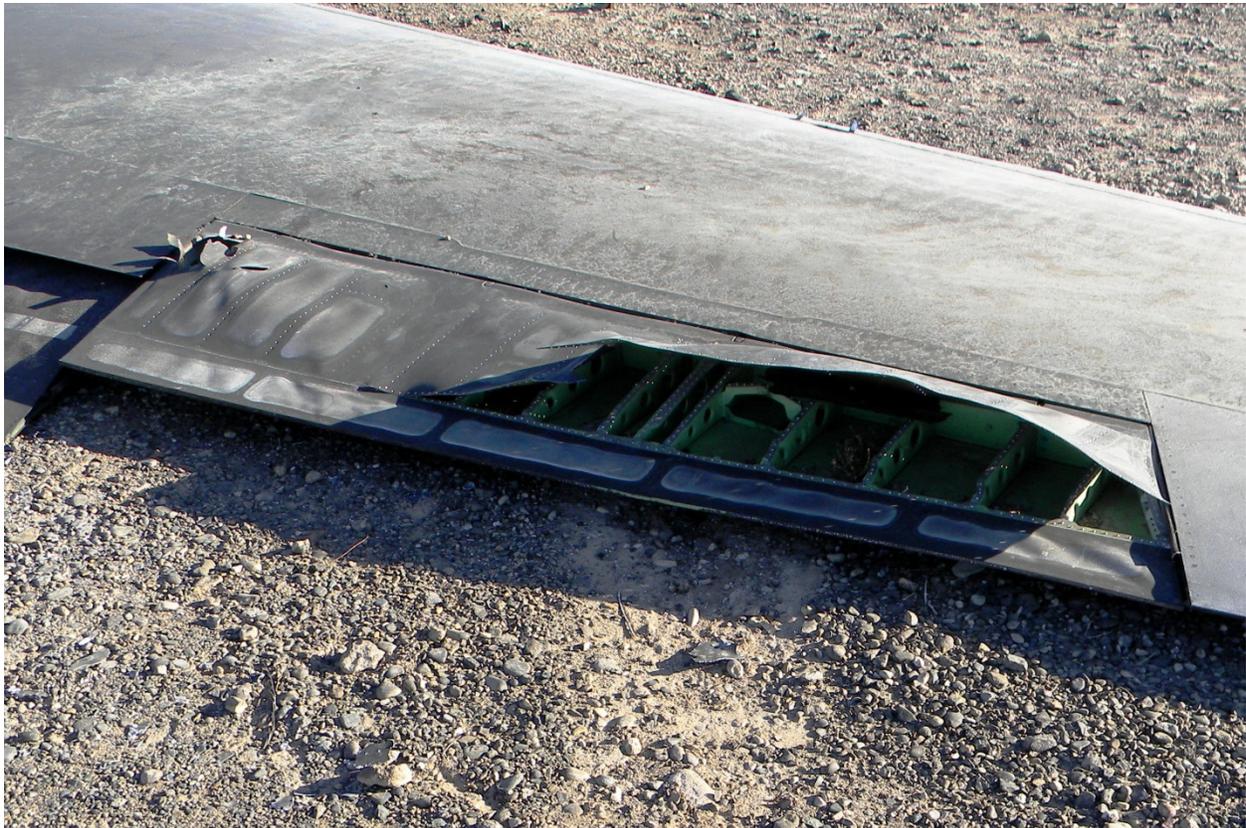
Figure 33 Right Wing Aileron

The aileron surface was intact except the upper skin surface was bulged and detached near the outboard end (Figure 33). There was a small hole near the inboard end which had upward petalling. All attachment points were confirmed to be intact.

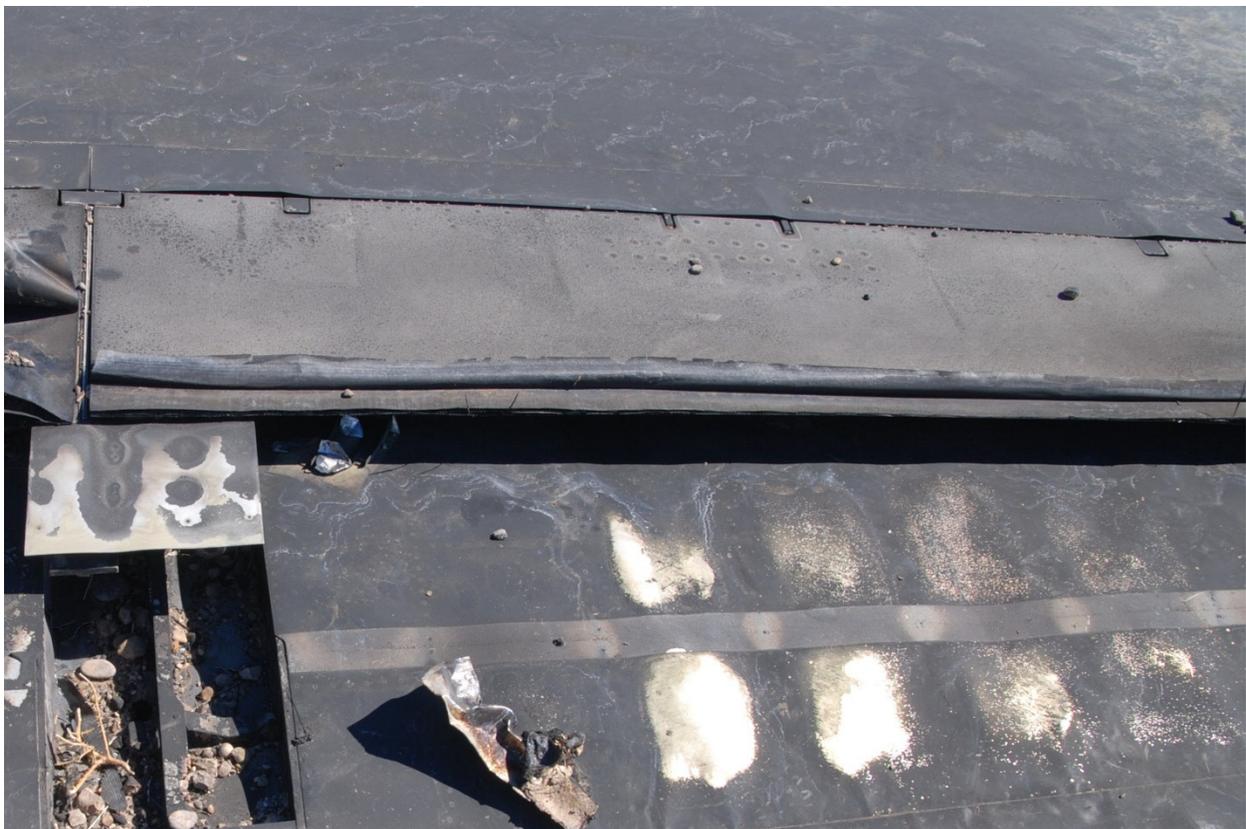
Figure 34 Right Outboard Spoiler

The outboard spoiler was intact with all hinges and actuator attached (Figure 34). The middle spoiler had some surface delaminated, with hinges present but detached from surface, the attach points for the actuator intact, and attached to the surface (Figure 35). The inboard spoiler had extensive heat damage and delamination of the surface (Figure 36). All hinge points were detached and the actuator attach fitting fractured.

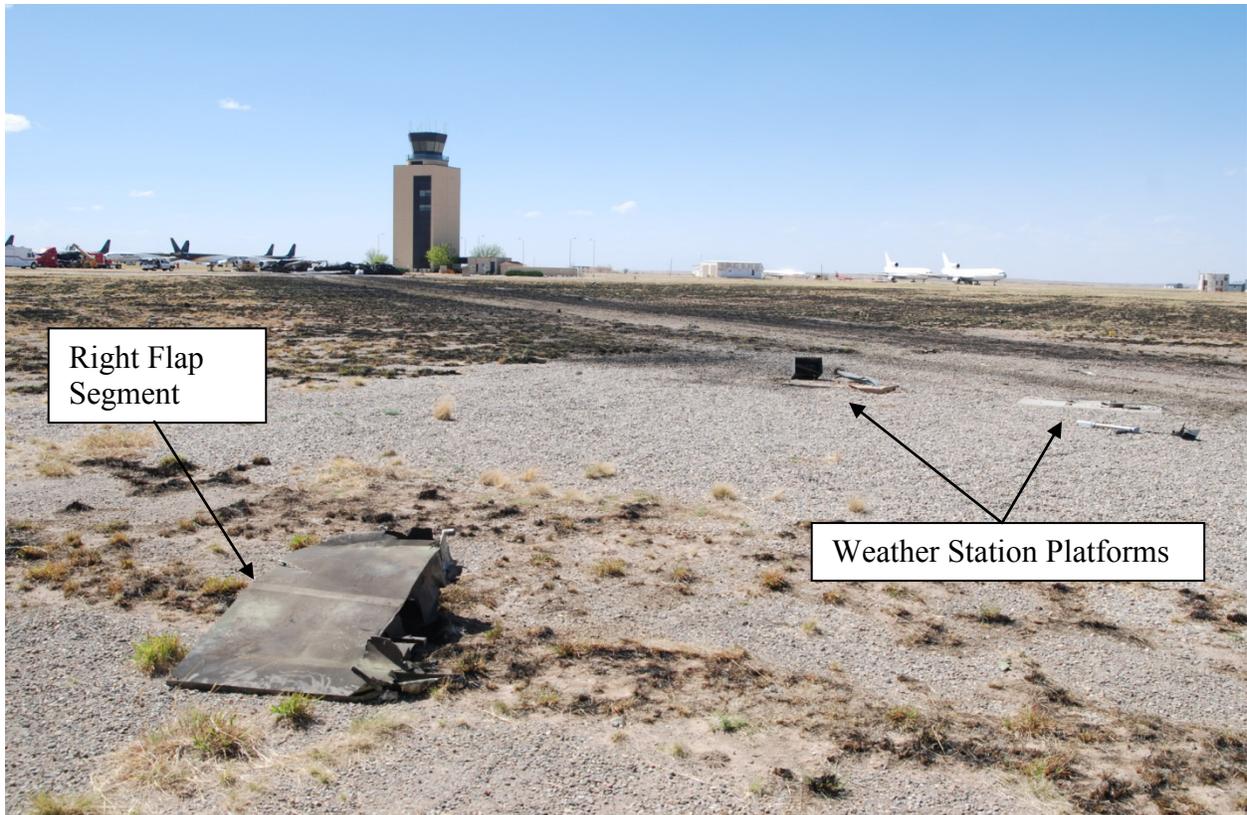
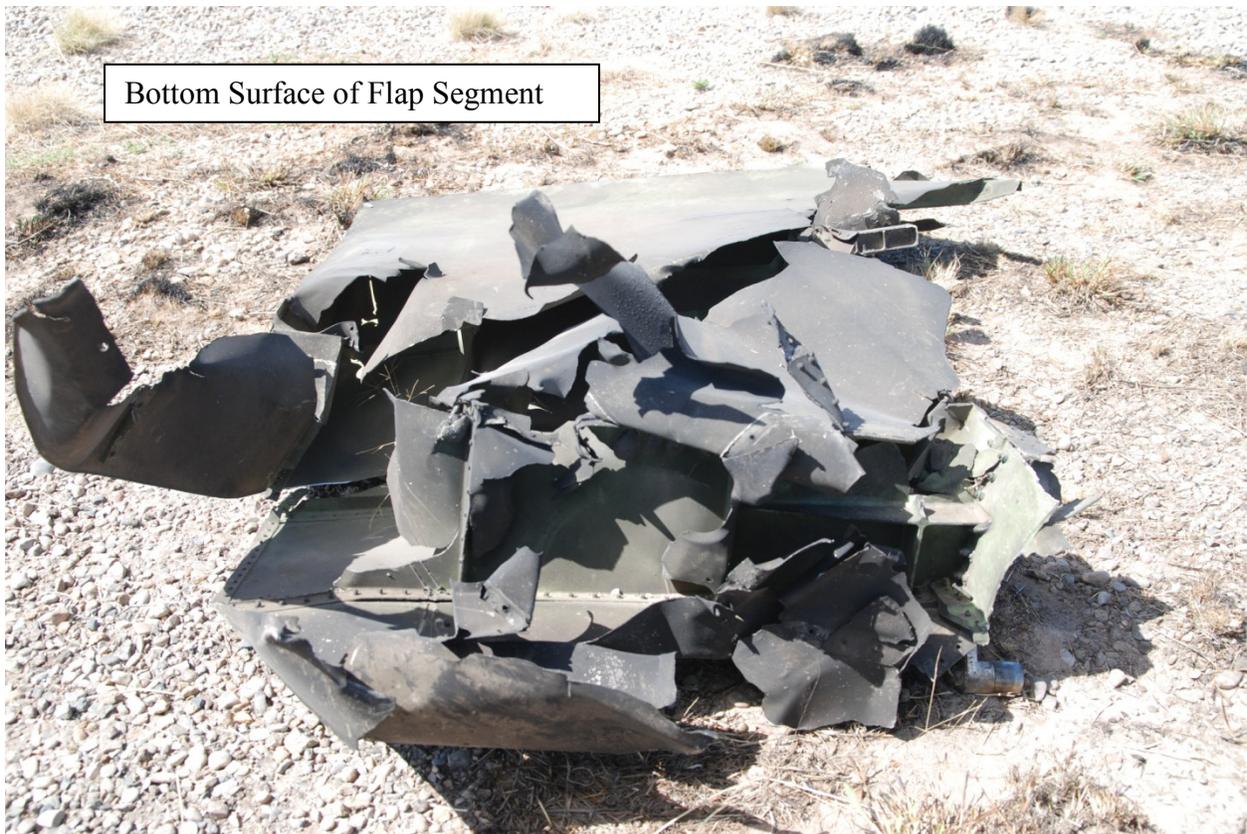
The flap surface inboard of track A was located in the debris field (Figures 37, 38). The flap surface was consumed from track A to approximately 1 foot inboard of track C. The flap was intact from track C to the most outboard point. The track B jackscrew was still attached to the carriage and to the track (Figure 39). The jackscrew position was measured from the upstop to the top of the ballscrew – 16.75 inches, and from the downstop to bottom of ballscrew - 12 5/8 inches. Flap track C was intact with the carriage still attached to the jackscrew (Figure 40). The Track C jackscrew position was measured from the downstop to bottom of ballscrew – 10.25 inches, the upper portion could not be accessed for measurement. According to Gulfstream these measurements of the jackscrew position are consistent with flaps in the 10 degree position.

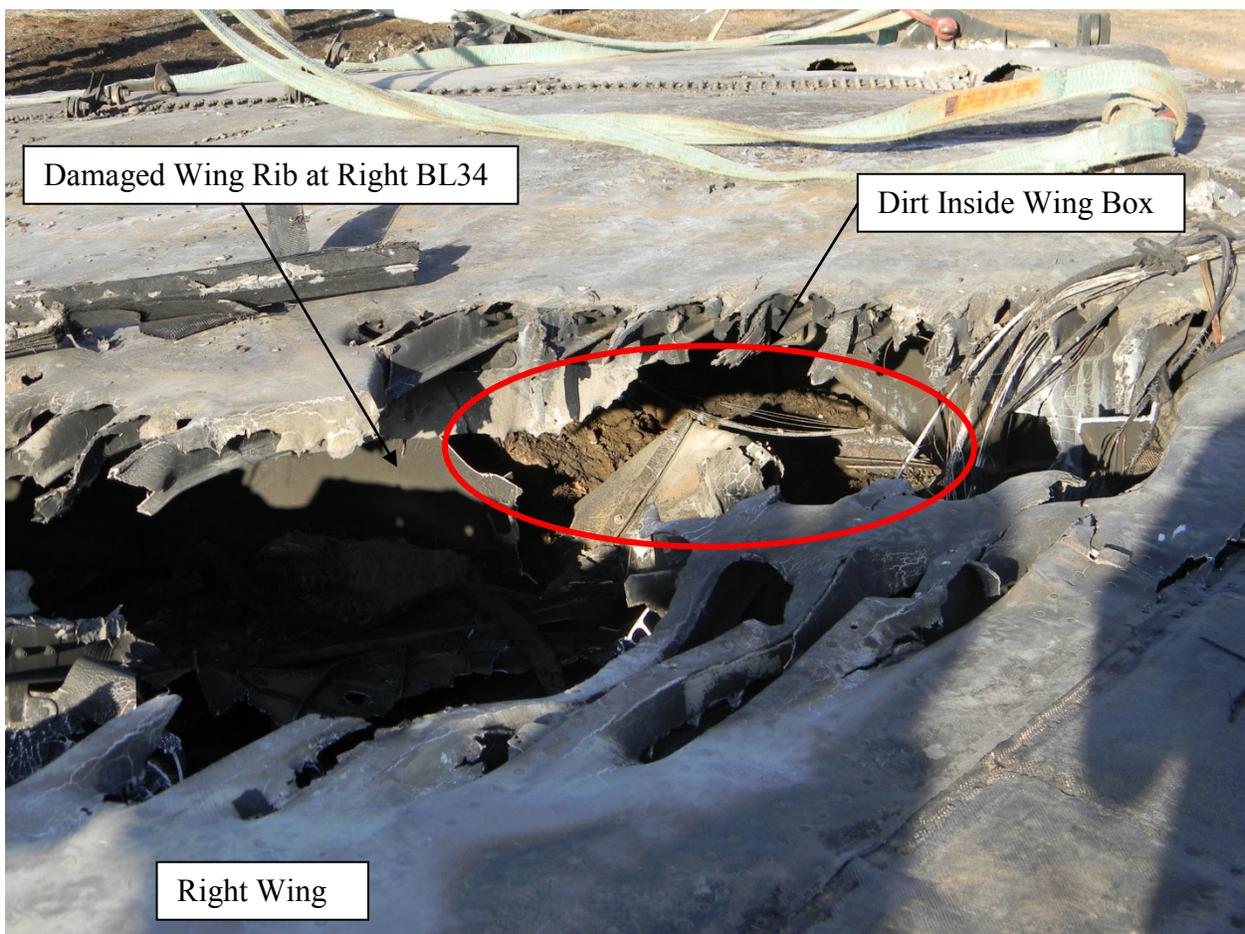
Figure 41 Center Wing Box Damage

Extensive damage to the center wing box floor, ribs and trusses could be observed through the melted area of the right wing (Figure 41). This area is a portion of the fuel tank. There was an accumulation of dirt inside the wing box. During recovery the fuselage was lifted off the wing, providing access to the damage. The forward spar had a large hole to the right of centerline (Figure 42). The lower skin was bent up in the area and a crack spanned from the hole to the upper skin. The upper skin was bent and separated from the spar. Inside the wing box it was observed that the truss at right BL 6 was damaged, the rib at right BL 34 had a large hole, and there was an accumulation of dirt inside the wing box (Figure 43). The rear spar of the wing box had a large hole outboard of the rib at right BL 34, which extended from the top skin to the lower skin. The lower skin was also fractured and missing.

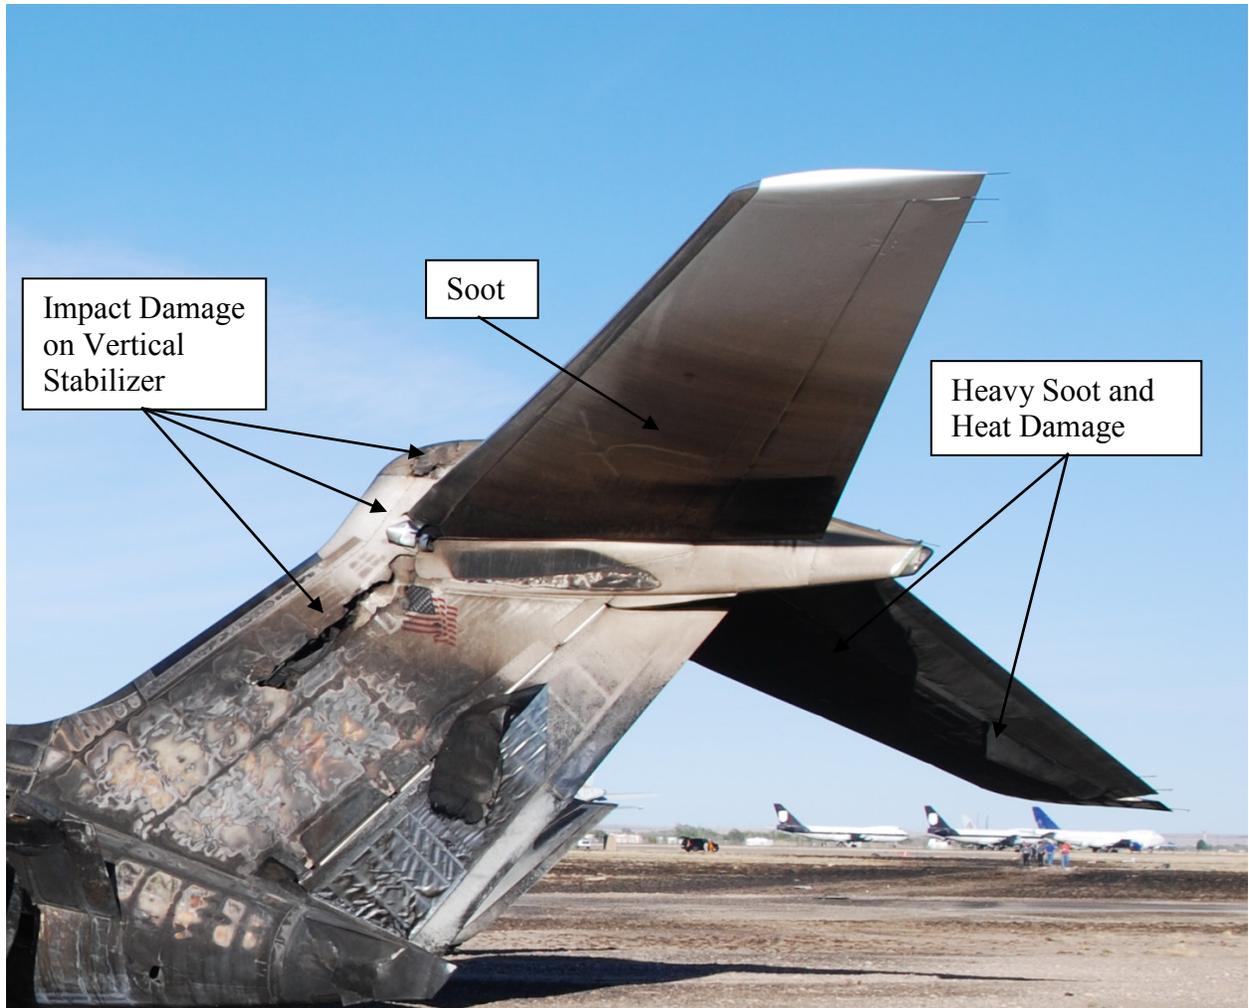
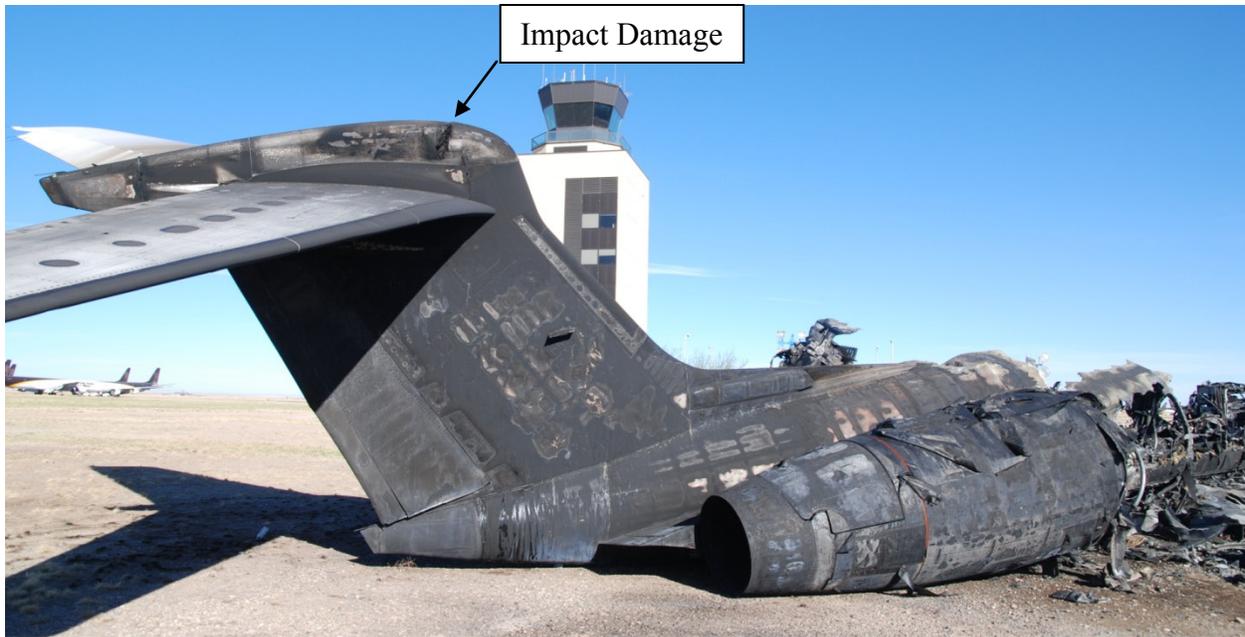
The vertical stabilizer had heavy sooting and heat damage to the skin on both sides (Figures 45, 53). There was an impact mark on the left side which extended to the top.

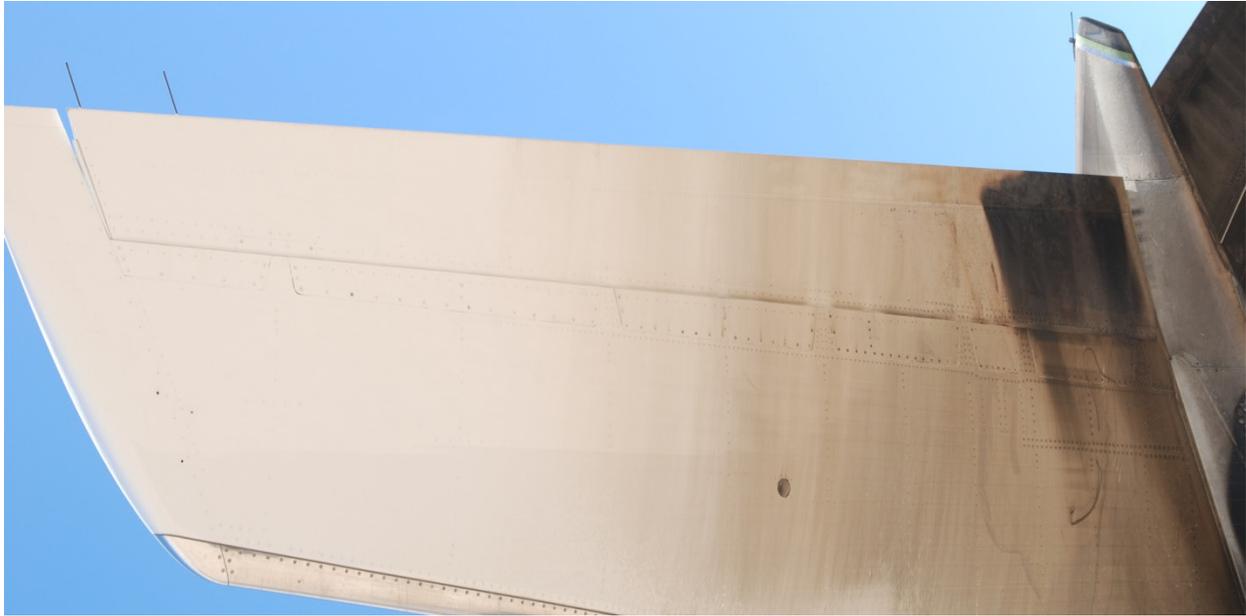
Figure 49 Left Elevator Lower Surface

The left elevator surface was intact with minor sooting on innermost trailing edge (Figure 49). The actuator access panels were removed. All actuator attach fittings were intact (Figure 50). No heat damage or sooting was evident.

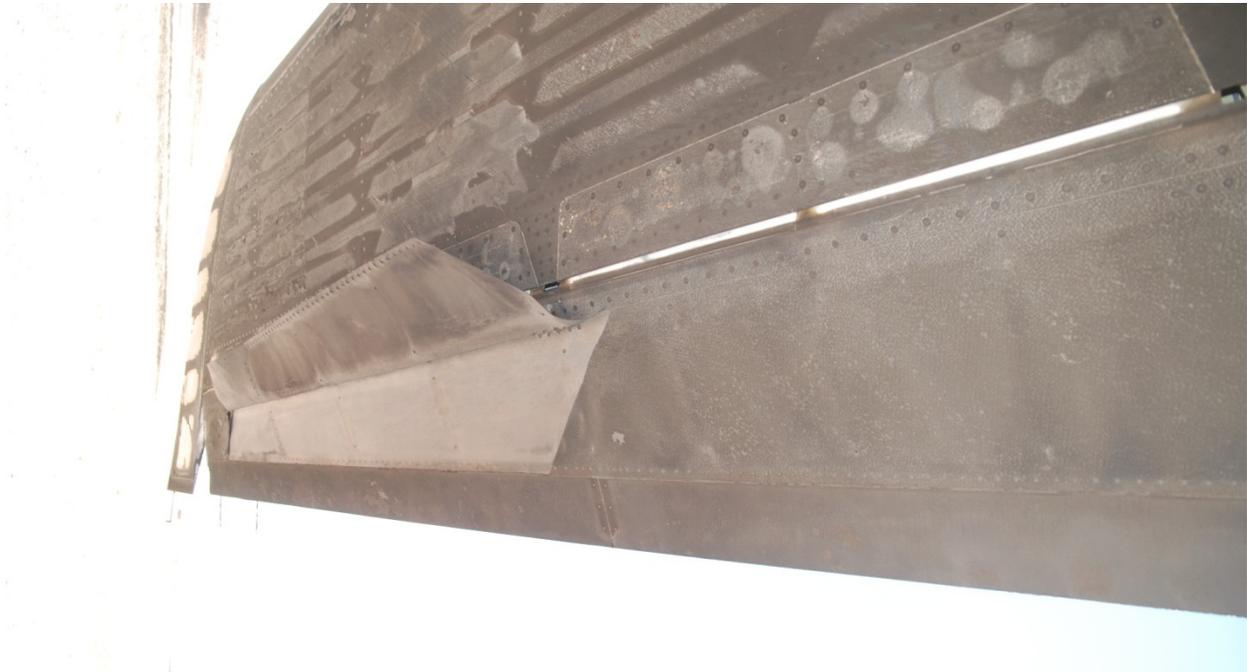
Figure 51 Right Elevator Lower Surface

The right elevator surface was intact with heavy sooting and significant heat damage to the outboard portion skin (Figure 51). The actuator access panels were removed. All actuator attach fittings were intact (Figure 52). No heat damage, but minor sooting was evident.

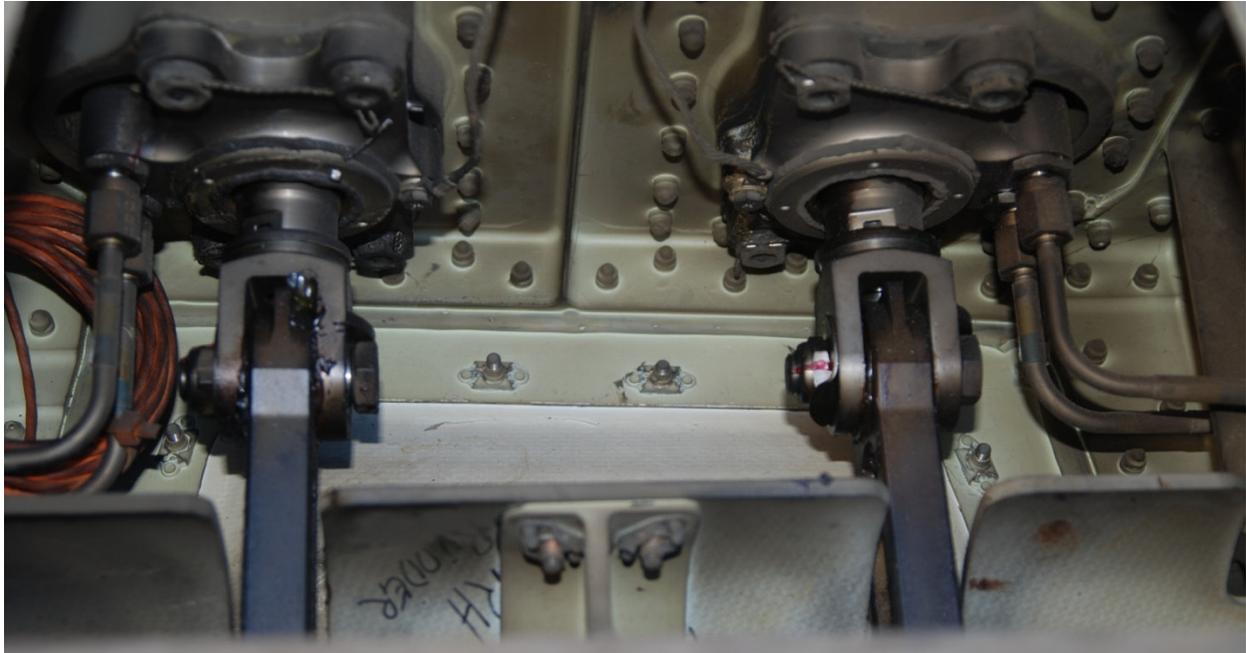
Figure 54 Rudder Actuators

The rudder had heavy sooting and significant heat damage to the skin. The access panels were removed and the actuator attach fittings were intact (Figure 54).

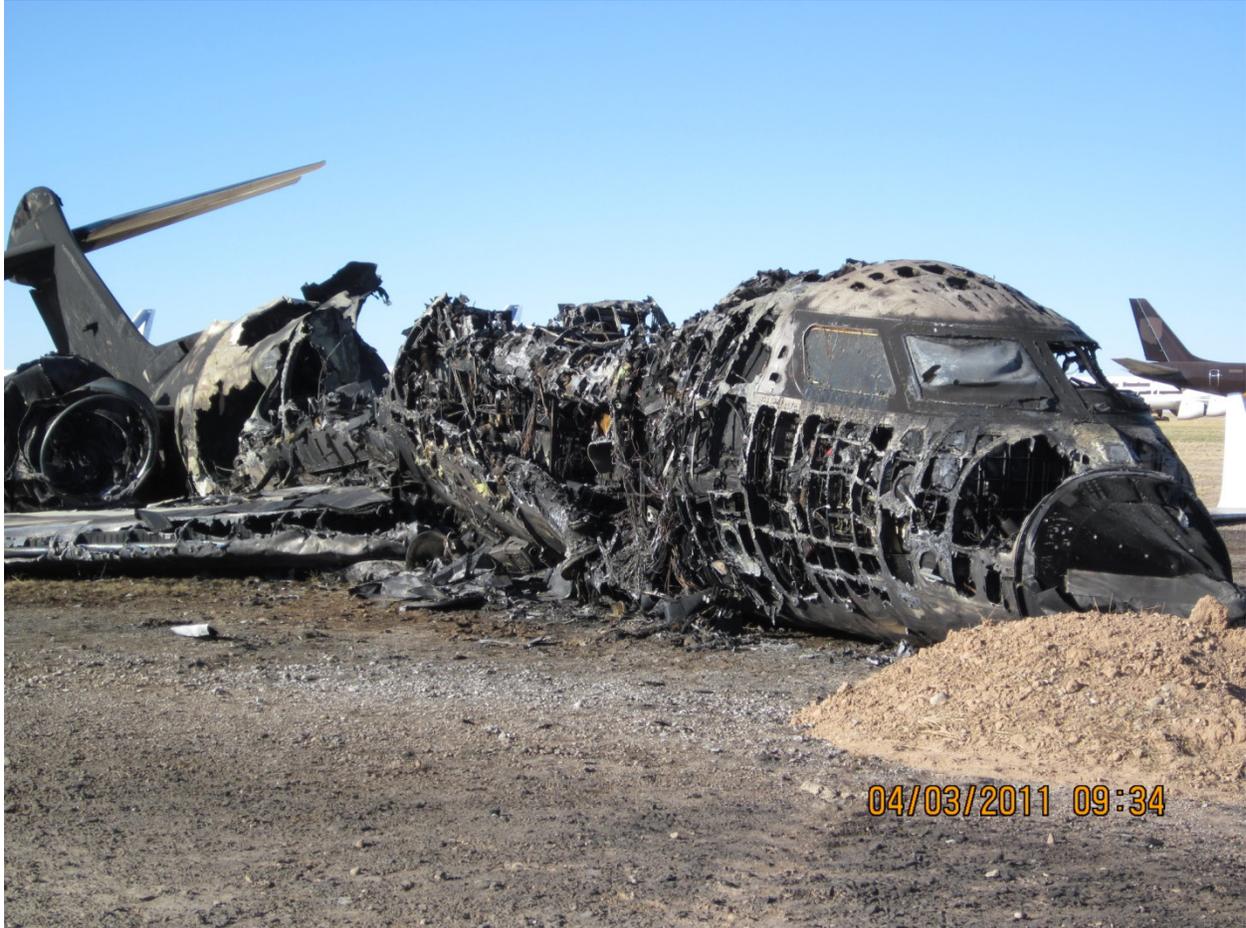
Figure 55 Right Forward Fuselage

The fuselage was severely damaged by the post crash fire (Figure 55). The crown of the airplane was mostly consumed from the flight deck to the aft pressure bulkhead. Figures 56 – 58 show

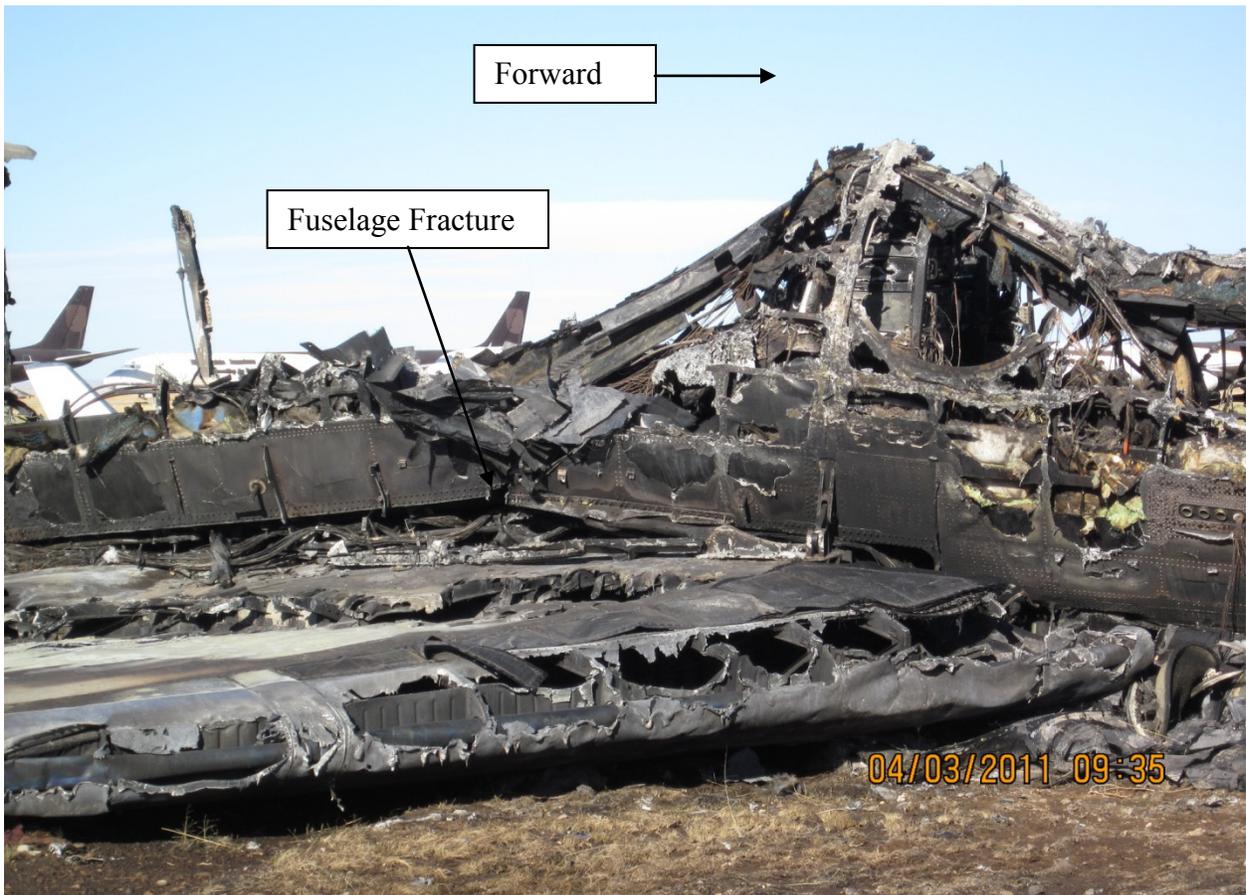
Figure 57 Right Center Mid Fuselage

the forward, mid, and aft fuselage segments respectively from the right side. The fuselage was fractured at approximately fuselage station 580 (Figure 57). Figures 59-60 show the right wing to fuselage linkages. Figure 61 shows the overview of the fuselage from the left side. Figures 62 – 64 show the forward, mid, and aft fuselage segments respectively from the left side. Figure 65 shows the main entry door. Figures 66-67 show the left wing to fuselage linkages. Figure 68 shows the fuselage station diagram for the airplane.
