**NATIONAL TRANSPORTATION SAFETY BOARD
OFFICE OF AVIATION SAFETY
WASHINGTON, D.C. 20594**

AIRWORTHINESS SPECIALIST'S REPORT OF INVESTIGATION

DCA11MA076

Operator: Gulfstream Aerospace Corporation
Aircraft: GVI (G650), Serial Number 6002
Location: Roswell, NM
Date: April 2, 2011
Time: 0934 MDT

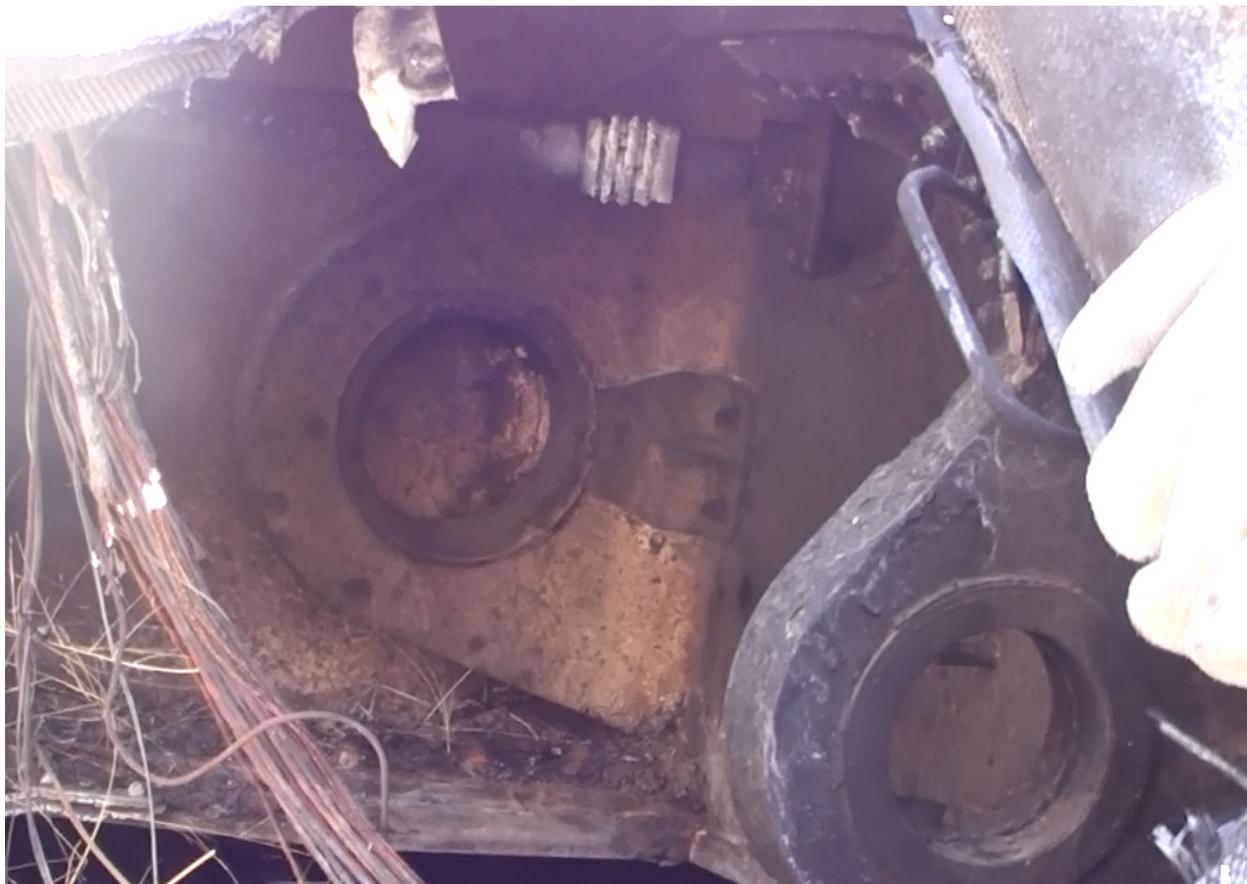
Figure 84 Right Main Gear Trunnion Mount

The right main gear came to rest near the damaged runway information sign. It was still attached to the wheels and tires. The aft trunnion pin was fractured and the forward trunnion pin had damage on the upper edge (Figures 81, 82). The shock strut inner cylinder was still attached. The outer shock strut cylinder was separated and found approximately 10 yards from the gear. The inboard wheel was still inflated, but the outboard wheel had numerous punctures and was deflated. The side brace actuator was still attached to the side brace fitting on the rear spar (Figure 83). The Trunnion mount was intact (Figure 84).

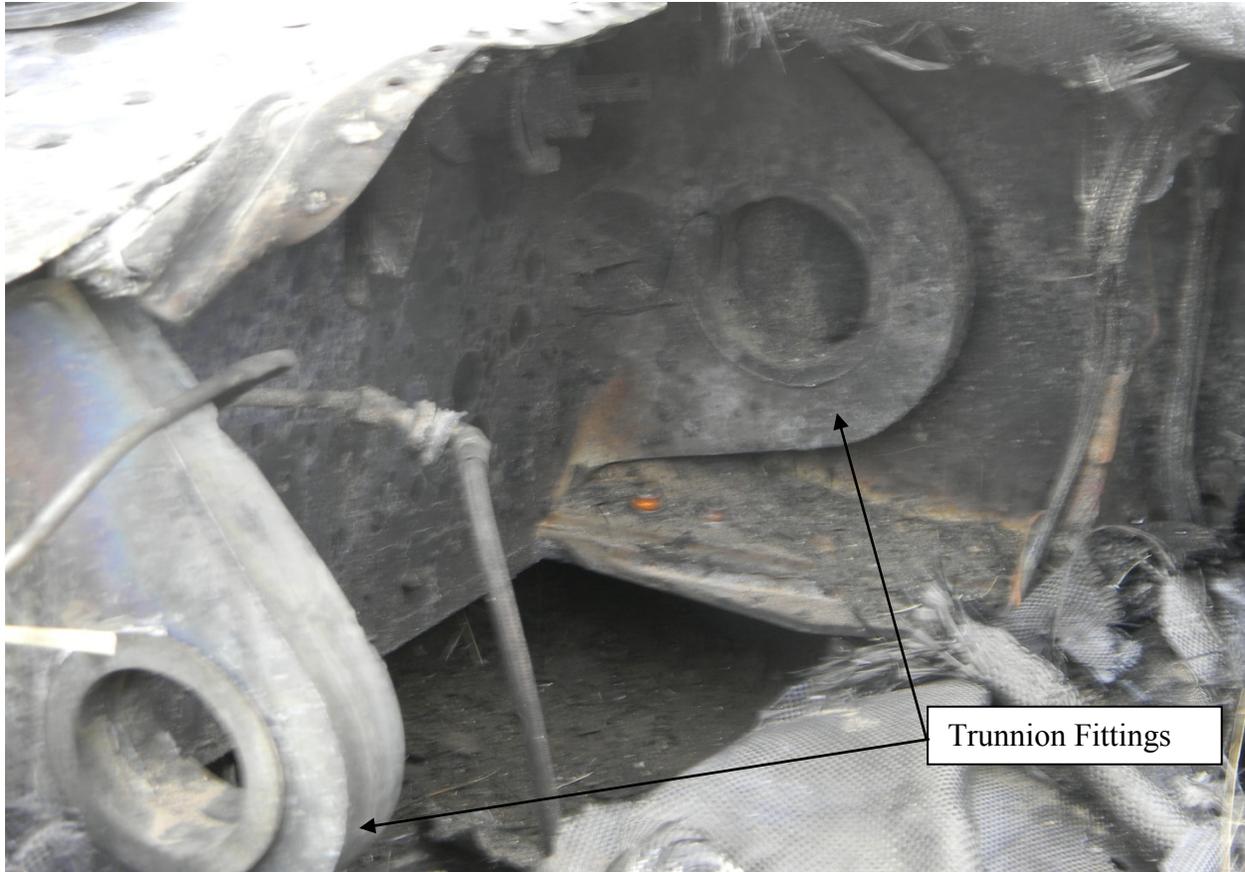
Figure 89 Left Main Gear Trunnion Mount

The left main gear came to rest approximately 100 yards past the concrete culvert to the left of the airplane path. The left main gear fractured approximately at the wheel height (Figure 85). The aft trunnion pin fractured (Figure 86). The side brace was still attached. The side brace fuse pin was fractured on one side (Figure 87). The outboard wheel was inflated and the inboard wheel was deflated. The inboard wheel had a large hole in the tire which was in line with a dent in the inner wheel hub. The shock strut was separated from the gear and fractured at the upper and lower attach fittings. The side brace aft attachment fitting was bent (Figure 88). The trunnion mount was intact (Figure 89).

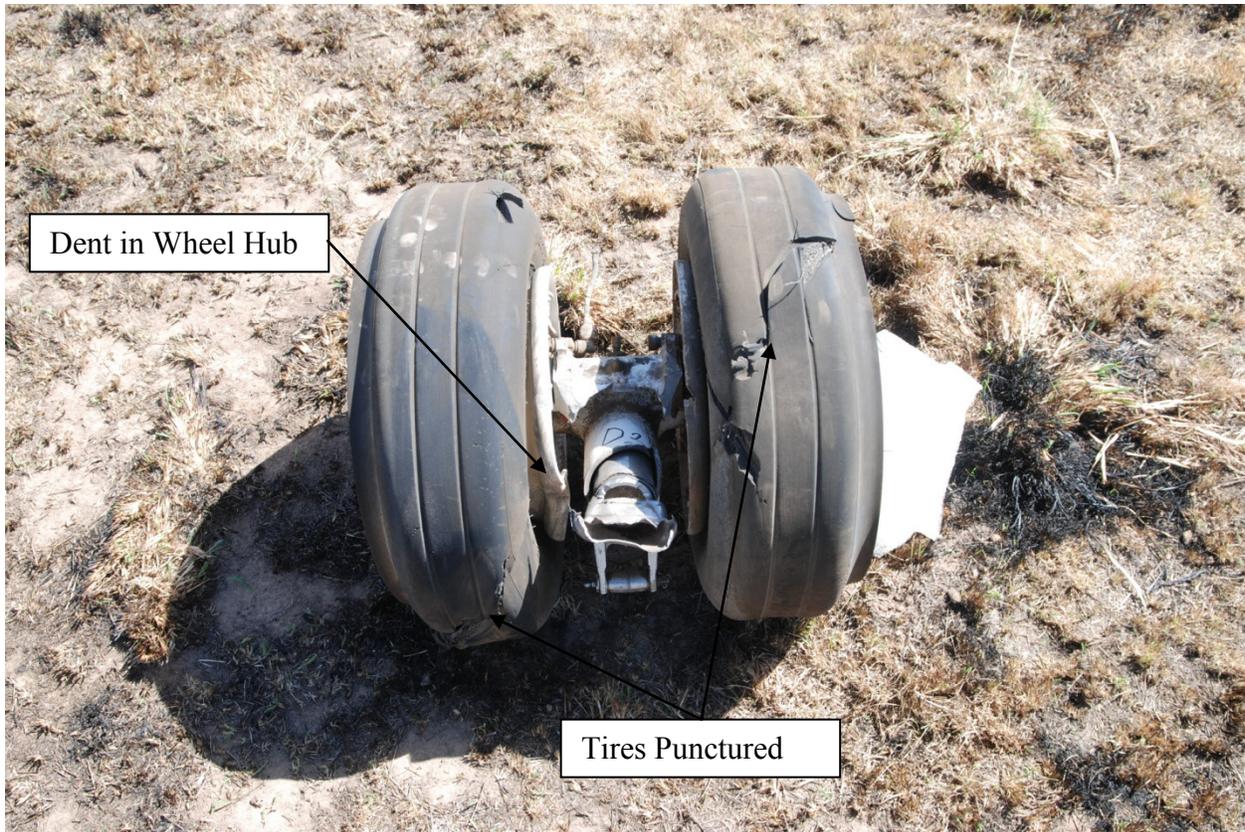
Figure 90 Nose Gear Wheel Assembly

The nose gear wheel assembly came to rest approximately 10 yards from the concrete culvert to the left of the airplane path (Figure 90). The shock strut was fractured below the wheel height. Both wheels were deflated. There was a large dent in inner hub of the right wheel.
