**Technischer Bericht /
Technical Report**

O-TR0500/11-ISS02

Projekt/Project: **BR700-725**

Thema/Subject: **Analysis of EMS Data from the last flight of Aircraft 6002**

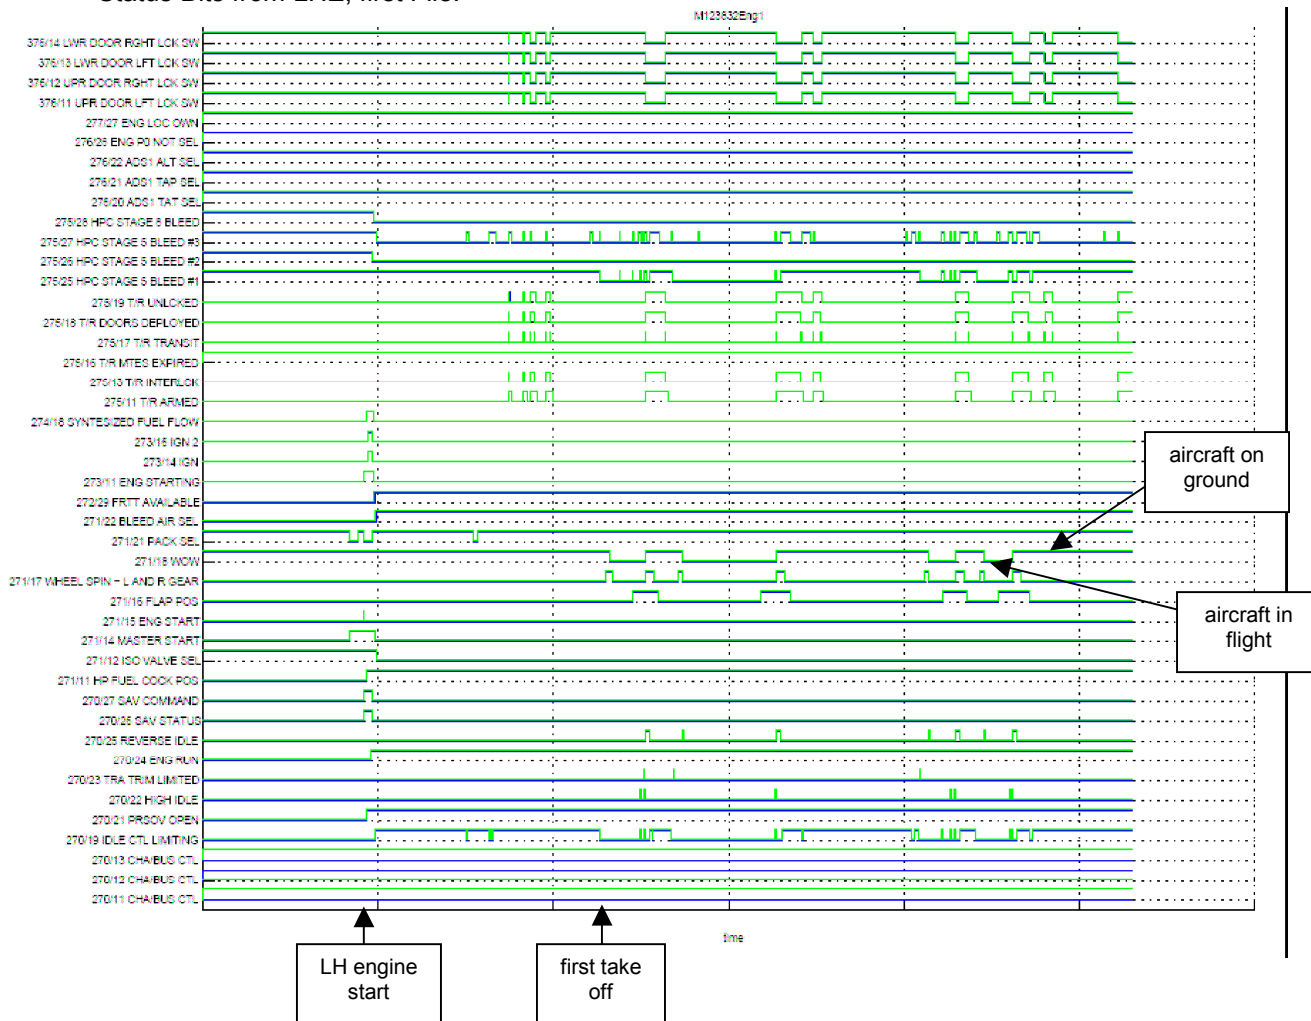
Status Bits from LHE, first File:

All of the bits which were set true report only normal system status. None of the bits which would report anomalies (for example a surge detection) were set true. This shows that the engines performed nominally throughout the period for which EMS data is available.
