# ALERT SERVICE BULLETIN

NO. 206L-09-163

**MODEL AFFECTED:** 206L Series

**SUBJECT:** MAIN ROTOR BLADES P/N 206-015-001-115, /-117, /-119 & /-121 SPAR SPACER, ONE TIME INSPECTION OF.

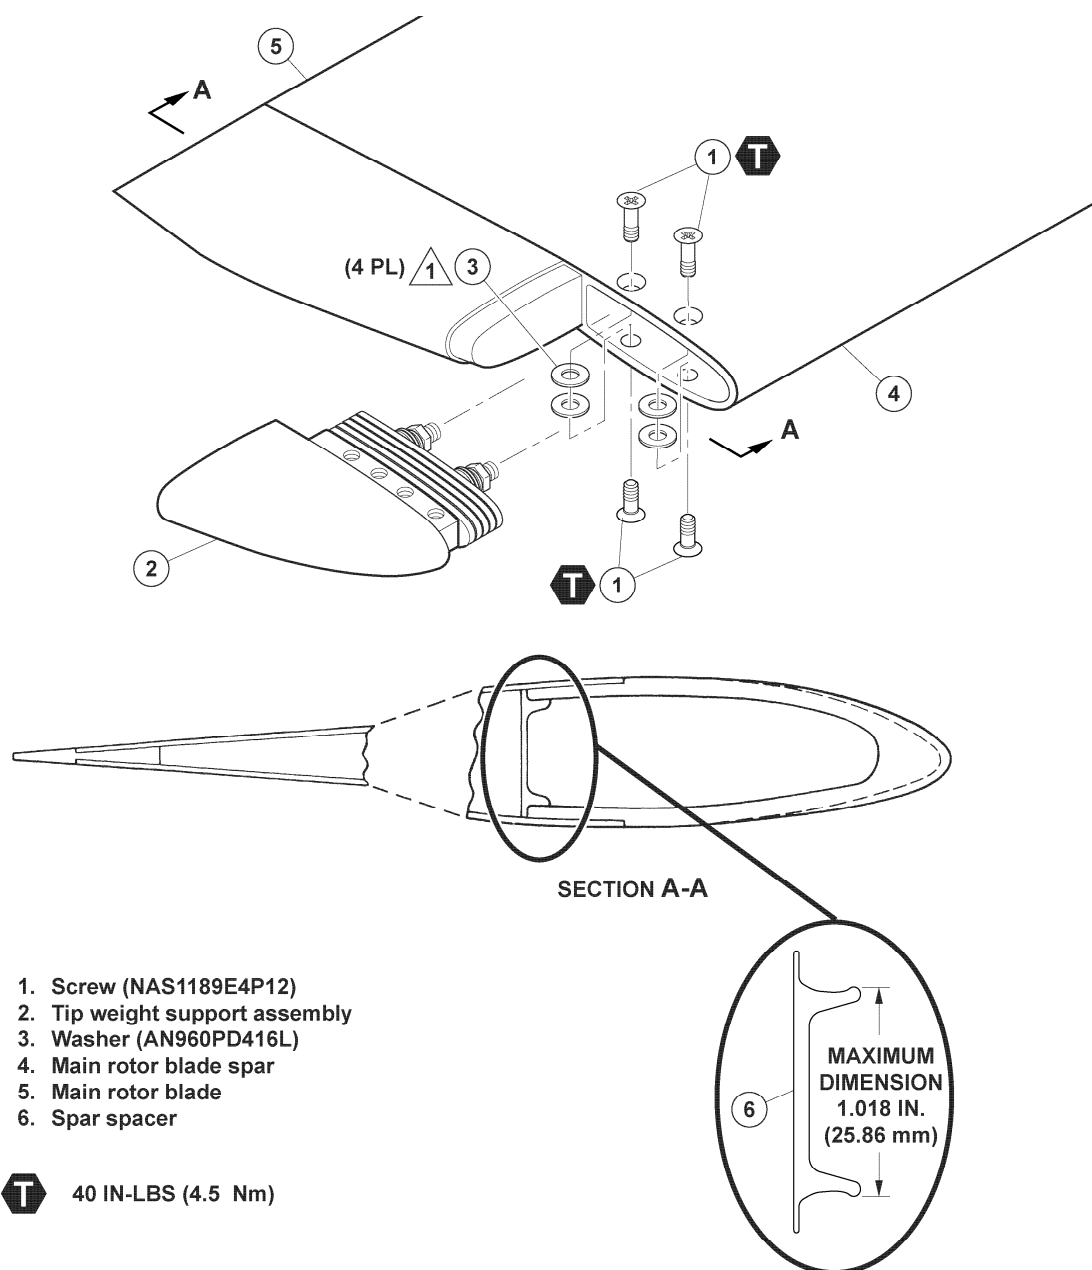
Figure 1. Main rotor blade spar spacer inspection.

Oversize spar spacer (6) is approximately 0.030 inch (0.762 mm) larger than the maximum dimension limit of 1.018 inch (25.86 mm)

- b. Use a caliper and measure the main rotor blade spar spacer (6) width as shown on Figure 1.
  - c. Record your dimension.
- 3. Proceed with the installation of the tip weight support assembly (2) on the main rotor blade (5) as follows:

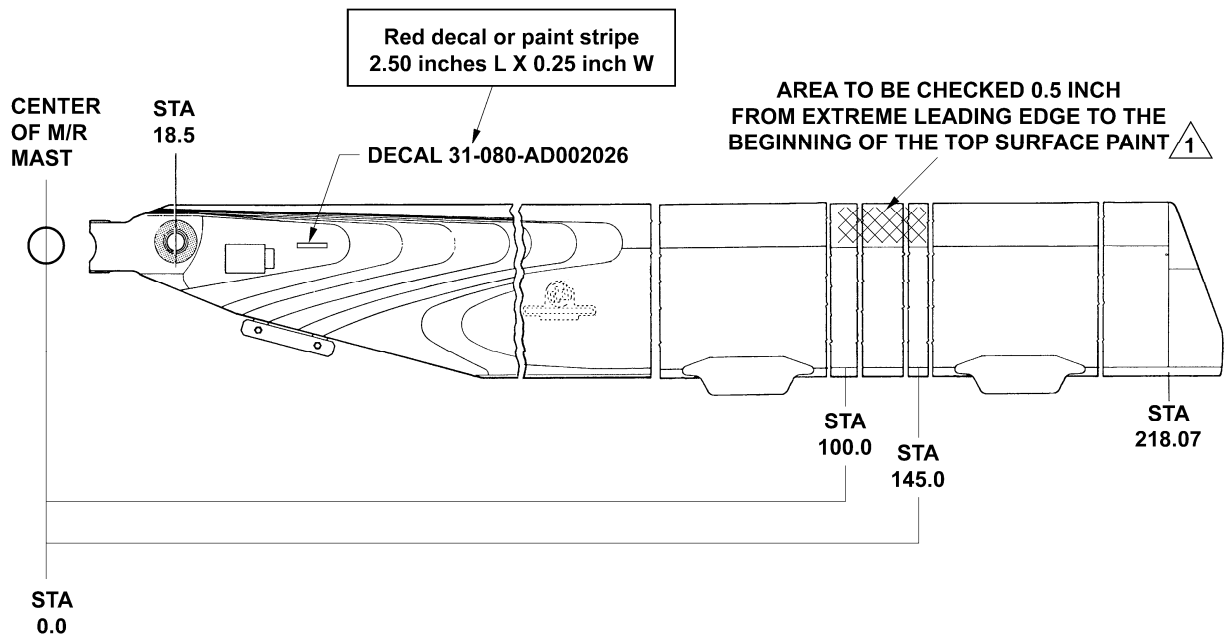
**Figure 2. Main Rotor Blade Area to be checked.**

- e. After 10 to 20 seconds, wipe off the solution with cheesecloth (C-486) in a spanwise direction.
  - f. Carefully check affected area for evidence of a crack. If a crack is present, the blue food coloring solution will remain in the crack as the excess of solution is wiped off and/or the cheesecloth will catch on the rough edges of the crack.

3. Mark the top surface of affected main rotor blade to identify station 100 and 145 as follows:
  - a. The center of the blade bolt is blade station 18.5 (blade station zero being at the center of the mast). Use a permanent ink marker and make marks at blade stations 100 and 145. Refer to Figure 2.
