# 747 Service Bulletin

Number: 747-32A2465  
Date: December 2, 1999  
Revision 1: July 20, 2000  
ATA System: 3211

**SUBJECT:** LANDING GEAR - Wing Gear - Outer Cylinder Aft Trunnion - Inspection and Corrosion Preventative Compound (CPC) Application

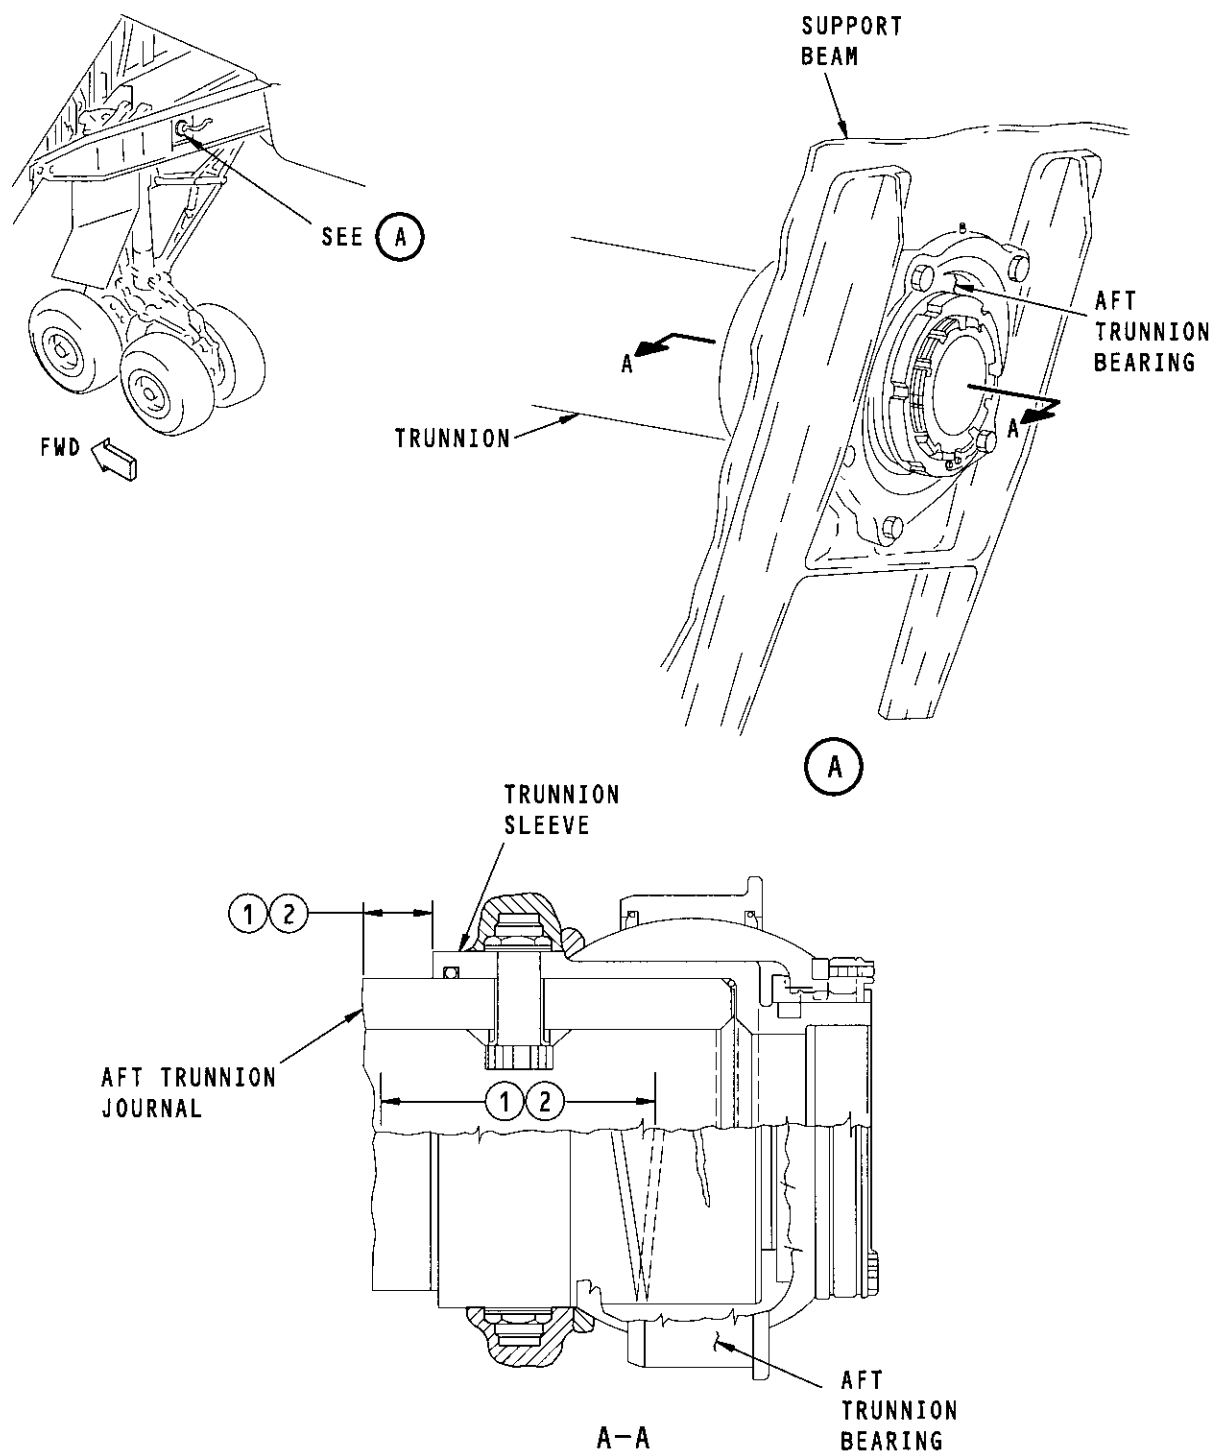
FIGURE 2. AFT TRUNNION DETAIL VISUAL INSPECTION

It has been determined that the cracks and subsequent fracture were caused by corrosion in the aft trunnion.

STEP	TASK	NAME	PROCEDURE	REFERENCES	NOTES
1	Clean	Aft trunnion			(a)
2	Inspect	Aft trunnion	Detail Visual using a Boroscope		for cracks and corrosion

(a) Outer diameter - 1" forward of trunnion sleeve; Inner diameter - 1" forward and aft of the bolt

- A. Install the door locks. Refer to 747 or 747-400 AMM 32-00-30.
- B. Extend aft flaps to get access to aft trunnion. Refer to 747 or 747-400 AMM 27-51-00.
- C. Do a detailed visual inspection as specified in Figure 2.
- D. If cracks or corrosion are found, contact Boeing for repair information before further flight.
- E. If no cracks or corrosion are found, do the CPC application as shown in Figure 3
- F. Repeat the Part 1 - Inspection/CPC Application at an interval not to exceed 6 months.
- G. Retract the aft flaps. Refer to 747 or 747-400 AMM 27-51-00.
- H. Remove the door locks. Refer to 747 or 747-400 AMM 32-00-30.
- I. Put the airplane back to a serviceable condition.
