# ALERT SERVICE BULLETIN

**No. 76A003**

**SUBJECT: ENGINE CONTROLS**

NR drop in flight - Slow drift in the XPC anticipator (collective pitch signal)

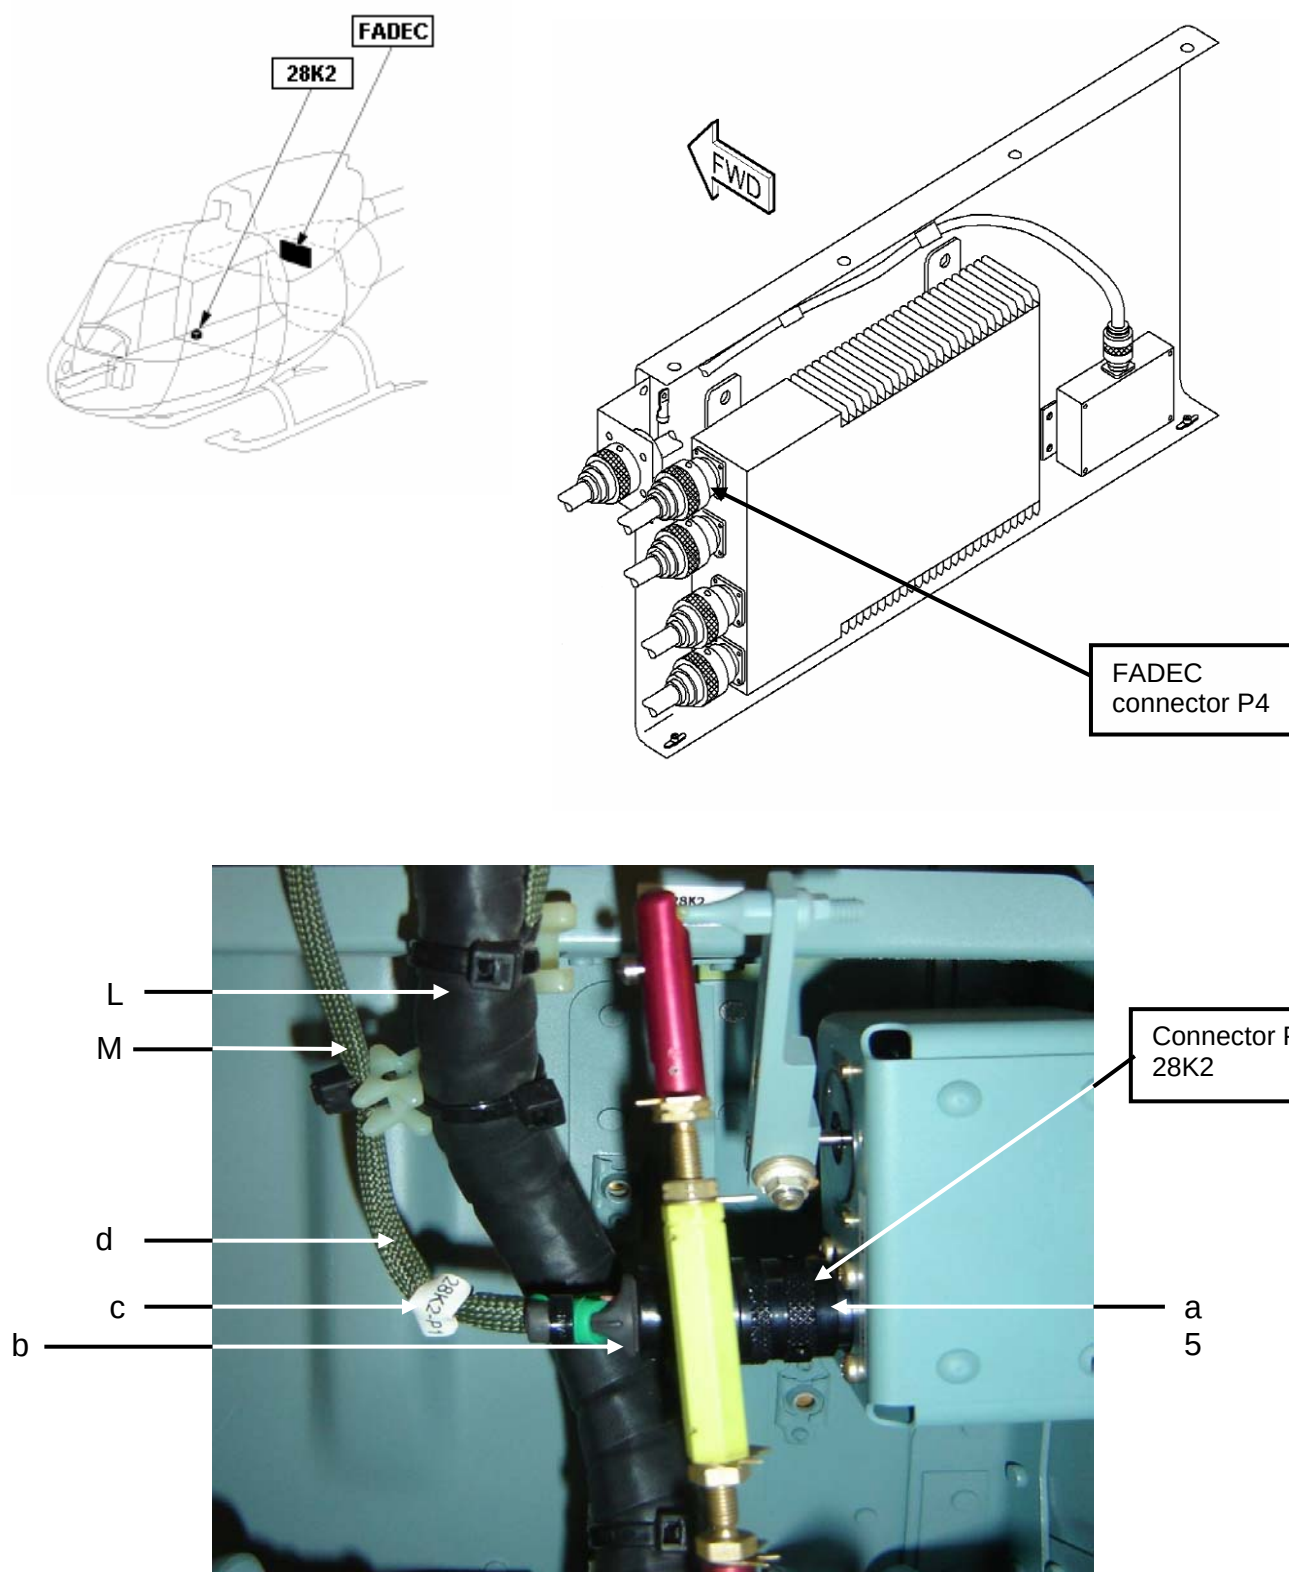
Figure 1

The investigation conducted by EUROCOPTER has shown that the reported occurrences were due to deterioration of the electrical harness that connects the XPC anticipator potentiometer to the FADEC. A potential over-length of the electrical cables is coiled near the anticipator potentiometer. The radii of curvature of these cable loops can lead to deterioration of the insulating material. That deterioration may allow contact between one of the three wires of the cable and the cable shielding due to compression, causing the XPC signal value to drift downward.

- Disconnect electrical connector P4 from the FADEC (Figure 1).
- Disconnect the electrical connector P1 from XPC anticipator (28K2) (Figure 1).
- In zone Z (Figure 2), cut and discard the binding clamps, then remove the spiral wrap tubing from electrical harness (L), in order to release the XPC cable over-length (M).

- Cut the XPC cable to eliminate any loops and potentially damaged areas.
- Unplug the contacts from the XPC connector.
- Retain connector (a), adapter (b) and marker sleeve (c) (Figure 1).

## 2.B.2.c. Installing the connector (Figure 1)

- Strip the conductors.
- Crimp contacts (5) to the conductors.
- Cover the cable with NOMEX sheath (d).
- Adjust the length of NOMEX sheath (d).
- Fit marker sleeve (c).
- Fit connector adapter (b).
- Insert contacts (5) into connector (a) in accordance with WDM 80-11-00.
- Tighten adapter (b) on connector (a).
- Conduct an electrical continuity test.
- Test the insulation between each of the three wires, then between each wire and the ground connection.
- Connect the electrical connector P1 of potentiometer XPC.
- Connect the electrical connector P4 on the FADEC side.
- Fit the spiral-wrap tubing that was removed previously, again round electrical harness (L).
- Secure electrical harness (L) with binding clamps.
