Factual Report  
Ref: NTSB Identification Report CEN14FA010

Altimeter, Model 5934  
manufactured by United Instruments, Inc.

Purpose: to examine the condition and functionality of an altimeter recovered from the aircraft accident site.

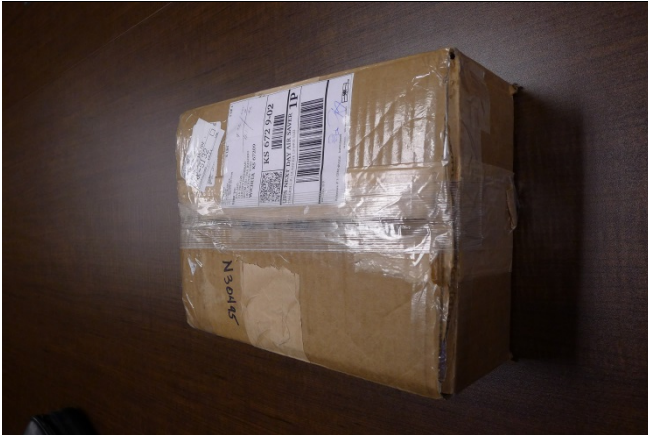
Photo 1- as received at UI

The box containing the altimeter was brought to United Instruments at 10:00 AM, Tuesday, December 17, 2013, by the FAA and Cessna representatives. (Photo-1)

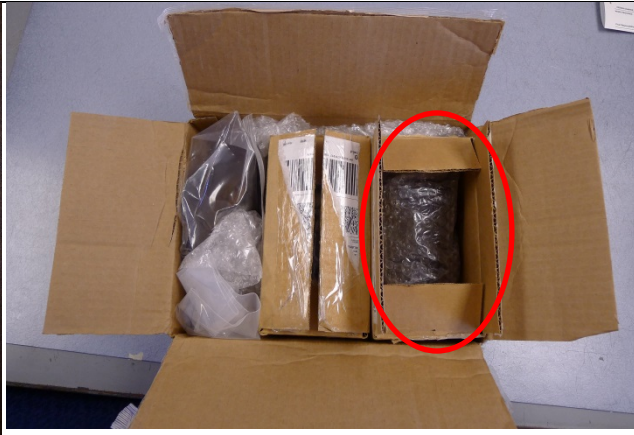
Photo 2- alt in right side box

Opened the box at the United Instruments Repair Station. (Photo-2)

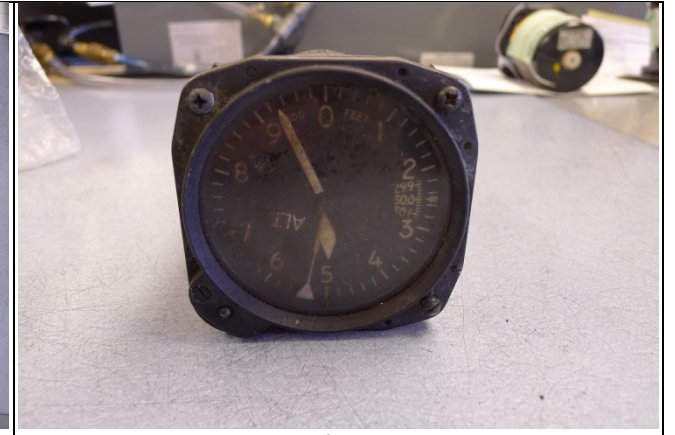
Photo 3- front view 1

- B. The outer surfaces of the instrument were dirty and charred. (Photos-3, 4, 5, 6, 7, 8 and 9)
  - C. All views
    - 1). Front: The barometric adjustment stem, P/N 1114-309101, with knob, P/N 1114-300100, was broken off (Photo-14) from the case assembly P/N 1114-032602. The pointers as received indicated approximately: 925 ft per large pointer, P/N 1114-030101, 4,950 ft per intermediate pointer, P/N 1114-030201, and 4,000 ft per disc pointer, P/N 5934-1-105 (Photo-3). All 3 pointers were loose and no longer connected through the gear train. The barometric pressure setting was 29.98 inches of mercury. The instrument's dial configurations were United instruments' standard type and were not to Cessna specification.

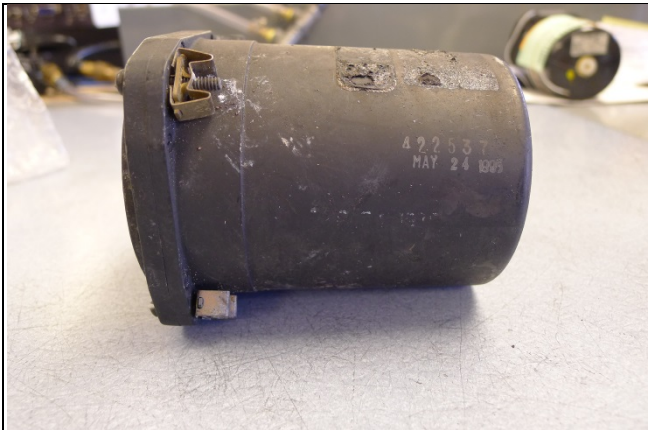
Photo 4- right side view

- 2). Right Side: Number, 422537, with date, May 24, 197 ( ), ink marked. (Photo-4)
    - 3). Left Side: There were no significant markings, but a Mid Continent maintenance label at the left corner of the case was visible (Photos-6 and 11).

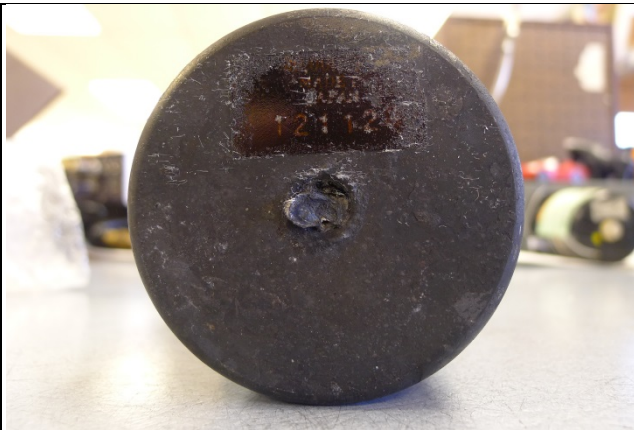
Photo 5- rear view

- 6). Rear Side: The UI nameplate , or ID plate, on the rear side the housing was missing. The pressure fitting at the pressure port was melted or broken flush at the rear side of the case. (Photos-5 and 10)

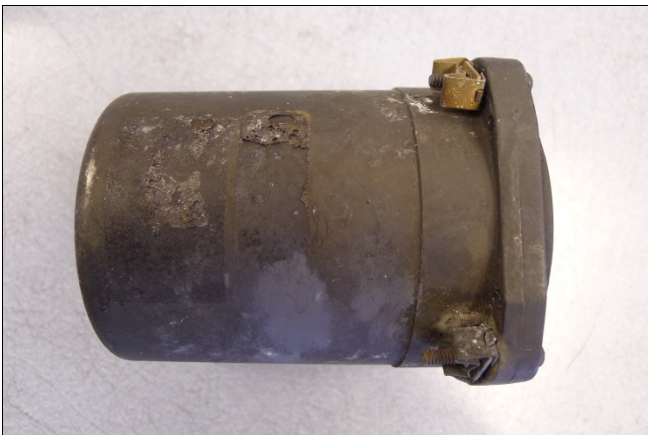
Photo 7- top view

- 4). Top: There were labels, which appeared burnt. (Photo-7)
    - 5). Bottom: Ink marked 'MAR 25 19( ) ( )'. (Photo-8)

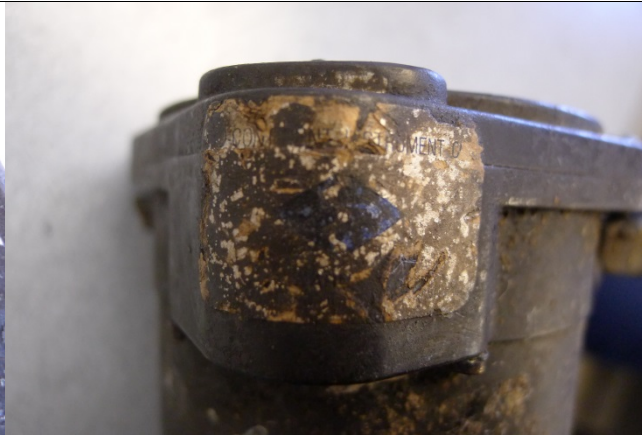
Photo 11- MCI seal on lower left side

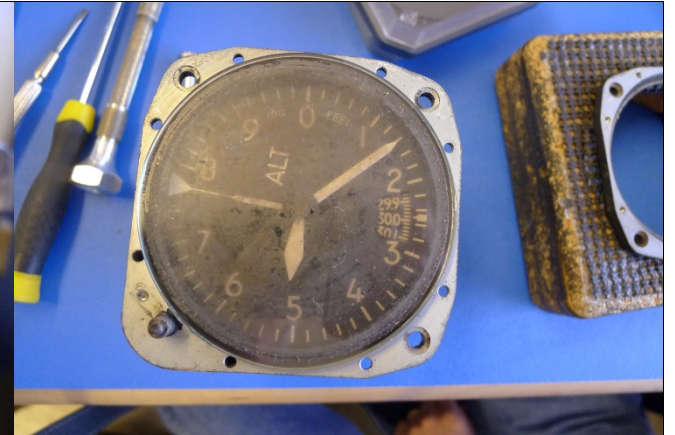
Photo 12- case front side

3. Disassembly
- A. Removed the instrument's bezel, 1114-300500 (Photo-13), from the case and again checked the pointer indications: 140 ft per large pointer, 5,100 ft per intermediate pointer, and 78,000 ft per disc pointer, this time (Photo-12). The bezel (Photo-13) was securely tightened to the case assembly, and the cover glass, P/N 1114-300700 and sealing gasket, P/N 1114-310002, appeared to be undamaged by the heat and/or impact. The large pointer hub had paint detached, possibly caused by heat from the glass where the pointer hit at the impact. As shown in the photo, all three pointers came loose, being detached from the mechanism with dial toward the cover glass due to impact(s). (Photos-17 and 18) The white and black substances observed on the dial appeared to be the paint from the above large pointer. (Photo-19)

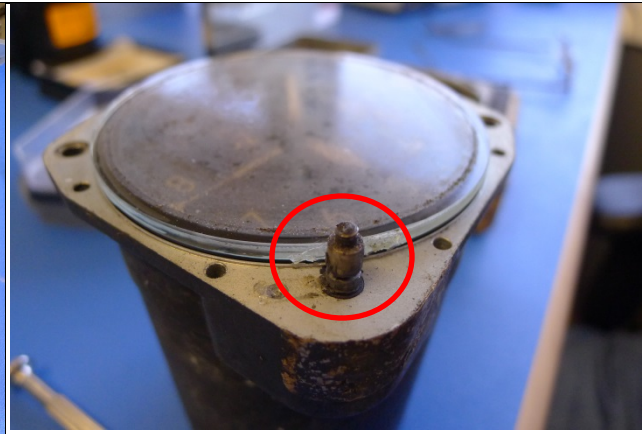
- barometric adjust knob shaft broken
- aluminum nameplate missing or burnt
- pressure fitting melted or broken

Photo 14- baro adj stem

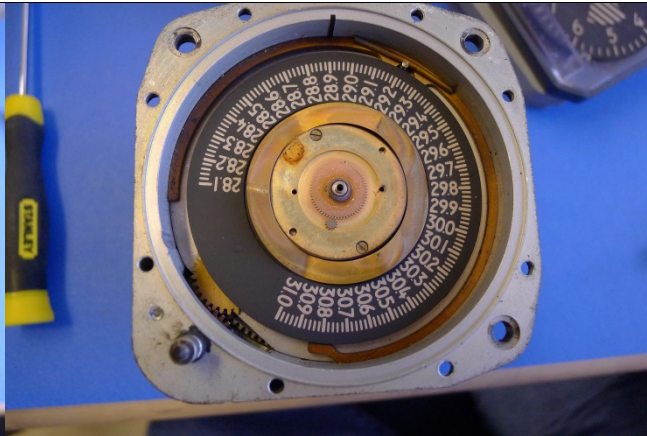
Photo 20- main dial removed

- B. The top plate assembly, P/N 1114-030401, had a brown spot (Photos-20, 21 and 23), but we could not determine what that was from and when it started. This would not have caused any loss of the function of the altimeter. The gear train in the top plate ran smoothly when driven with a finger. This might need to be run in an actual altimeter mechanism to ascertain the actual smoothness if the FAA and NTSB wishes. (Photos-23 and 24)

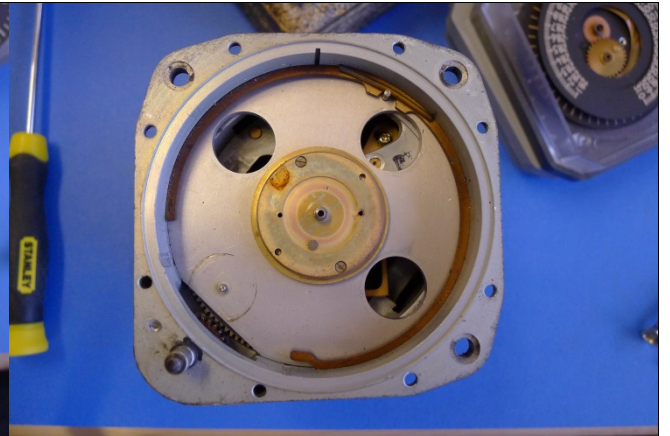
Photo 21- barometric dial removed

- C. Top plate ring, P/N 1114-302301, and retaining pin, P/N 1114-304400, were securing the mechanism assembly in the case. (Photo-21)
- D. The top side of the altimeter mechanism assembly, P/N 1114-031100, looked normal. (Photo-22)

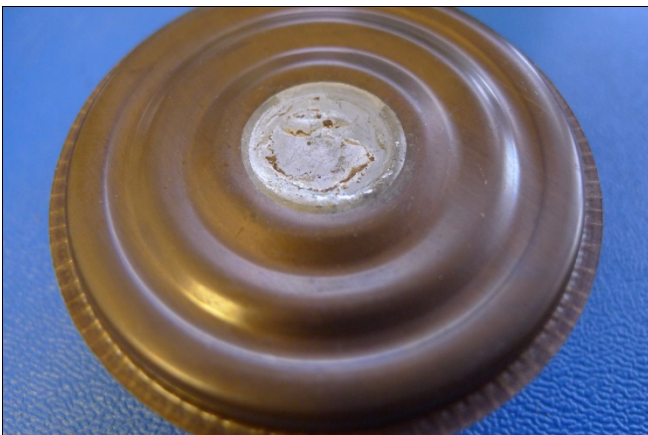
- E. The mechanism assembly had its major parts components detached: the diaphragm assembly, P/N 1114-033600 (Photo-25), and the balance assembly, P/N 1114-032000 (Photo-26), totally came off from the mechanism assembly.

- all pointers shifted forward
- diaphragm assembly detached from the mechanism assembly
- balance plate assembly torn off at the spring
- rocking shaft assembly pivots broken off and the sector gear bent by the counter-weight

Photo 25- diaphragm assy, detached

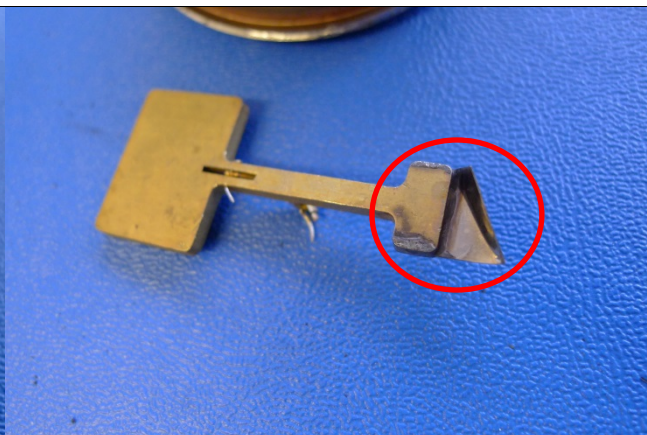
Photo 26- balance plate assy, torn, 1 of 2

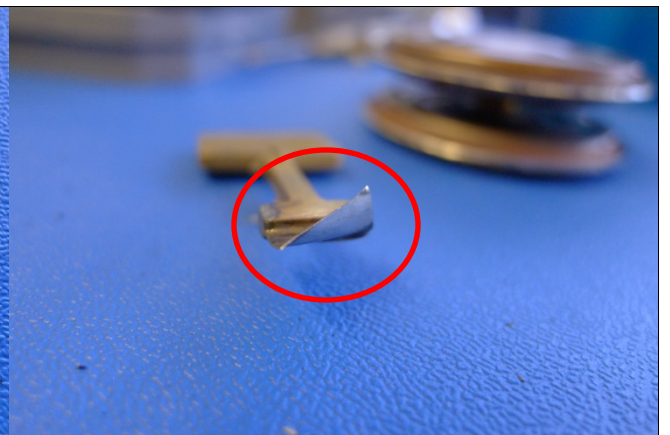
- B. The balance plate, P/N 1114-032100, had been sheared at the spring and the linkage within the assembly totally separated. (Photos27, 29 and 39)
- C. The rocking shaft and sector assembly, P/N 1114-032201, had its pivots at both ends, one on the shaft and the other on the mechanism frame, broken and no longer secured (Photo-38). The sector gear on the rocking shaft assembly, P/N 1114-032300, was bent (Photo-37).

Photo 27- balance plate assy, torn, 2 of 2

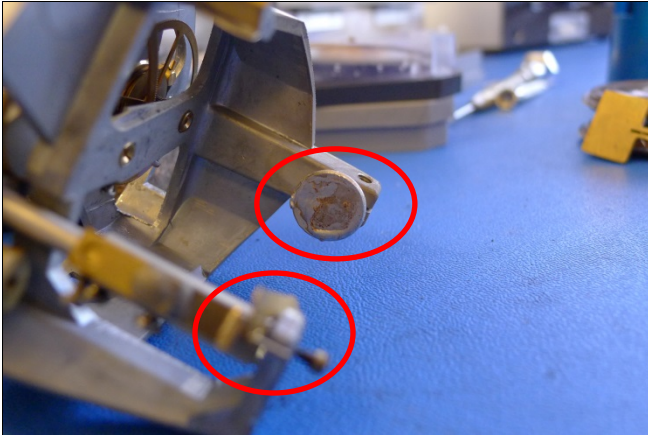
Photo 28- mech frame without diaph assy 1 of 2

4. Examination of the components
- A. The diaphragm assembly consists of a post on one side, and the bimetal assembly on the other, both of which are soldered to the diaphragm, P/N 2644-452101, (Photos-28 and 31). Both the post and the bimetal assembly were separated from the diaphragm at the solder points. (The bimetal assembly, consists of an adjustment plate, P/N 1114-306201, compensator assembly, P/N 1114-033700, hold plate, P/N 1114-306300, and screw, P/N 2112-173042, connected to the rocking shaft assembly, P/N 1114-032300, with the link, P/N 11145-308100, (Photosd-34, 35 and 36)). The soldered areas looked smooth as if the temperature became high enough to melt solder during or after their detachment of the parts (Photo-32 and 33). The link between the bimetal and the rocking shaft was bent (Photo-30).

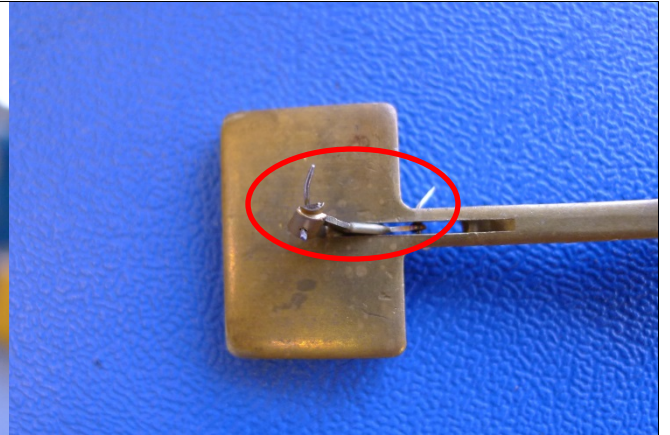
Photo 30- bent link on balance plate assy

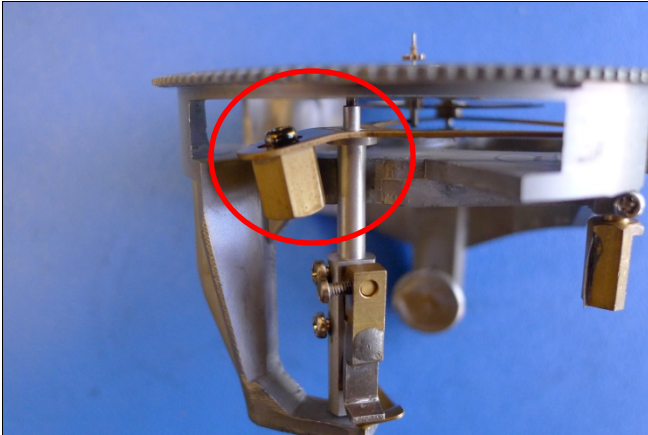
Photo 37- sector gear assy with bent sector gear

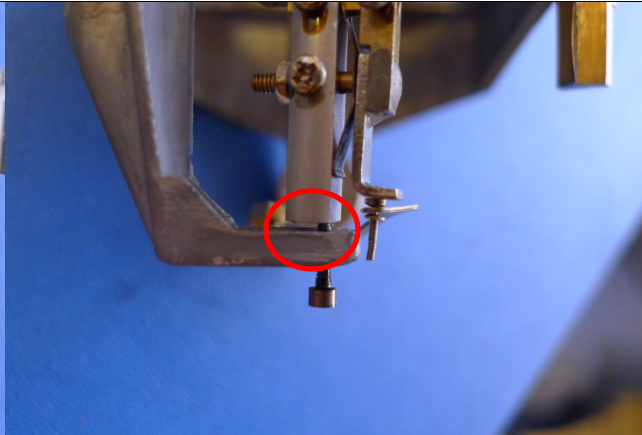
Photo 38- pivot, broken

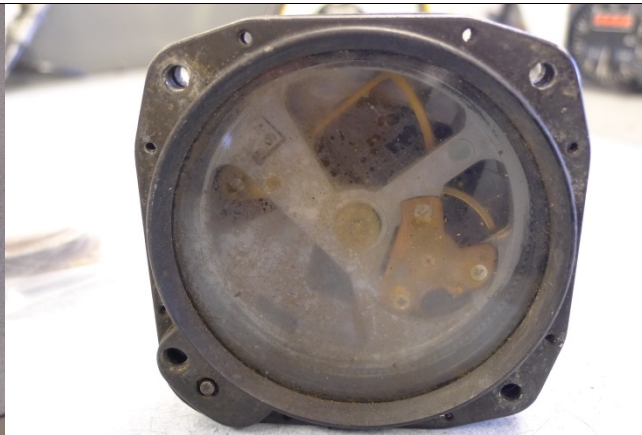
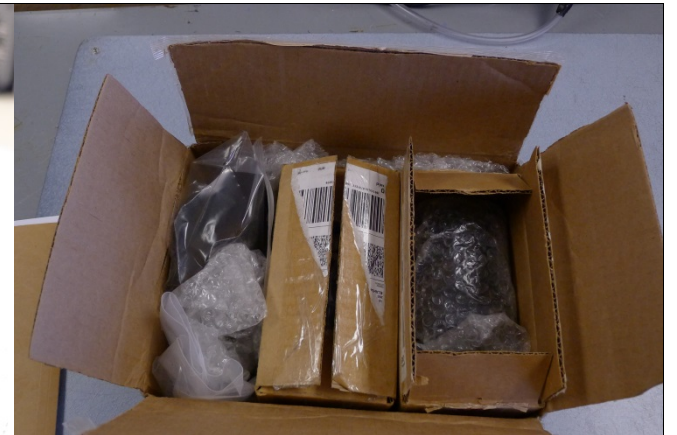
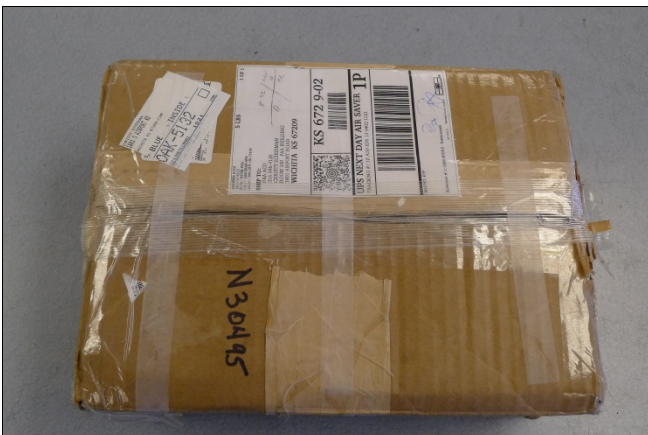
5. Abnormal appearances and functions: the appearances are as noted above and the functions could not be verified because of the severity of the damage to the internal parts.
6. Reassembly: the parts were assembled to the extent possible and the loose parts were placed in the small plastic bags. (Photos-41, 42, 43 and 44)
7. Functional Testing: was not possible to assembled back to an altimeter since the major parts of the instrument were broken to pieces.
8. Further examination requested: none
