Eurocopter Submission

Submitted to the Bureau d'Enquêtes et d'Analyses
and the National Transportation Safety Board on 3 December 2012

NTSB Accident #: CEN11FA599
Operator: Air Methods Corporation
Aircraft Type and S/N: Eurocopter AS 350 B2, S/N 3728
FAA Registration: N352LN
Date & Time: 26 August 2011, 1841 CDT
Location: Mosby, Missouri

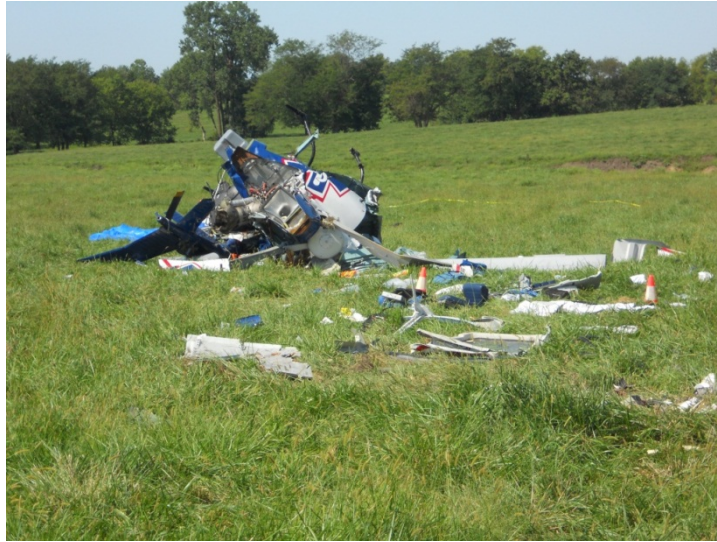
Photo 1: Main Wreckage

The aircraft structure was heavily fragmented and scattered along the debris path (approximately 100 feet in length). All impact signatures were consistent with low main rotor RPM (NR) and a high rate of descent. The impact signatures to the components of the airframe structure were consistent with the initial impact occurring in a nose-low and slight left-bank attitude, oriented opposite the direction of travel.

The main rotor and tail rotor drive systems were examined for mechanical continuity and power signatures. No pre-impact anomalies were identified, and signatures indicated a lack of power/RPM on impact.

The helicopter's fuel tank was intact and located in the midst of the main wreckage. No fuel was observed and no odor of fuel was noted at the accident site; less than one liter of fuel was found in the fuel system tank and lines (which were generally intact). The airframe fuel filter system was removed from the airframe by the investigative team for inspection; no fuel was observed in the lines on the engine side of the filter, and only a residual amount of fuel was observed in the lines on the tank side of the filter. When the drain valve at the bottom of the filter bowl was depressed, no fuel was observed. No fuel was seen in the sight glass. The fuel quantity gauge was removed from the wreckage and retained by the NTSB IIC for future examination.

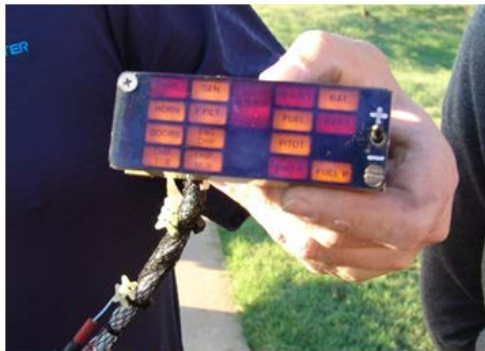
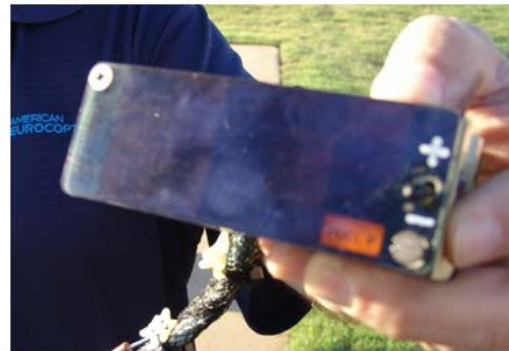
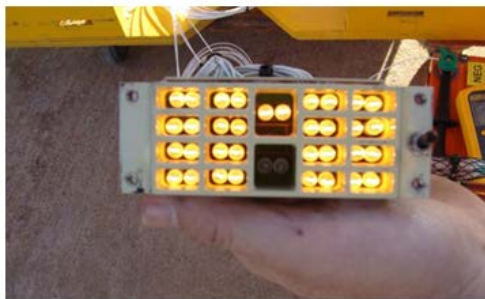
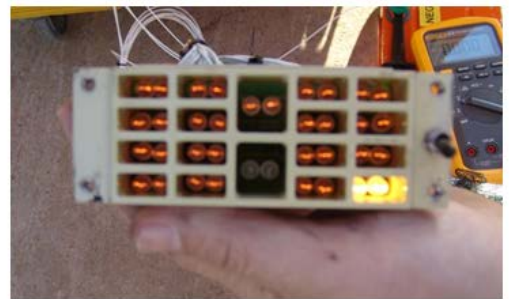
Photos 2 through 5: Caution-Warning Annunciator Panel

An operational check of the caution-warning annunciator panel was performed, which revealed that all lights were working properly. Examination of the individual light bulb filaments revealed the filaments of both "FUEL" bulbs exhibited a slightly stretched coil and smaller bend radii in the filament profile at the bulbs support wires when compared to an exemplar light bulb. The slightly stretched filament coil indicates that the "FUEL" light was illuminated at the time of impact.

As noted above, the instrument panel was configured with Night Vision Goggle (NVG) lighting and filters. The brightness switch on the caution-warning annunciator panel was found on the "-/ "dim" setting at the accident site. During the examination, the panel was illuminated in daylight conditions and observed in both "bright" and "dim" settings. With the panel in the "dim" position as it was found at the accident site, only the "FUEL P" light (the only light that does not convert to the dim setting by design) was conspicuously illuminated. It is unknown whether the panel was switched to the "dim" setting during the previous NVG training flight and never returned to "bright" for the accident flight, switched to "dim" during the accident flight, or if this setting occurred during impact.

On "Bright" with NVG lens and no Lens

On "Dim" with NVG lens. and no Lens

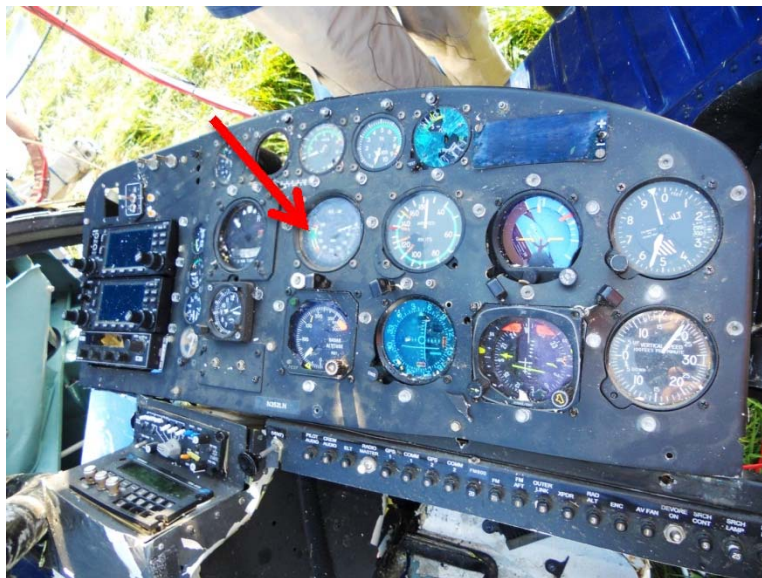
Step 2 of the autorotation procedure refers to monitoring and controlling main rotor rpm (NR). The NF/NR gauge is a dual gauge representing engine free turbine speed (NF) and rotor rpm (NR). The green arc represents the 375-394 rpm NR range. See figure below.

Photo 6: N352LN pilot instrument panel (post-accident).
Location of the NF/NR gauge indicated by the red arrow.
