National Transportation Safety Board

Railroad Accident Brief

Amtrak Train Derailment on BNSF Railway Tracks

Cimarron, Kansas

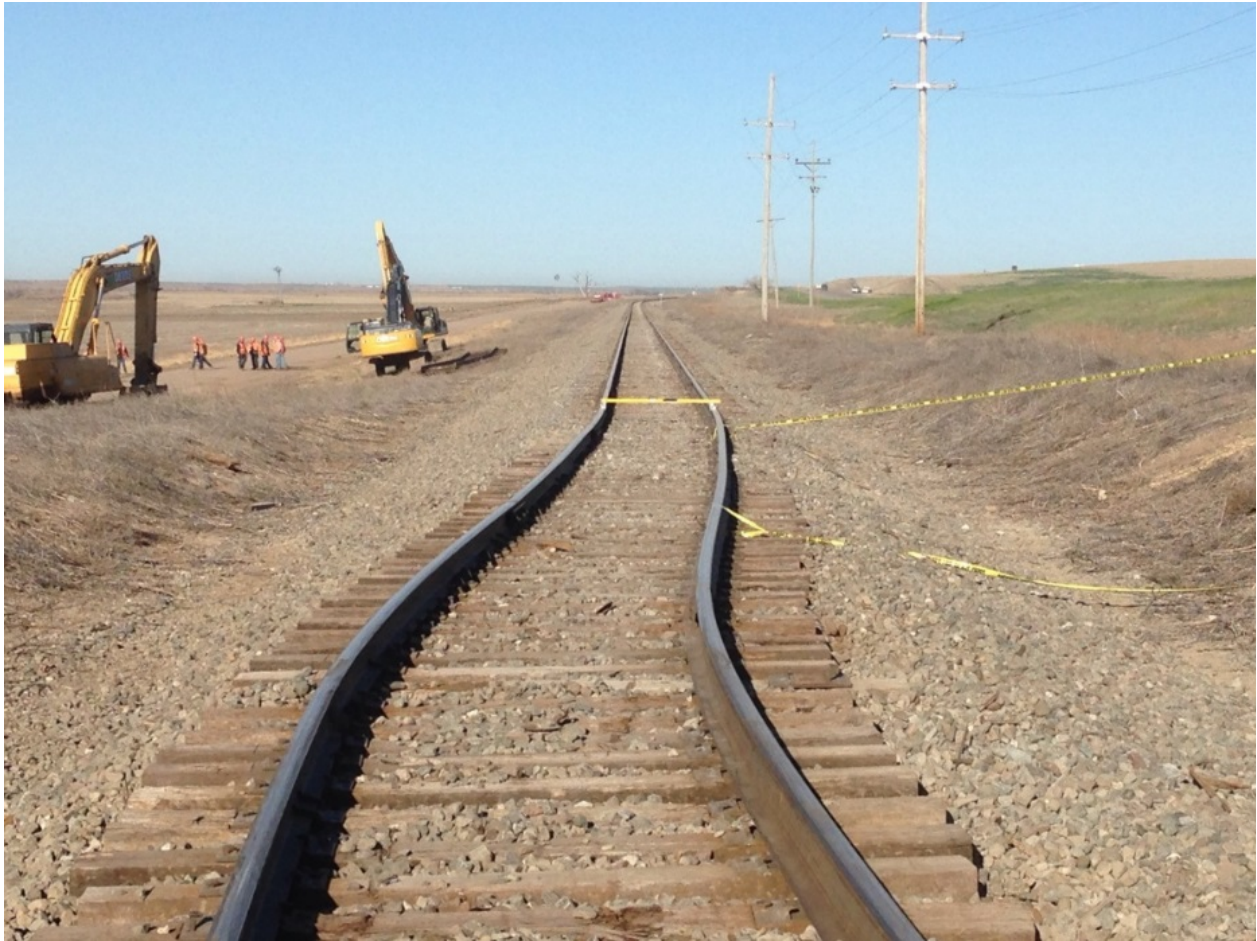
Figure 3. Looking west from the point of derailment at the misalignment (or lateral shift) of the track after the train moved over the shifted track. (Photo: FRA)

The forward-facing camera recorded the train as it approached the displaced rails. The video showed a distortion where the truck had hit the track immediately before the derailment. The event recorder records an emergency brake application immediately after the distortion comes into view. The derailment occurred 25 feet beyond where the truck hit the track.

The National Transportation Safety Board determines that the probable cause of the derailment was the agriculture truck driver’s failure to properly secure his unattended truck, which rolled downhill and struck the BNSF railroad tracks causing them to misalign. Contributing to the accident was the failure of the truck’s driver and his supervisor to report the incident to the local authorities.

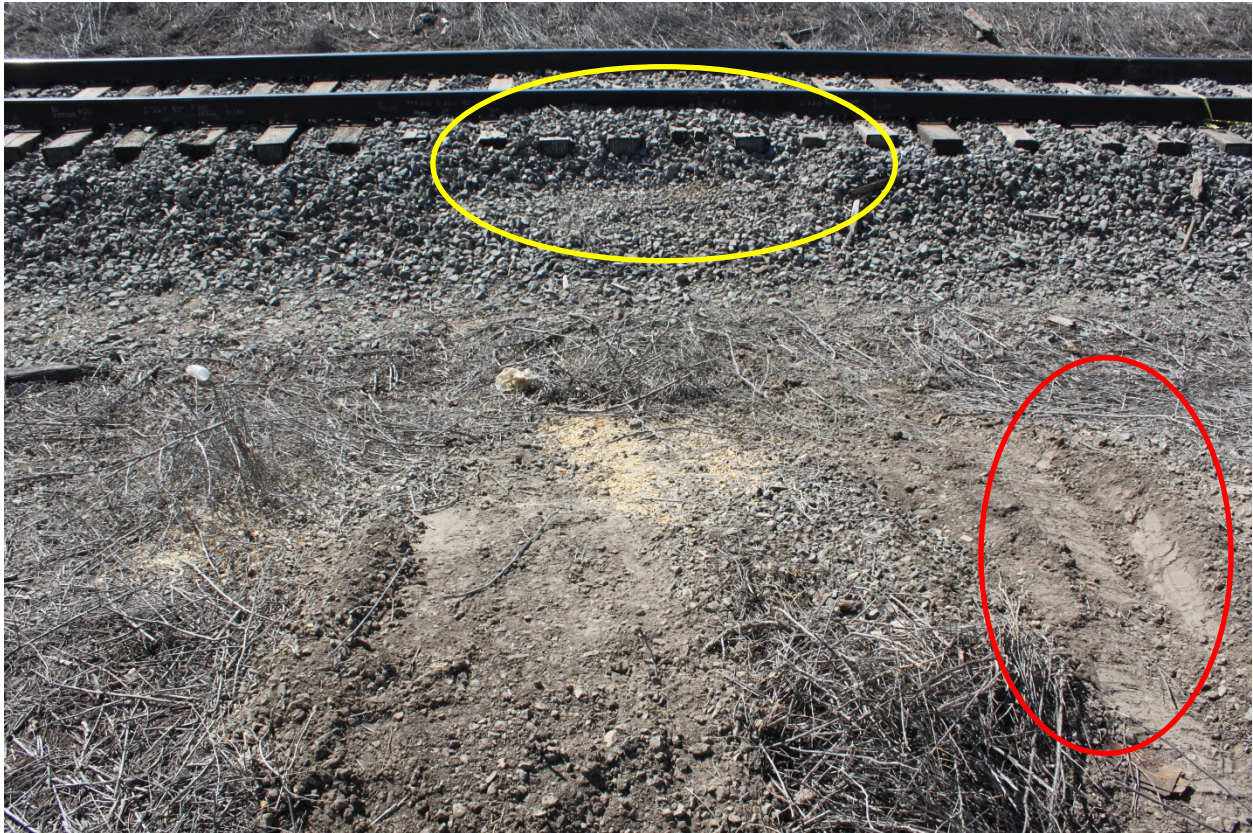
At the scene, investigators found recent damage to the north ends of the ties at MP 373.07, recent tire marks perpendicular to the point of impact, and some cattle feed on the ground. (See figure 4.)

Figure 4. A red circle marks the impression from the truck's tire in the rock at the side of the tracks. The yellow circle marks the spot where the truck hit the railroad tracks.

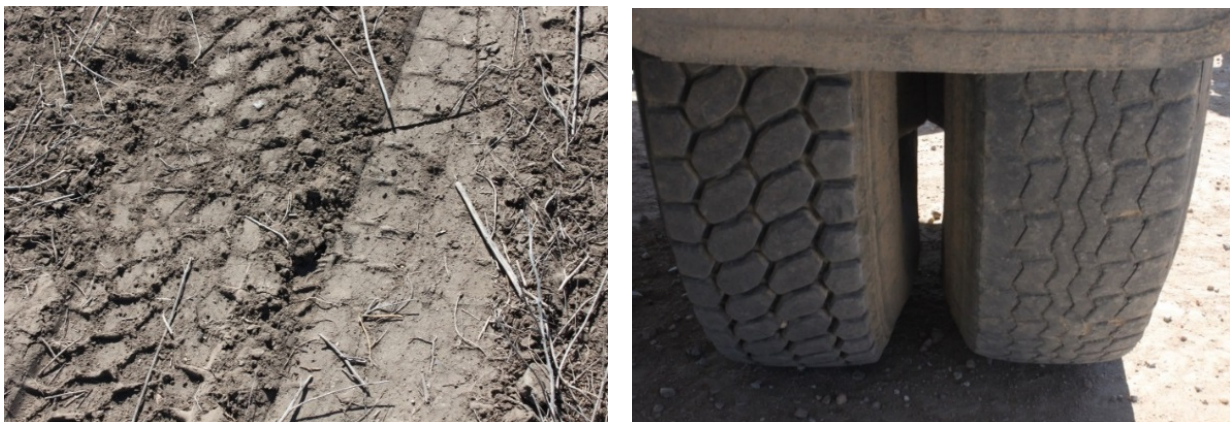
Figure 6. Tread pattern adjacent to MP 373.07; the right rear tires of the agricultural truck.
