APÉNDICE B

INFORMACIÓN DEL SITIO DEL ACCIDENTE

DIFERENCIAS DE CONFIGURACIÓN DE FLOTA EN LA TRANSFERENCIA DE ACTITUD (Vertical Gyro) DEL COPA 737

ANÁLISIS DEL CANAL DEL TONEL DEL DFDR

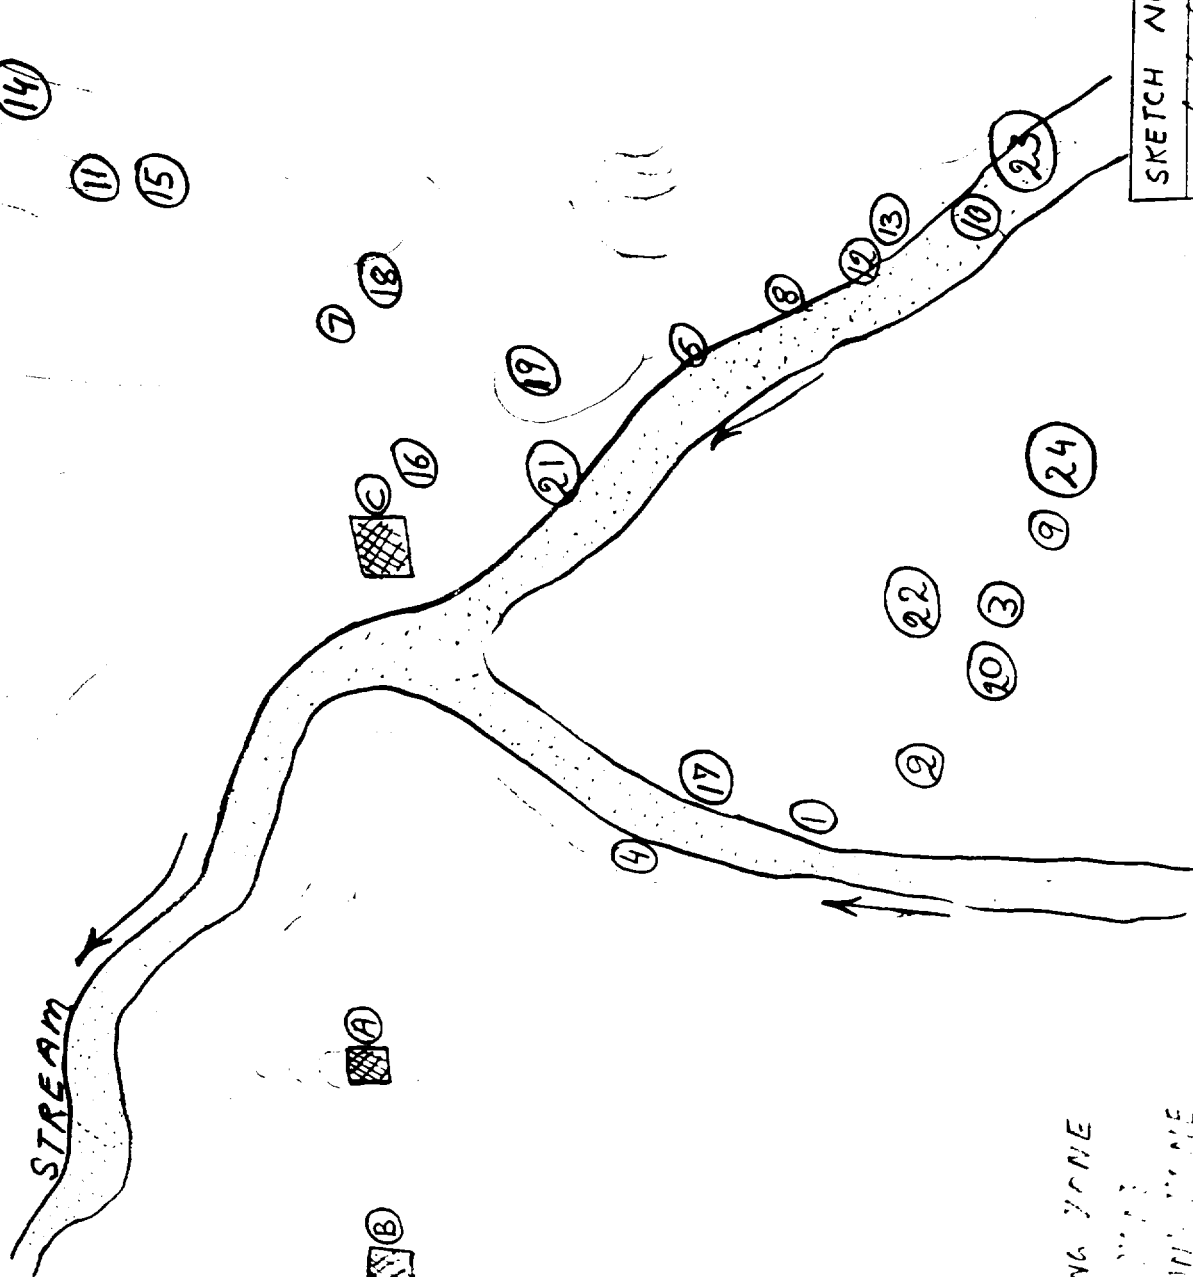
WREC. AGE DISTRIBUTION DIAGRAM

- A) UPPER LANDING ZONE
- B) MID LANDING ZONE
- C) LOWER LANDING ZONE

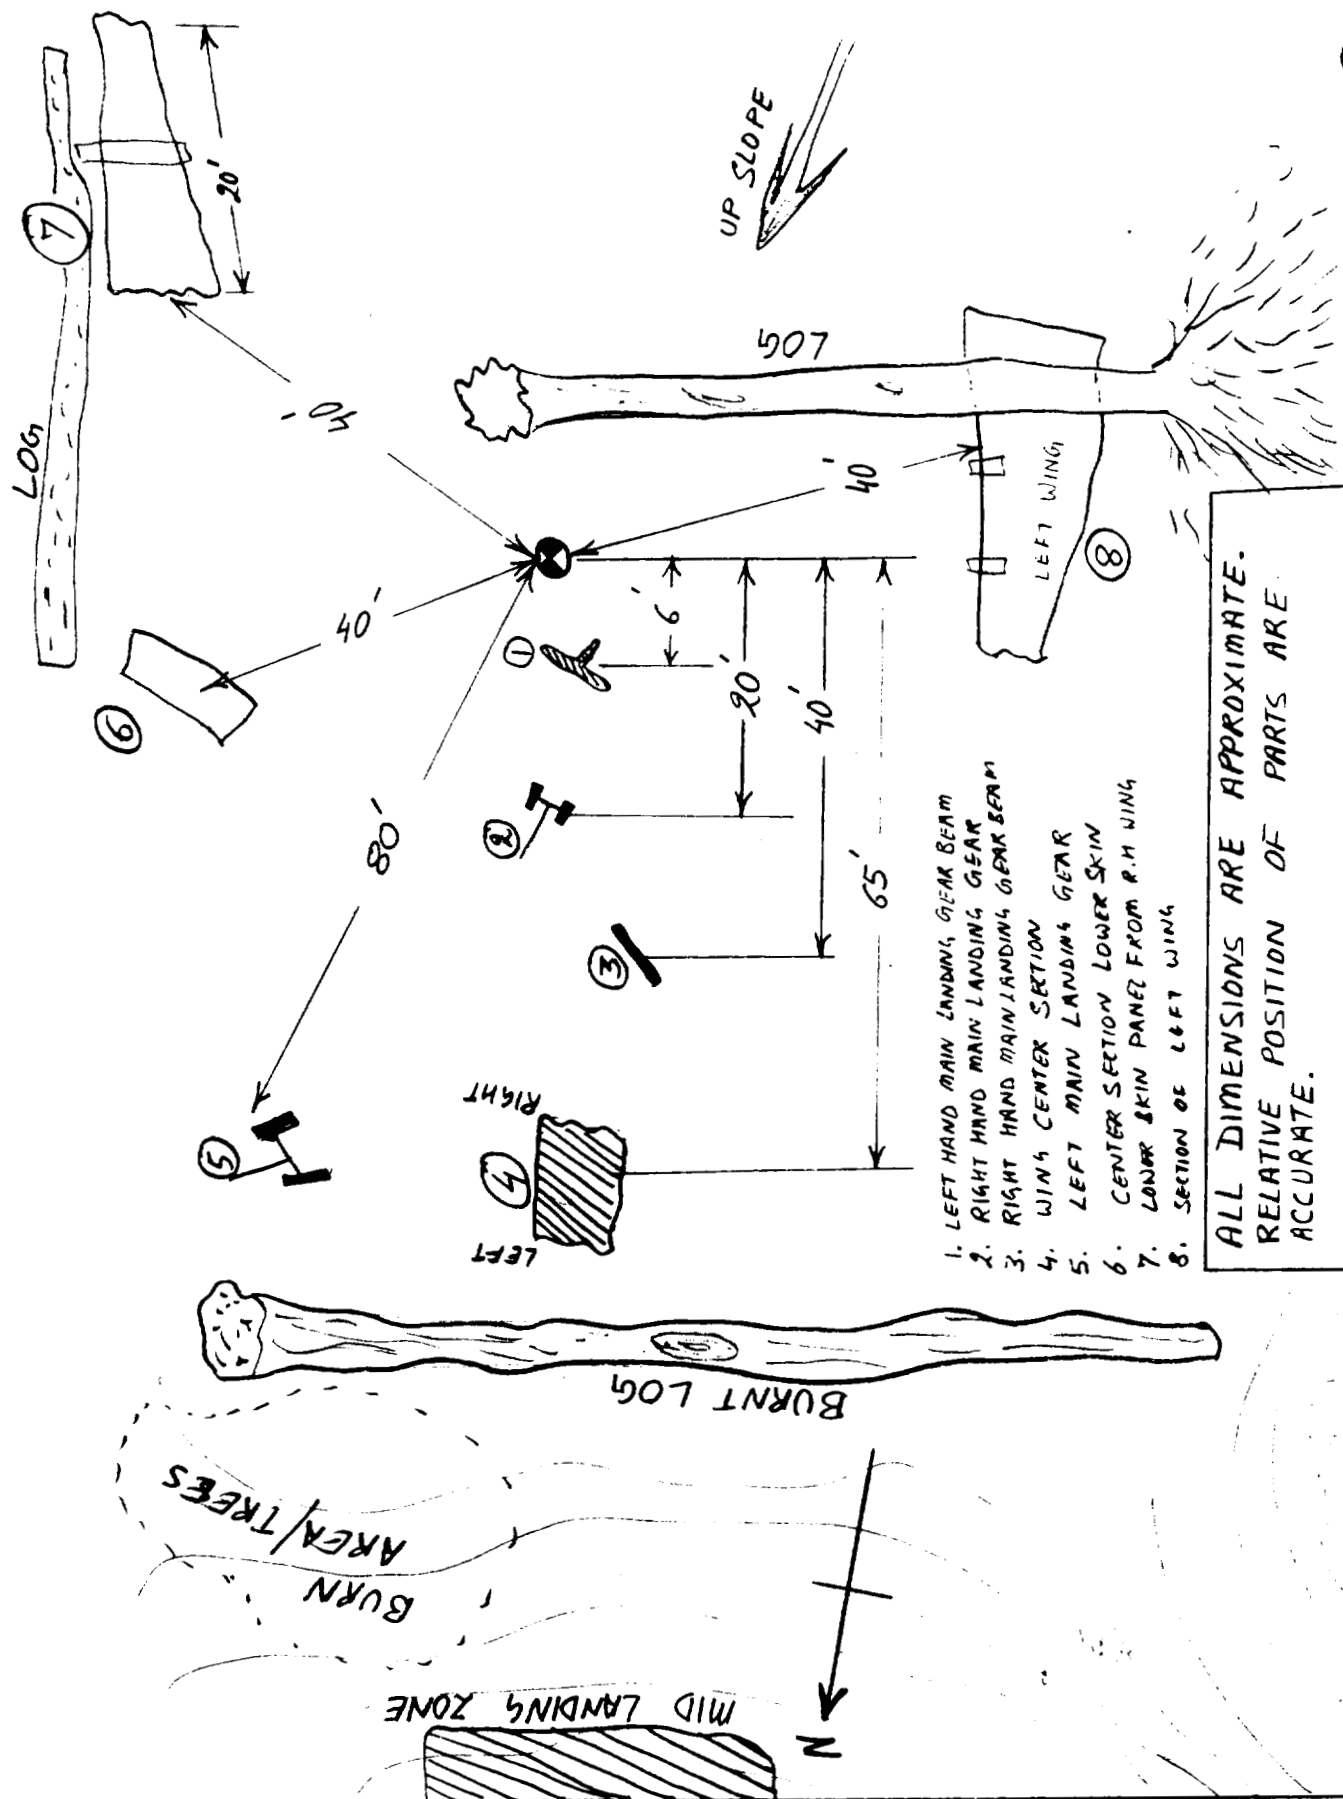
MAIN WRECKAGE - WING CENTER SECTION

ALL DIMENSIONS ARE APPROXIMATE.
RELATIVE POSITION OF PARTS ARE
ACCURATE.

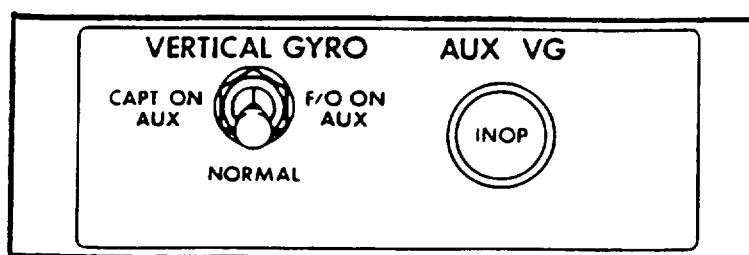
AIRCRAFT PC001 (EX-SINGAPORE)

AN AUXILIARY VERTICAL GYRO (VG) WAS INSTALLED, IN ADDITION TO VG NO. 1 AND VG NO. 2. A DEDICATED ATTITUDE (VG) TRANSFER SWITCH WAS LOCATED ON P9 FORWARD ELECTRONICS PANEL. A TOGGLE SWITCH (SIDE TO SIDE) ENABLED EITHER CAPTAIN (CAPT ON AUX) OR THE FIRST OFFICER (F/O ON AUX) TO SELECT AUX. VG. (BOTH COULD NOT CHOOSE AUX. VG AT THE SAME TIME.) WITH THE SWITCH IN 'NORMAL' POSITION, CAPT WAS ON VG NO. 1 AND F/O ON VG NO. 2.

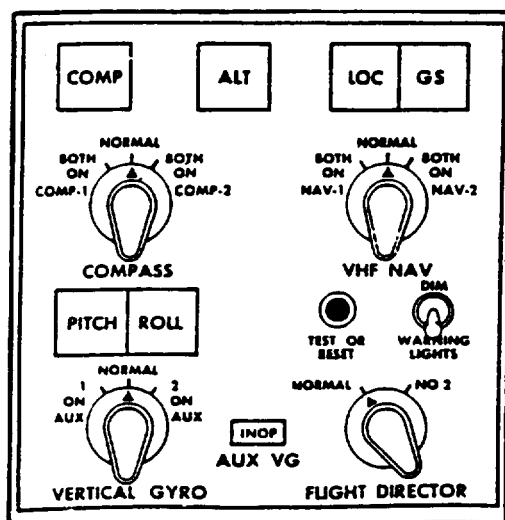
AIRCRAFT PG401 (EX-AIR NEW ZEALAND)

AN AUXILIARY VERTICAL GYRO (VG) WAS INSTALLED IN ADDITION TO VG NO. 1 AND VG NO. 2. A VG TRANSFER SWITCH, A PART OF THE INSTRUMENT TRANSFER PANEL, WAS LOCATED AT P5 OVERHEAD PANEL. A ROTARY SWITCH ENABLED EITHER CAPTAIN (1 ON AUX) OR THE FIRST OFFICER (2 ON AUX) TO SELECT AUX. VG. (BOTH COULD NOT CHOOSE AUX. VG AT THE SAME TIME.) WITH THE SWITCH IN 'NORMAL' POSITION, CAPT WAS ON VG NO. 1 AND F/O ON VG NO. 2.

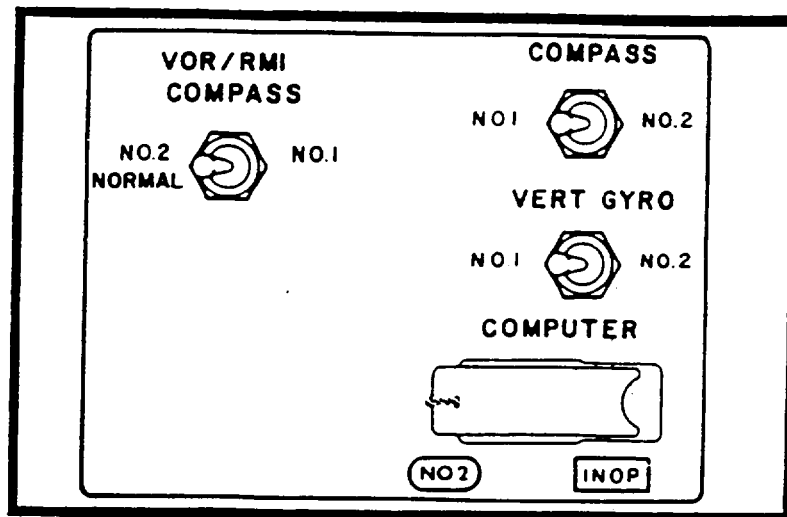
AIRCRAFT PY341 (EX-LUFTHANSA)

NO AUXILIARY VG WAS INSTALLED. A VG TRANSFER SWITCH, A PART OF THE INSTRUMENT TRANSFER PANEL, WAS LOCATED AT P1 CAPTAIN'S INSTRUMENT PANEL. A TOGGLE SWITCH (SIDE TO SIDE) ENABLED CAPTAIN TO SELECT EITHER VG NO. 1 OR VG NO. 2. NO VG TRANSFER CAPABILITY WAS PROVIDED FOR THE FIRST OFFICER.

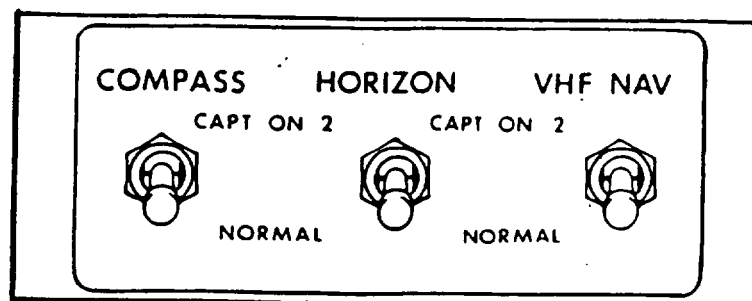
AIRCRAFT PG572 (EX-ALL NIPPON)

NO AUXILIARY VG WAS INSTALLED. A VG TRANSFER SWITCH, A PART OF THE INSTRUMENT TRANSFER PANEL, WAS LOCATED AT P5 OVERHEAD PANEL. A TOGGLE SWITCH (UP-DOWN) ENABLED CAPTAIN TO SELECT EITHER VG NO. 1 (NORMAL) OR VG NO. 2 (CAPT ON 2). NO VG TRANSFER CAPABILITY WAS PROVIDED FOR THE FIRST OFFICER.

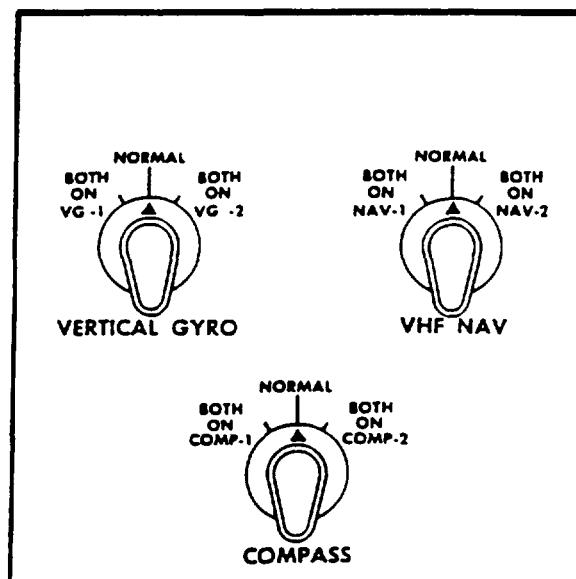
AIRCRAFT PJ112 (EX-BRITANNIA)
 AIRCRAFT PJ107
 AIRCRAFT PJ106
 AIRCRAFT PJ116

NO AUXILIARY VG WAS INSTALLED. A VG TRANSFER SWITCH, A PART OF THE INSTRUMENT TRANSFER PANEL, WAS LOCATED AT P5 OVERHEAD PANEL. A ROTARY SWITCH ENABLED CAPTAIN TO SELECT VG NO. 2 VIA F/O'S ADI (BOTH ON VG-2) OR F/O TO SELECT VG NO. 1 VIA CAPTAIN'S ADI (BOTH ON VG-1). WITH THE SWITCH IN 'NORMAL' POSITION, CAPT WAS ON VG NO. 1 AND F/O ON VG NO. 2.

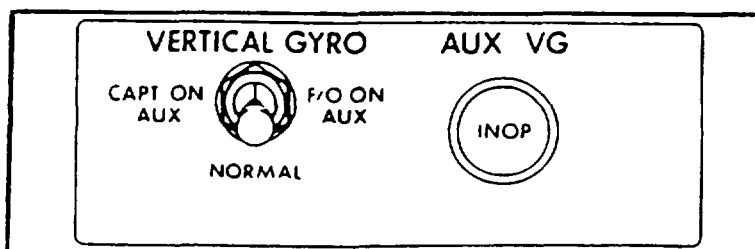
PIEDMONT 737-200

AN AUXILIARY VERTICAL GYRO (VG) WAS INSTALLED, IN ADDITION TO VG NO. 1 AND VG NO. 2. A DEDICATED ATTITUDE (VG) TRANSFER SWITCH WAS LOCATED ON P5 OVERHEAD PANEL. A TOGGLE SWITCH (SIDE TO SIDE) ENABLED EITHER CAPTAIN (CAPT ON AUX) OR THE FIRST OFFICER (F/O ON AUX) TO SELECT AUX. VG. (BOTH COULD NOT CHOOSE AUX. VG AT THE SAME TIME.) WITH THE SWITCH IN 'NORMAL' POSITION, CAPT WAS ON VG NO. 1 AND F/O ON VG NO. 2.

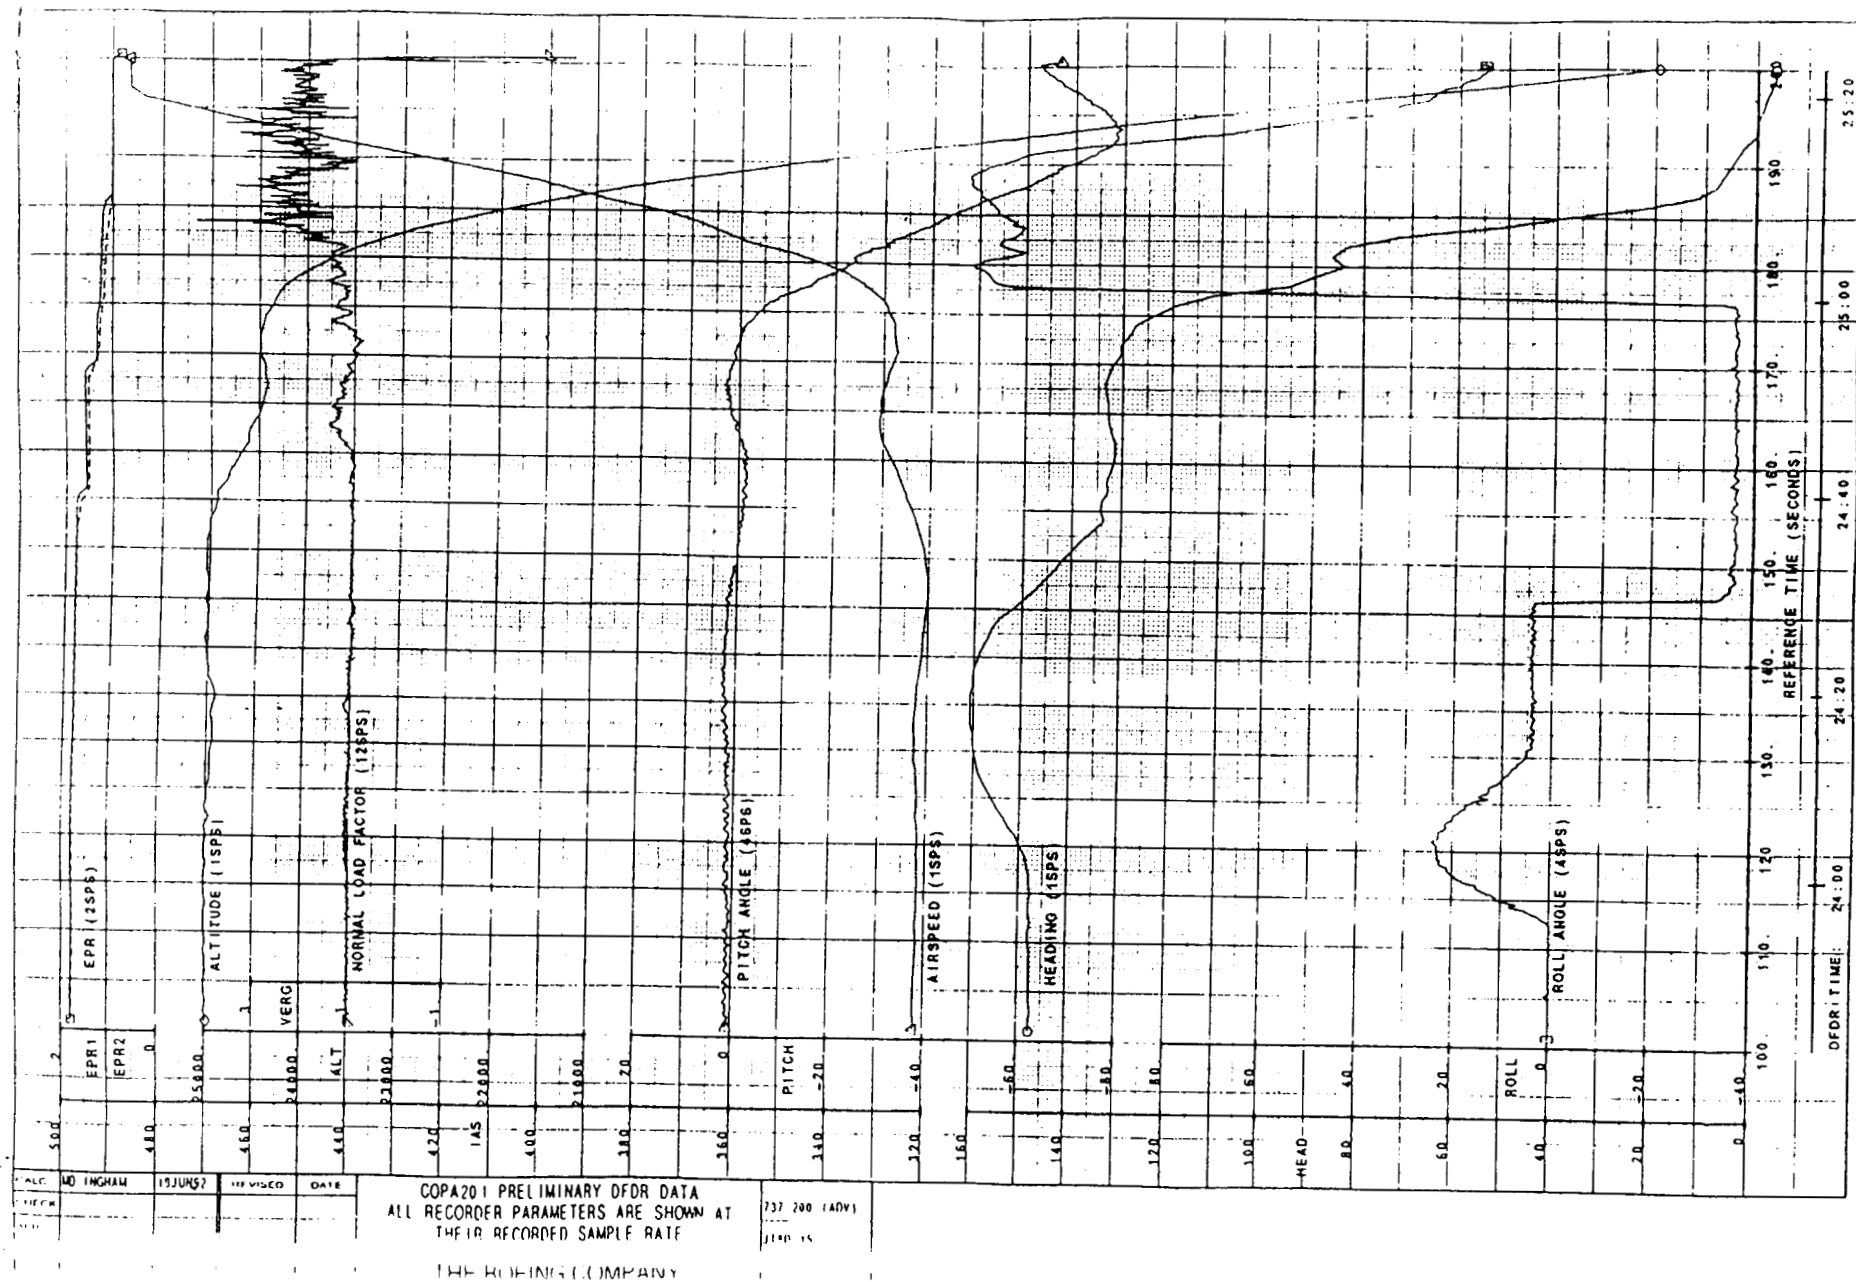
FIGURE 1

The FDR information provided to Boeing by the NTSB, is plotted in Figure 1. The last 100 seconds of the flight are included on the plot. FDR time is noted on the bottom scale for reference.

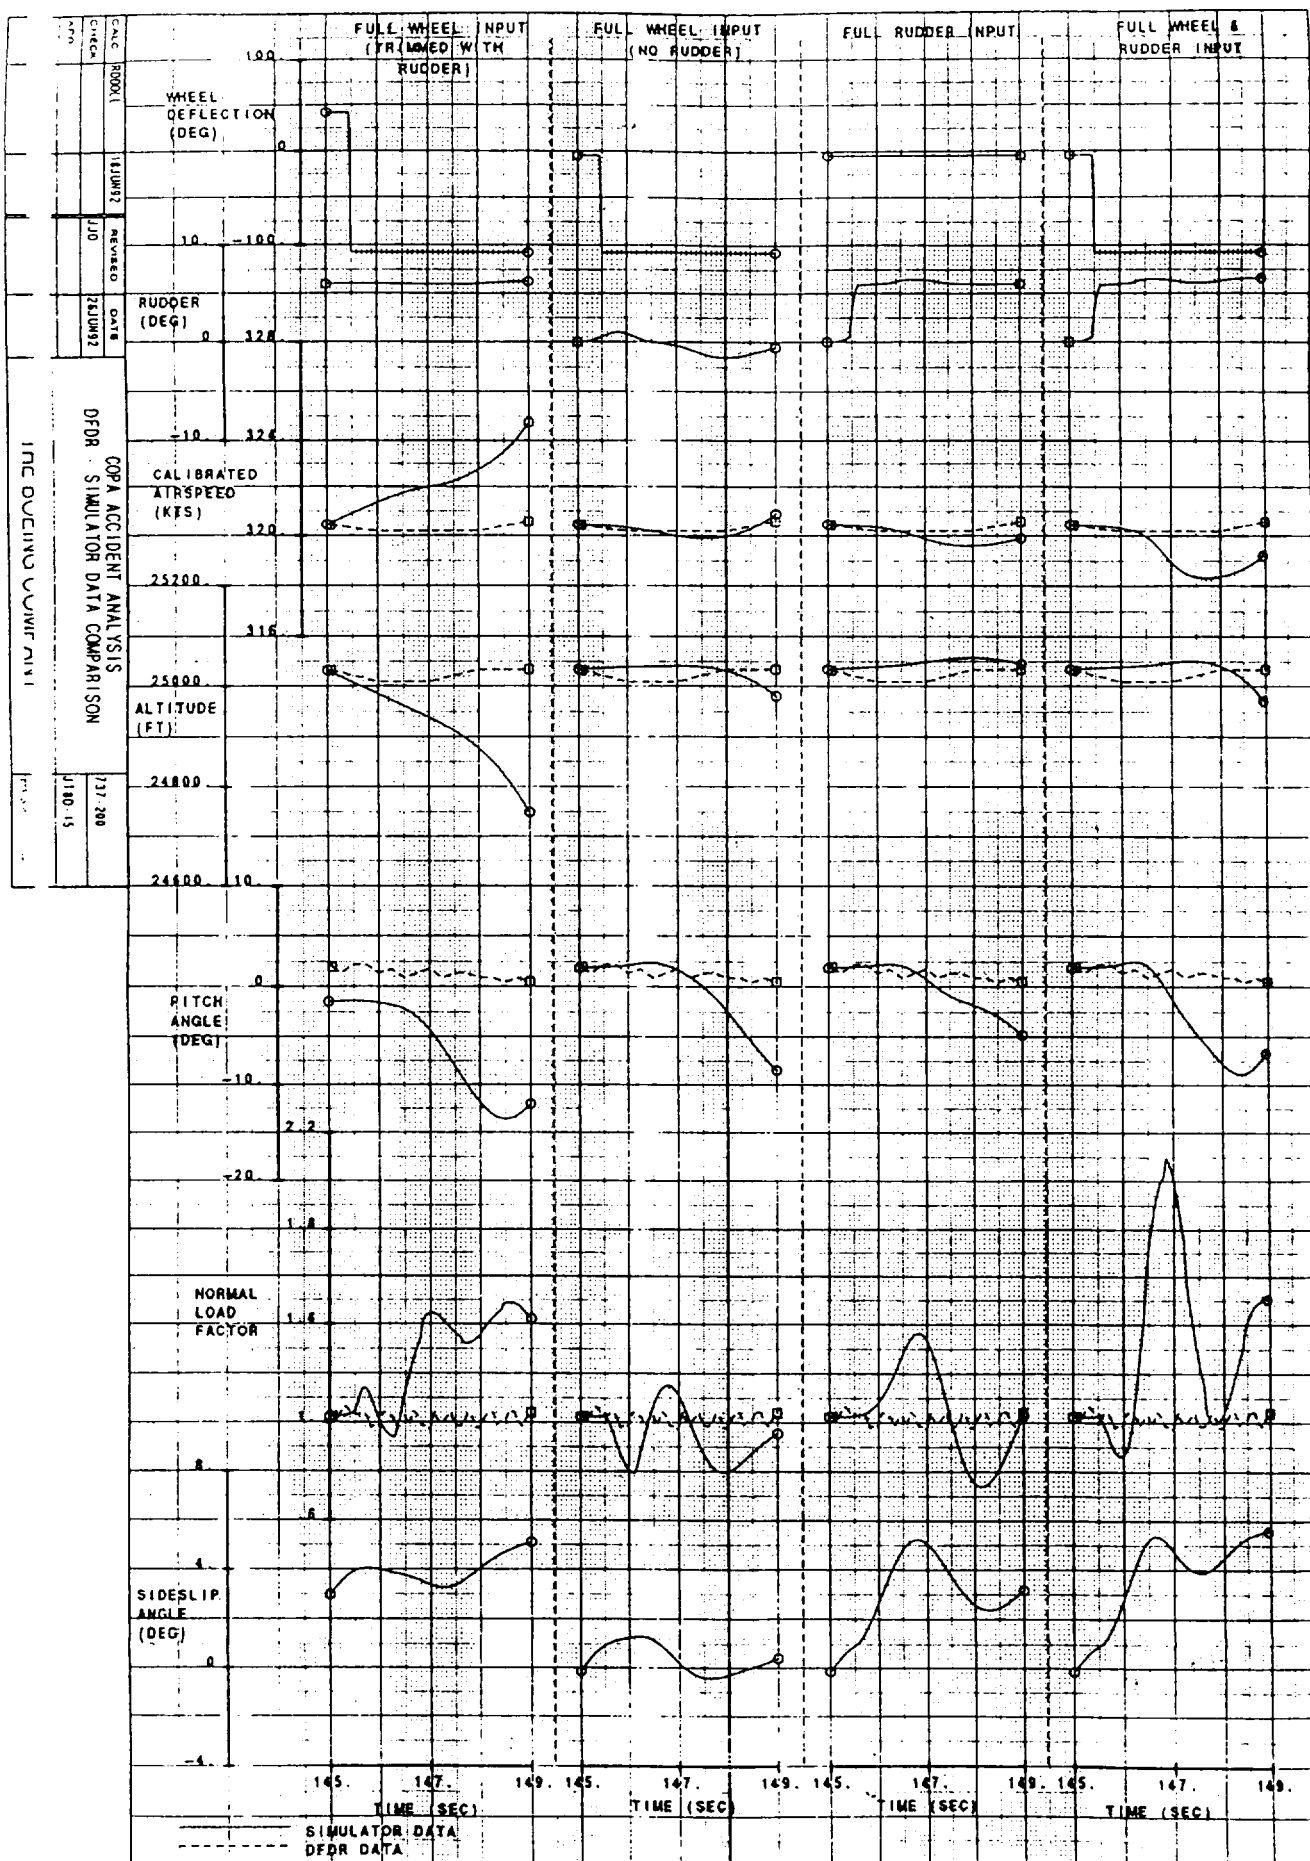
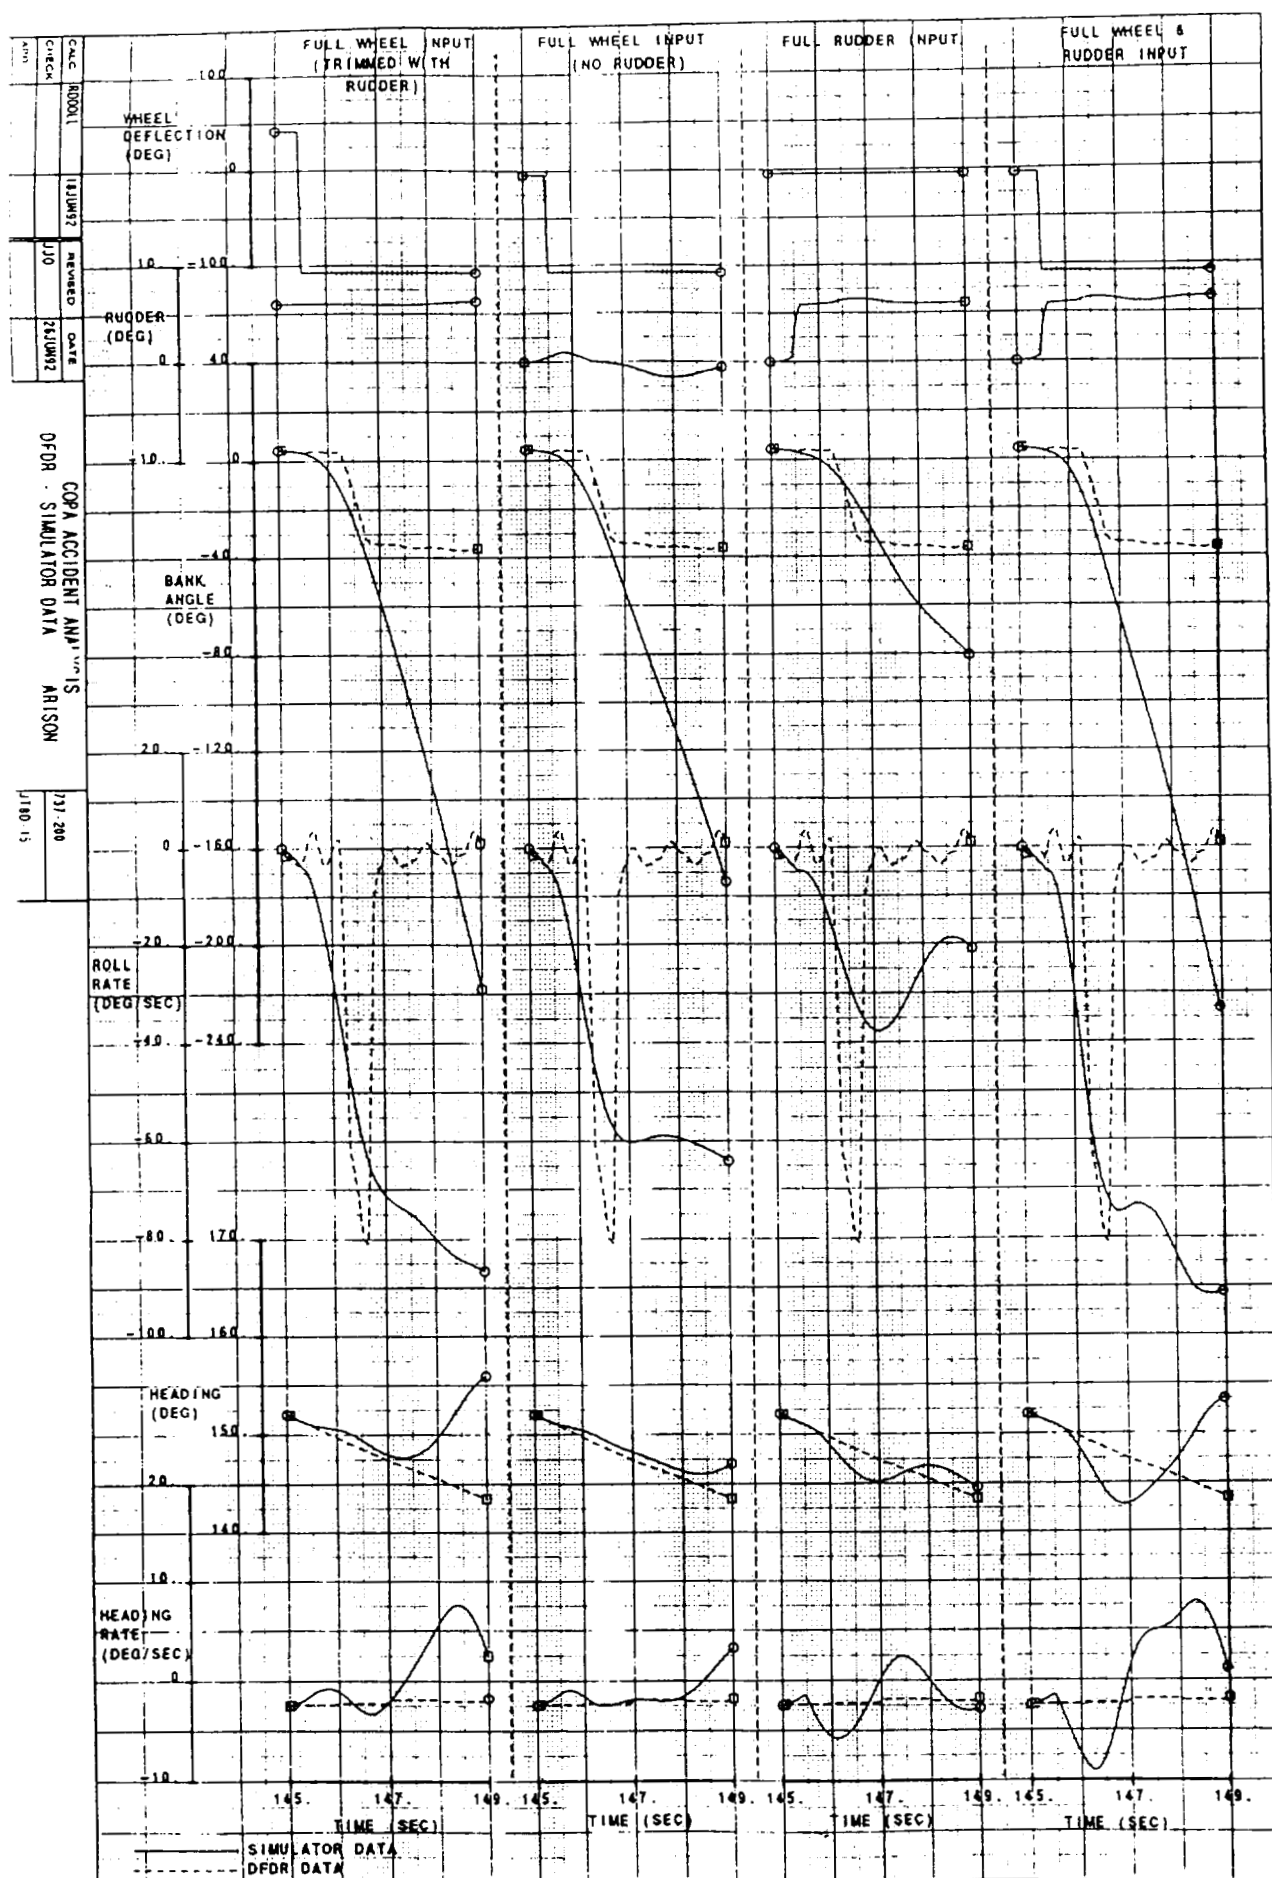
x Additionally, the simulator roll rate data in Figures 2 and 3 shows a much different profile than does the recorded FDR data. While the aircraft is capable of producing the level of roll rate recorded on the FDR, the roll acceleration that the aircraft is capable of producing is far less than that recorded on the FDR. In other words, the sharpness of the roll onset cannot be produced by aircraft control inputs. Also, the disturbance to the load factor shown in the plots of maximum wheel and rudder inputs are not evident in the FDR traces.
