#### RE-EXAMINACIÓN DEL SINCRO DE TONEL PARA EL VG#1

Subject: Vertical Gyro Roll Synchro Lab Analysis, COPA 737-200,  
HP-1205CMP, Accident Near Tucuti, Panama, June 6, 1992

# EQUIPMENT QUALITY ANALYSIS REPORT

SUBJECT: *COPA, Number One Vertical Gyro, Roll Synchro Rotor Disassembly.*

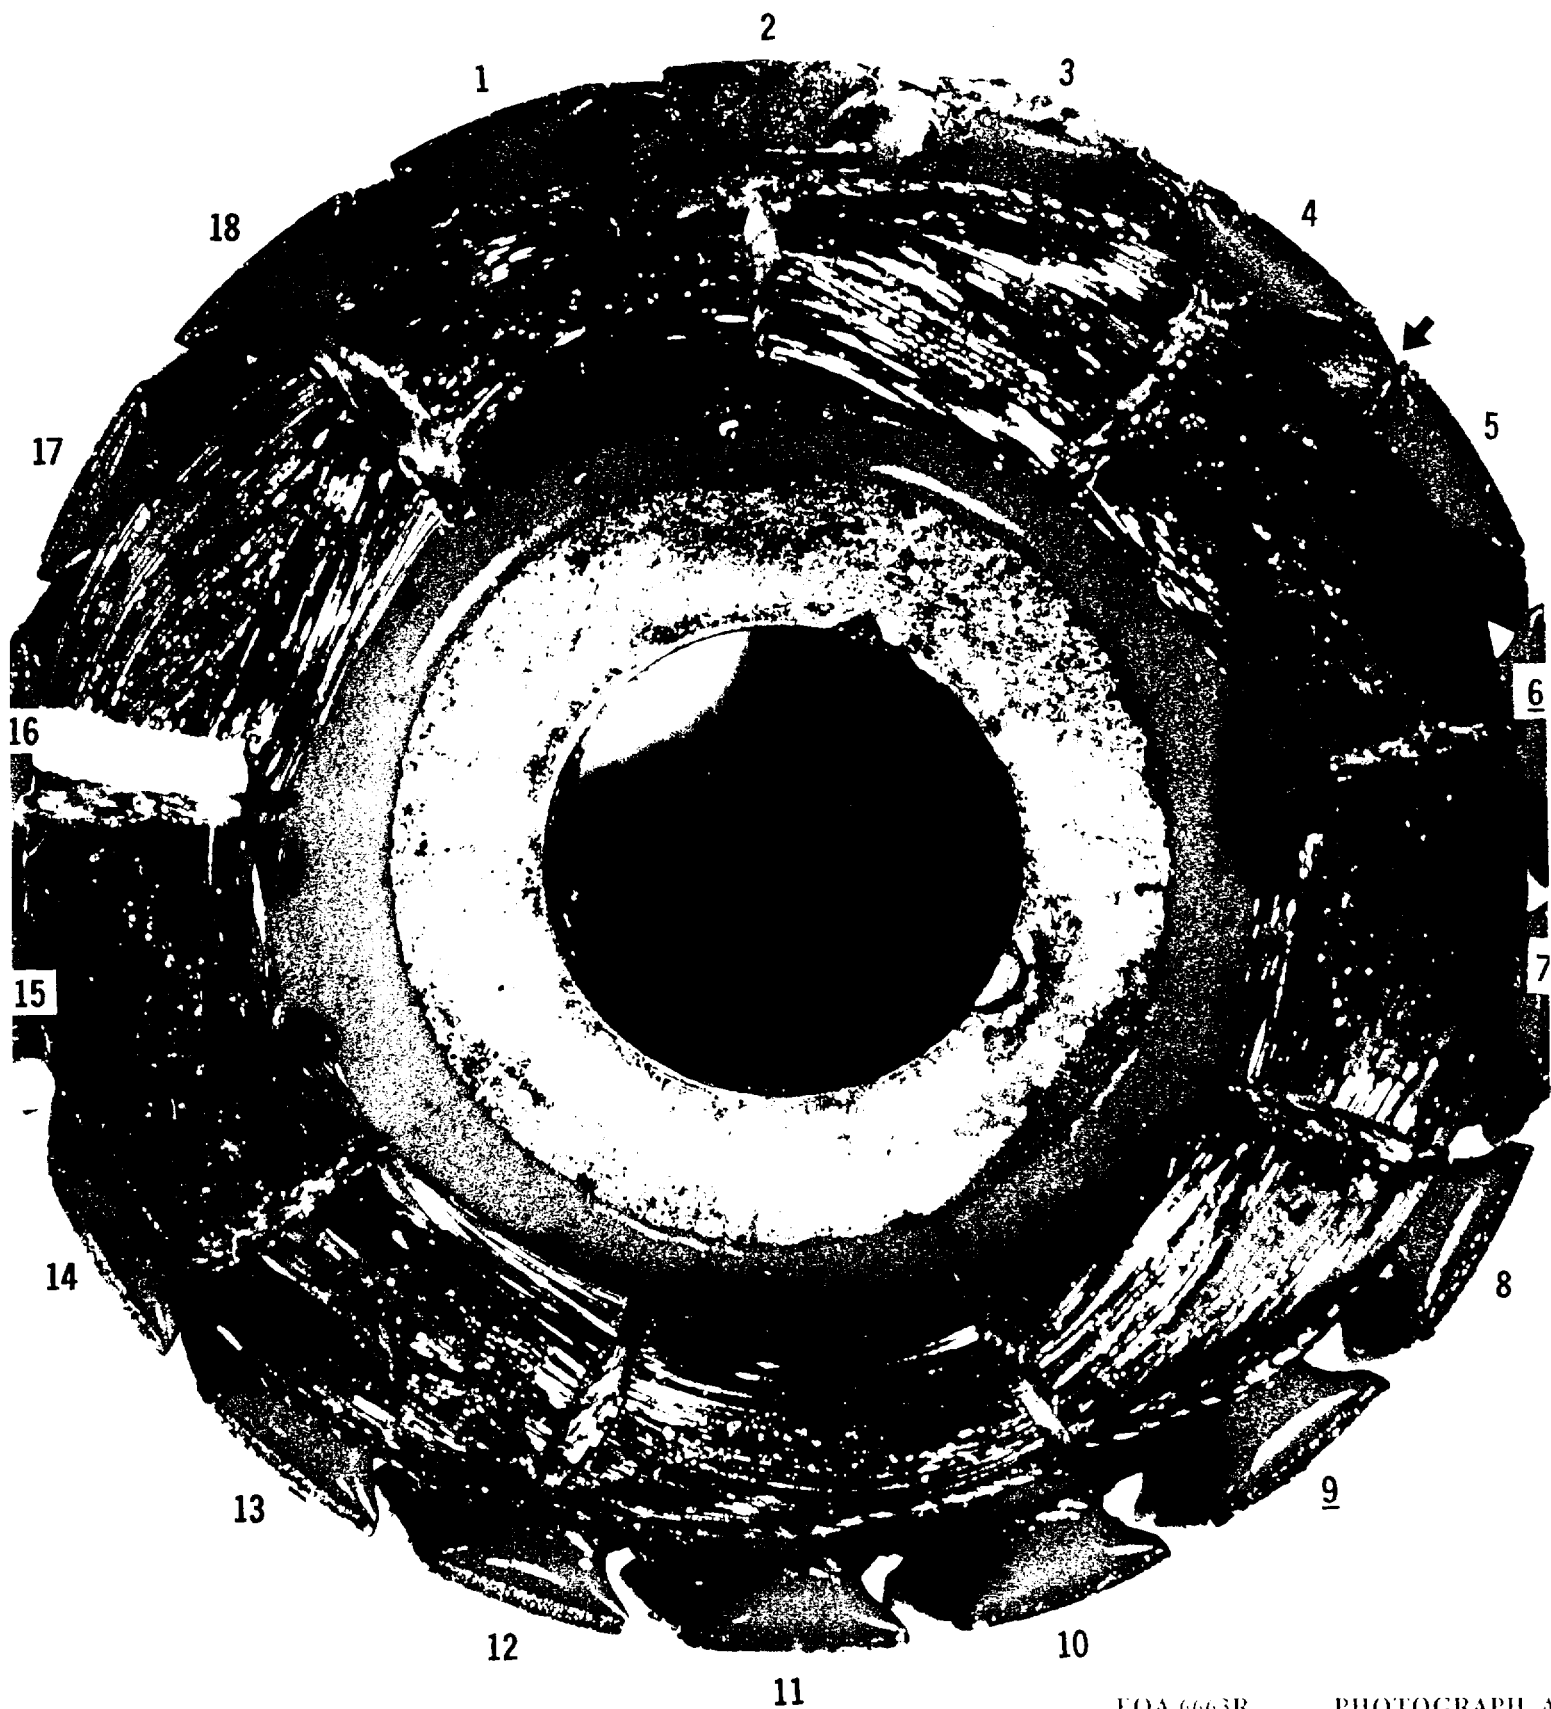
FQA 6663R PHOTOGRAPH A

Overview of the rotor in as received" condition. (Front view for analysis purposes)

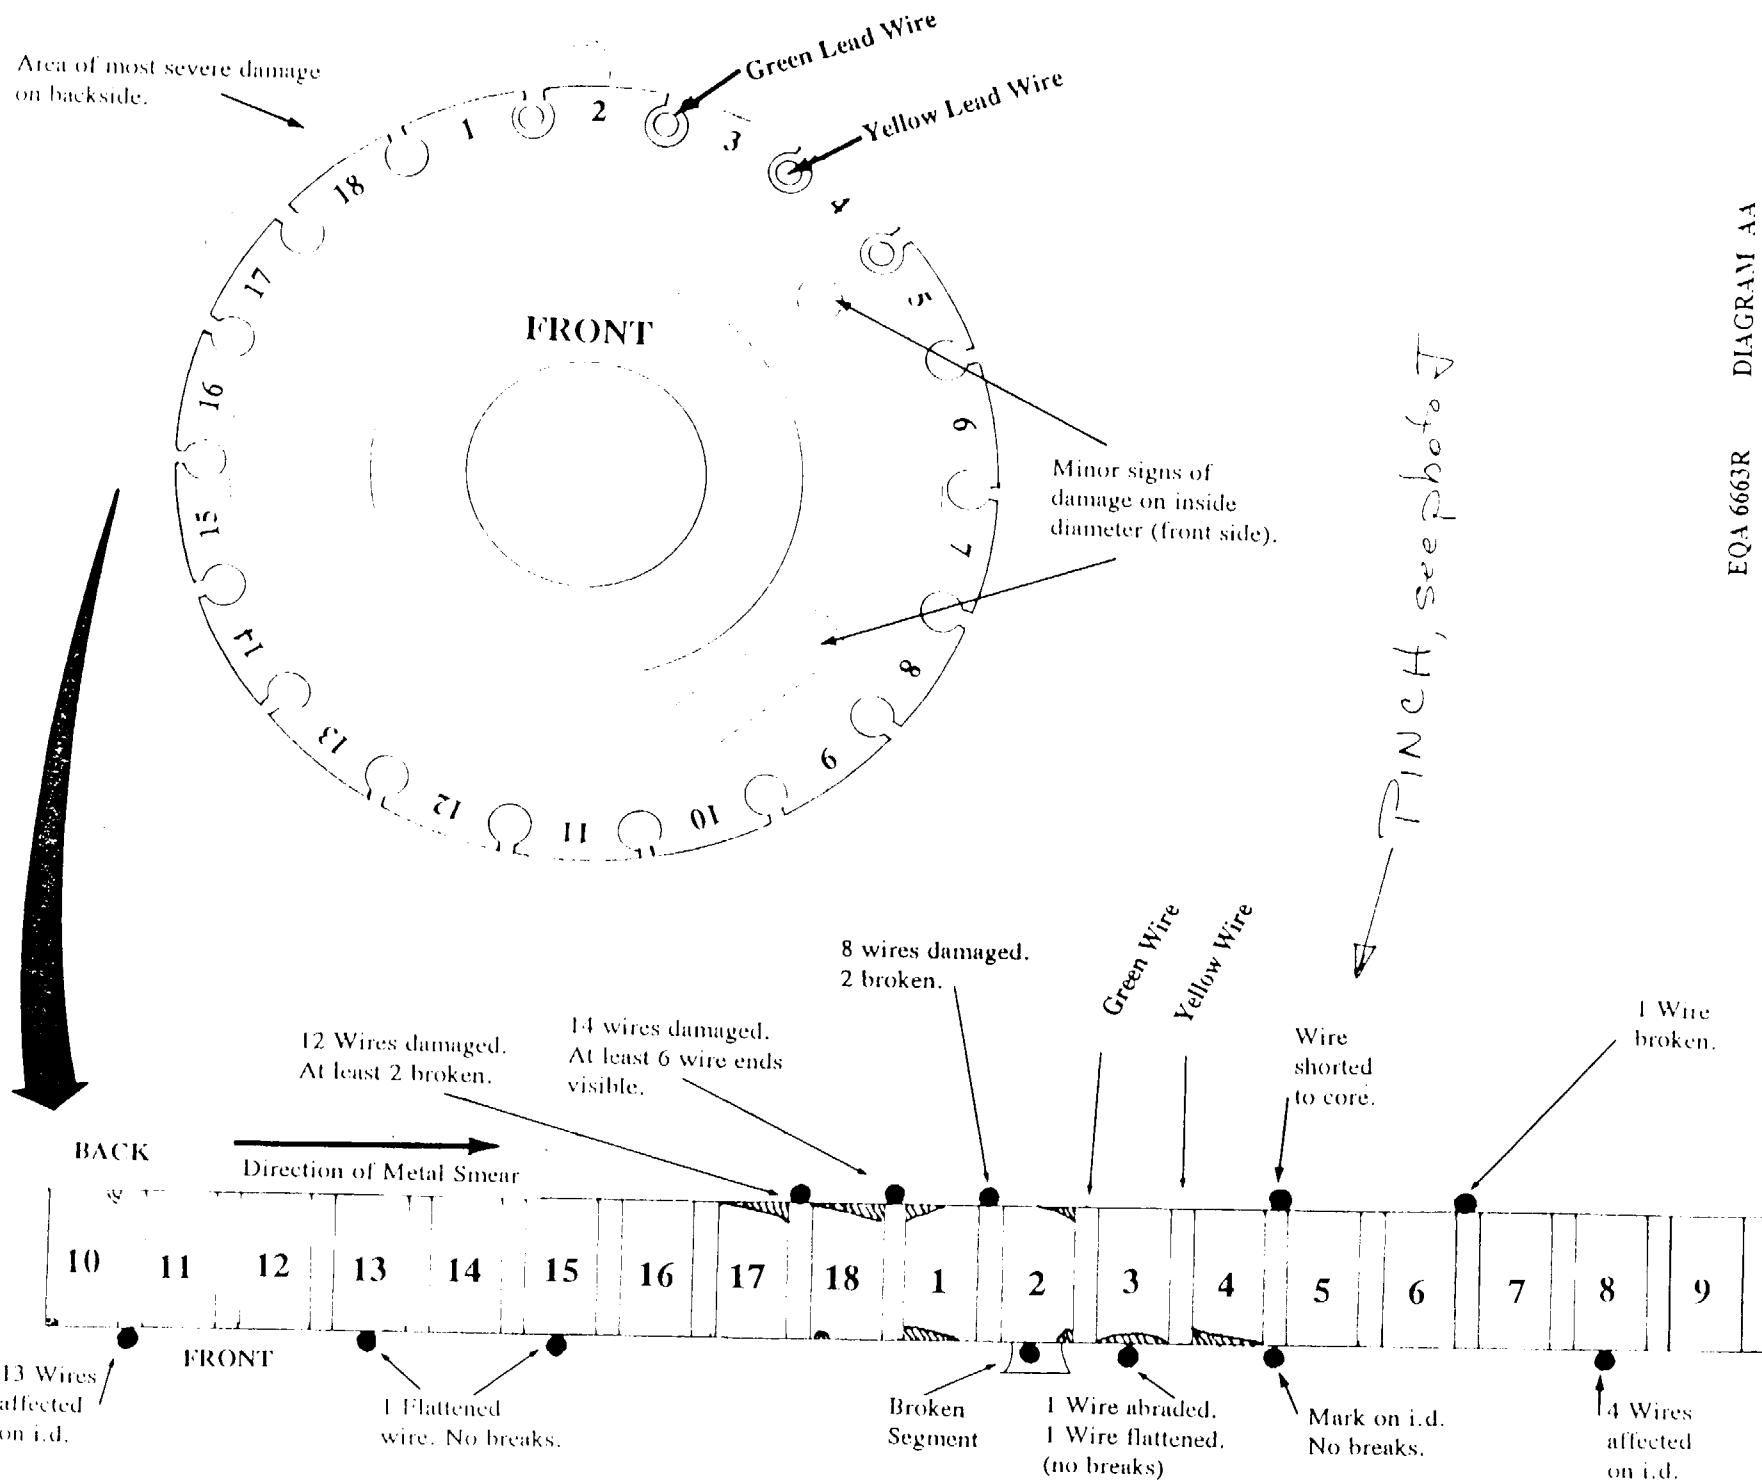
EQA 6663R DIAGRAM AA

Visual and microscopic examinations were performed on the rotor. Several areas of physical damage and one manufacturing discrepancy were in evidence. See the enclosed diagram AA. The following damage was noted:

PINCH, see photo J

Map of damage seen on the rotor in the "as received" condition.

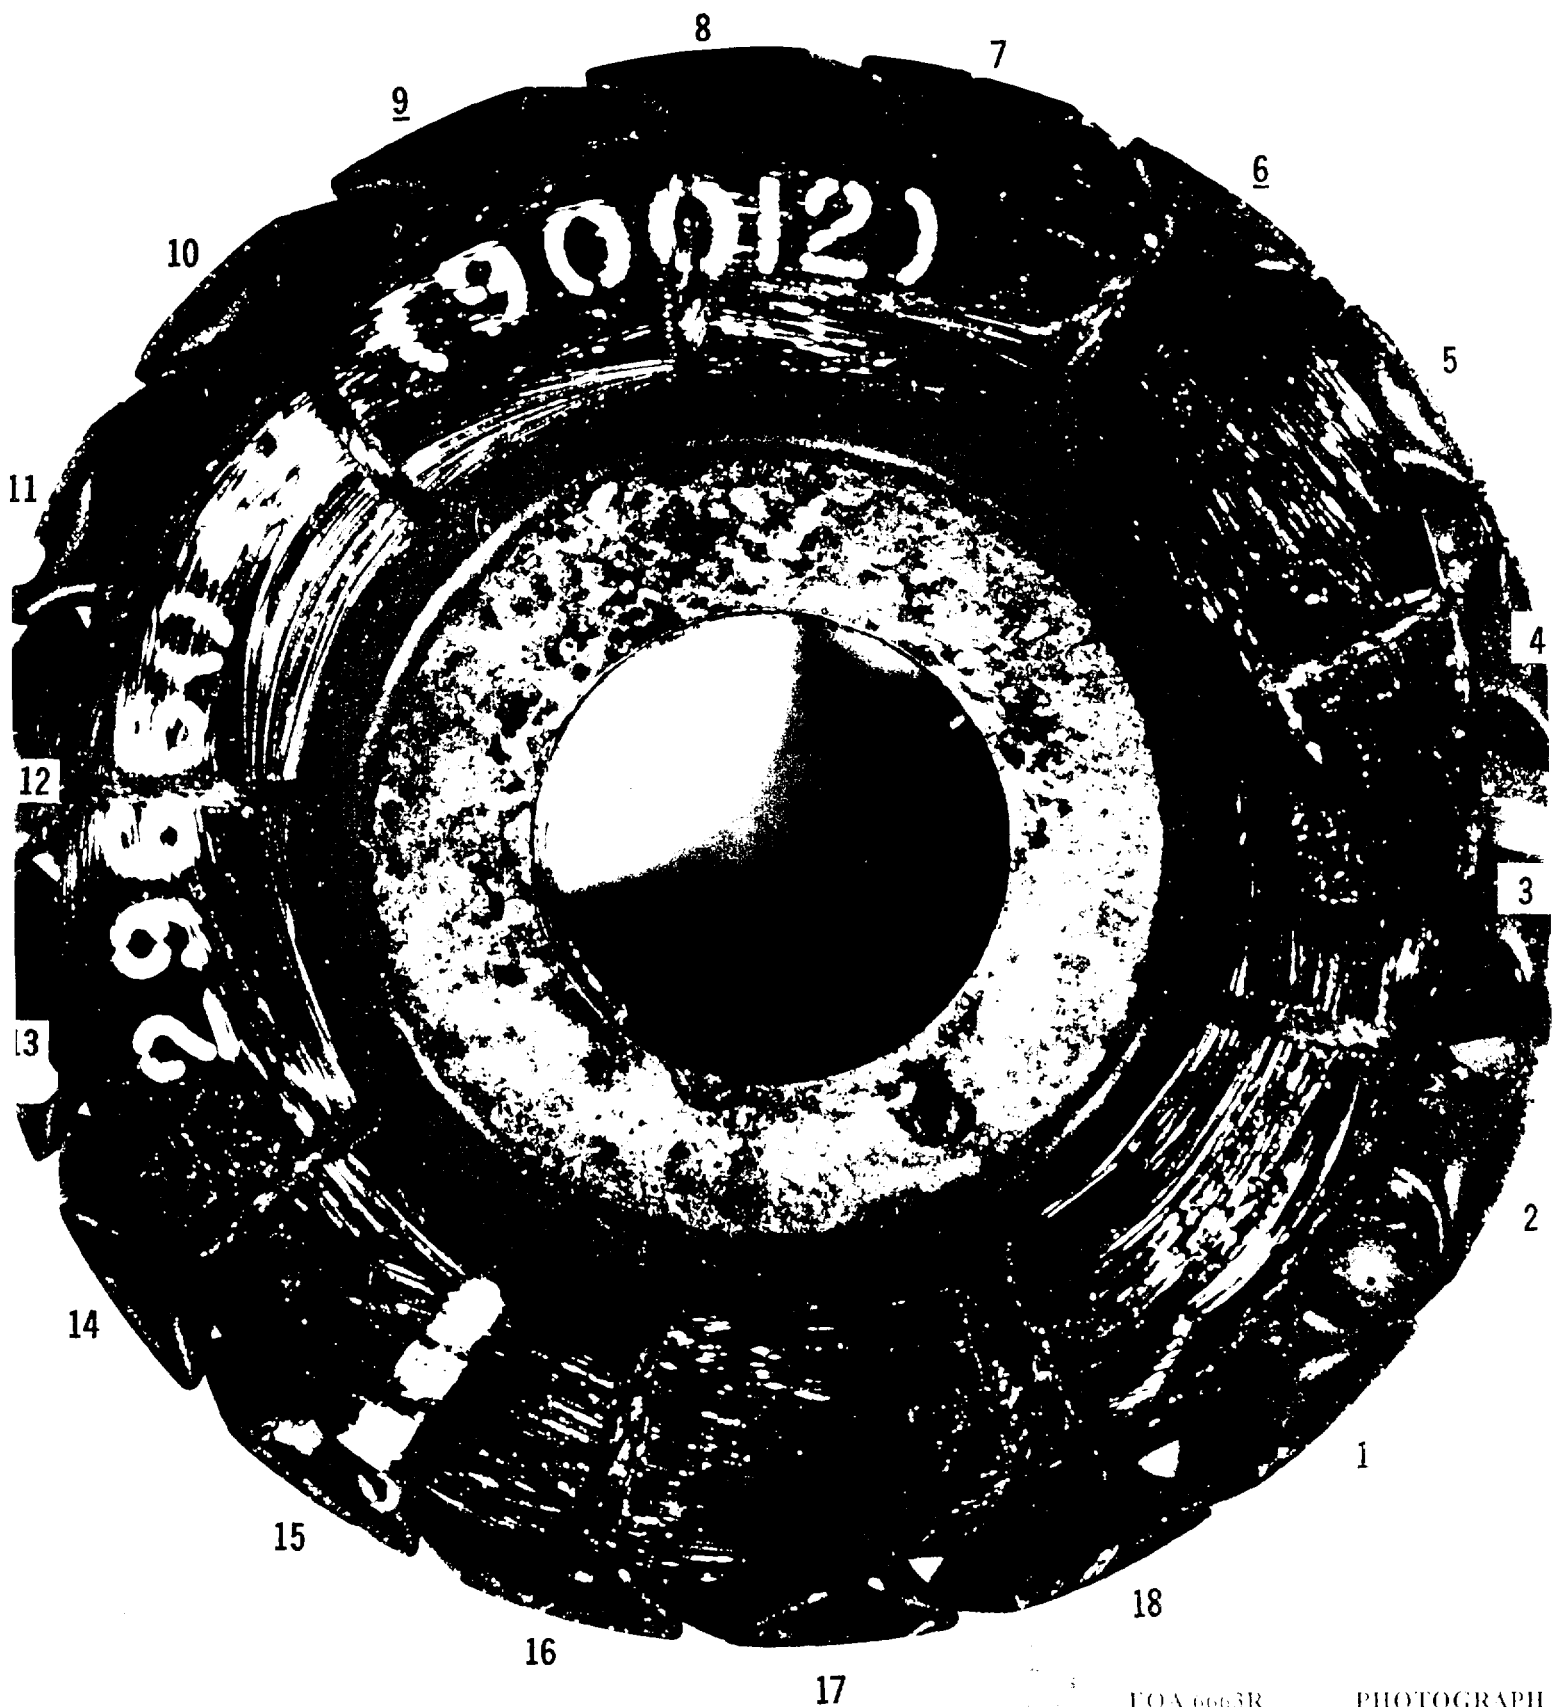
PHOTOGRAPH 8

Overview of rotor in "as received"  
condition. "Back view"
