## ANALYTICAL ENGINEERING REPORT

REPORT No.: 9-5576-WP-94-346

SUBJECT: 737 COPA VG1 Roll Rate Synchro Rotor Investigation

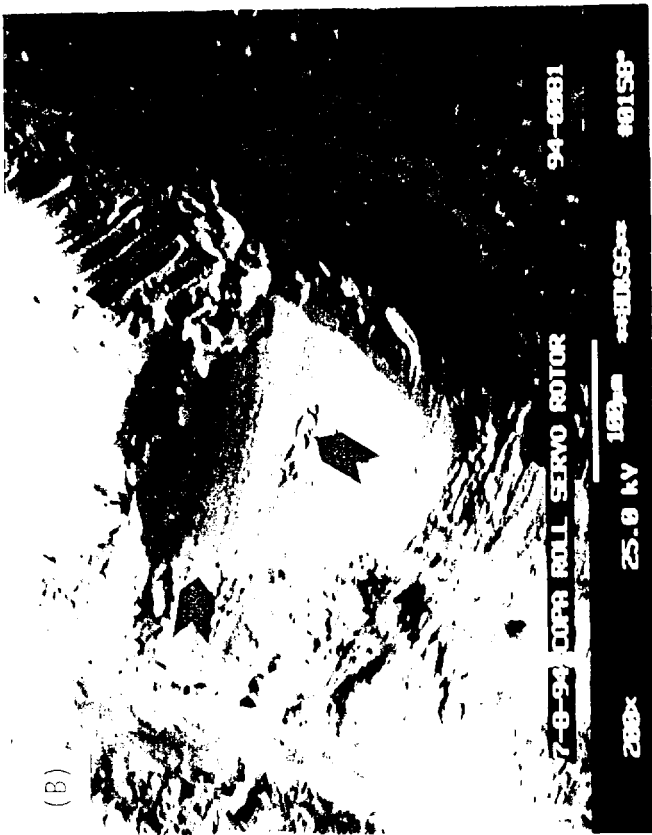
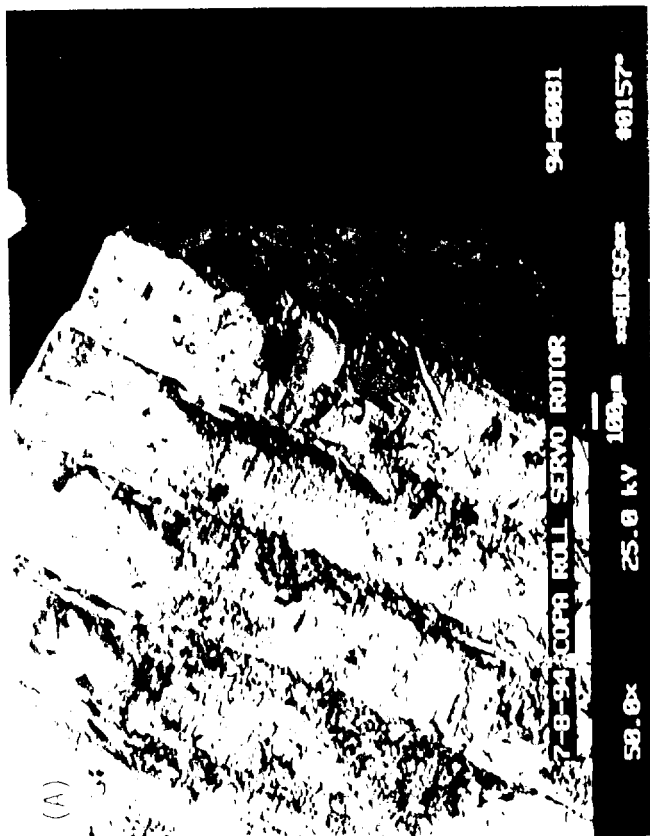
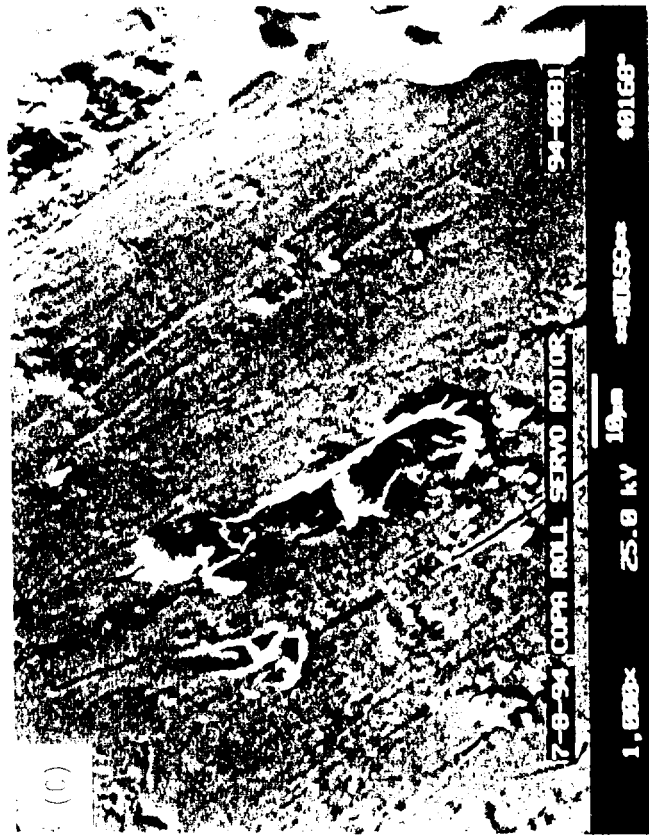
The coil magnet wire was reported to be 39 AWG which is specified as 0.035" diameter exclusive of insulation. The gage of the wire was confirmed by optical microscopy (0.034" wire diameter with 0.003" of insulation). The width of the groove in the dimple is consistent with the wire diameter.

A couple of small indentations adjacent to the groove in the wear dimple (Figures 4B and 4C) were examined in detail for any indication of melting or copper transfer from the wire to the iron-silicon rotor that could result from resistive heating or electrical arcing. No copper was detected with energy dispersive spectroscopy (EDS) capabilities of the SEM; nor was any evidence of melting confirmed. The analysis could not determine, one way or the other, whether the shorting existed at the time of the accident. ✓

Figure 4: SEM micrographs of wear dimple and details. Arrows in (B) indicate center wear groove and suspect short indications. Close-up of indications shown in (C).
