Appendix B:

Tank Car Group Examination Observations, March 3, 2015

Mount Carbon, West Virginia

NTSB # DCA15FR005

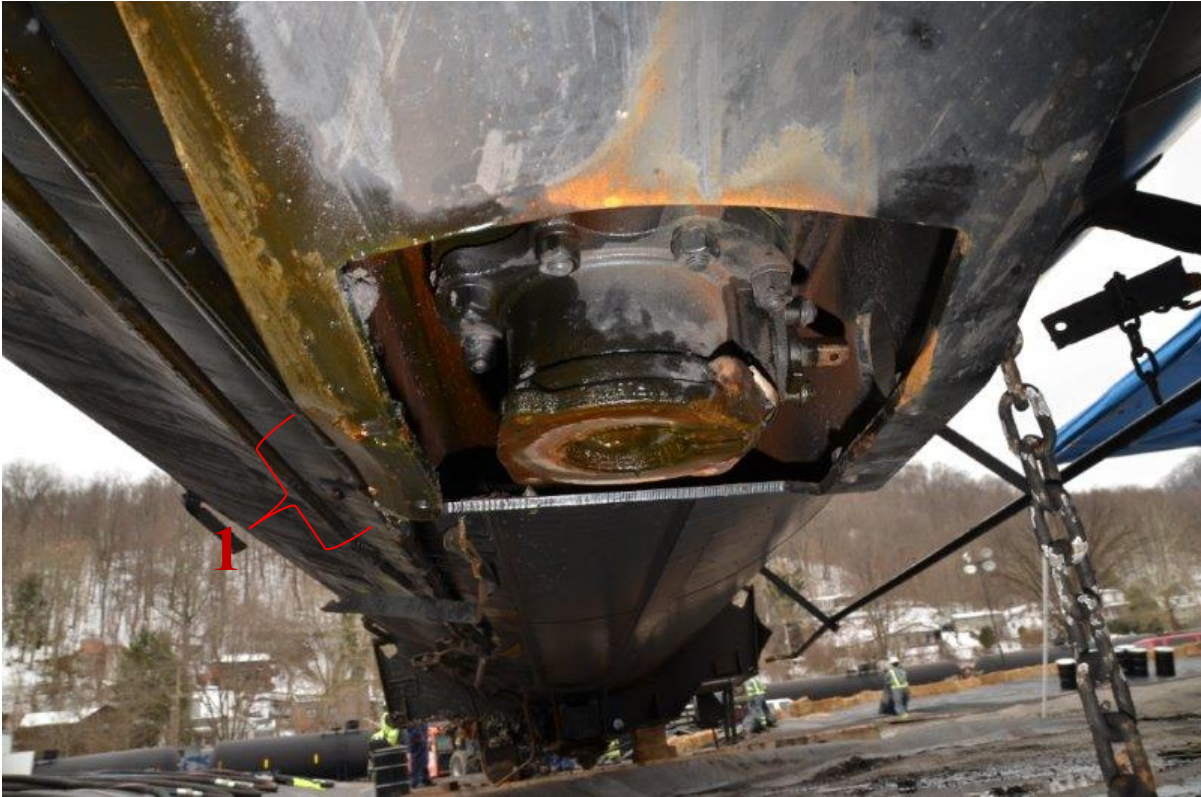
Figure 5: GATX 286233 bent skid protection indicated by Item 1, and leaking bottom outlet valve.

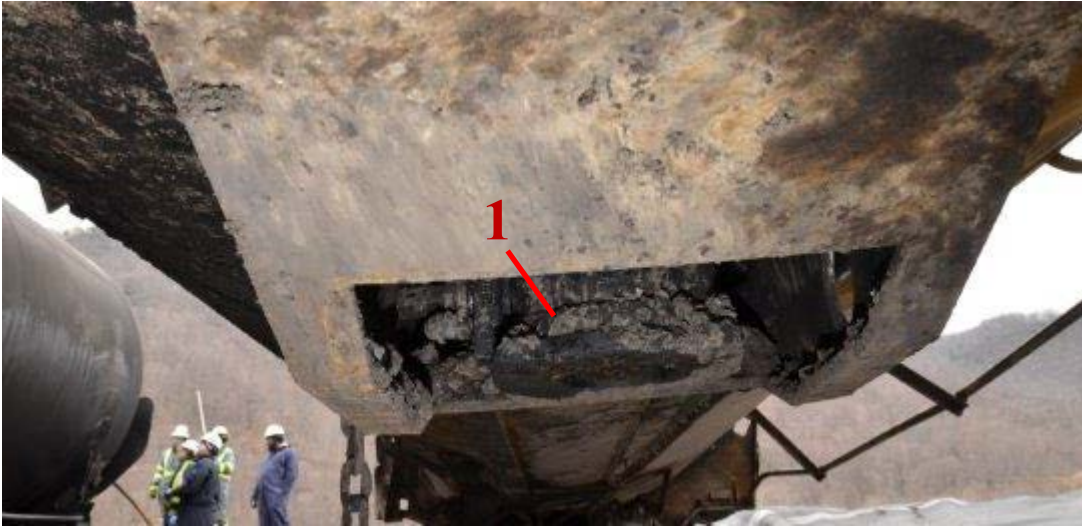
1. Bottom outlet nozzle sheared off and bottom outlet valve was 1/8 opened at derailment site. Operating handle was broken away.
2. Dent 11 ft. longitudinal, 7 ft. transverse, 8-inches deep.
3. Flattened area 14 ft. longitudinal, 3 ft. transverse.
4. Dent 18 inches by 18 inches, 1 inch deep.
5. Dent 2 ft. longitudinal, 1 ft. transverse, 2 inches deep.
6. Dent to head shield and tank – 24 inches by 18 inches, 2 inches deep into tank head.

Figure 8: GATX 286241 bottom outlet valve, reclosed by response personnel.

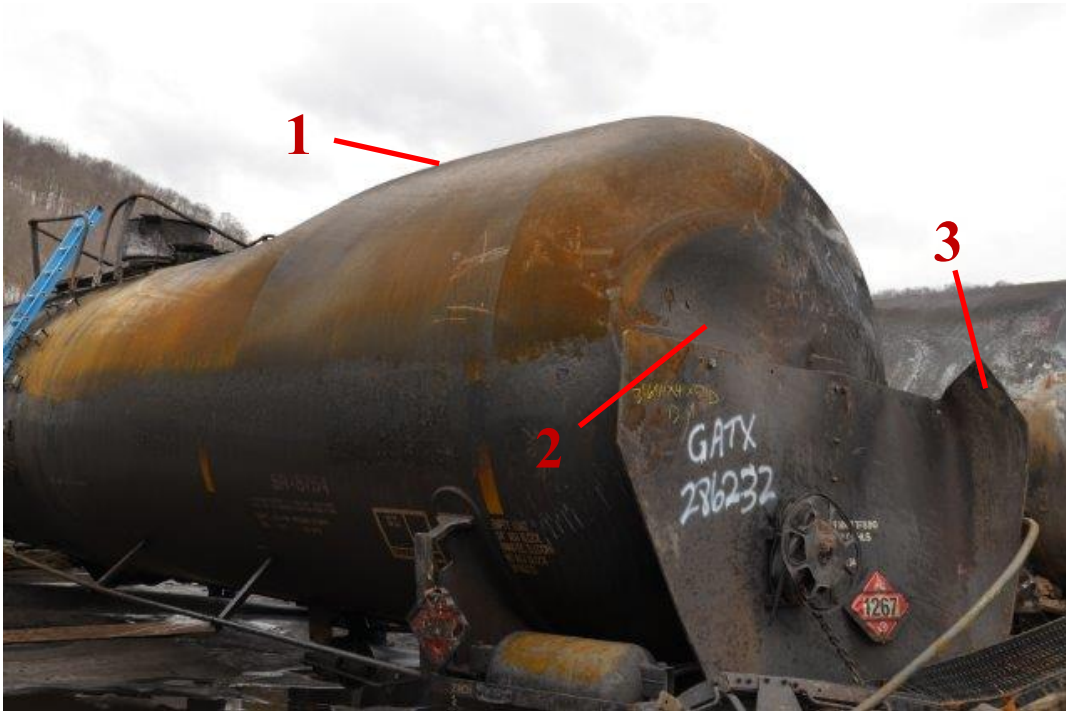
Figure 10: GATX 286232 B-end shell bulging and head damage.

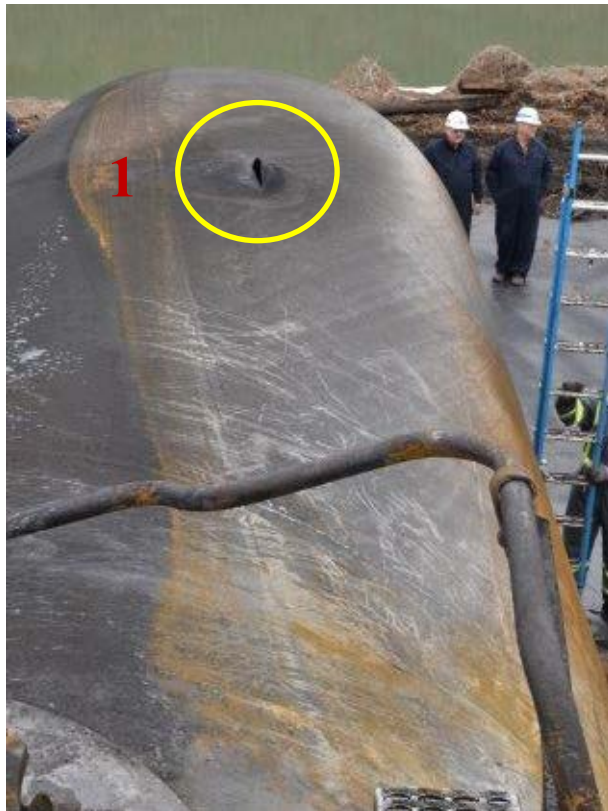
Figure 11: GATX 286232 thermal tear.

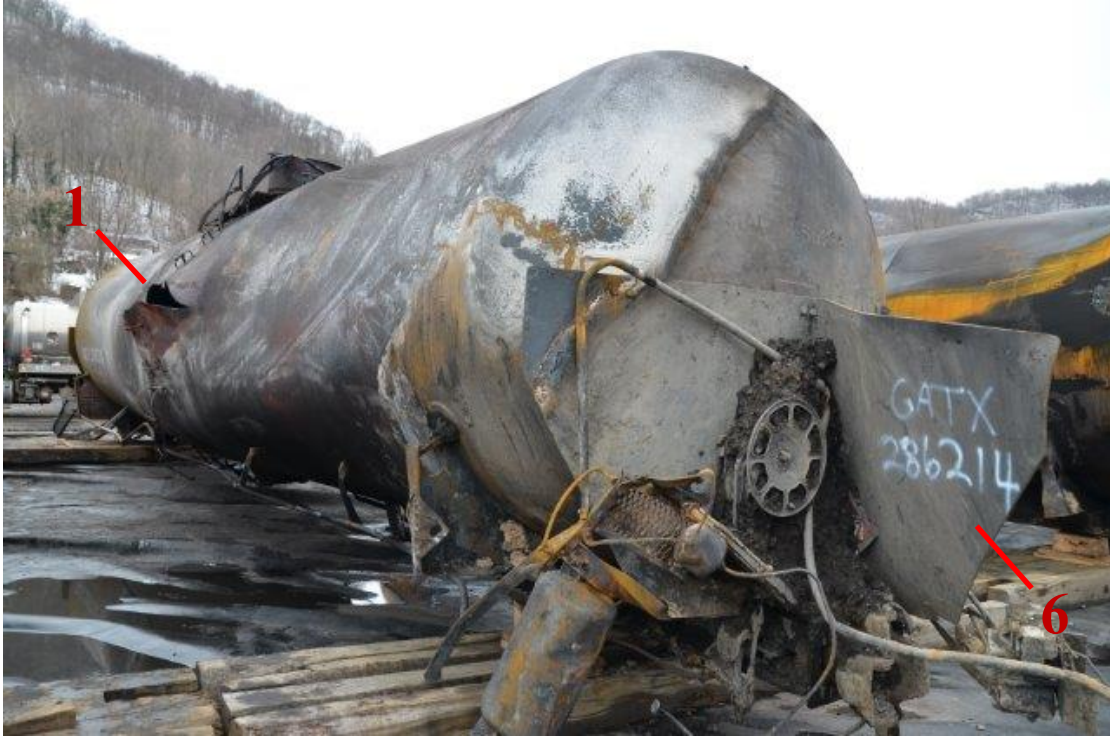
1. Thermal tear 8 ft. longitudinal, 1.5 ft. transverse. Shell thinning measured to 0.311 inches near the center of the breach.
2. Entire right side of car was wrinkled.
3. Bottom outlet nozzle and operating handle sheared off. The BOV remained closed.
4. Top fittings and pressure relief device were heavily fire damaged.
5. Dent to head above head shield, 2.5 ft. wide, 2 ft. high, 2.5 inches deep.
6. Right half of B-end head shield pulled forward with 90 degree bend.

Figure 13: GATX 286214 thermal tear and head shield damage.

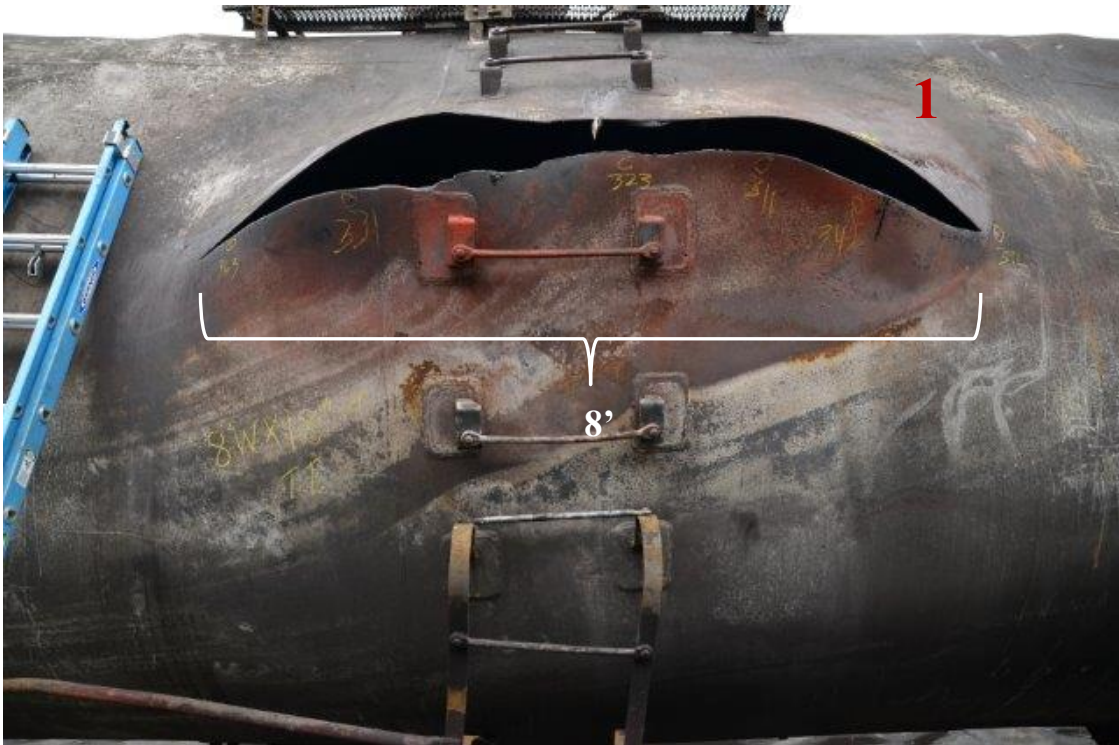
Figure 14: GATX 286214 thermal tear with material thickness measurements.

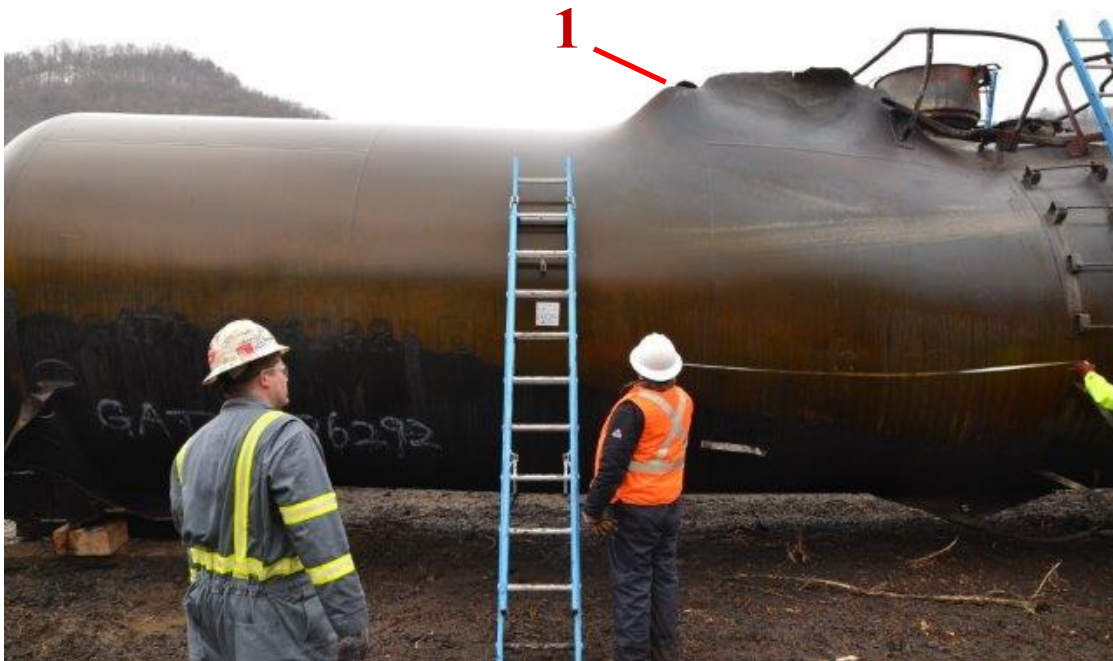
1. Thermal tear, irregular fracture 8.5 ft. longitudinal, 1.5 ft. transverse. Shell thinning measured to 0.292 inches at the center of the tear.
2. Top fittings fire damage within protective housing.
3. Hand rail punctured by impact with an object having the shape of a nut.
4. Head shield bolts missing from bracket.

Figure 17: GATX 286292 thermal tear and shell bulging.

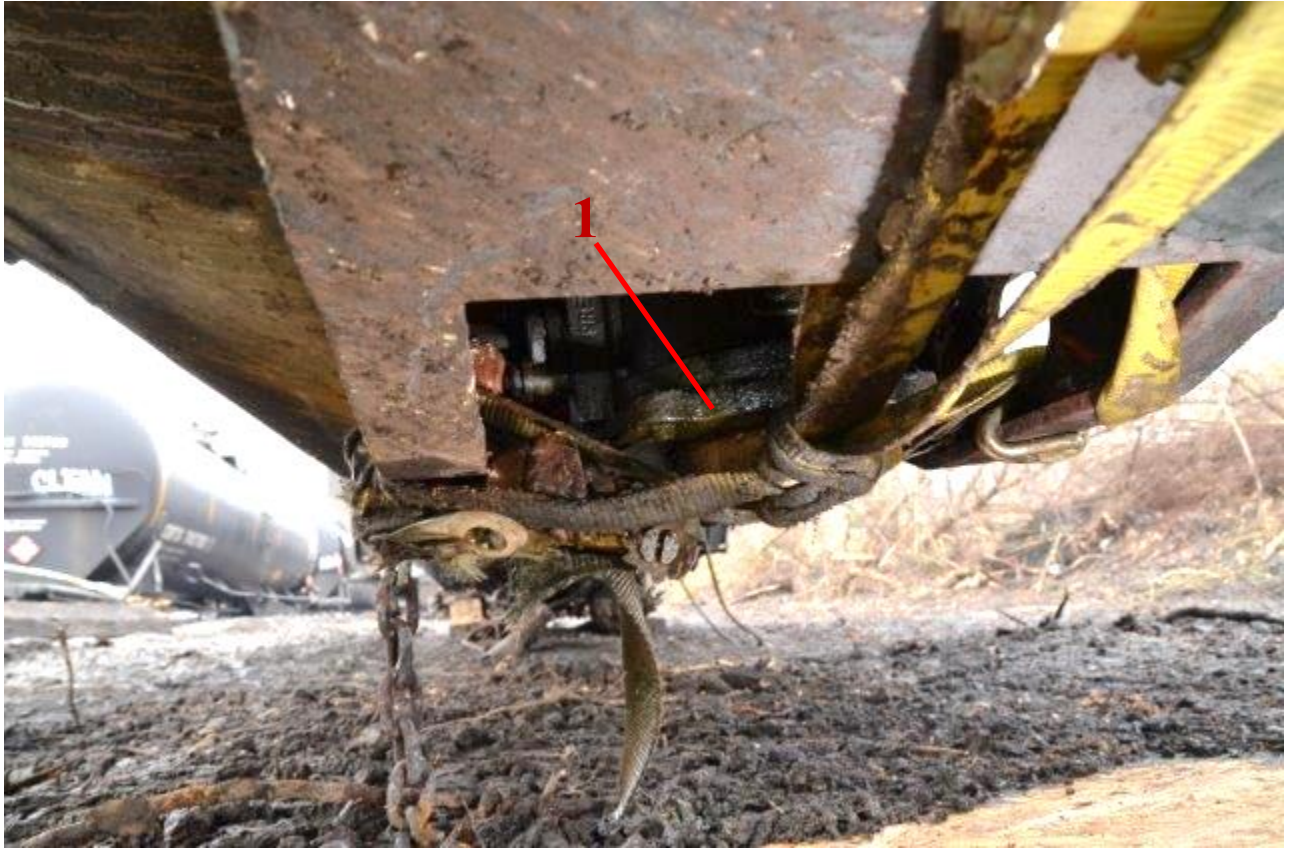
1. Bottom outlet nozzle sheared away and ball valve leaked. Responders inserted wooden plug into opening to stop leakage.
2. Bulge with material thinning, 16 inches longitudinal, 30 inches transverse.
3. Dent, 5 ft. longitudinal, 1 ft. transverse, 3 inches deep.
4. Dent, 3 ft. by 3 ft., 1 inch deep.
5. Dent, 6 ft. by 6 ft., 5 inches deep.

Figure 19: GATX 286274 bottom outlet valve fitted with wooden plug and straps to secure leakage.

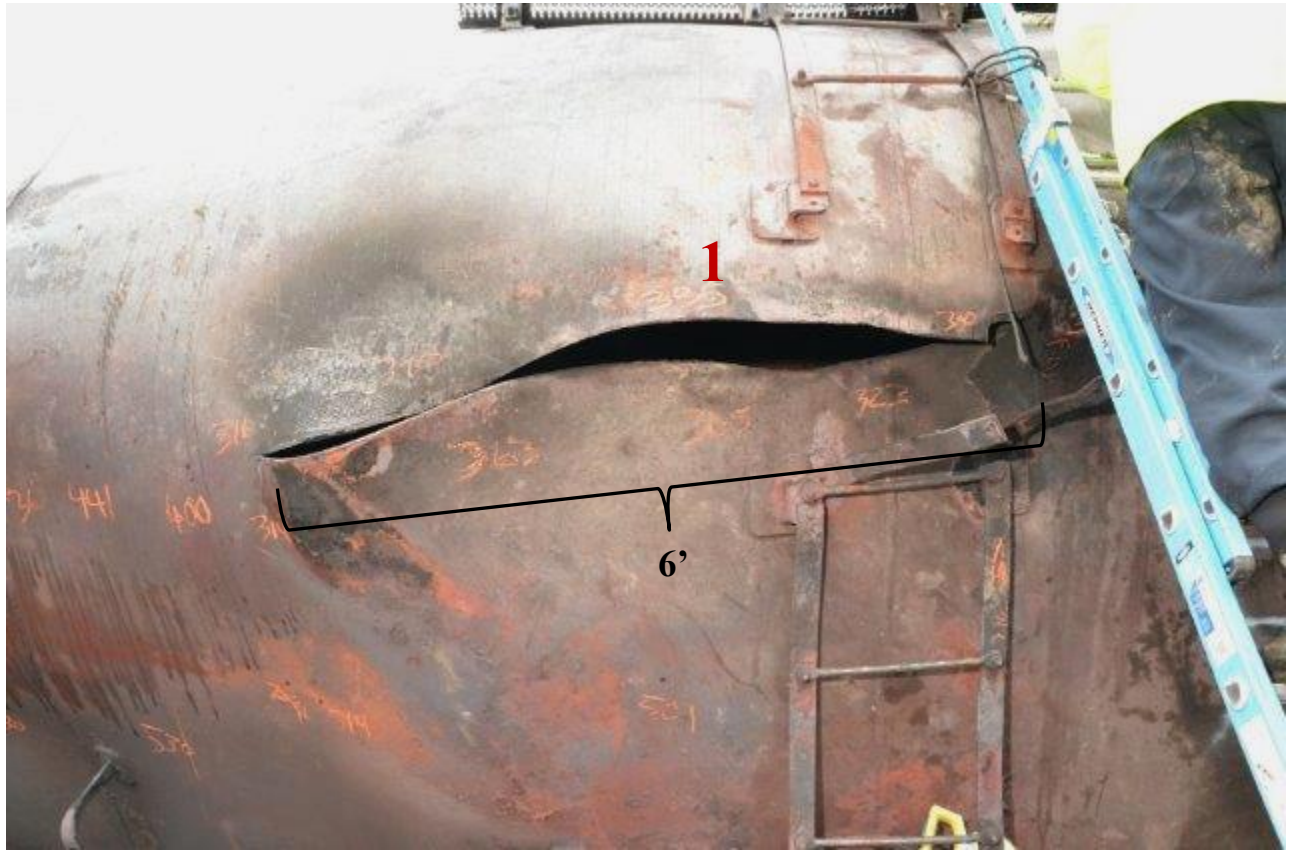
1. Thermal tear, about 6 ft. longitudinal. Material thinning to 0.305 inch near center of tear.
2. Flattening and wrinkling of entire left side.
3. Heavy fire damage to valves and pressure relief device.
4. Bottom outlet valve fire damage to valve seat, damp with oil.

Figure 21: CBTX 741512 thermal tear with material thinning.

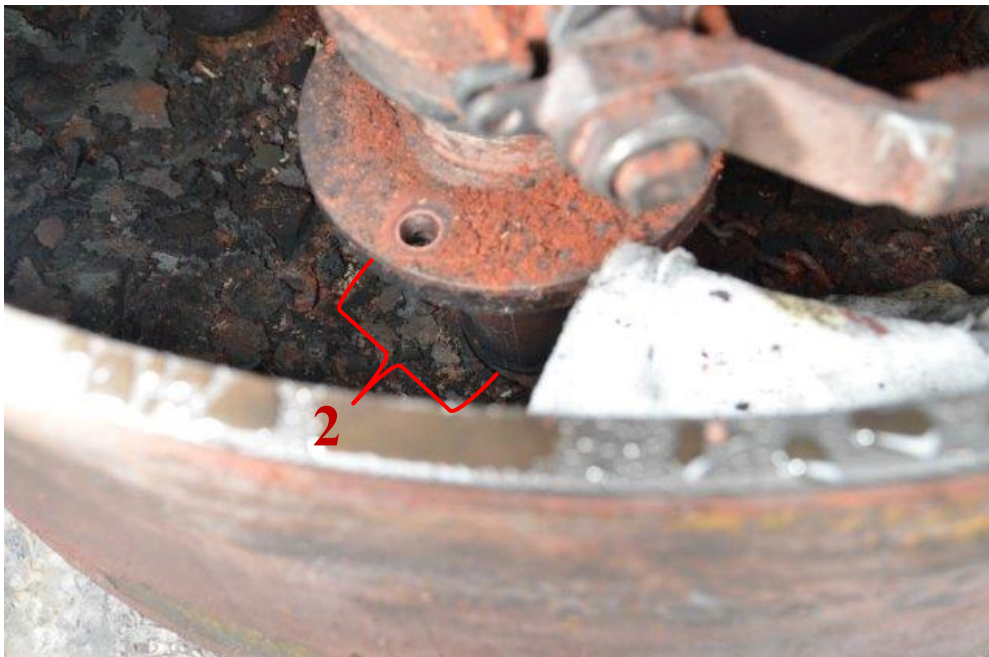
Figure 26: Liquid line valve and flange displacement, missing flange nut.

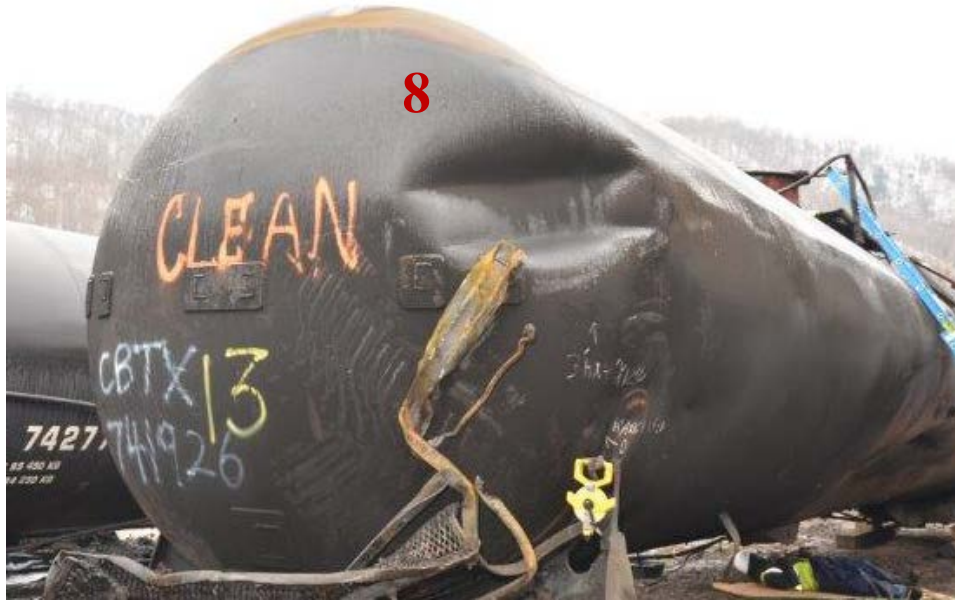
Figure 27: A-end head impact damage, half-height head shield missing.

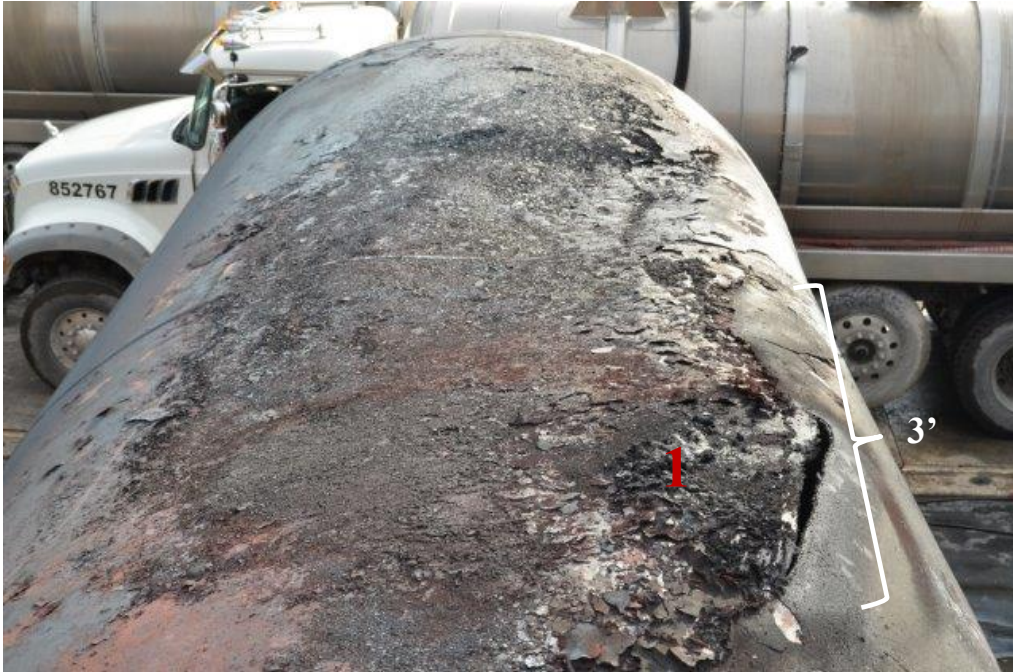
1. Thermal tear, 36 inches longitudinal, 2 inches transverse. Tear was within a bulge 10 feet longitudinal, 6 feet transverse. Severe thermal damage to surrounding shell material.
2. Protective housing cover burn-through.
3. Dent, 18 inches by 18 inches, 2 inches deep.
4. BOV nozzle sheared off, valve was closed.
5. Dent, 4 feet longitudinal, 3 feet transverse, 3 inches deep.

Figure 29: Thermal tear on tank top looking toward B-end, and associated thermal damage to the tank shell.

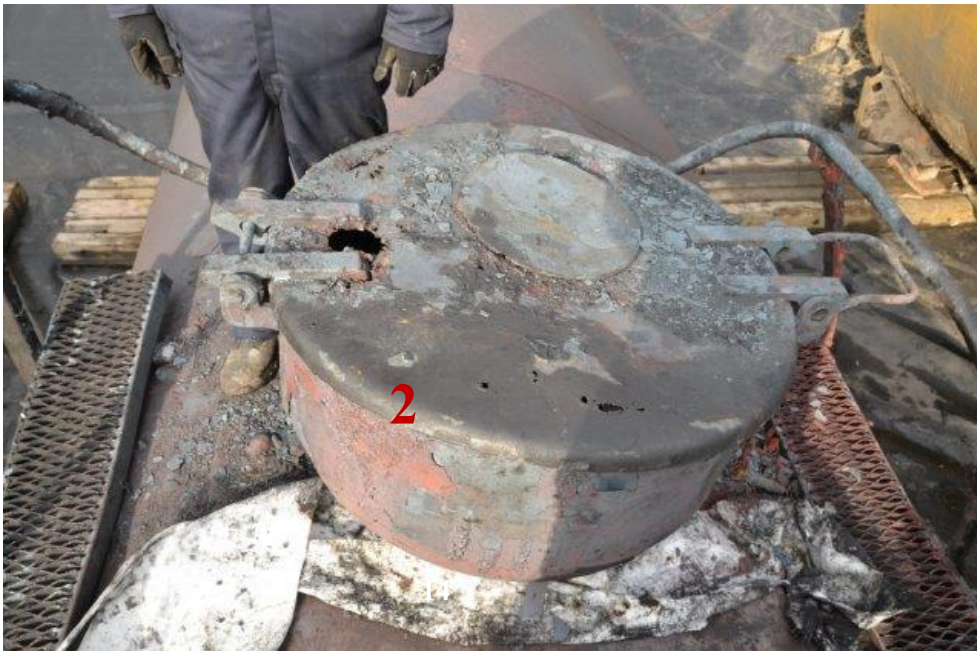
Figure 30: Top fittings protective housing cover burn-through.

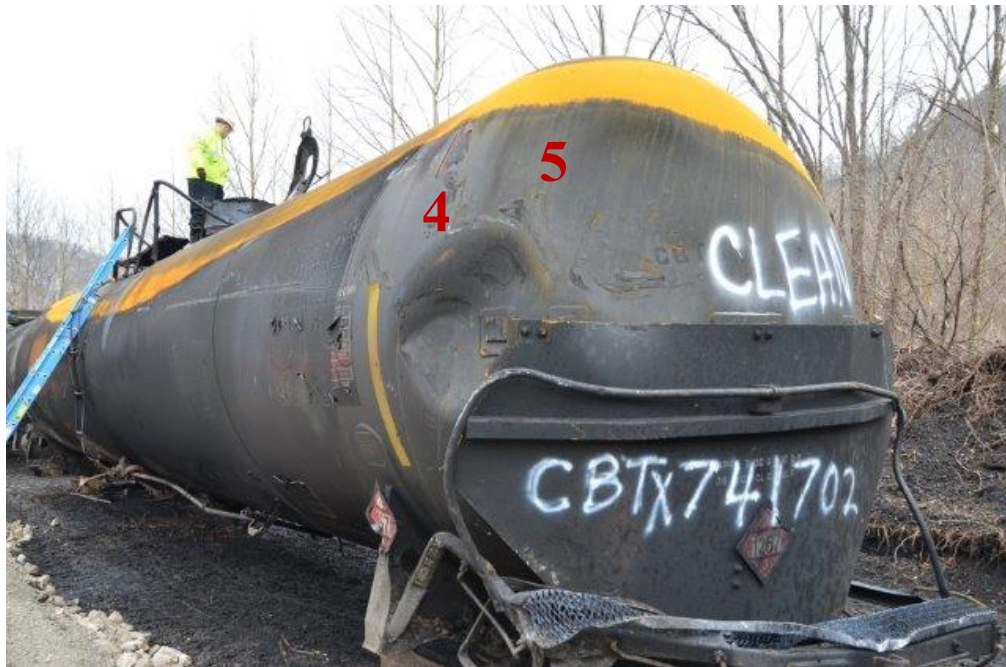
Figure 33: Dent to A-head not intercepted by half-height head shield.

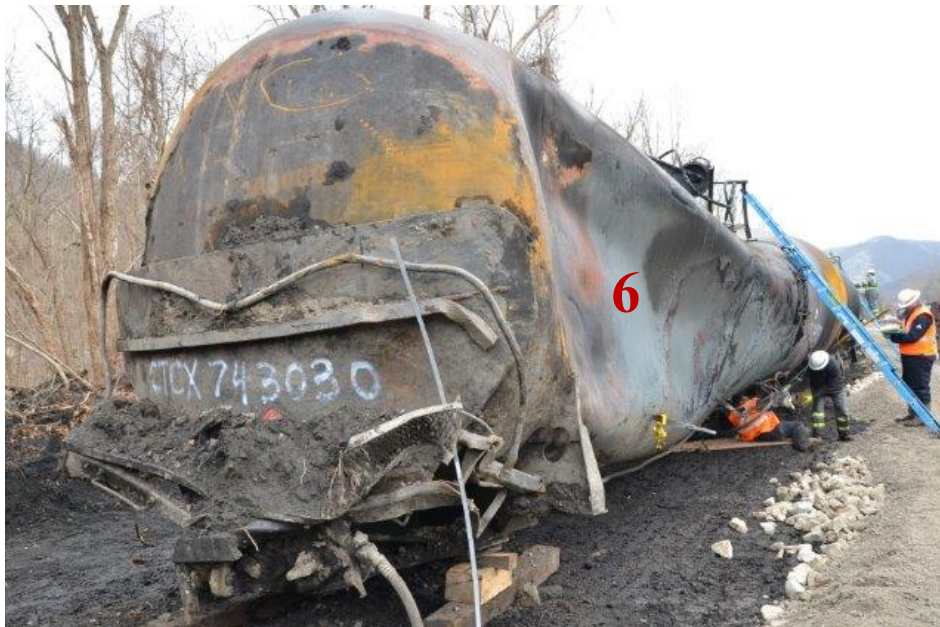
Figure 36: Left side shell compression, and A-end head.

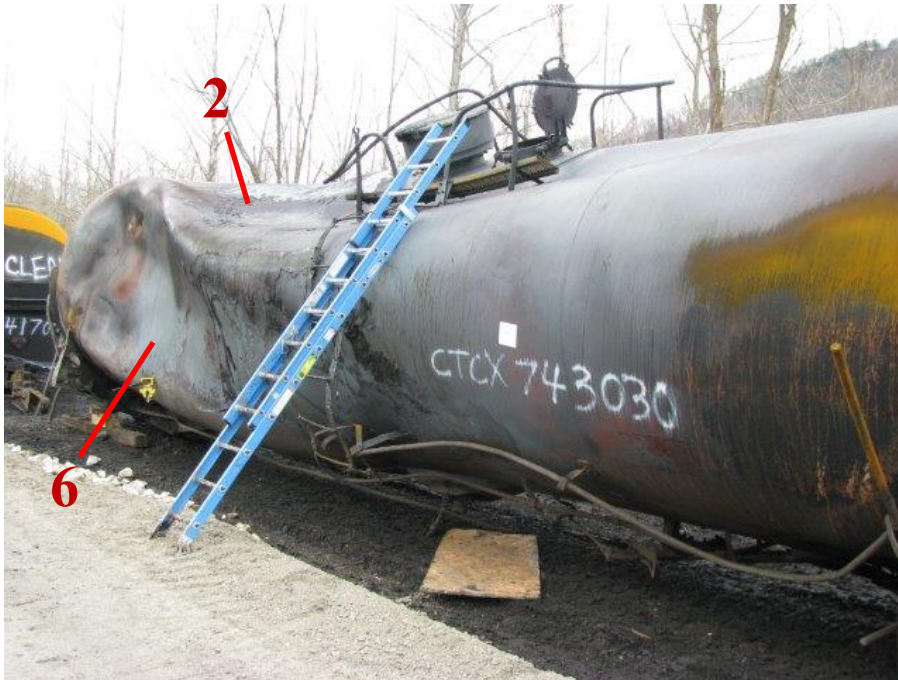
Figure 37: Left side shell compression and top flattening.

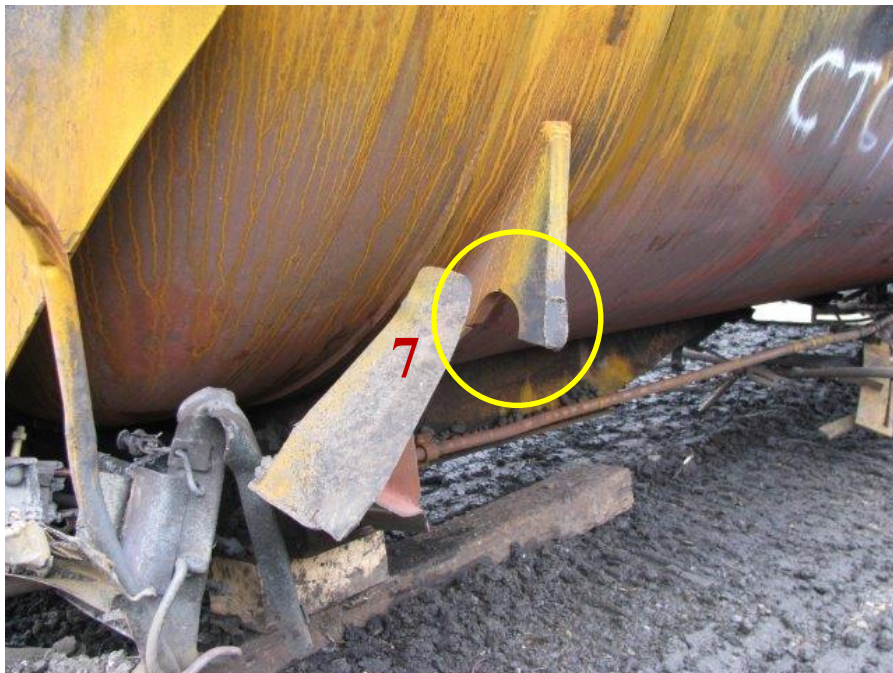
Figure 38: Upper bolster structure protuberance after bottom structure torn away at B-R end.

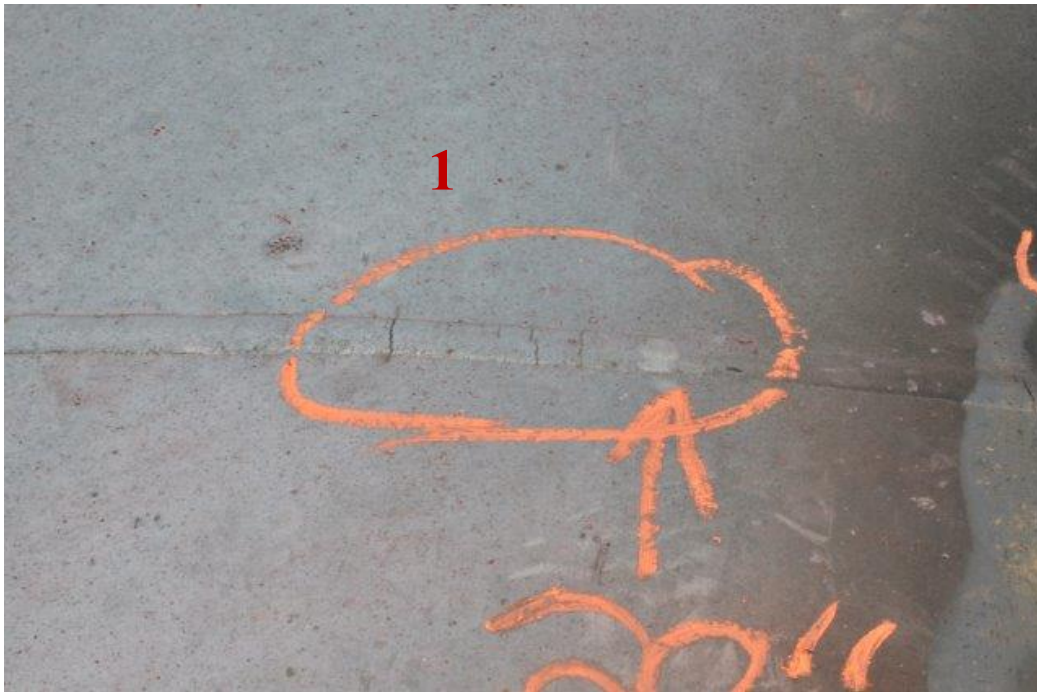
1. Thermal tear, 20 inches, two angular longitudinal segments, surrounded by a bulge 9 feet longitudinal, 7 feet transverse. Material thinning to 0.426 inch. Cracking of adjacent transverse barrel weld. Paint scorching at A-end shows car was tilted downhill toward B-end about 20 degrees.

Figure 42: Close up of barrel section transverse weld cracks.

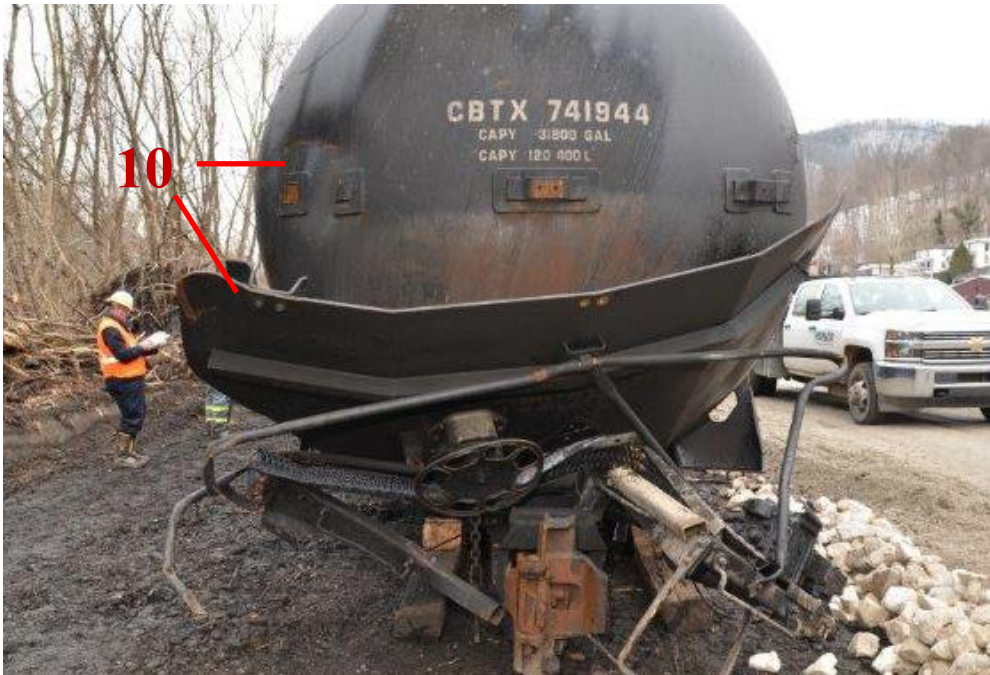
Figure 43: B-end head shield separation.

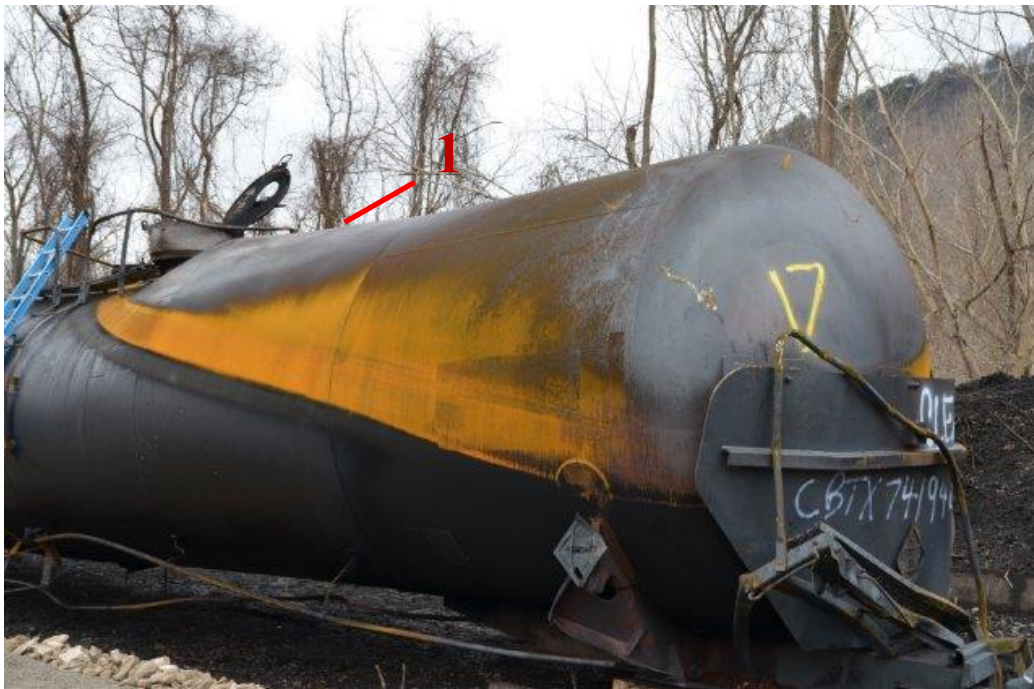
Figure 44: A-end head and vapor space bulging.

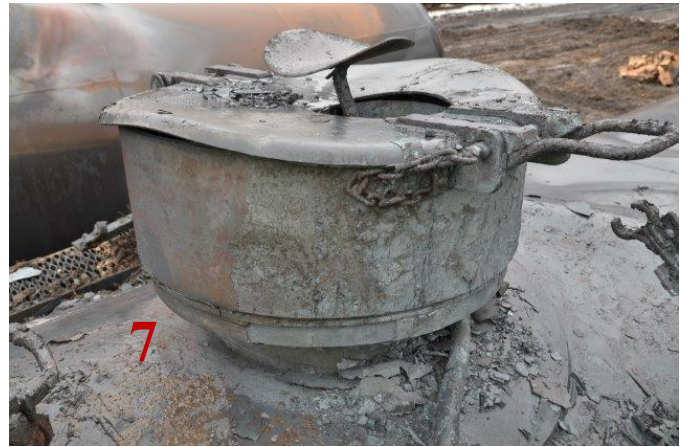
Figure 49: Top fittings protective housing thermal damage.

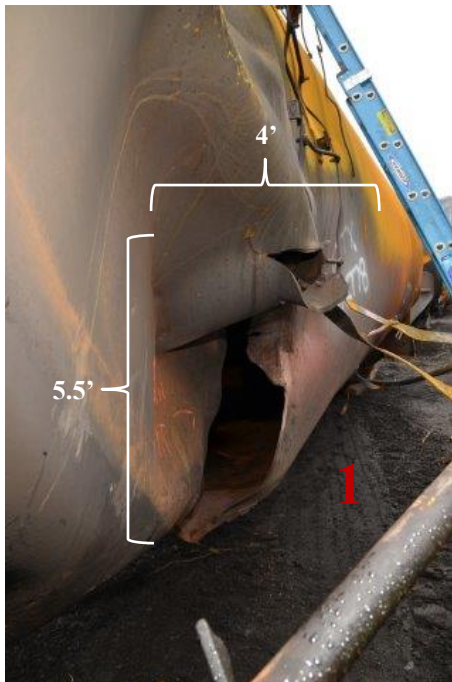
1. Puncture with irregular fractures and material curling, 4 feet longitudinal, 5.5 feet transverse.
2. Dent, 14 feet longitudinal, 6 feet transverse, 10 inches deep. Gouge runs along the center of the dent.
3. Shell flattening and buckling with fractures in folded material top and bottom (items 4 and 5).
4. Fractures, two irregular fractures in folded shell material associated with shell buckling.
5. Fracture in folded shell material associated with shell buckling.
6. Dent, 7 feet longitudinal, 6 feet transverse, 7 inches deep.
7. Head shield punctured, dent to head 4 feet wide, 3 feet high, 11 inches deep. Tank head fractured at toe of left side of head pad fillet weld, with hole measuring 0.5 inches by 0.5 inches.

Figure 52: Puncture and fracture surfaces.

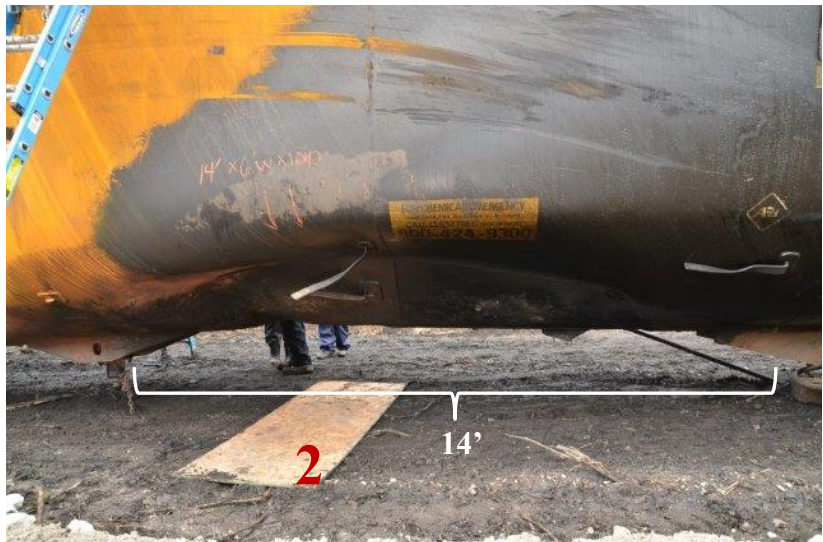
Figure 53: Dent and gouge in bottom left of tank car, B-end side of BOV.

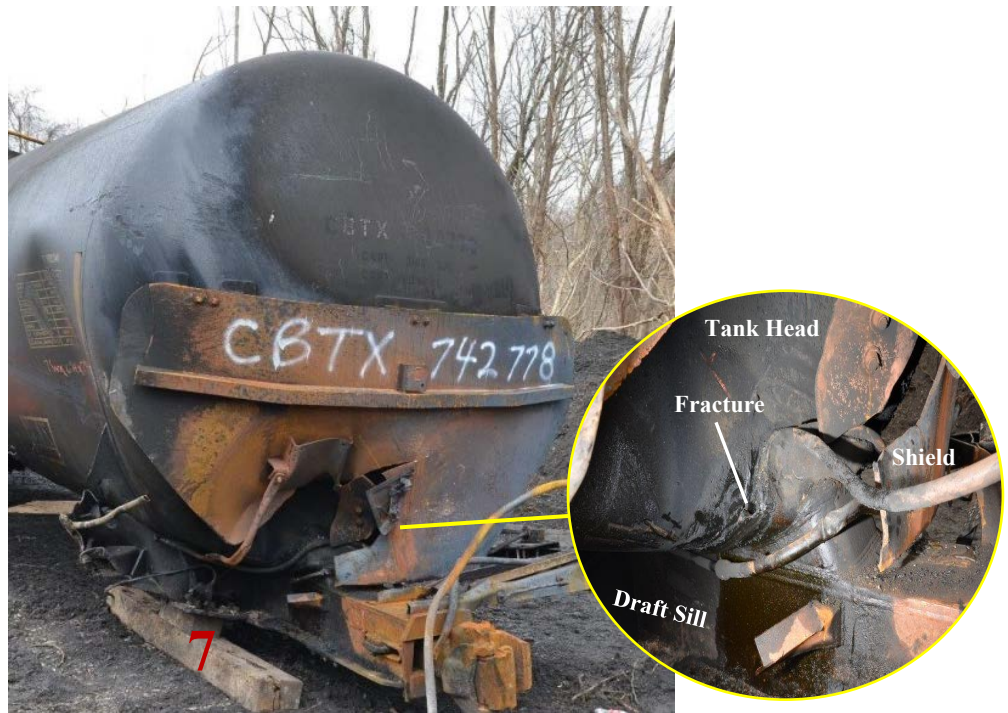
Figure 54: Punctured B-end head shield, and tank head fracture (inset image).

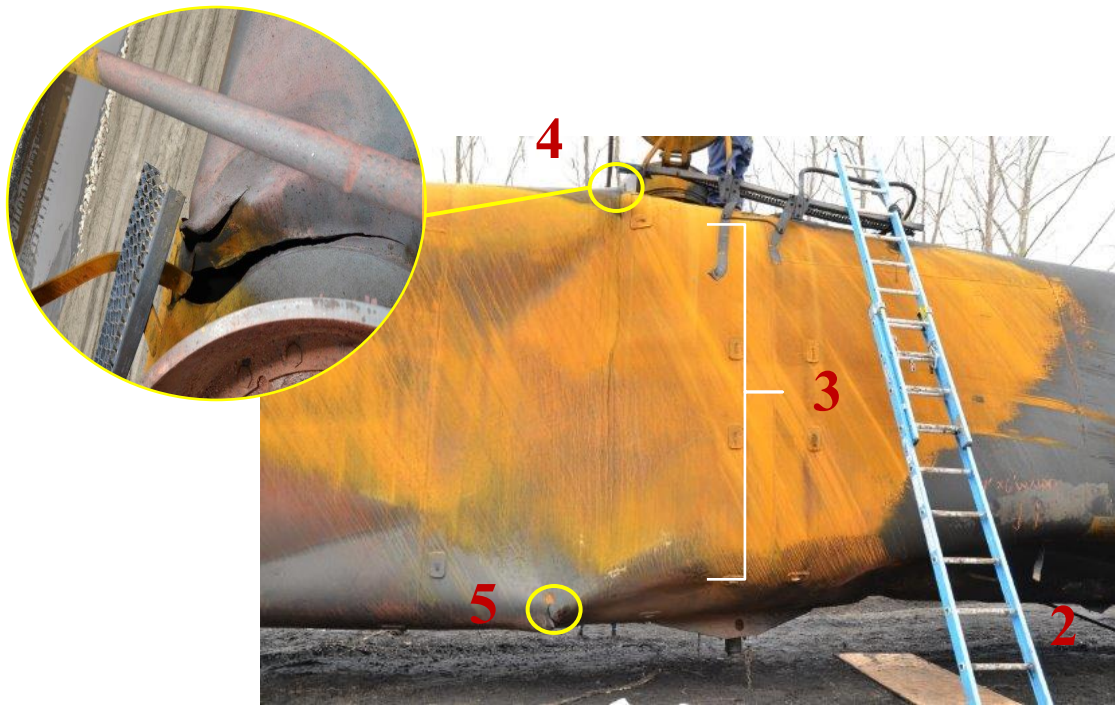
Figure 55: Flattened and buckled left side of tank car with shell fractures in folded material top and bottom.

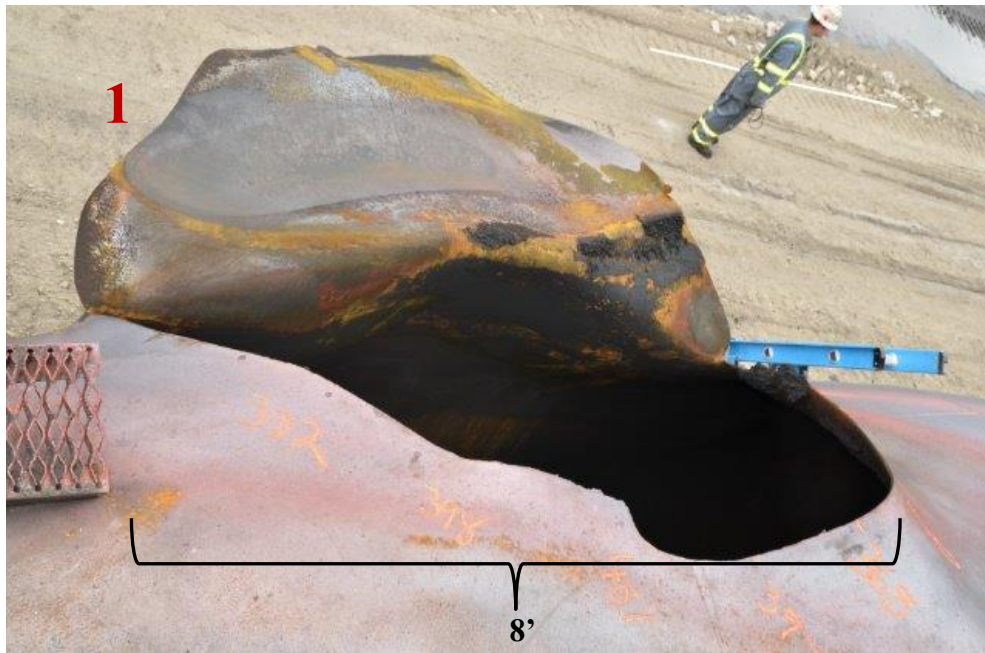
1. Thermal tear, 8 feet longitudinal, 50 inches transverse. Shell thinning to 0.340 inch.
2. Top valves intact with heavy fire damage.
3. BOV nozzle sheared off, operating handle closed.
4. Dent, 4.5 feet longitudinal, 6 feet transverse, 4 inches deep.
5. Dent, 6 feet longitudinal, 5 feet transverse, 6 inches deep.
6. Dent, 10 feet longitudinal, 6 feet transverse, 9 inches deep.
7. Dent, rounded centered on B-end head, about 6.5 feet diameter, 12 inches deep. Head shield missing.
8. Dent, rounded left side of A-end head, about 7.5 feet diameter, 18 inches deep. Head shield missing.

Figure 58: CBTX 741516 thermal tear as viewed from above.

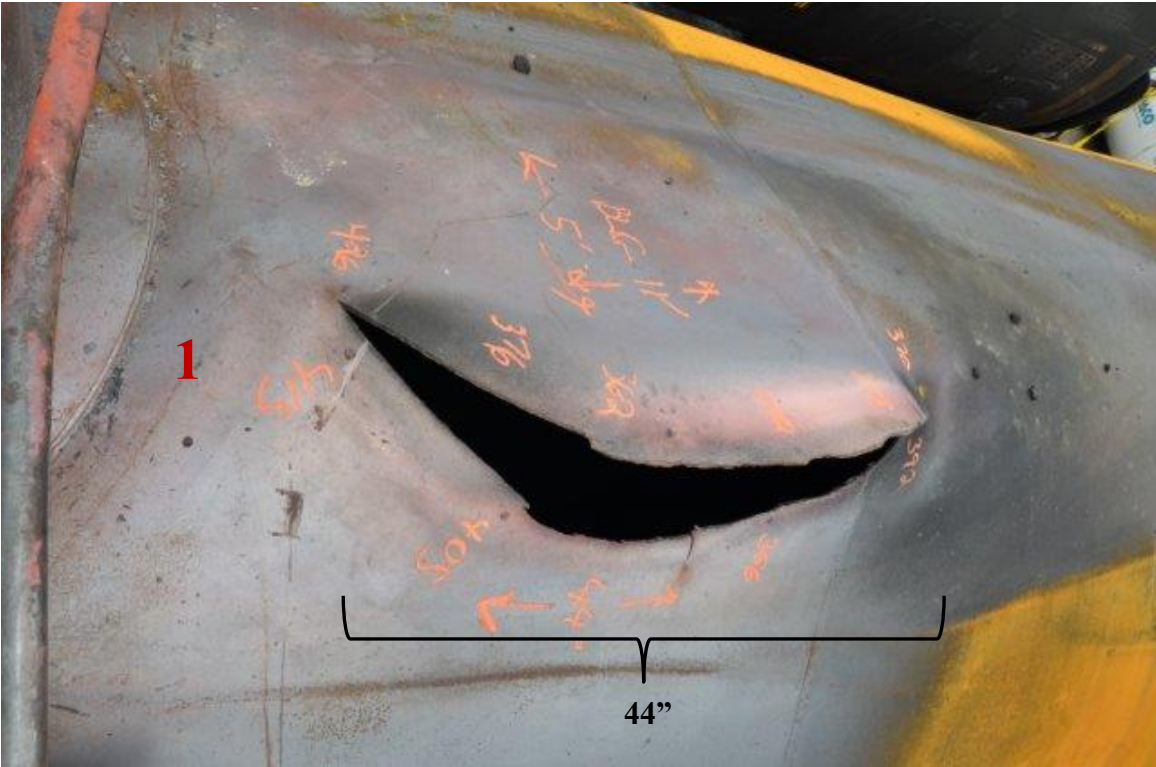
Figure 61: Close up of thermal tear to tank car CBTX741651.

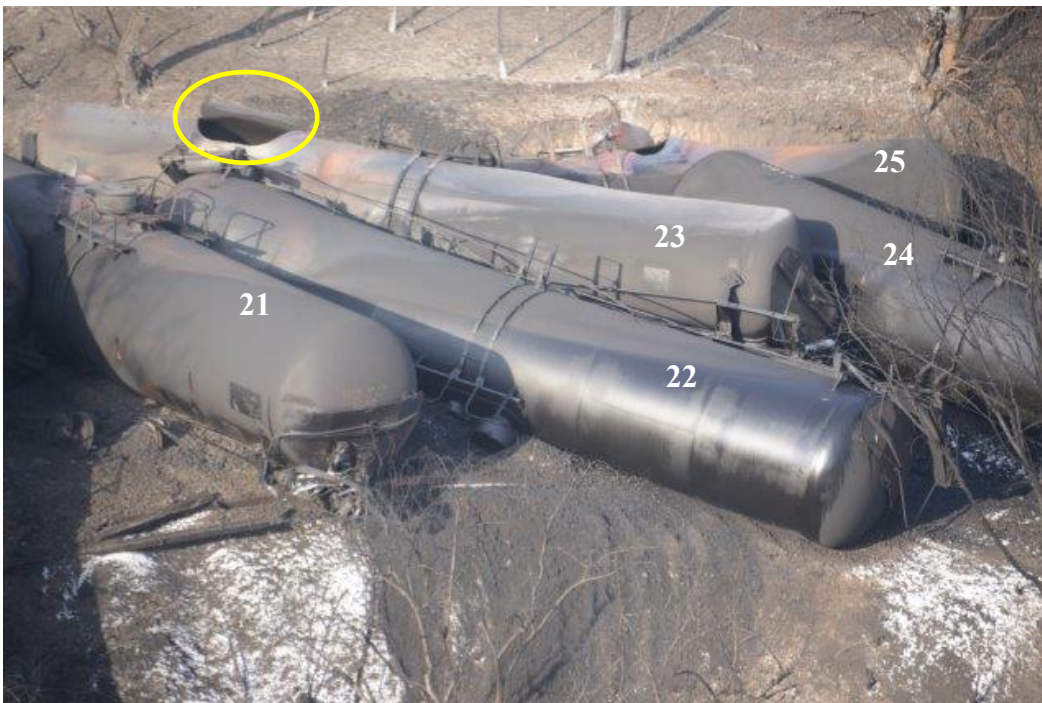
Figure 67: Resting position of CBTX 741946 highlighting the thermal tear (circle).

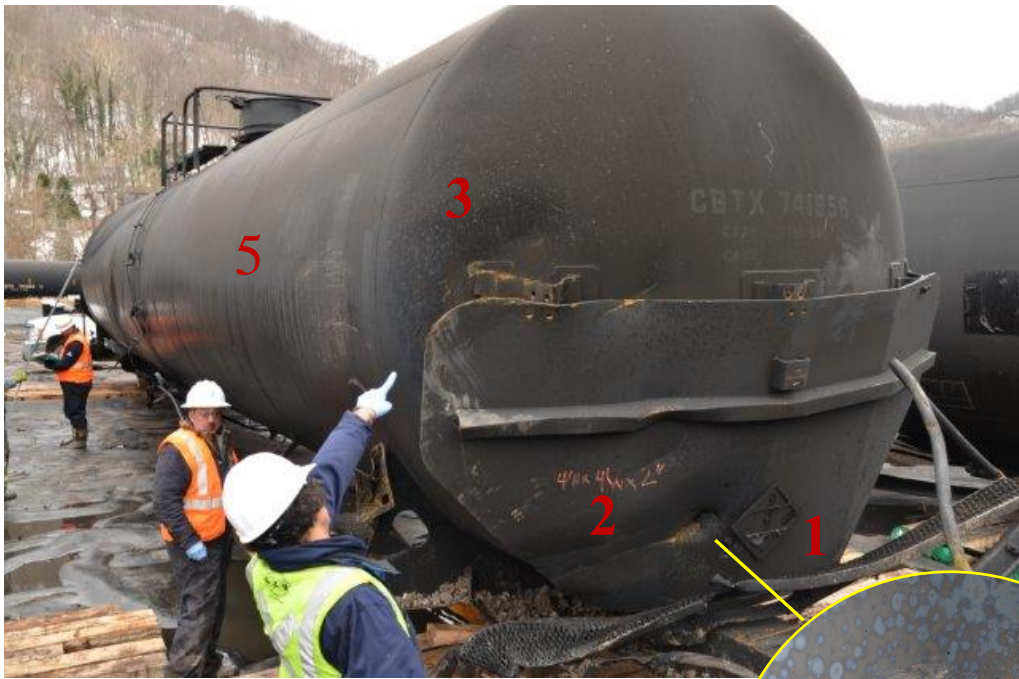
Figure 69: A-end head shield impact location and fracture.

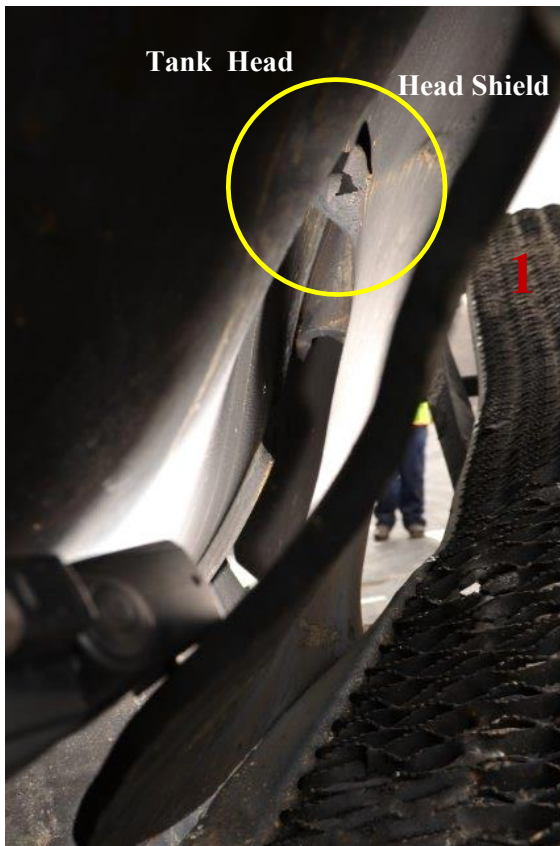
Figure 70: View between A-end head shield and tank head showing fractured head shield and impact damage to tank head (circle).

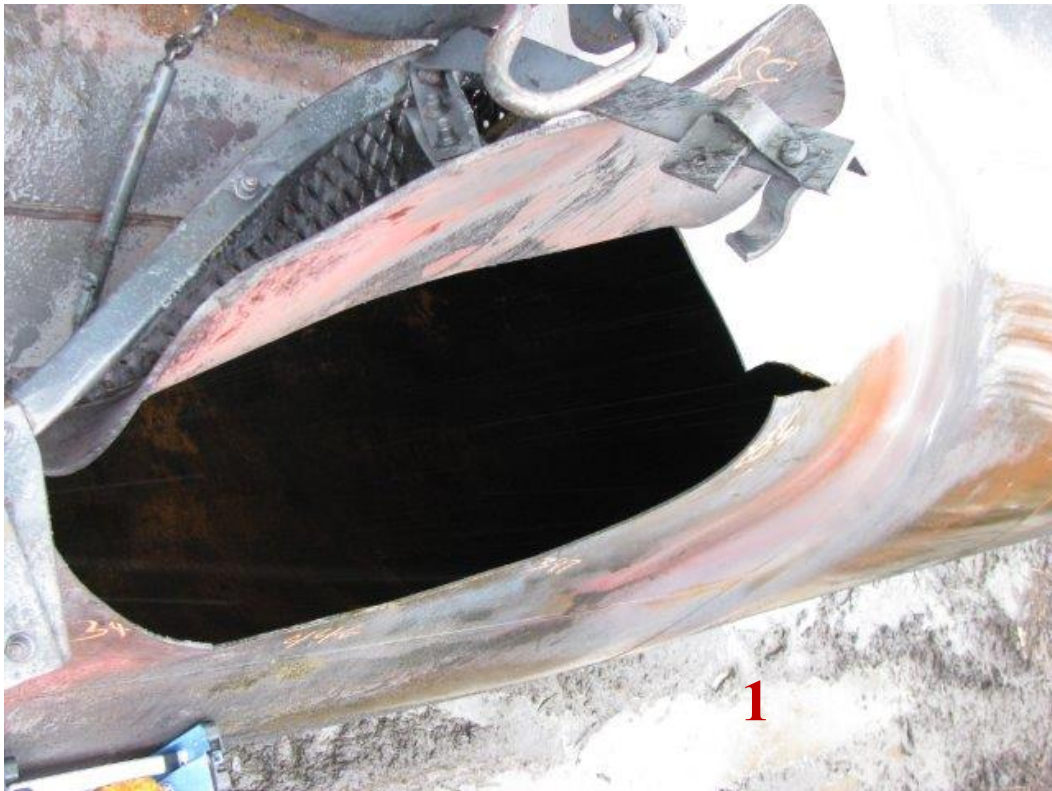
Figure 73: View of thermal tear from above.
