Appendix B:

Tank Car Group Examination Observations, March 3, 2015

Mount Carbon, West Virginia

NTSB # DCA15FR005

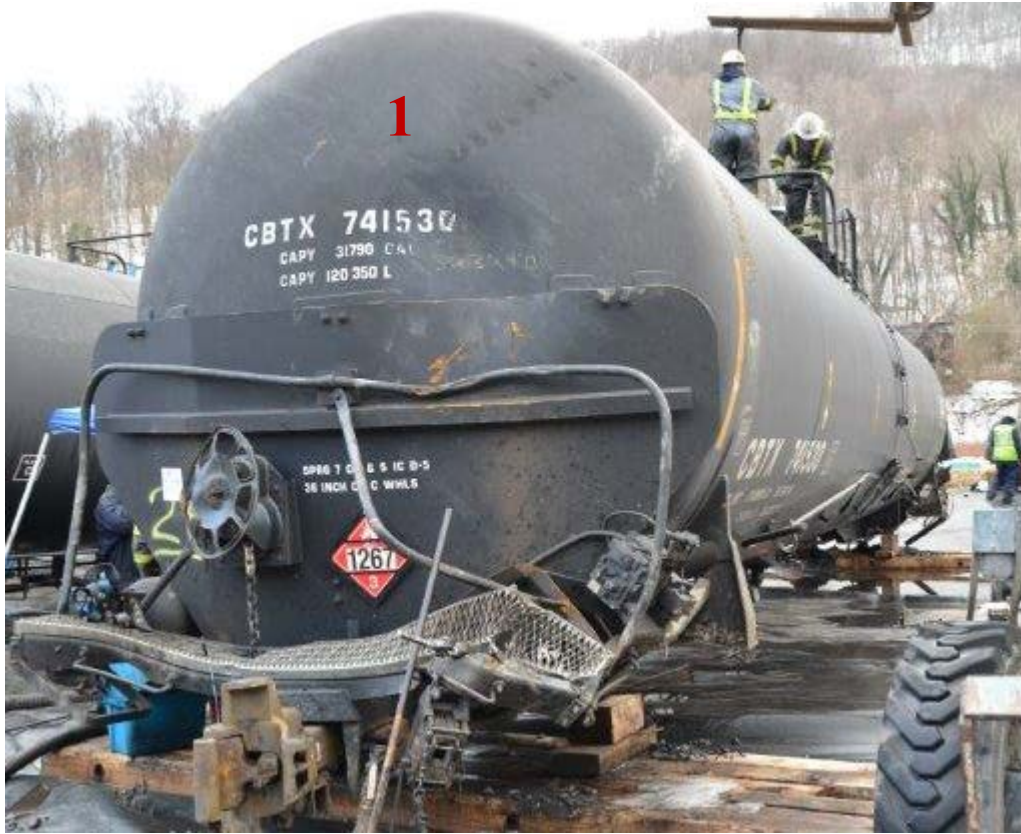
Figure 75: B-end head showing dent above head shield.
