Subject: Investigation of SCU 233700-109 S/N 0270 (HBC PN: 390-384011-0019)

On February 20, 2013, a Hawker Beechcraft model 390 Premier 1A business jet, registered N777VG, was destroyed in a landing accident at Thomson-McDuffie County Airport, GA, USA

This report describes the information download from the Spoiler Control Unit (SCU) 233700-109 S/N 0270 NV RAM memory IC chip component that was involved in the accident and delivered to Moog Aircraft on June 10, 2013.

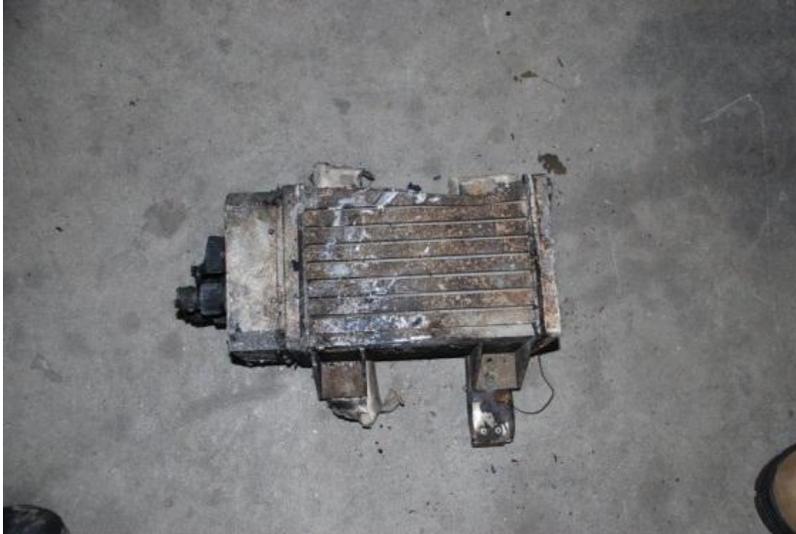
SCU S/N: 0270

- On 5/1/13 the NTSB sent Moog a picture of the burned SCU unit. Moog provided a response that the data recovery depended on the internal conditions.
- On 5/20/13 the NTSB contacted Moog and sent pictures of the internal cards removed from the unit. Moog did not know they were going to open the unit and remove the boards.

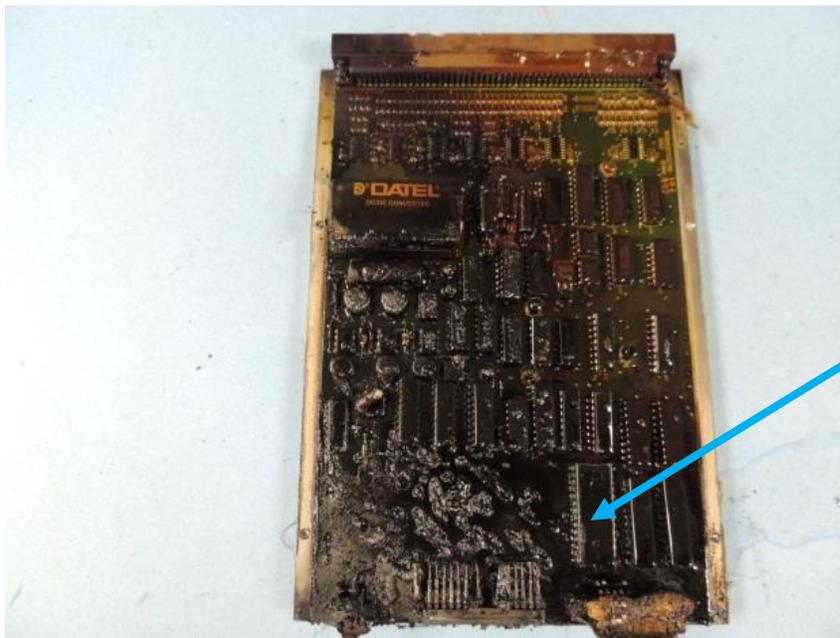
BIT / Diagnostics Board PN: 233498-001 from SCU S/N: 0270

- On 5/21/13 the NTSB notified Moog that the U3 memory chip was removed. Moog did not know the NTSB was going to remove the chip.
- On 5/22/13 the NTSB determined they would like Moog to mate the removed chip to an engineering asset board and attempt data download. The NTSB has been advised that while the chip is in good condition it could still be damaged and data recovery impossible.

U3 – NV RAM  
memory chip
