CEN17FA168

Pilatus PC-12/45, S/N 105; Honeywell Examination

Re: NTSB ID: CEN17FA168, N933DC, Pilatus PC-12/45, S/N 105; Honeywell examination

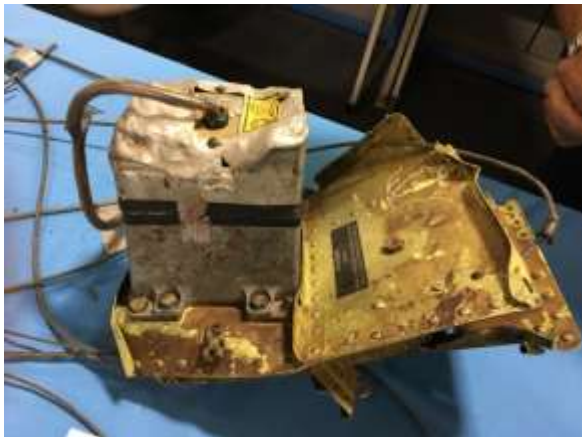
There was some crushing of the dust cover at the rear of unit in addition to a tear in the dust cover.

Crush damage at rear of the dust cover.  
Tear in dust cover.

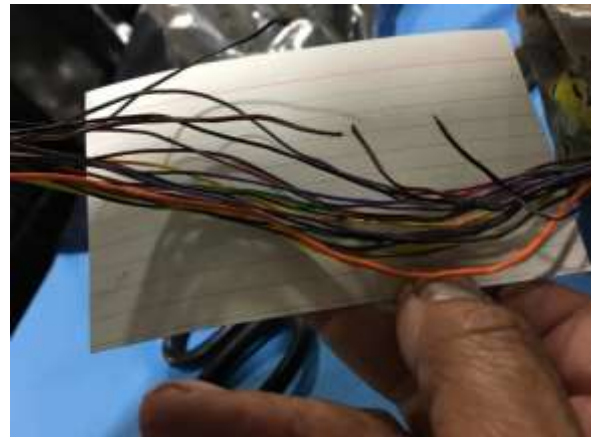
The wiring harness is damaged.

Impact damaged wiring harness.

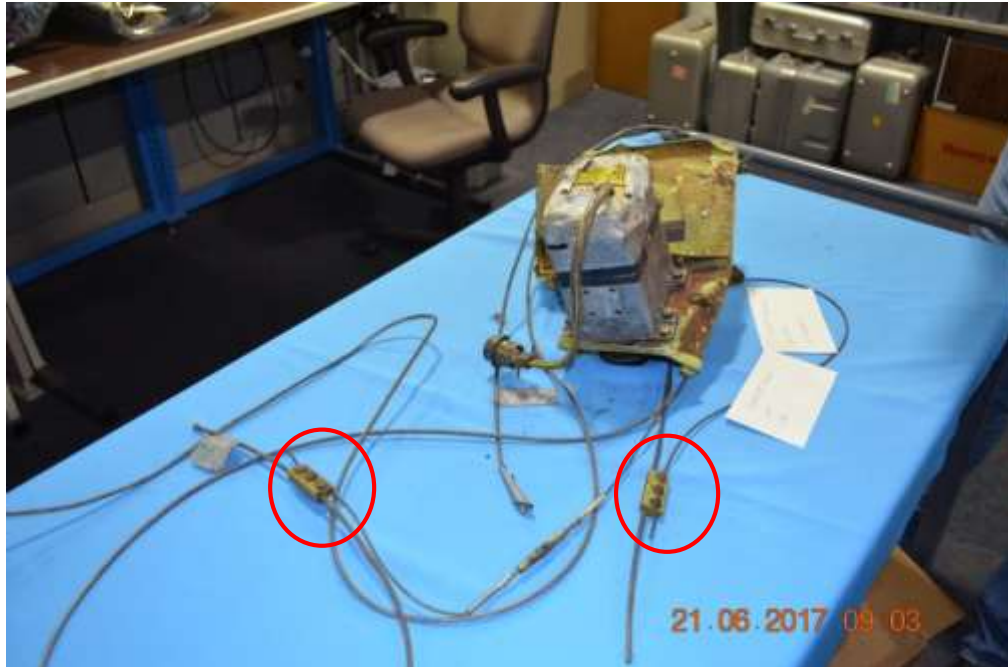
Bridal cable control clamps are intact.

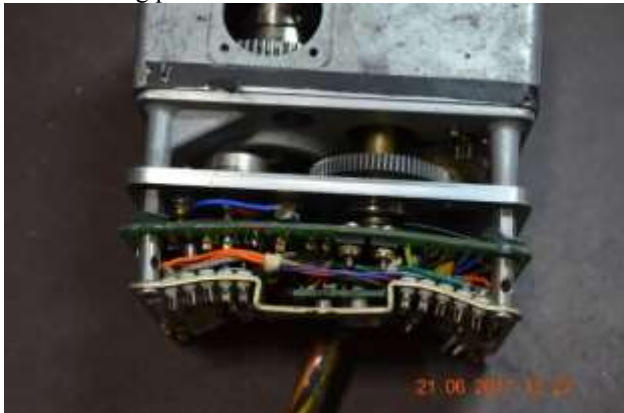
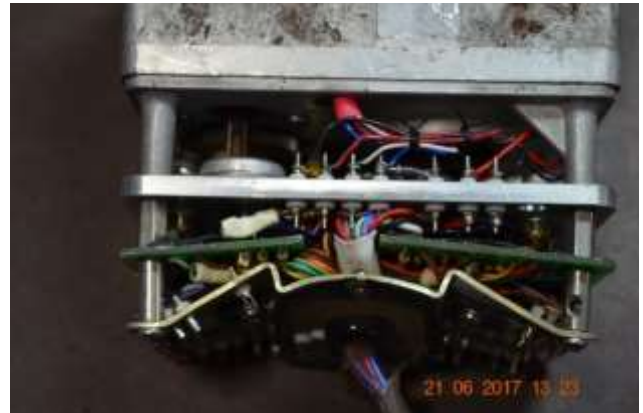
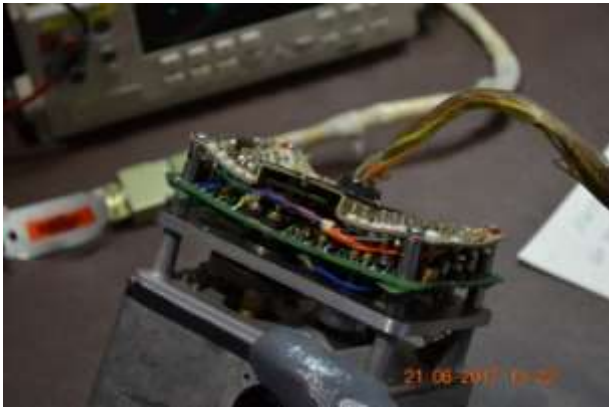
The dust cover was removed to allow inspection of the servo wiring and the circuit cards. The rear component mounting plate is bent inward.

Side view of servo with dust cover removed. The rear component mounting plate bent inward toward circuit board.

Opposite side view of the rear component mounting plate bent inward toward circuit board.

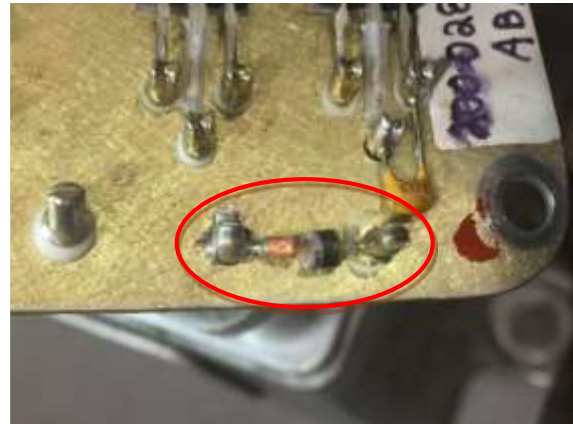
Broken diode (CR403) on the rear plate.

An exemplar test aid diode was installed for the broken CR403.

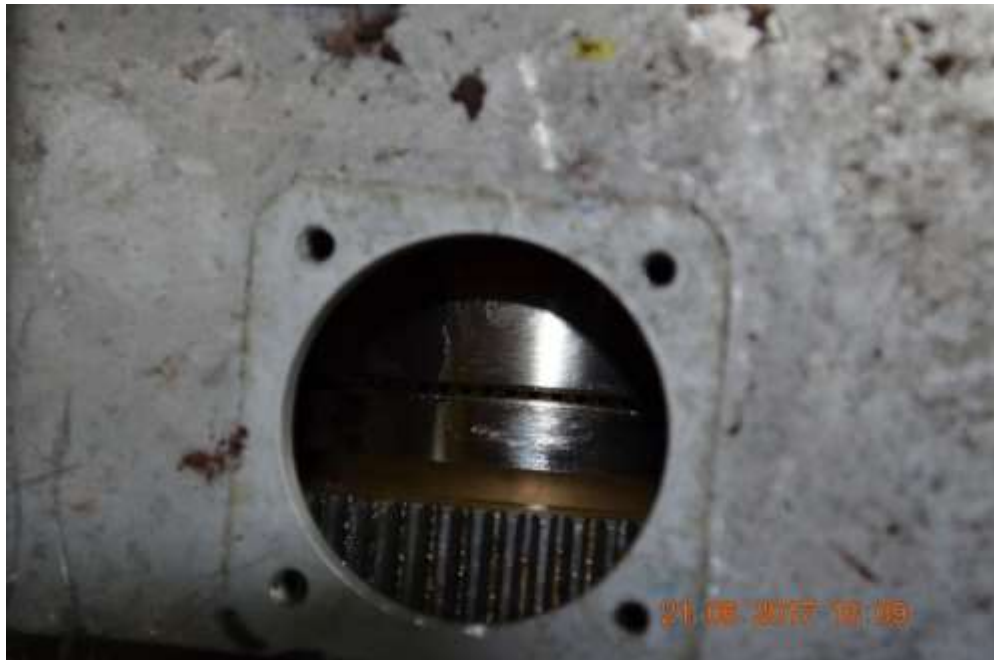
No anomalies were found during the servo drive train inspection.

View through inspection plate of main drive gear.

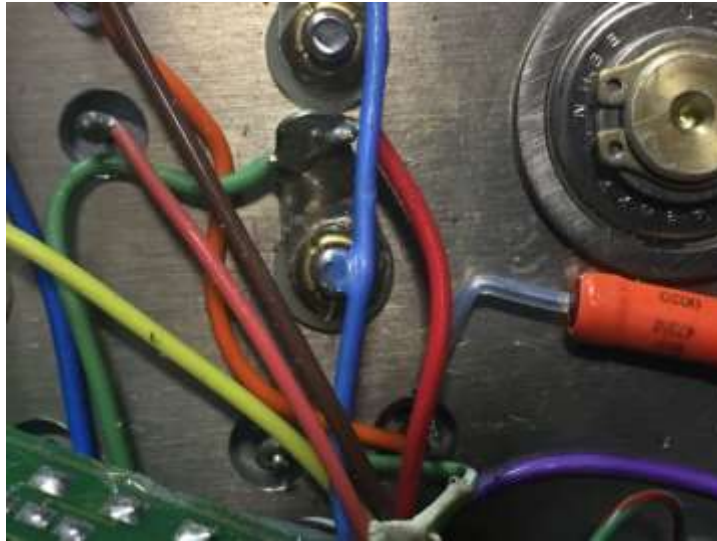
Circuit board (200-06444-0012) was lifted to visually examine the components. A blue wire was found contacting a screw due to the circuit board pressing up against it (impact related) resulting in a shorting condition. The blue wire had damaged insulation. The blue wire was moved away from screw.

KSA 372 SN M5626 Impact damaged blue wire.

When power was reapplied to the servo and the unit began an un-commanded run. The clutch engaged and disengaged when commanded.

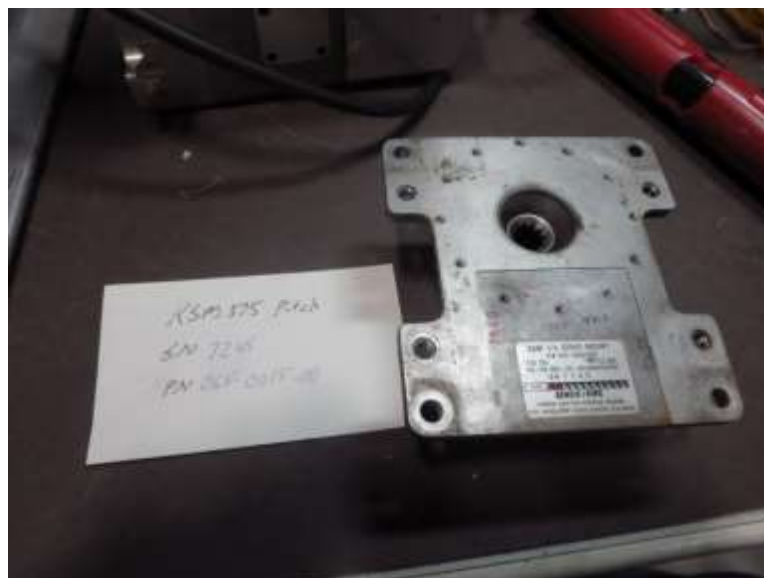
Mounting plate appears to in good condition. Dried clay/dirt observed on the mounting plate, the capstan, and the capstan / clutch cover.

KSM 375 SN 7245 Back side view

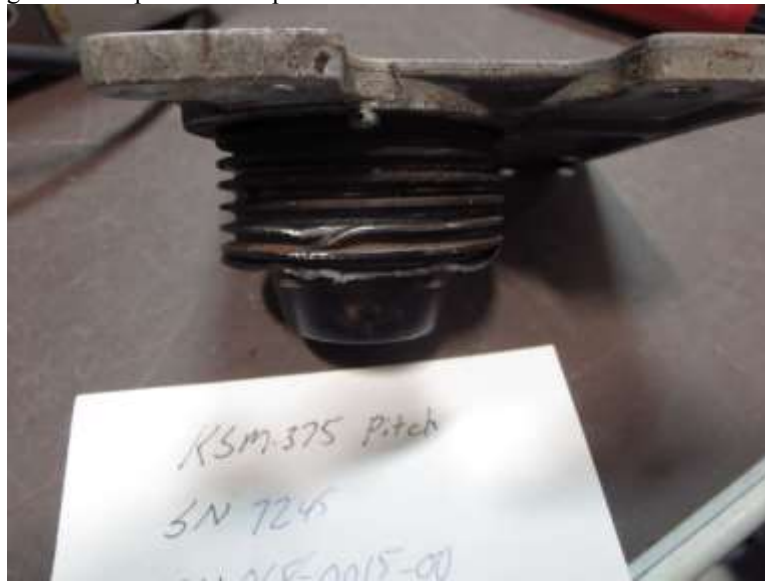
Observed impact damage to the Capstan and Capstan cover.

KSM 375 SN 7245 Front side and Capstan view

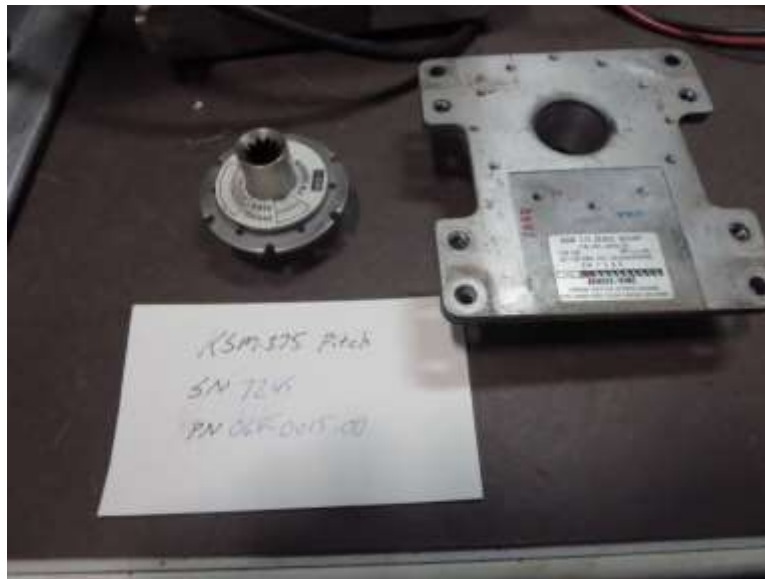
The clutch assembly was removed from the Servo Mount and inspected. No anomalies were detected.

KSM 375 SN 7245 Servo mount with clutch removed for testing

The KSM 375 Pitch Servo Mount functioned correctly; however, the clutch slipped at approximately 50 in/lbs (CW) and 50 in/lbs (CCW) against a limit of 40 +/- 5 in/lbs. The out of tolerance condition would not have an adverse impact on operation. The Aircraft Flight Manual provides preflight instructions to confirm proper operation and ability to overpower the autopilot clutches.

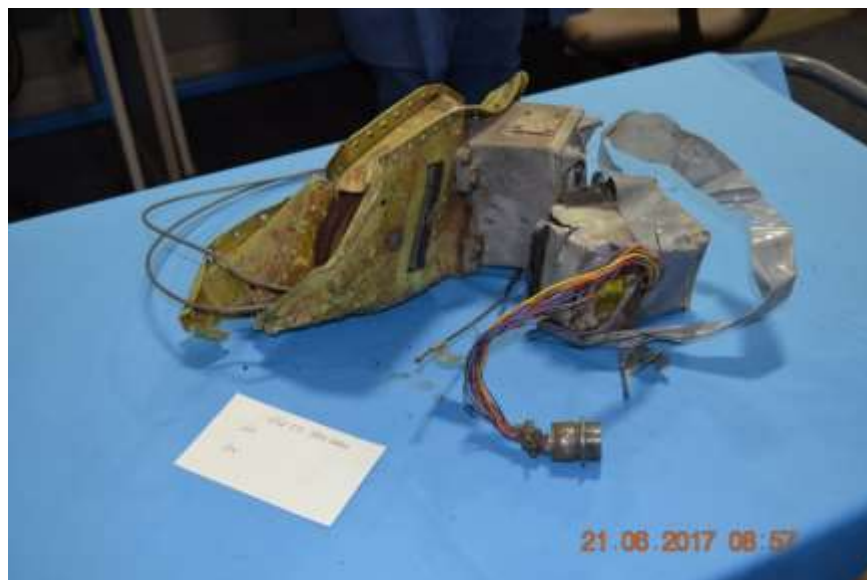
- The servo was visually confirmed to be in the disengaged state when received.
- The dust cover was crushed.
- The servo circuit cards were found detached from the main servo housing.
- The gear train appeared to be out of alignment.
- The servo housing was cracked
- A mounting boss was found broken.
- Connector back shell found broken.
- Wires found severed in the wiring harness.

KSA 372 SN 3600: As received

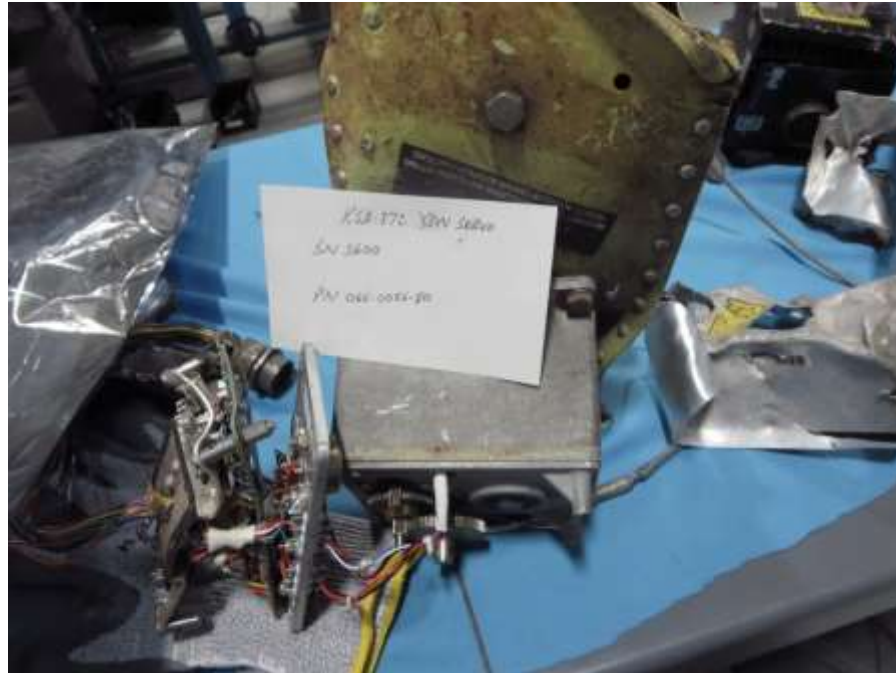
The back plate was found bent / crushed.

The circuit cards were found crushed and broken.

The access panel was removed from the servo housing and the clutch was found Not Engaged.

The motor/gear assembly turned freely by hand.

KSA 372 SN 3600 with dust cover removed.

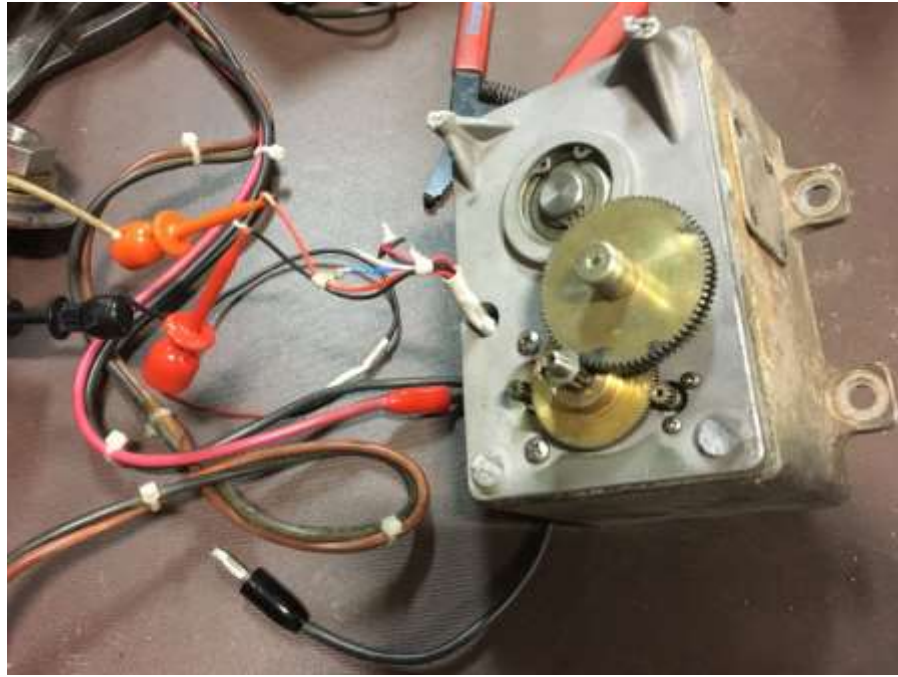
The motor functioned correctly in the Clockwise and Counter Clockwise directions.

The clutch solenoid wiring was isolated from the servo control circuitry. Power was applied to the servo clutch solenoid via an external power supply. The clutch solenoid engaged and disengaged satisfactorily.

KSA 372 SN 3600 testing of the servo motor and clutch solenoid.

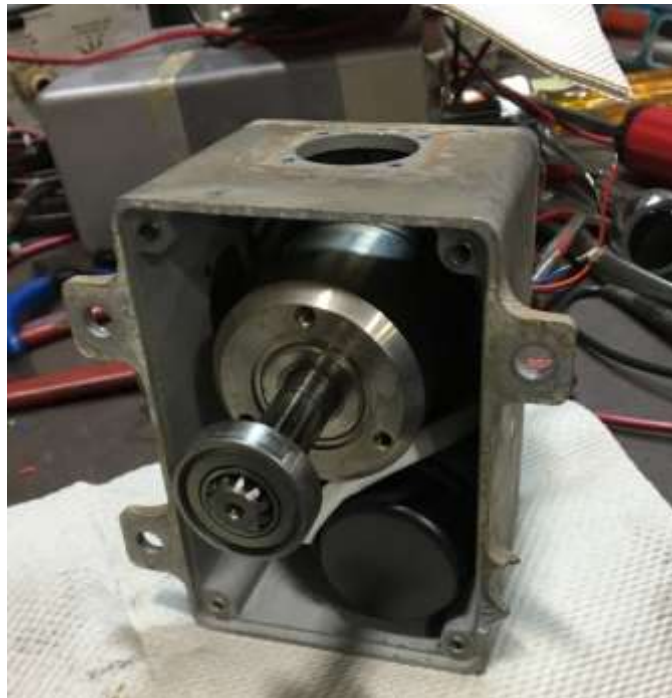
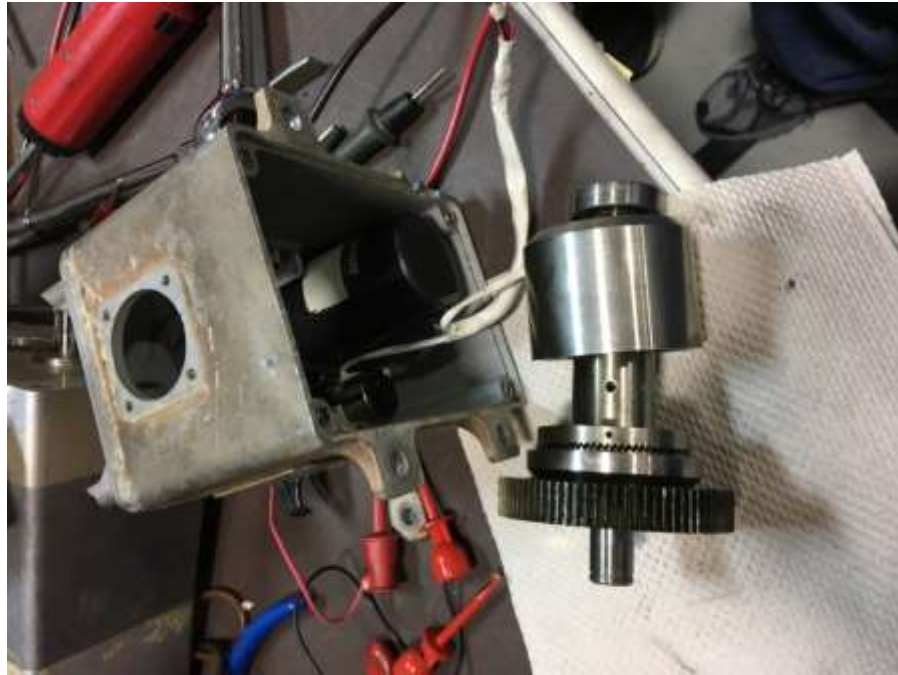
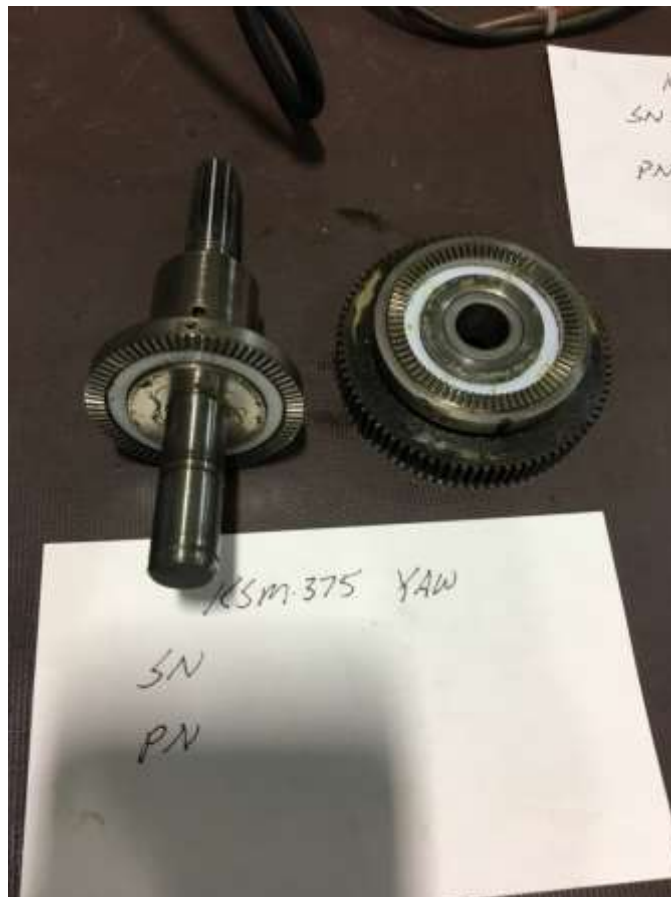
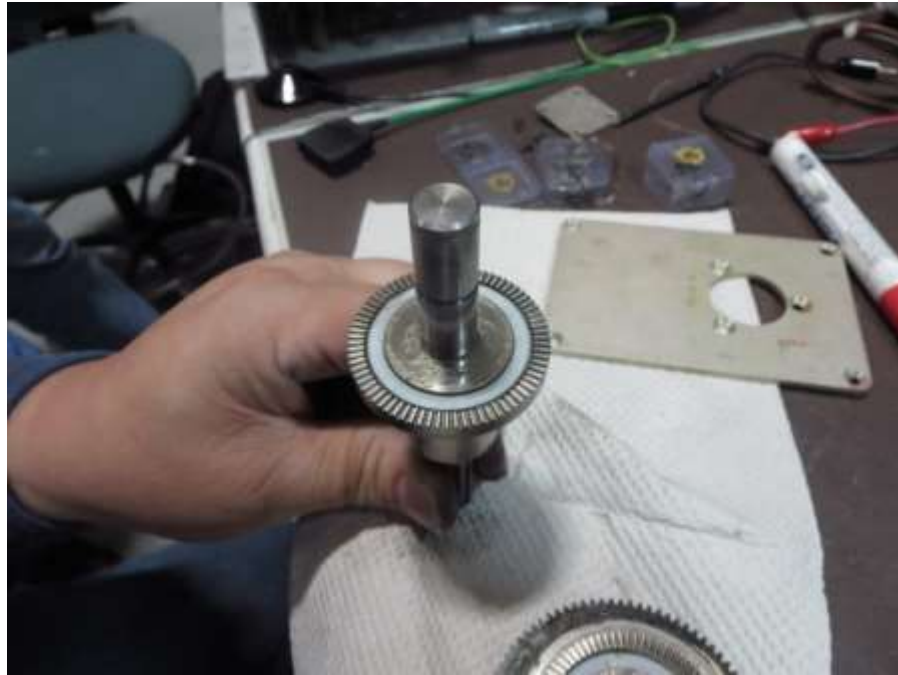
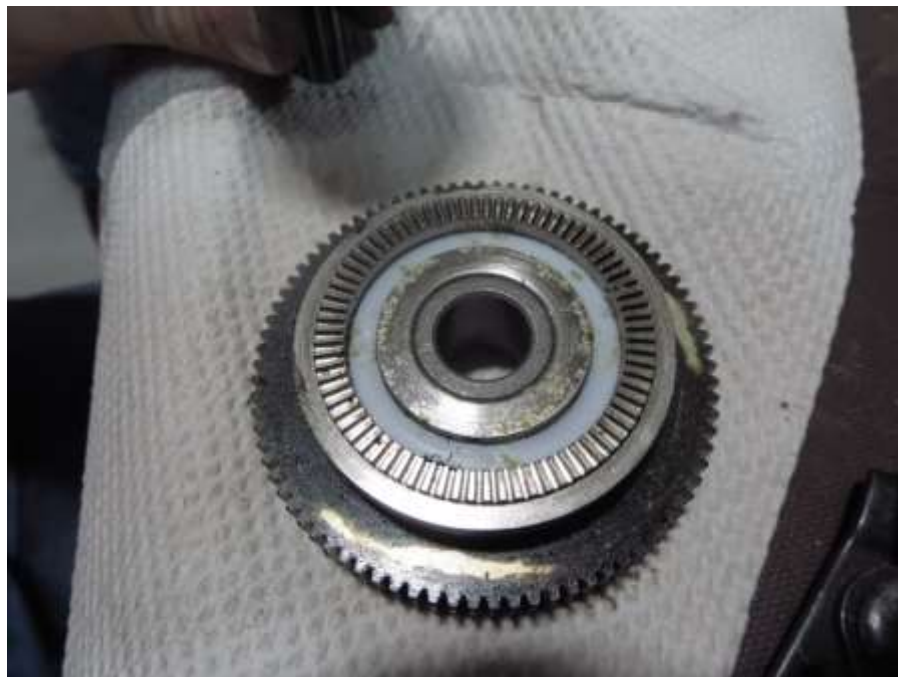
- No witness marks were observed on the clutch gear teeth crowns..

KSA 372 SN 3600: Cover removed to examine servo gear train.

KSA 372 SN 3600: Gear train removed for examination.

KSA 372 SN 3600: Gear train disassembled to examine “poker chip” gear face.

No witness marks were observed on the clutch gear teeth crowns. Due to extensive damage, testing of the complete servo was not possible. No adverse operation observed during standalone testing of the clutch solenoid and drive motor.

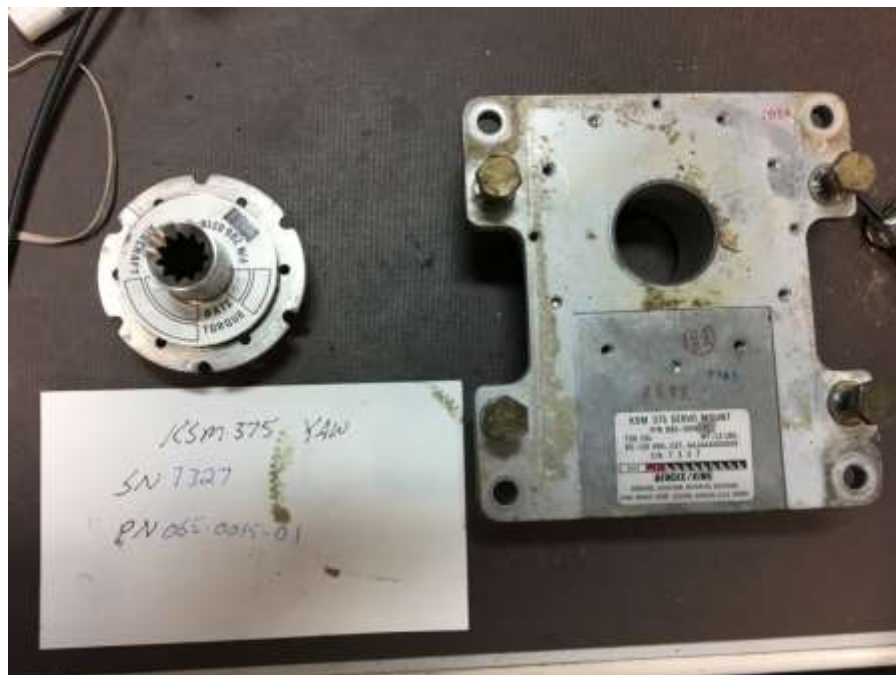
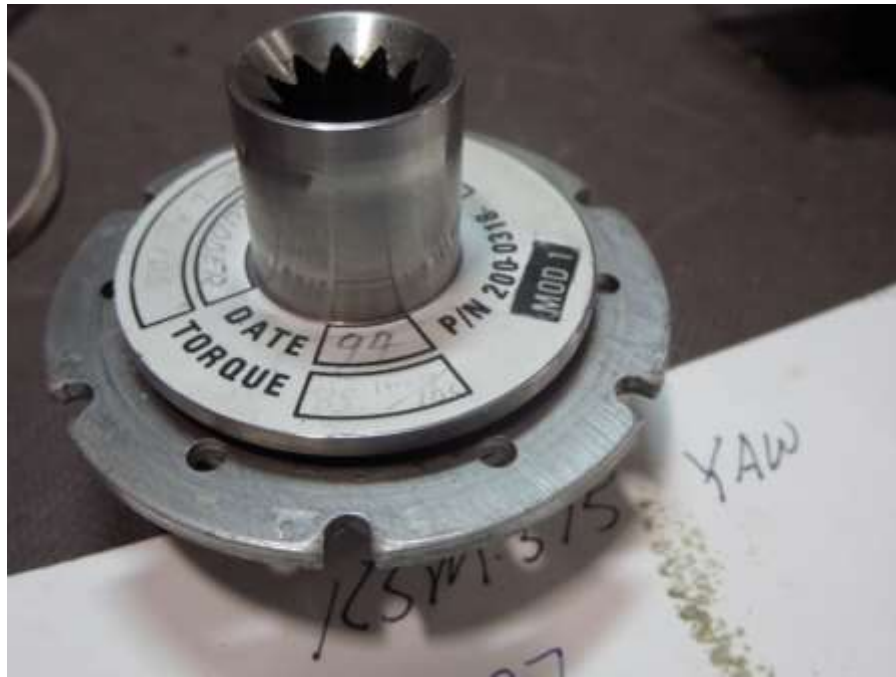
Mounting plate appeared to be in good condition. Dried clay/dirt observed on the mounting plate.

KSM 375 SN 7327 Mounting plate and clutch

The KSM 375 Yaw Servo Mount functioned correctly; however, the clutch slipped at approximately 50 in/lbs (CW) and 50 in/lbs (CCW) against a limit of 85 +/- 5 in/lbs. The out of tolerance condition would not have an adverse impact on operation. The Aircraft Flight Manual provides preflight instructions to confirm proper operation and ability to overpower the autopilot clutches.

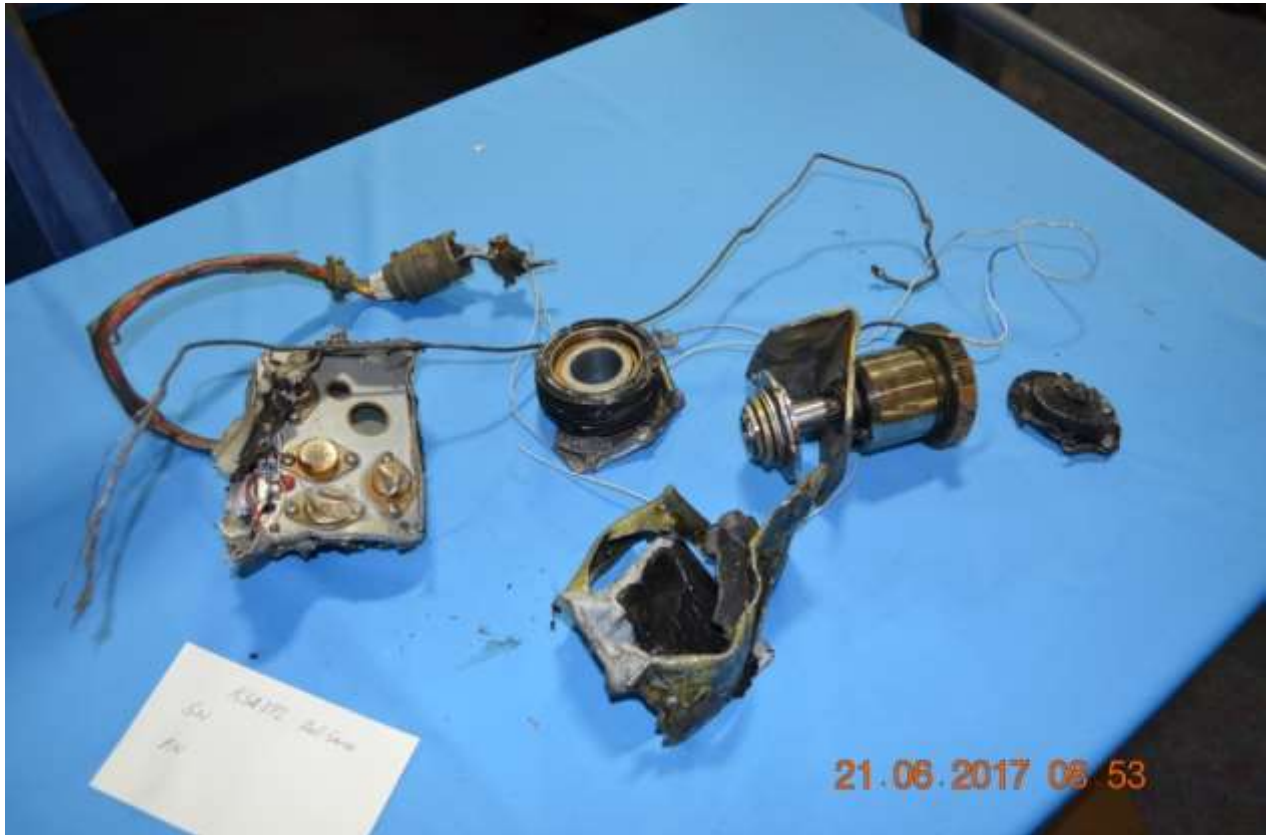
The Roll servo was received in a severely damaged state.

KSA 372 Roll Servo mounting plate and clutch

- Back plate / electronics assembly.
- Bridge cable
- Capstan with fractured mounting plate.
- Clutch solenoid assembly with slip clutch.
- Capstan cover.
- Dust cover.

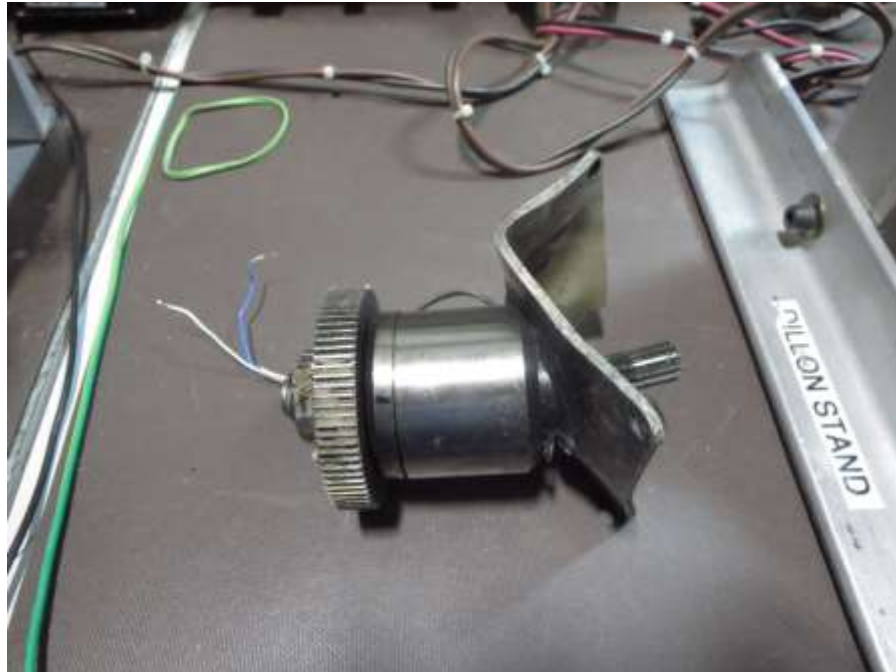
+28 VDC was applied to the blue and white Clutch Solenoid wires. The solenoid engaged and disengaged properly with the application and removal of power.

KSA 372 solenoid assembly.

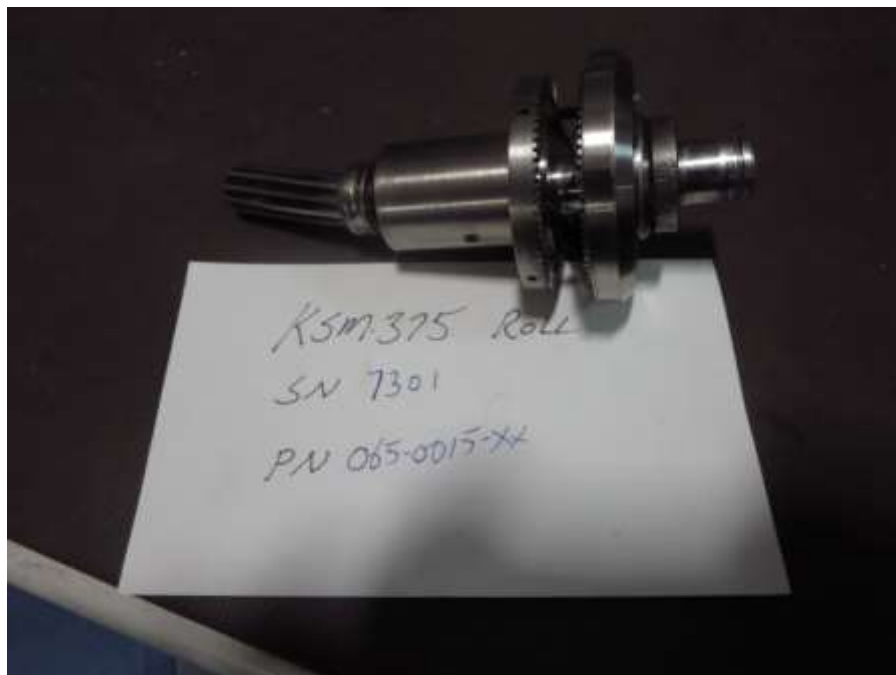
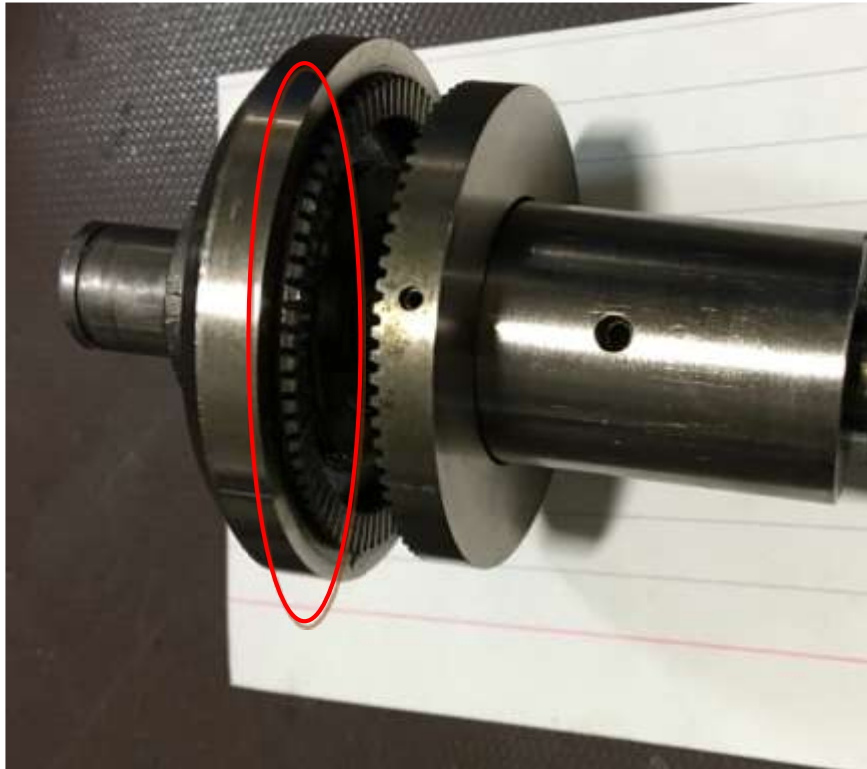
The clutch solenoid was disassembled for visual inspection. The “poker chip” gear was inspected and a witness mark was observed on the edge of the friction clutch gear from the blue/black mark counterclockwise (CCW) spanning approximately 180 degrees.

KSA 372 gear and shaft assembly.

KSA 372 Witness marks in edge of gear teeth..

Witness marks were observed on the edge of the Clutch gear teeth crowns. Due to the extensive damage testing of the complete servo was not possible. The clutch solenoid and drive motor were tested with no adverse operation observed.

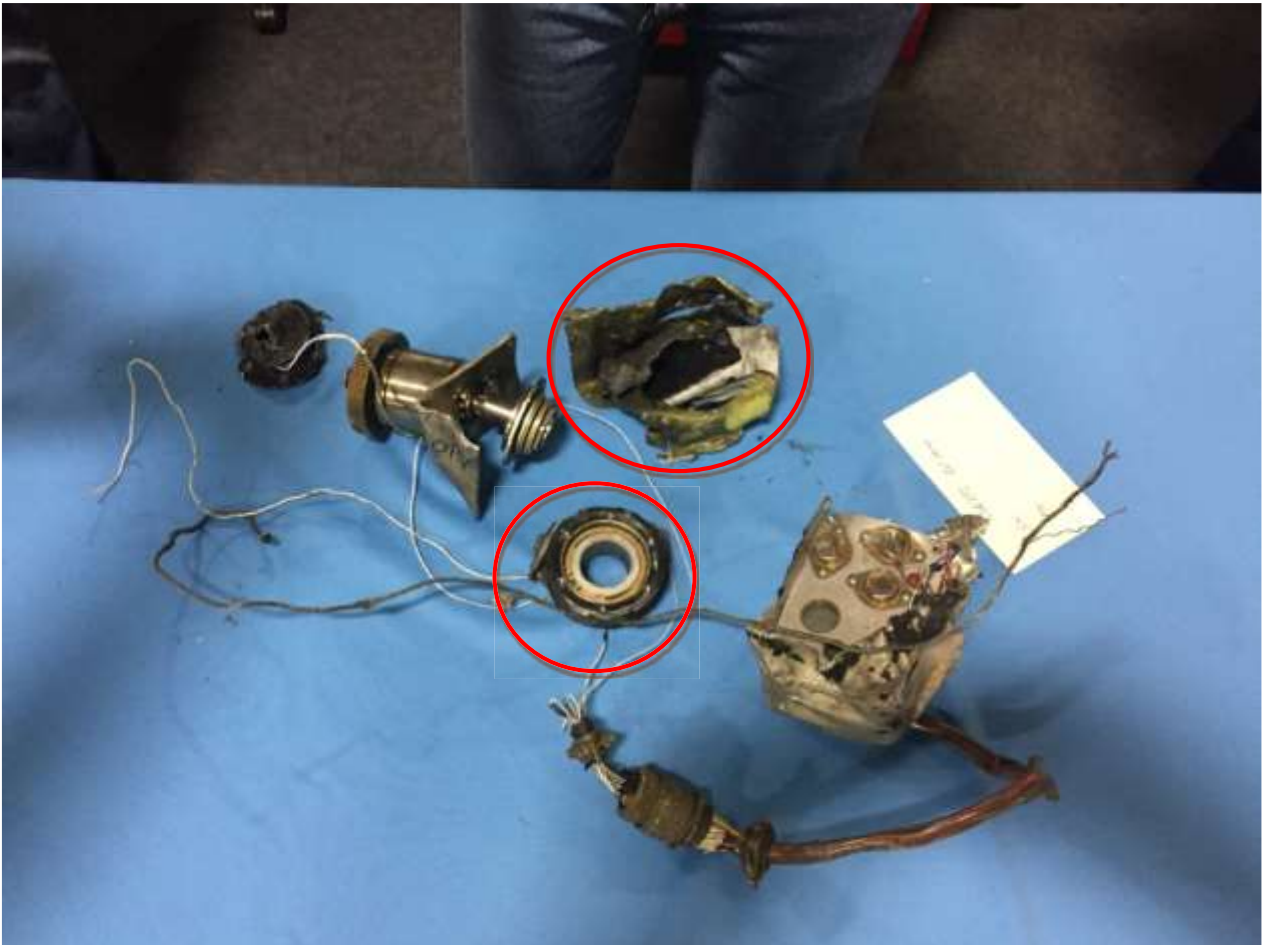
Servo Mount Inspection:  
The only portions of the servo mount recovered were a portion containing the ID plate, a portion behind the capstan, and a portion attached to a piece of the airframe.

KSM 375 SN 7301 Red circle: Portions of the servo mount

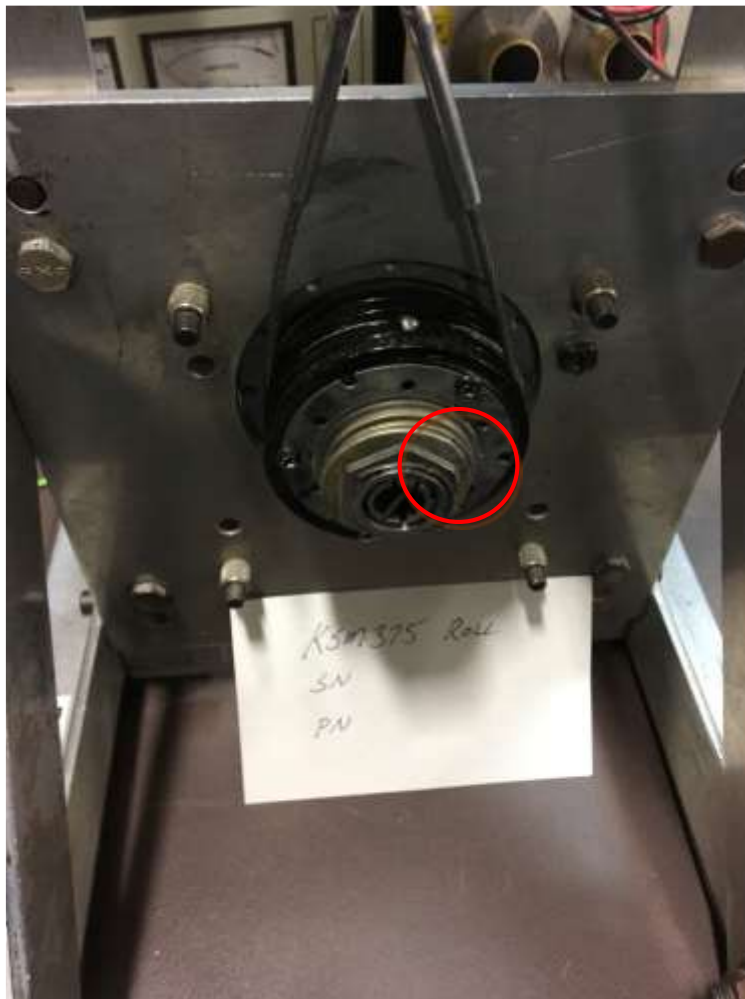
The friction clutch was separated from the capstan. The top of the clutch in the area of the torque nut was found with impact damage. There was also evidence of damage to the clutch disk.

KSM 375 SN 7301 Impact damage to clutch

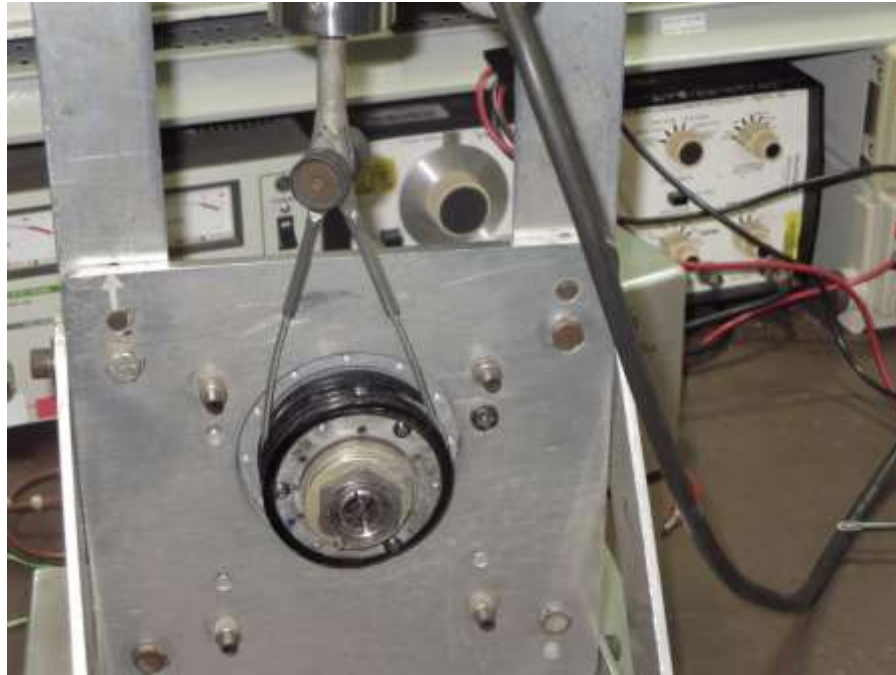
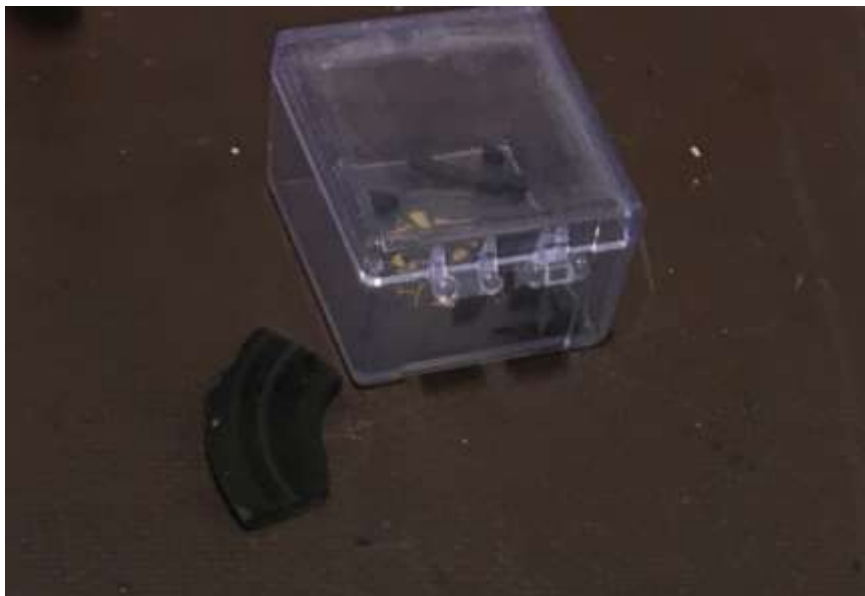
KSM 375 SN 7301 Clutch disk mounted on test stand

\*At initial run, the torque breakout was approximately 75 in lbs. As the clutch was operated in the CW and CCW directions, the torque decreased to a range of 37 to 62 in lbs. Further inspection revealed the carbon clutch disk was damaged / broken as a result of impact forces.

KSM 375 SN 7301 Collected portions clutch disk.

The KSM 375 Roll Servo Mount sustained extensive damage. Visual inspection showed damage to the clutch disk prior to testing. The clutch torque was in spec upon initial testing and decreased as the clutch was tested. Also observed were portions of the clutch disk accumulating at the base of the test stand

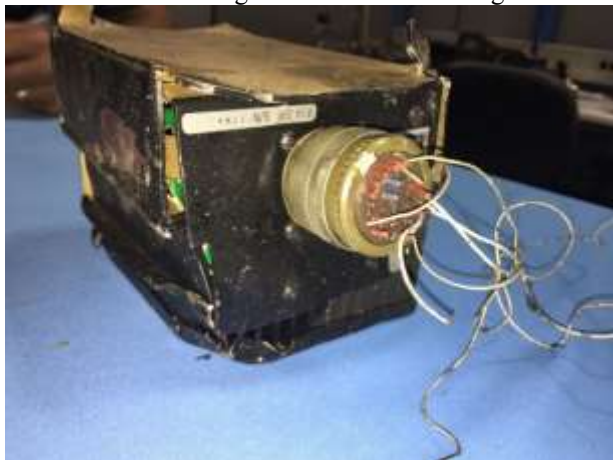
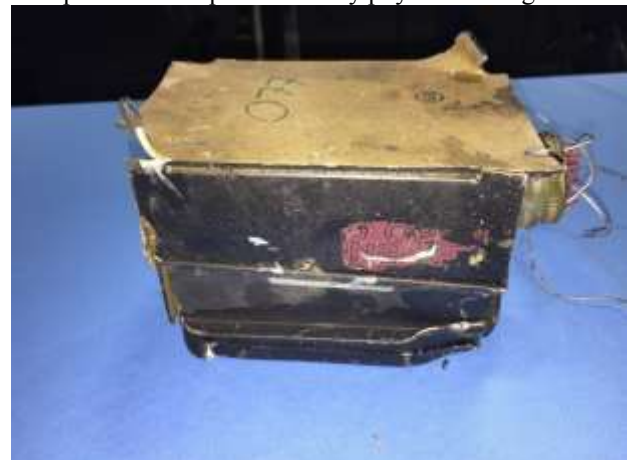
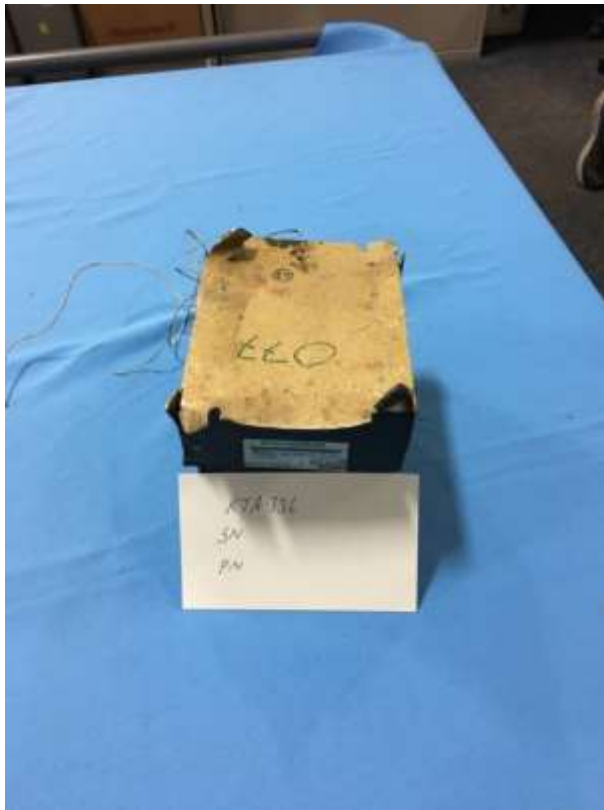
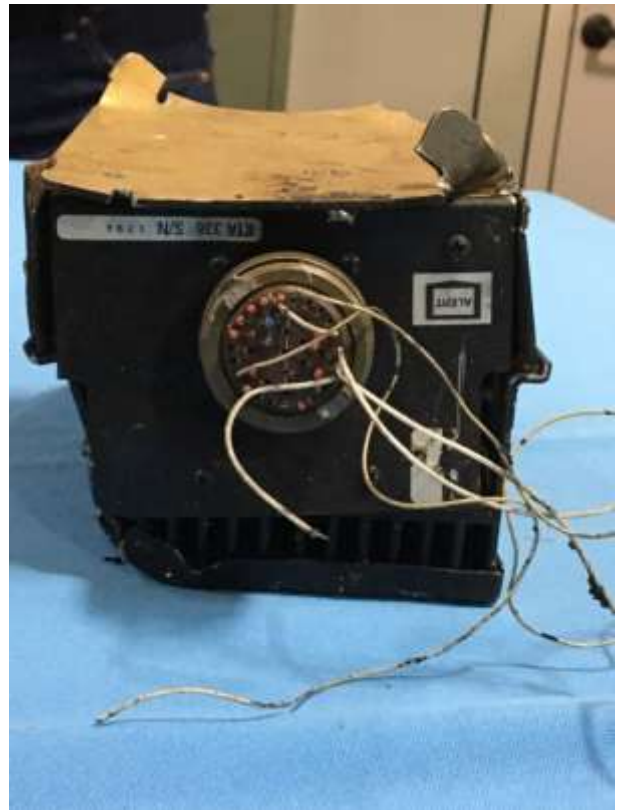
Crush damage to the case of the unit.

Damage to the unit base plate and connector plate.

KTA 336 SN 1794 Exterior view 1.

KTA 336 SN 1794 Exterior view 2.

KTA 336 SN 1794 Exterior view 3.

KTA 336 SN 1794 Exterior view 4.

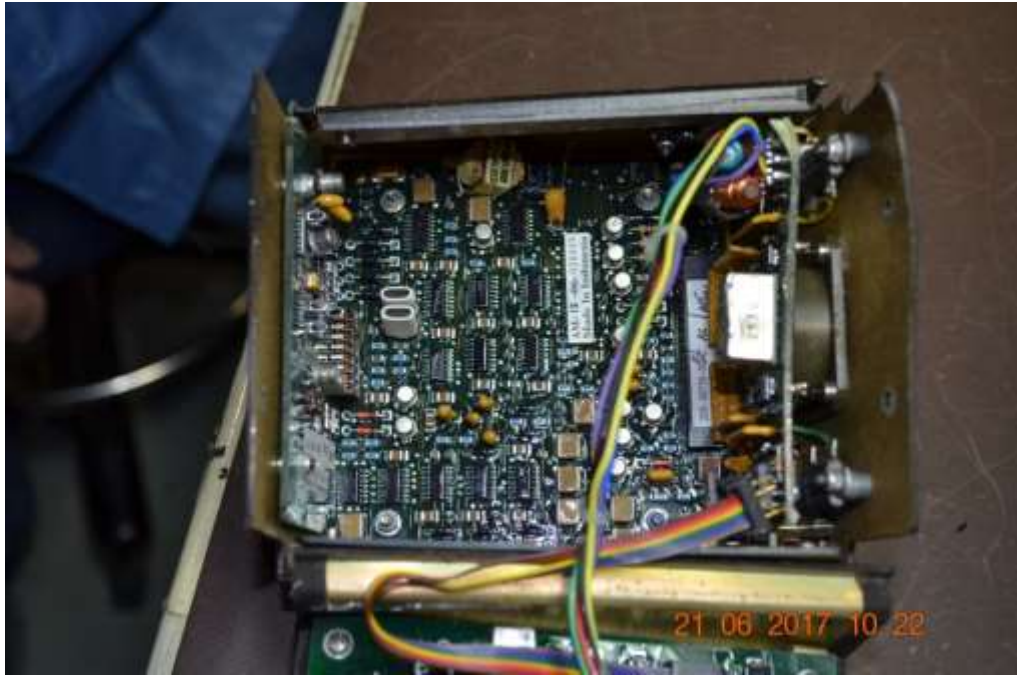
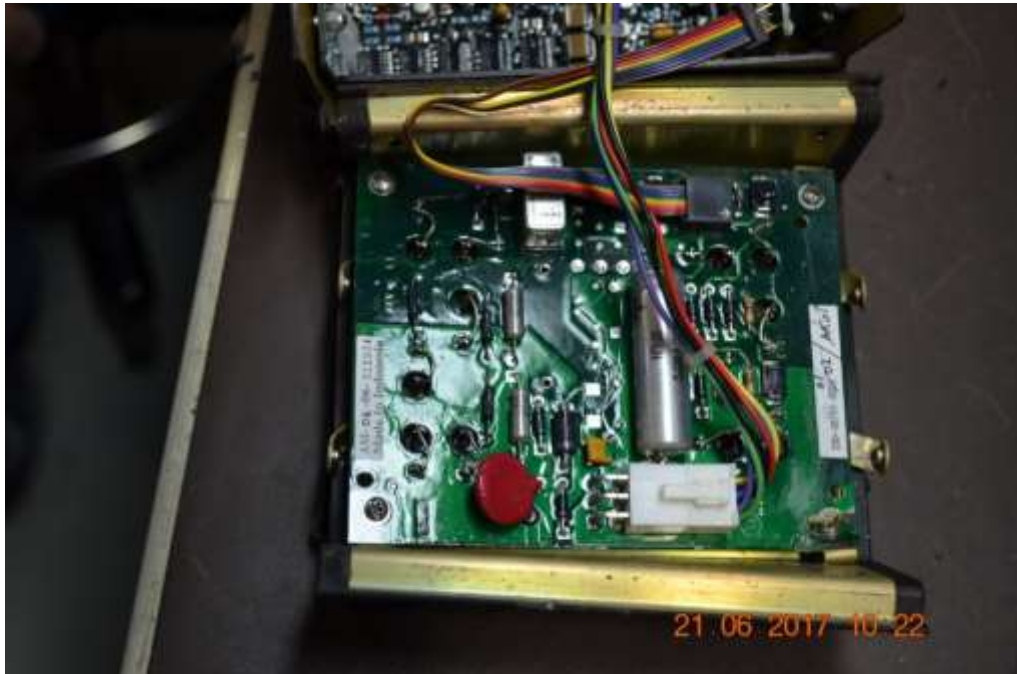
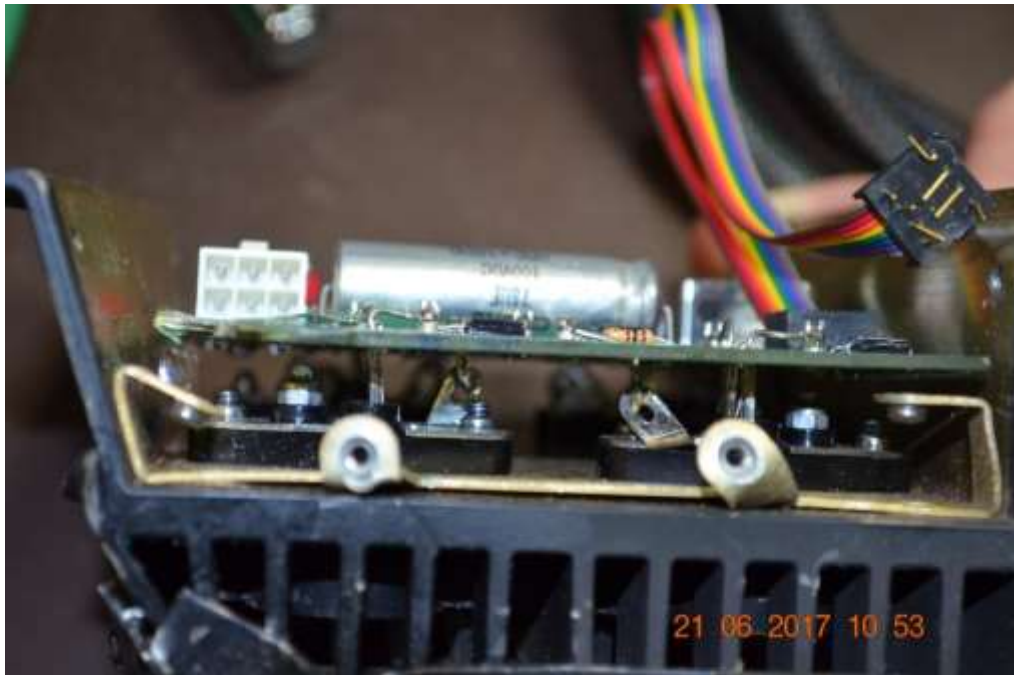
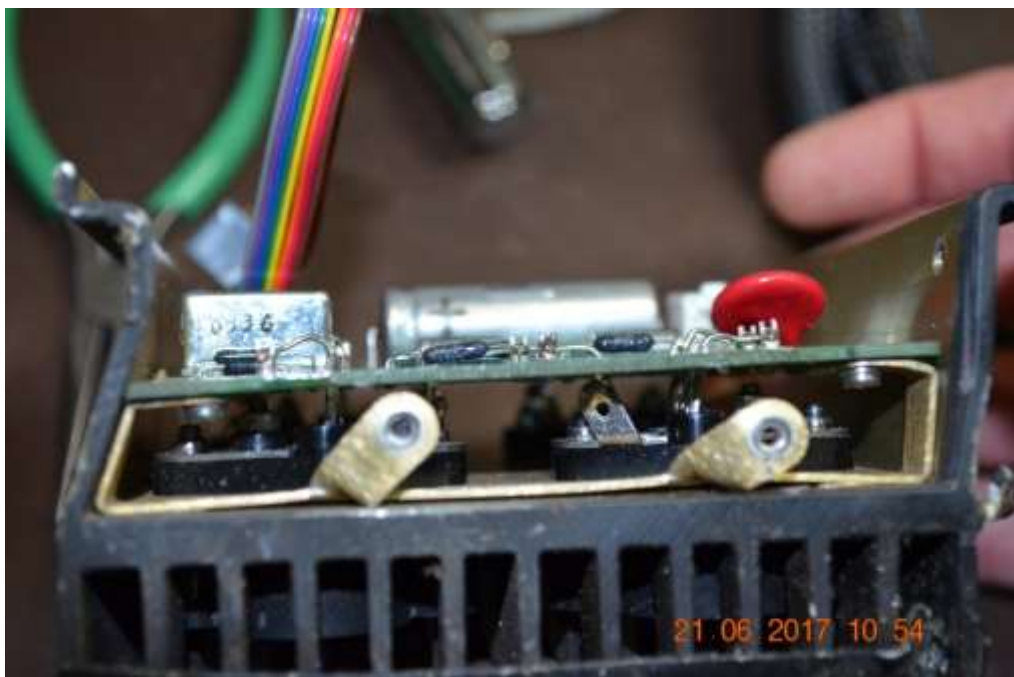
- Delamination of the rear connector board.
- Delamination on a corner of the servo amp board
- The audio transformer was found detached from the monitor board.
- The connector on the servo amp board to the rear connector board was found damaged.
- A power supply inductor on the connector board was found displaced.
- A filter cap was found with a lead detached.
- The rear connector was found displaced from the rear connector board.
- The servo amp board was found crushed in close proximity to the power transistors.

Power was applied to the KTA 336 Trim Adaptor. After approximately 30 seconds and audible “click” was heard and the unit drew high current. A transistor on the Logic board was found with the transistor case crushed into the transistor leads. The transistor leads were reformed to lift the case off the leads. The Servo Amp was connected to the Connector board and a retest was attempted. Upon the reapplication of power, the unit drew high current. The power transistors were measured with two showing shorted. The transistors were removed from their holder and tested individually for continuity with the transistors testing good. A short in the Servo amp board due to crush damage precluded any further testing.

KTA 336 SN 1794 Interior view 1.

KTA 336 SN 1794 Interior view 2.

KTA 336 SN 1794 Interior view 3.

KTA 336 SN 1794 Interior view 4.

Summary:  
Due to the impact damage, testing was not accomplished on the KTA 336 Trim Adaptor.

Under the direction of the NTSB Investigator, repairs were made to the extent possible to reestablish broken circuit connections. Bent pins on the Servo Amp board J101 ribbon cable were straightened to allow connection to the mating connector. When attempting to straighten the bent pins, Pin 1 (AT CMD UP) of the ribbon cable to J101 broke at the base of the pin. The Servo amp board was moved away from the power transistors on the heatsink assembly. Due to the broken ribbon cable pin, Servo Amp was deferred for the initial power on test.
