CEN17FA168

Pilatus PC-12/45, S/N 105; Honeywell Examination

Re: NTSB ID: CEN17FA168, N933DC, Pilatus PC-12/45, S/N 105; Honeywell examination

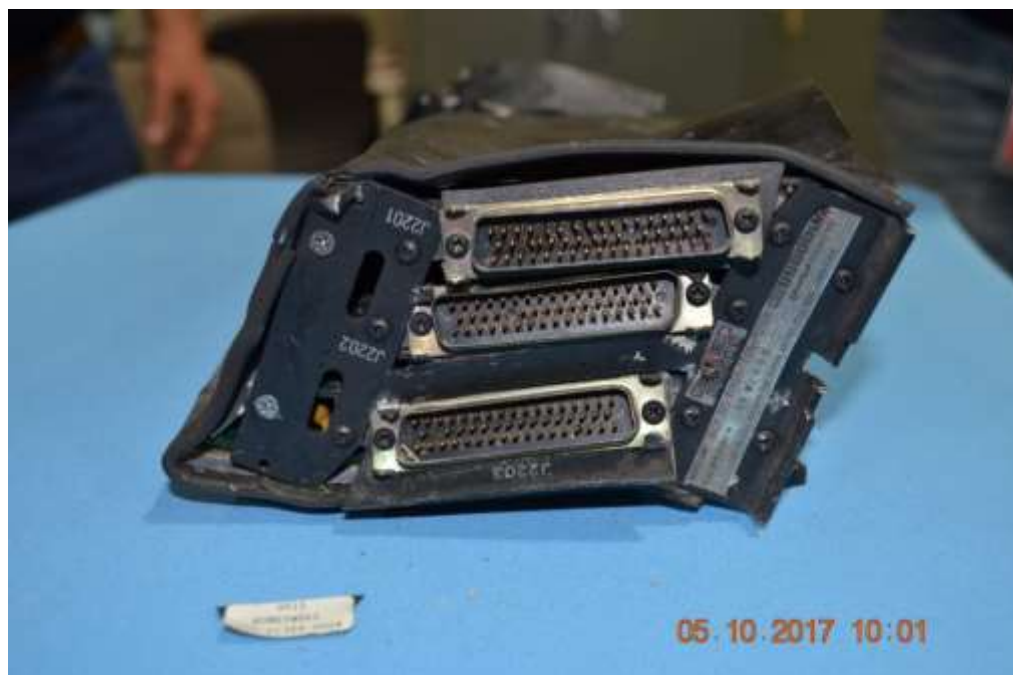
The KCP 220 Flight Computer sustained crush damage with some twisting of the unit. Removal of the dust cover revealed a number of components were dislodged and tore from the circuit boards. Some circuit boards within the unit sustained fractures from the impact damage.

KCP 220 SN 1898 End view showing unit twisting.

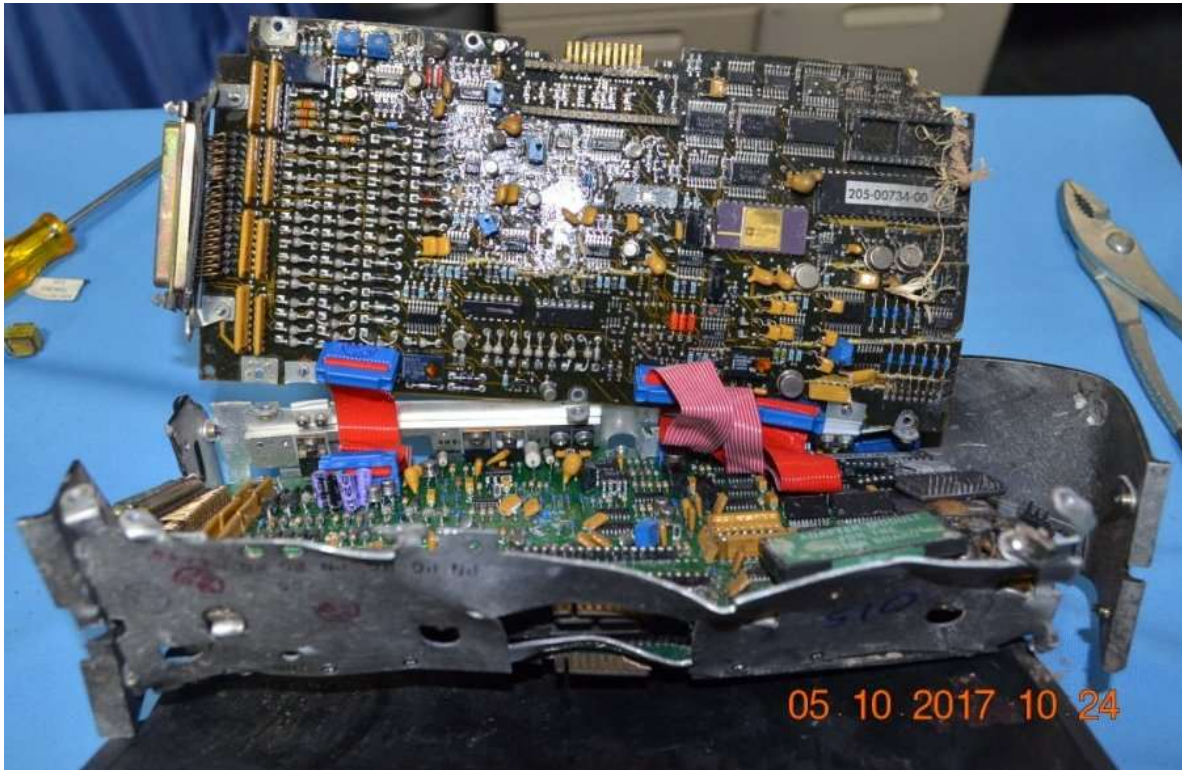
KCP 220 SN 1898 Interior view showing dislodged components and cracked circuit boards.

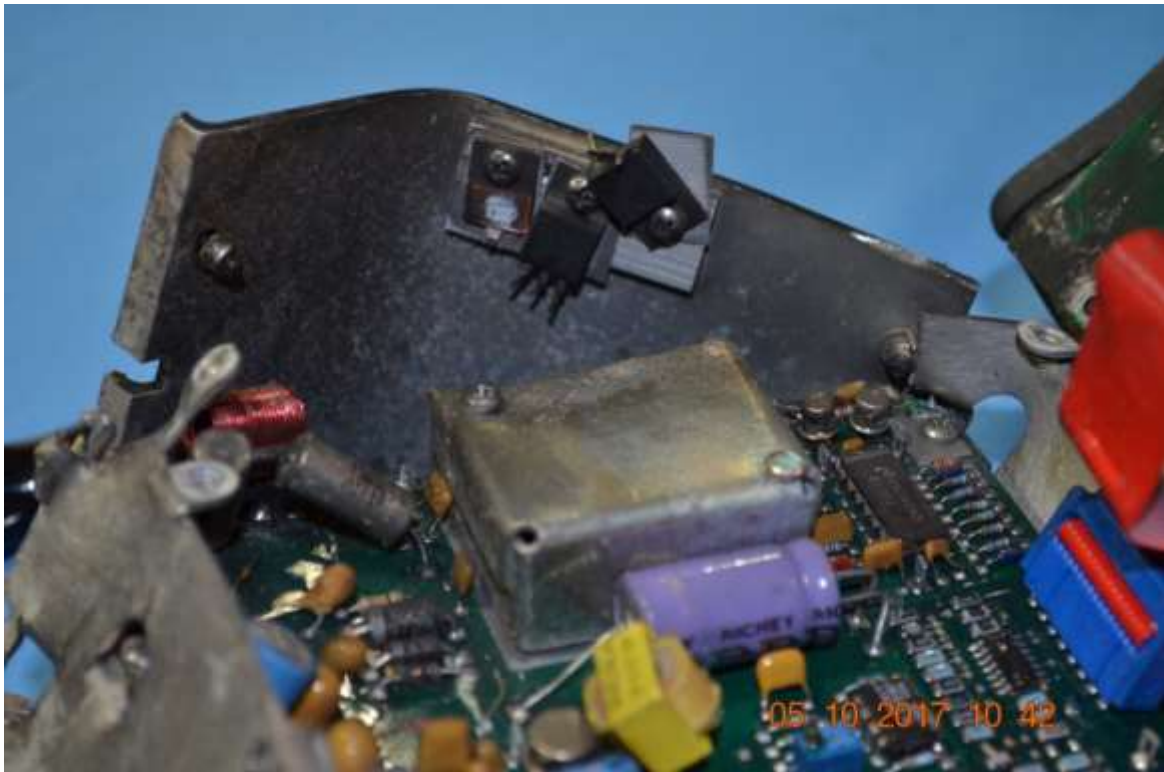
KCP 220 SN 1898 Interior view showing damage to the power supply circuitry.

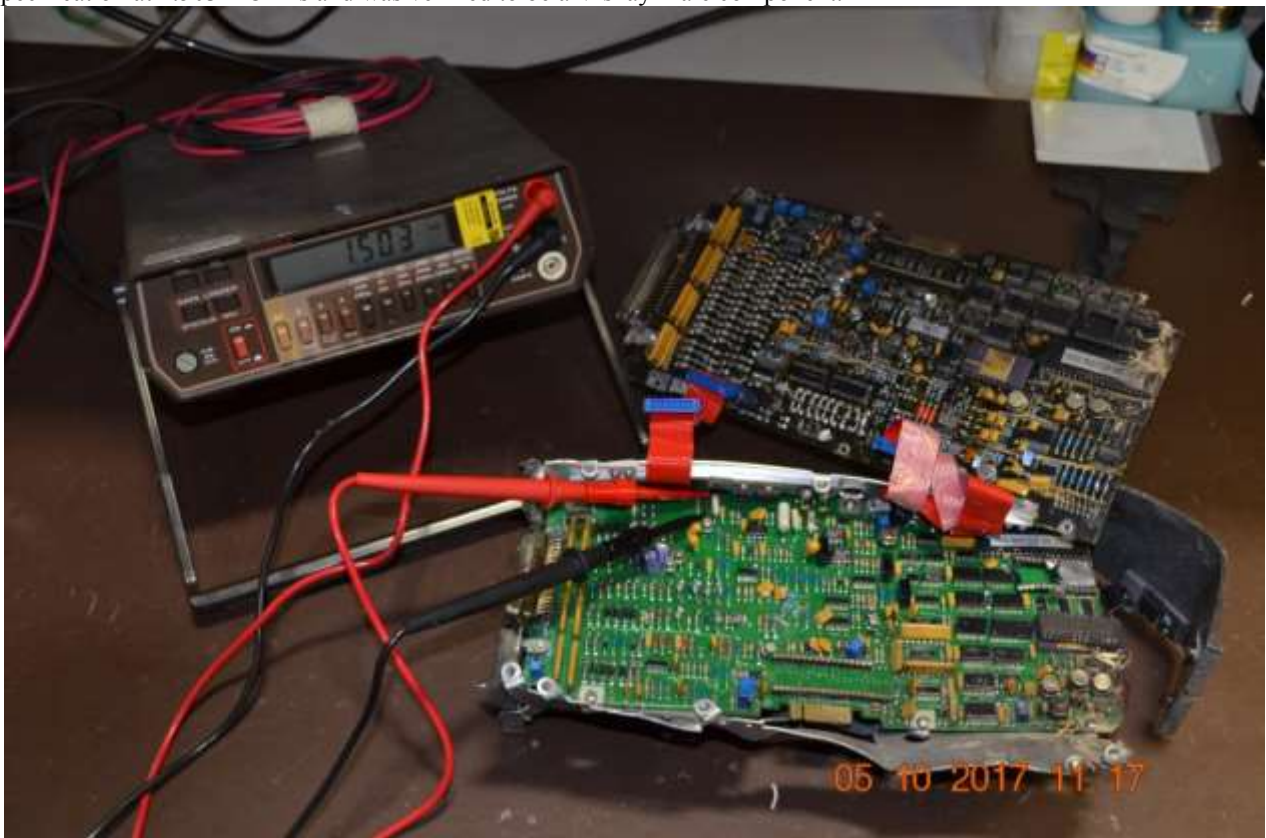
R259 was visually and electrically verified to be the correct component per Unit Mod 11. R259 measured in specification at 1.503 k Ohms and was verified to be a Vishay-Dale component.

KCP 220 SN 1898 Interior view showing R 259 (attached to clip leads).
