National Transportation Safety Board  
Tank Car Damage Assessment Form

Reporting Marks	CTCX 743002		Car Location City/State	Hendley, WV	
Date inspected	3/3/15	Railroad	CSX	DOT Specification	
Last Contained	Petroleum Crude Oil			Was product released?	
(Indicate One)	Jacket			Does car contain product	
Car builder		Stub Sill Design		Built Date	
Capacity (GAL)	31,790 us gals		LD Limit (LB)

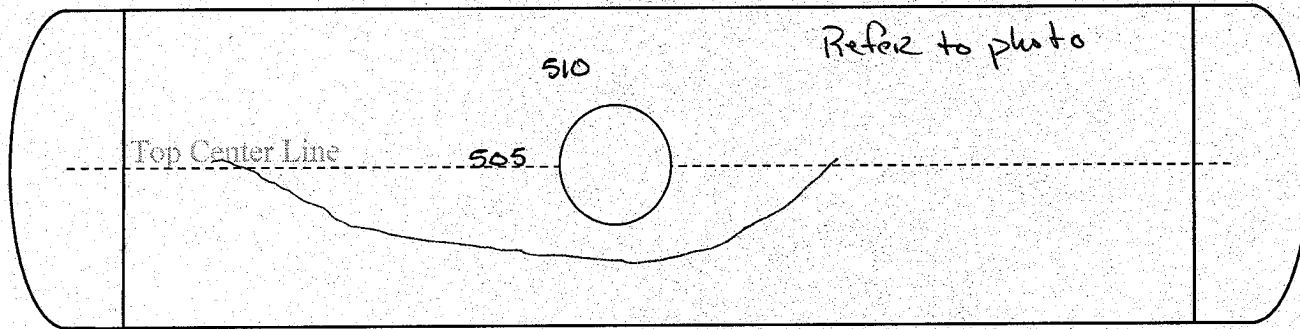
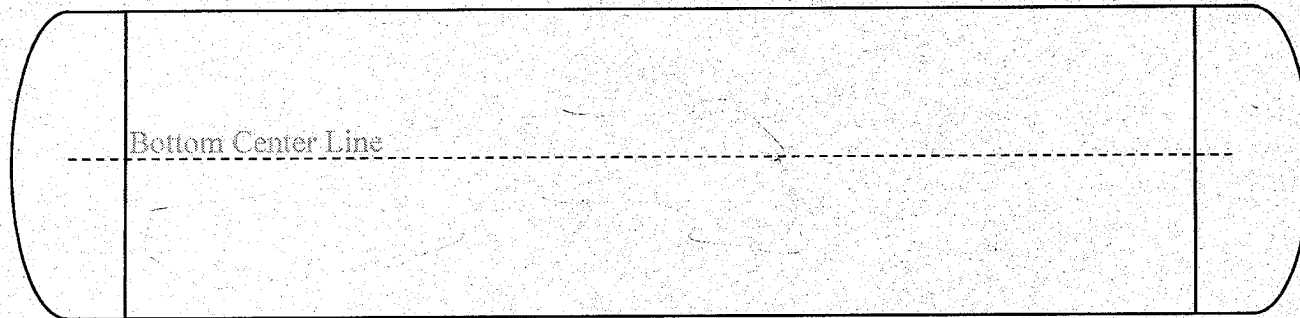
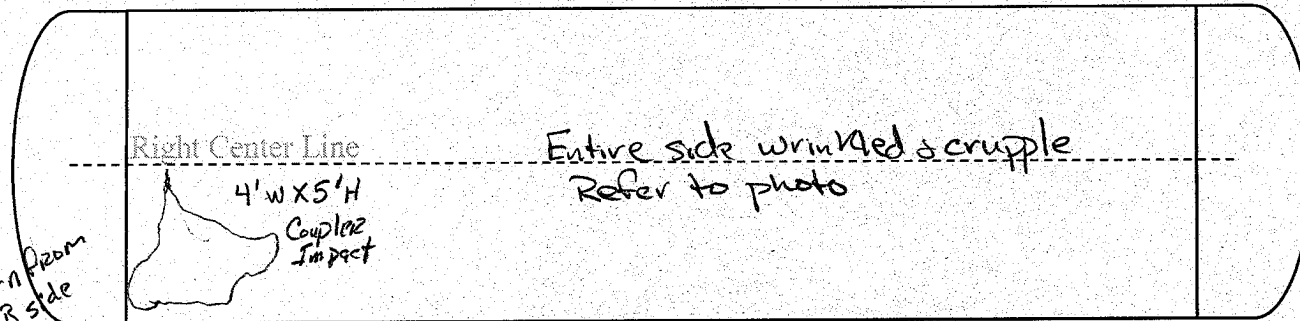
*Bad torn from tank AR side 4' in length*
