## **NATIONAL TRANSPORTATION SAFETY BOARD**

### **Attachment 12 – CLT Simulator Test**

**DCA14MA081**

## CHARLOTTE SIMULATOR WORK

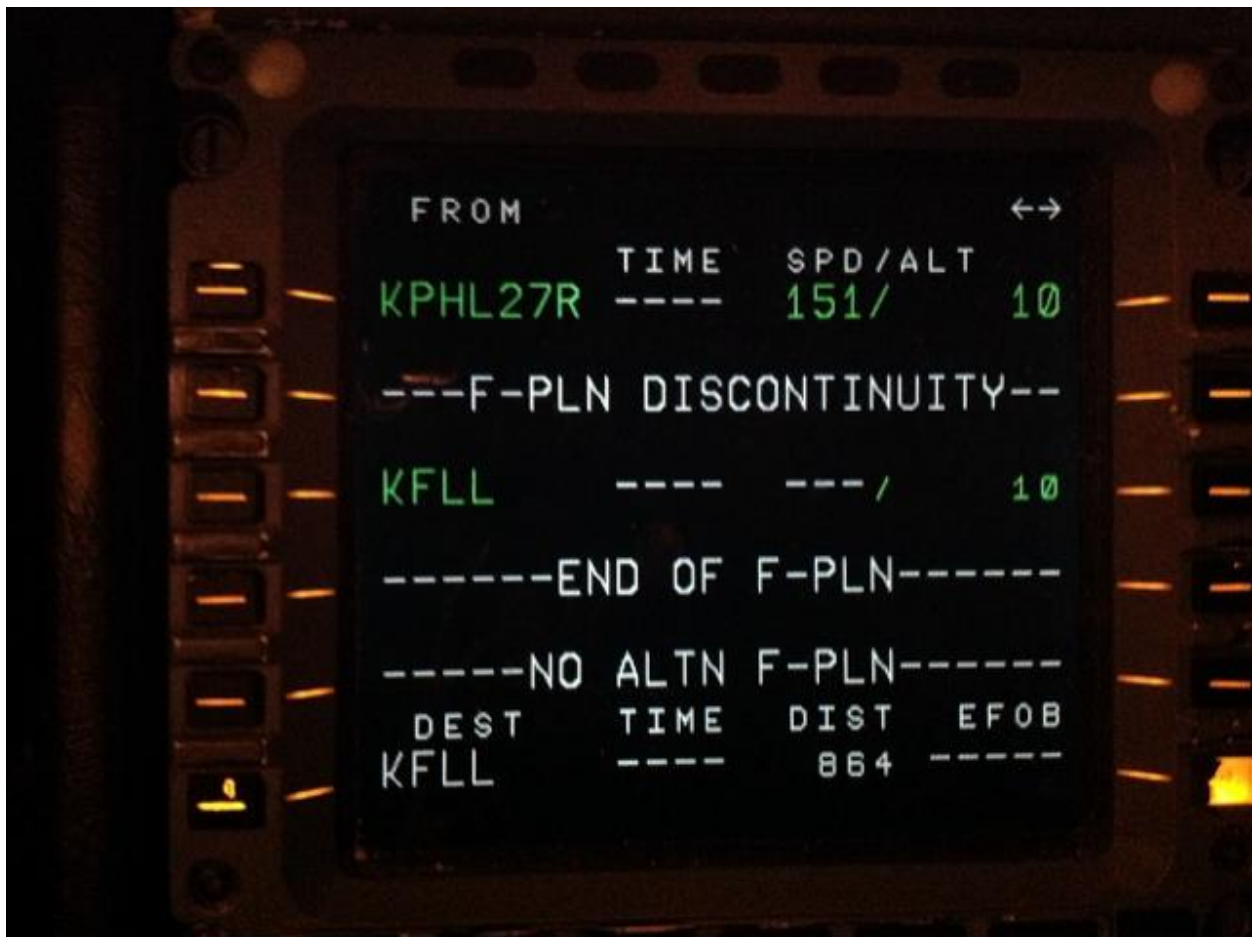
Photo 1: MCDU with PHL runway 27R inserted in the flight plan page.

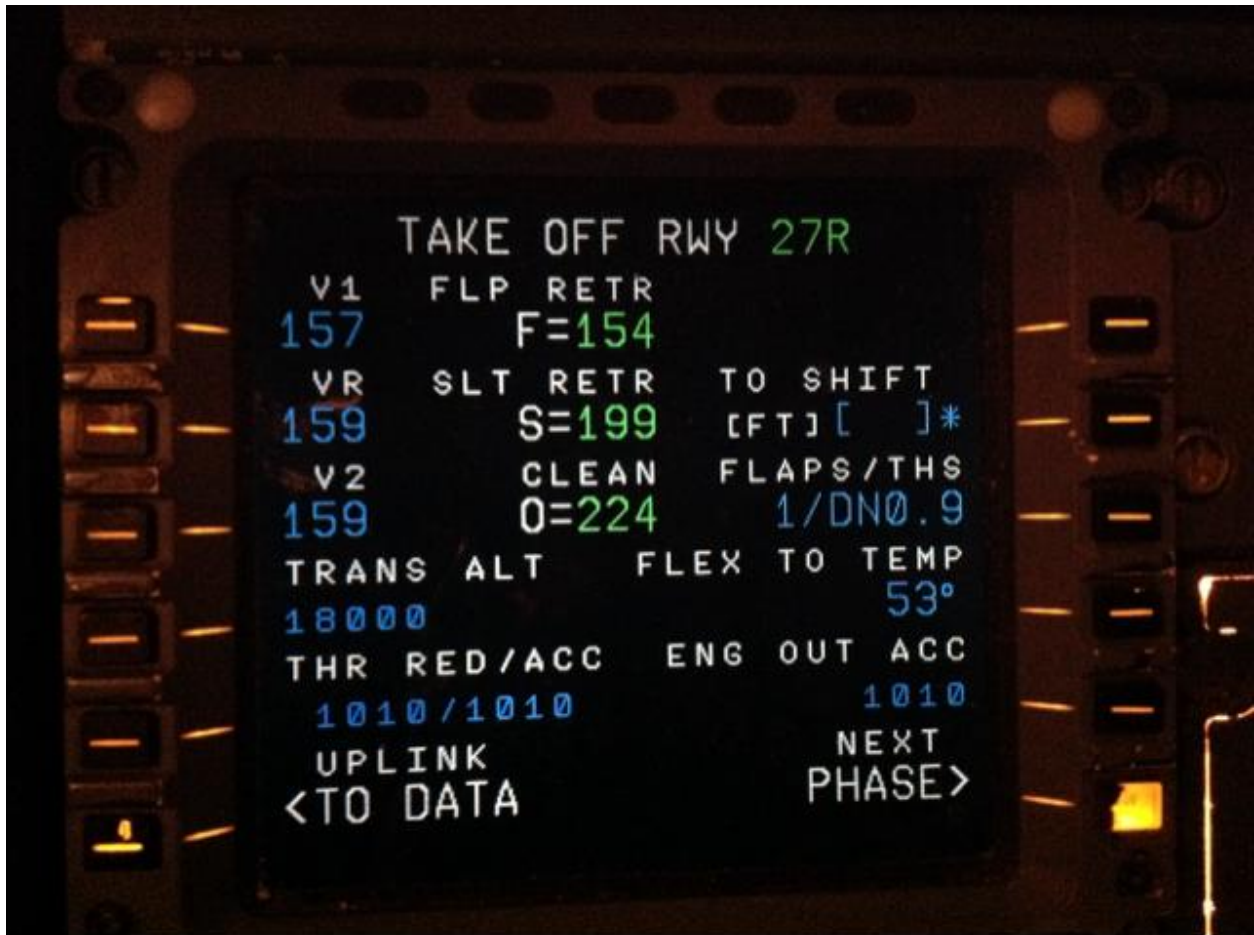
Photo 2: MCDU Takeoff page with V-speeds and Assumed Temperature inserted for PHL runway 27R.

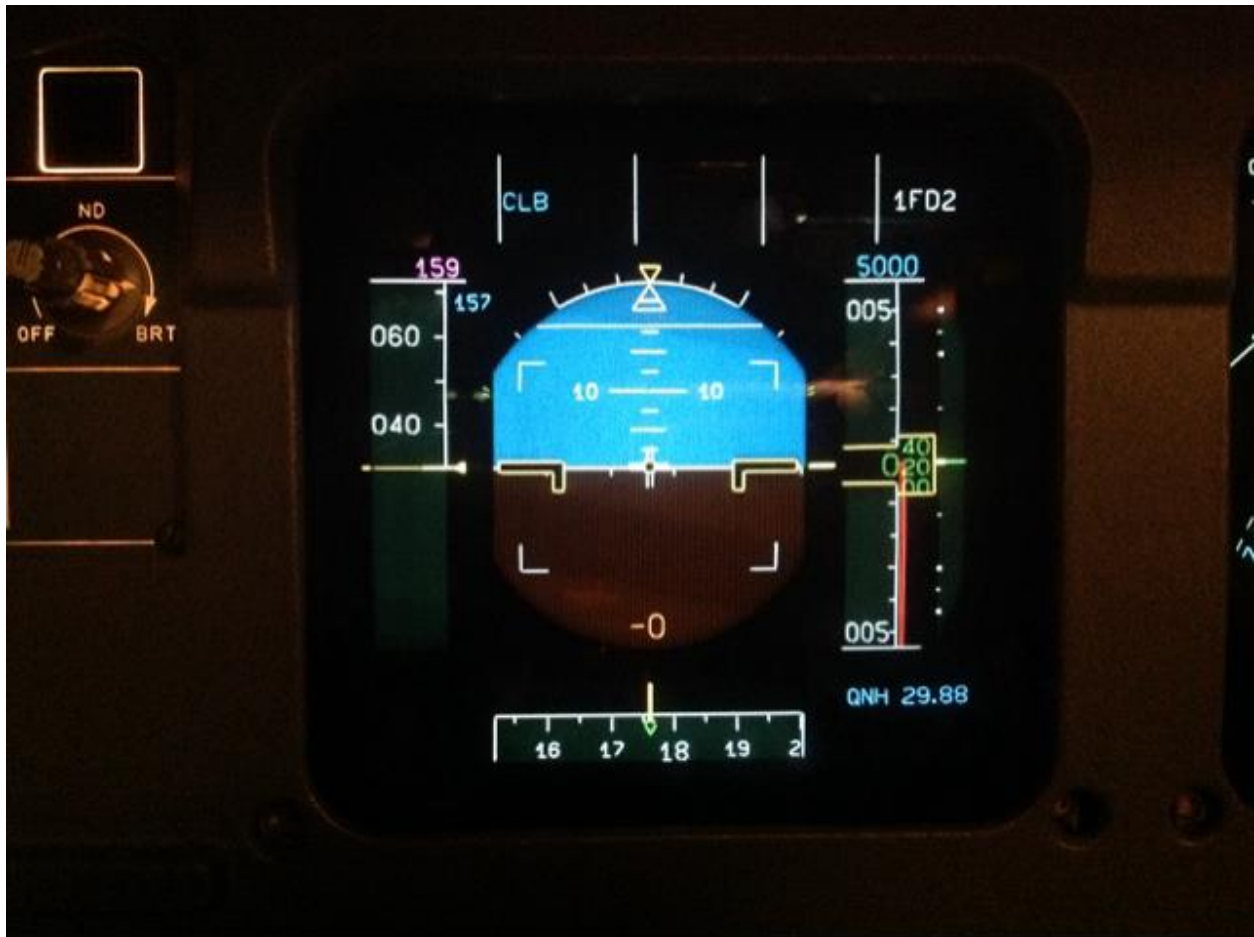
Photo 3: PFD with V-speeds inserted.

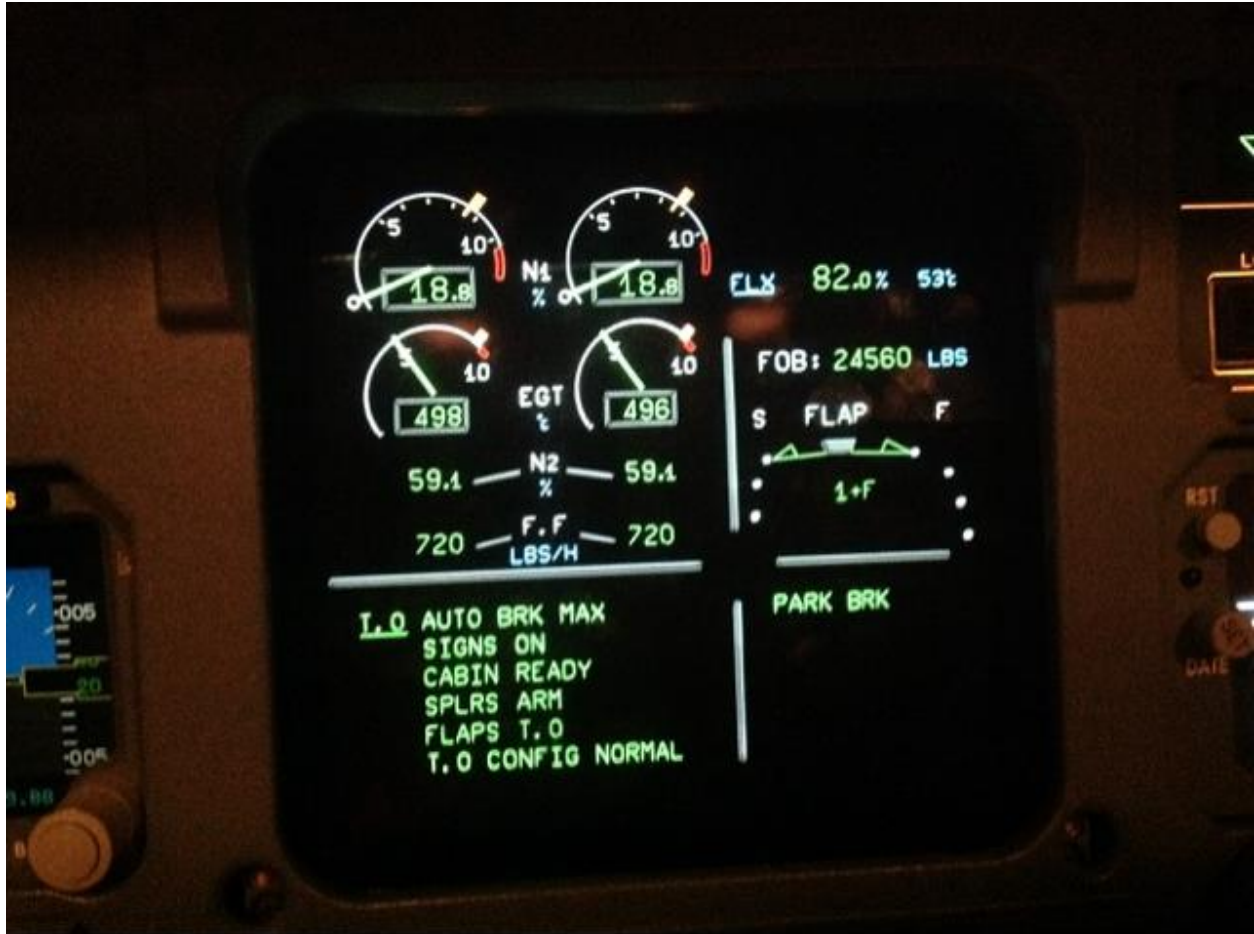
Photo 4: Upper ECAM with Assumed temperature inserted.

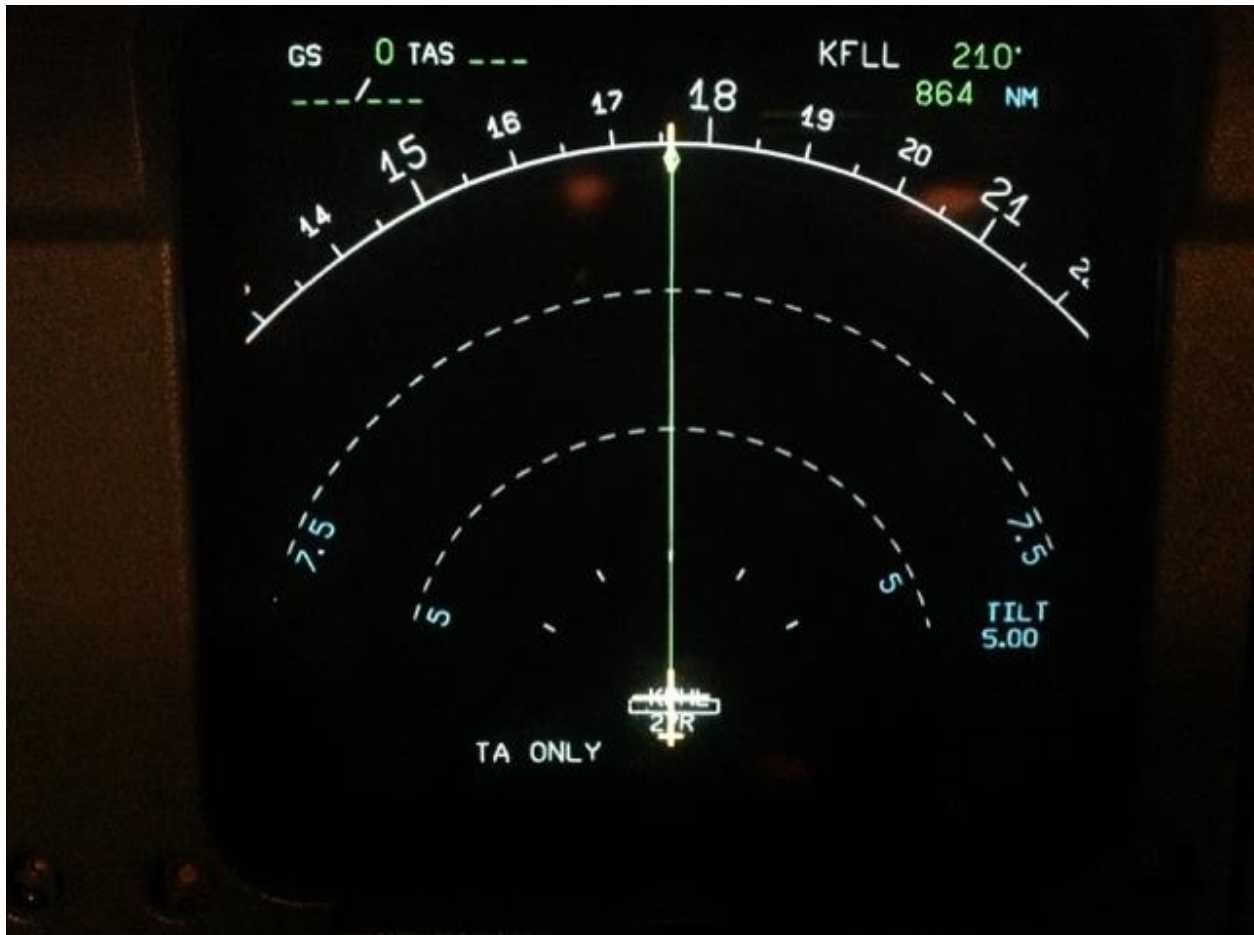
Photo 5: ND display showing PHL runway 27R

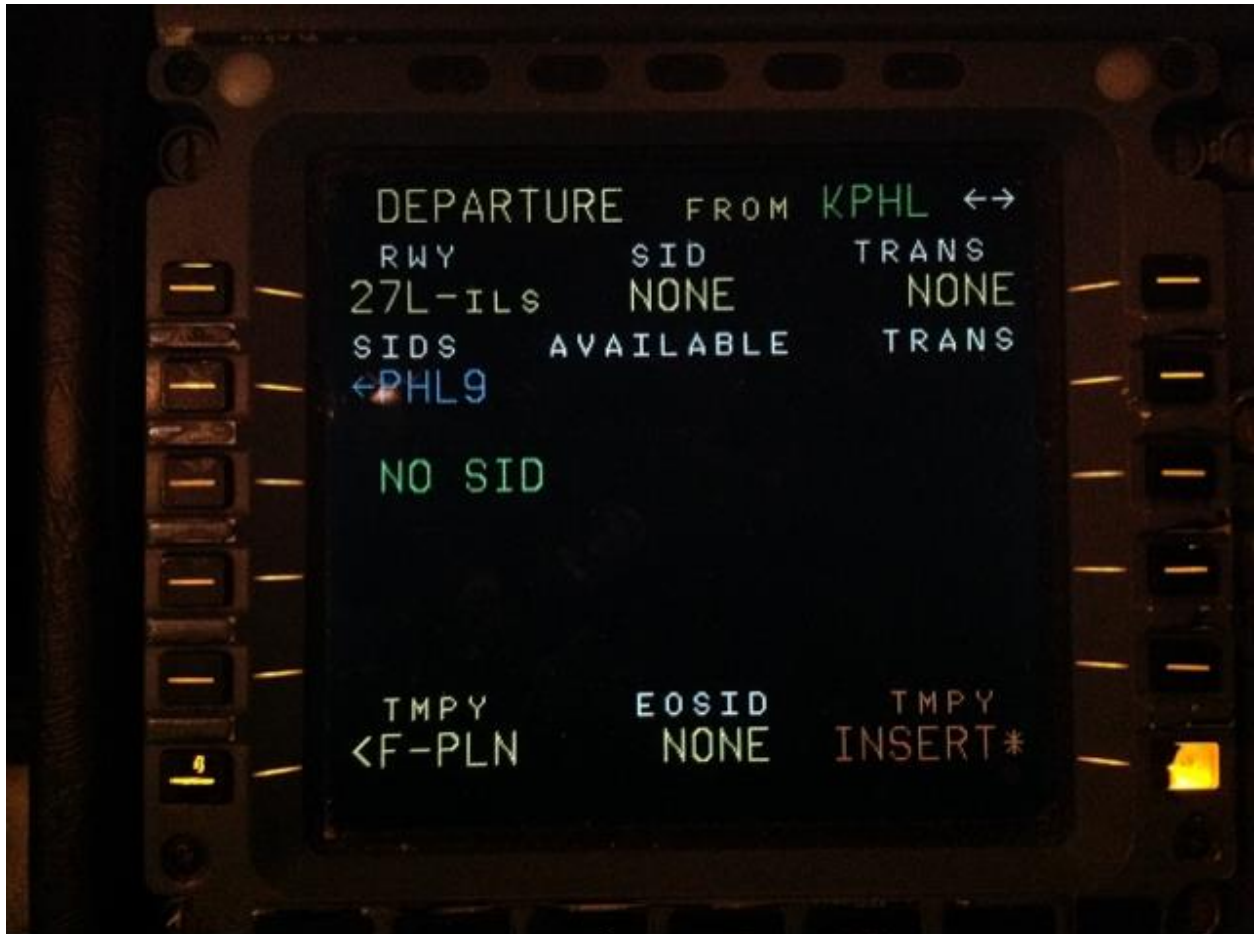
Photo 6: Insert prompt for PHL runway 27L.

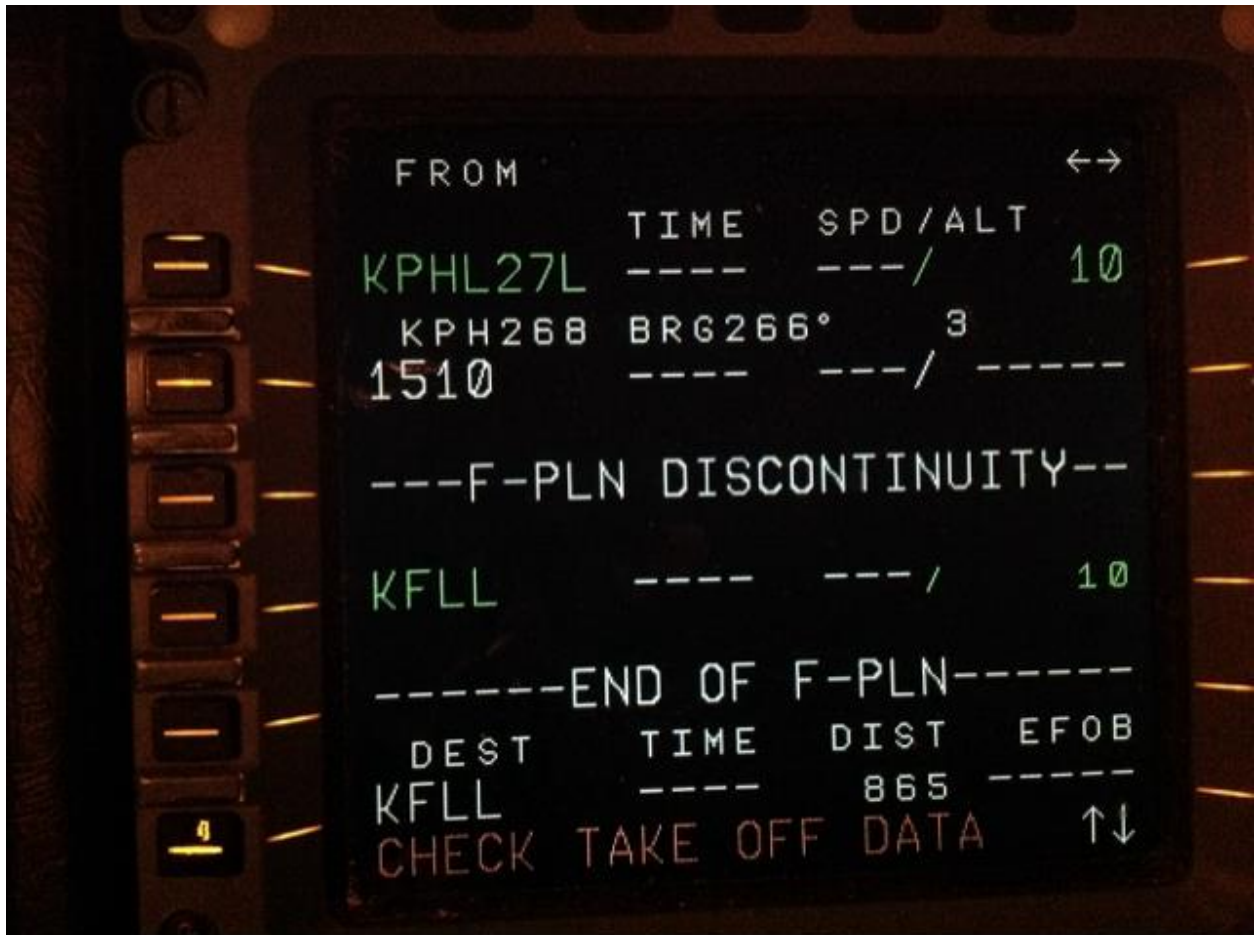
Photo 7: MCDU Takeoff page with 27L inserted and no V-speeds.

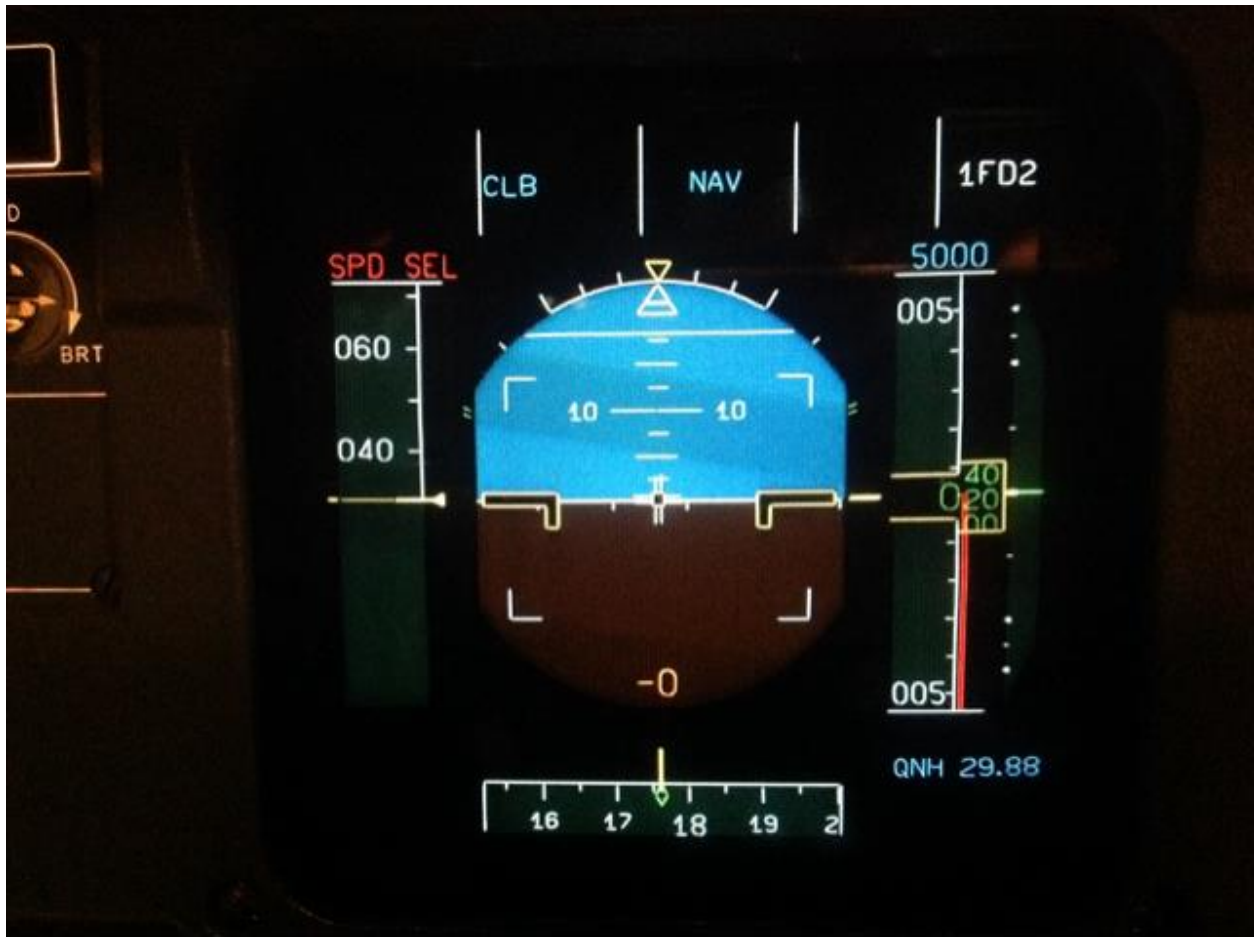
Photo 8: PFD with no V-speeds inserted.

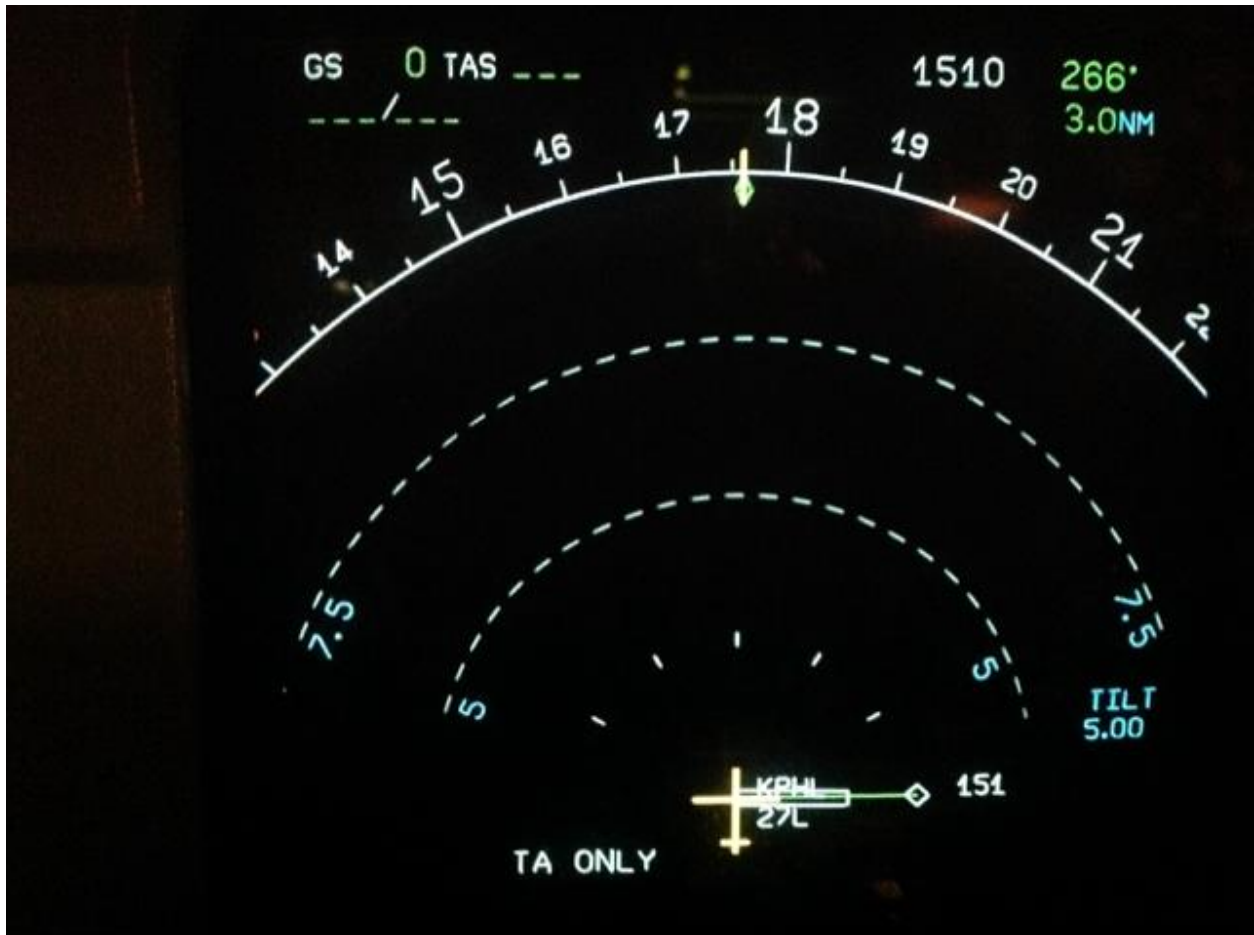
Photo 9: ND Display with 27L shown.

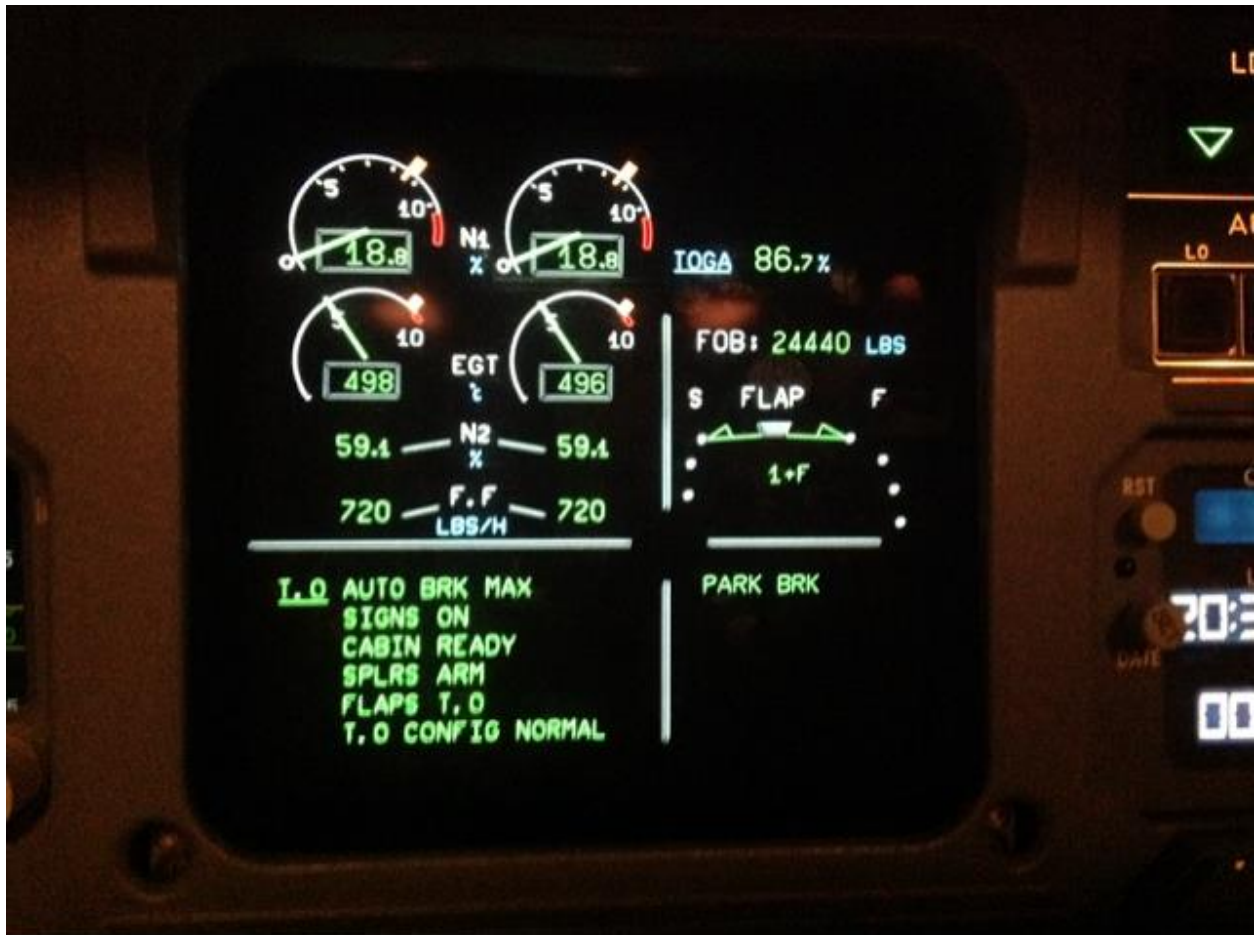
Photo 10: Upper ECAM without Assumed temperature inserted.

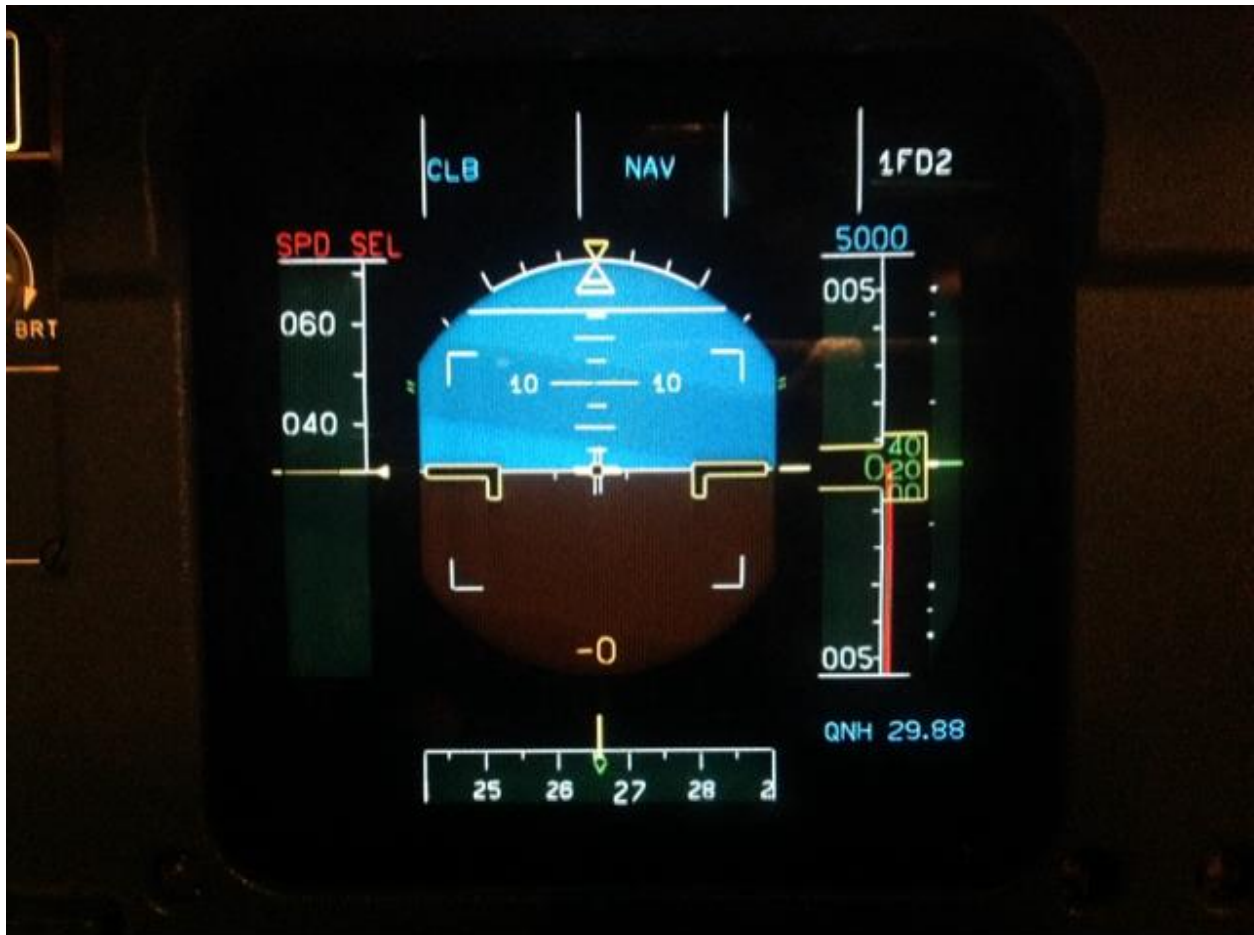
Photo 11: PFD without the V-speeds inserted.

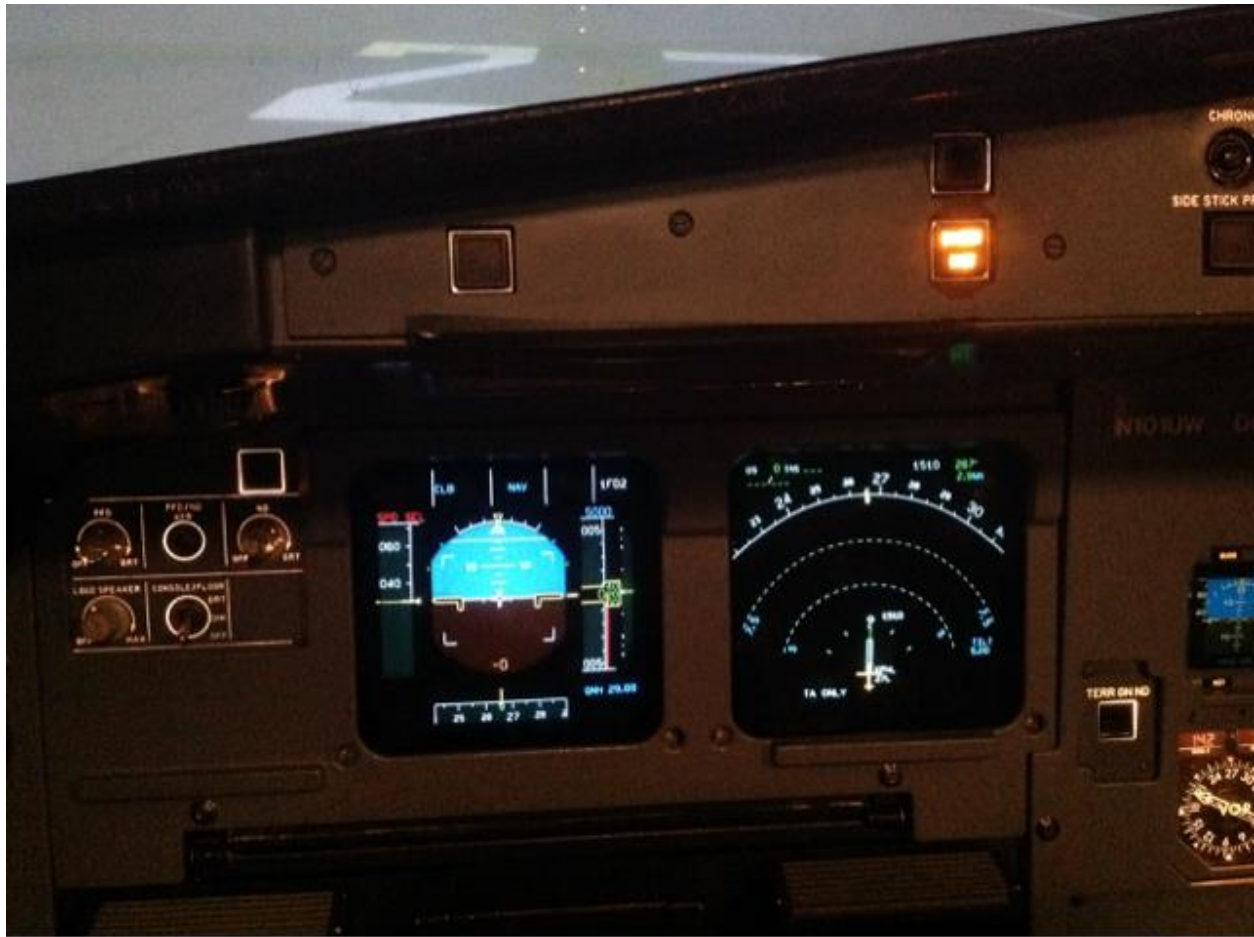
Photo 12: Forward displays (with master caution) when Flex thrust set without an assumed temperature.

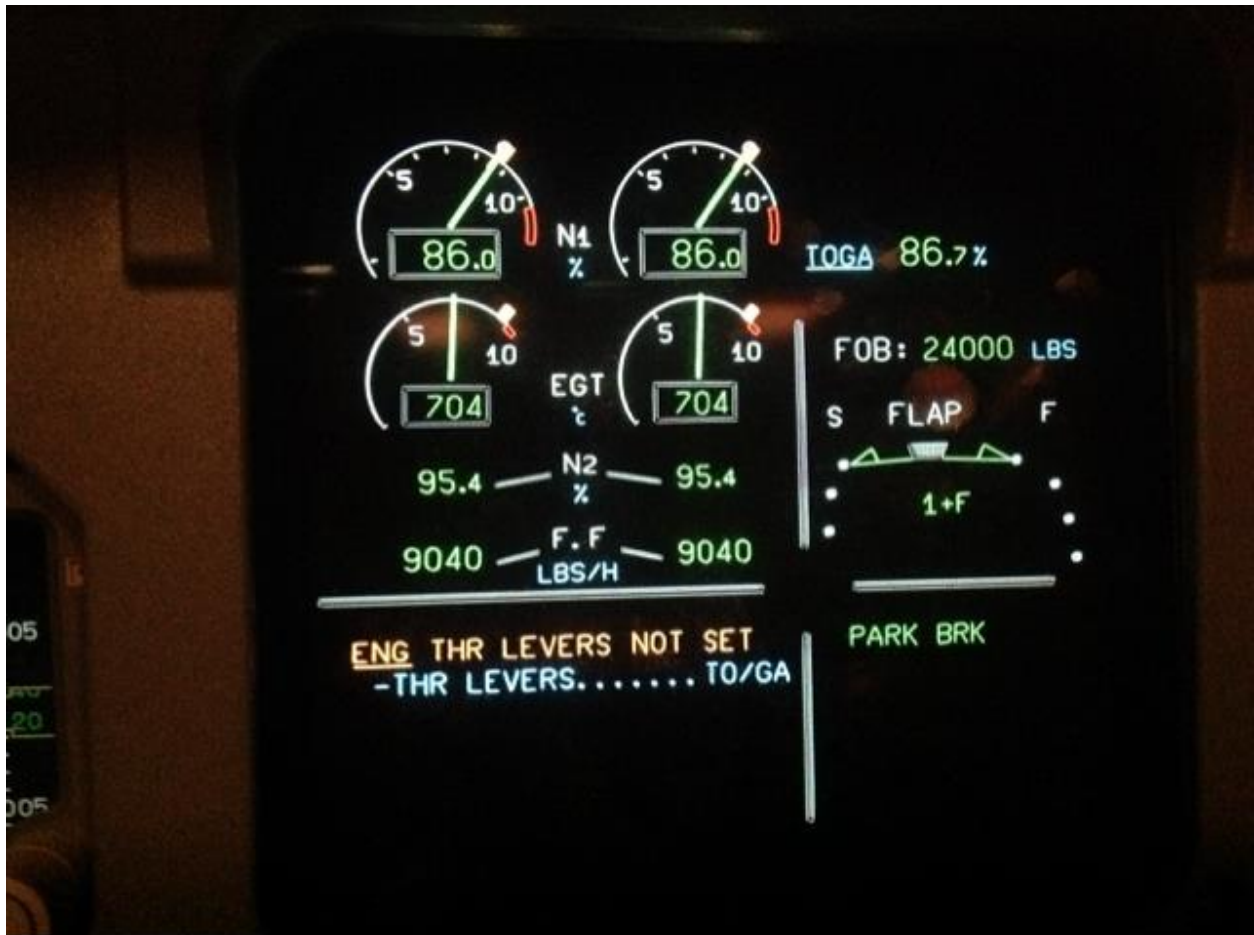
Photo 13: Upper ECAM when Flex thrust set without an assumed temperature.

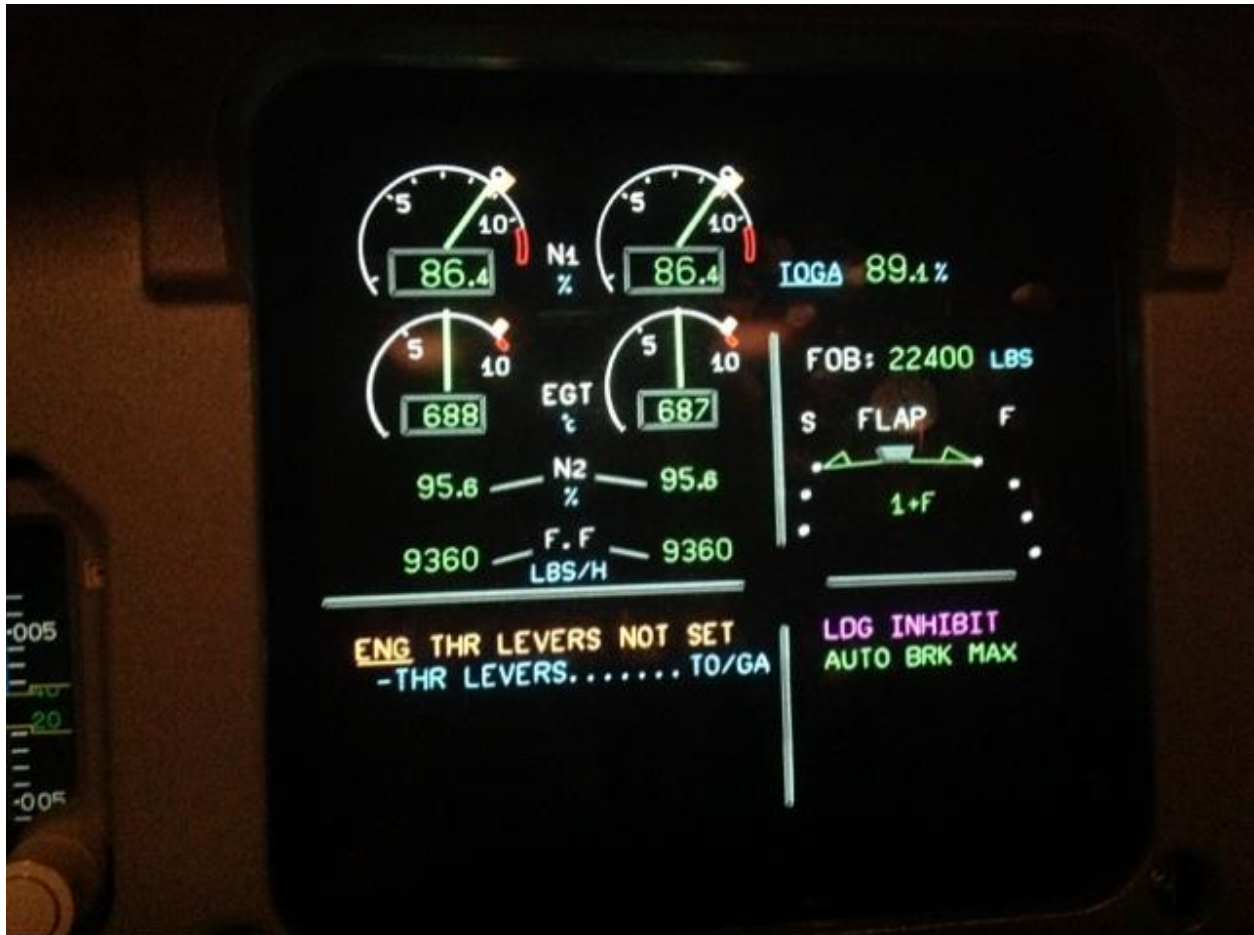
Photo 14: Upper ECAM when thrust set to Flex without assumed temperature as airplane reaches 80 knots and the “retard” aural alert sounded.
