**Download and Analysis of Four
Actuator IO Process (AIOP) Modules
from
Houma, LA
Agusta AW139 Accident Aircraft
Registration N385RH**

NTSB Identification: CEN13LA025
Accident occurred October 22, 2103 near Houma, LA
Aircraft: Agusta AW139, Registration: N385RH

Actuator IO Processor (AIOP) Investigation

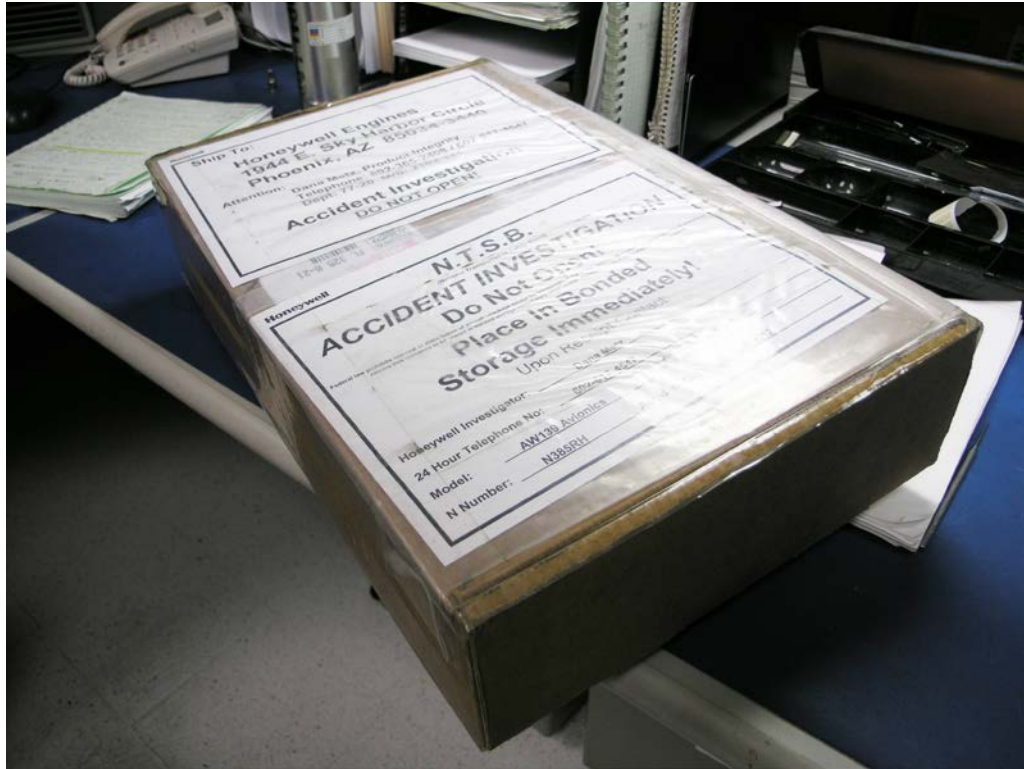
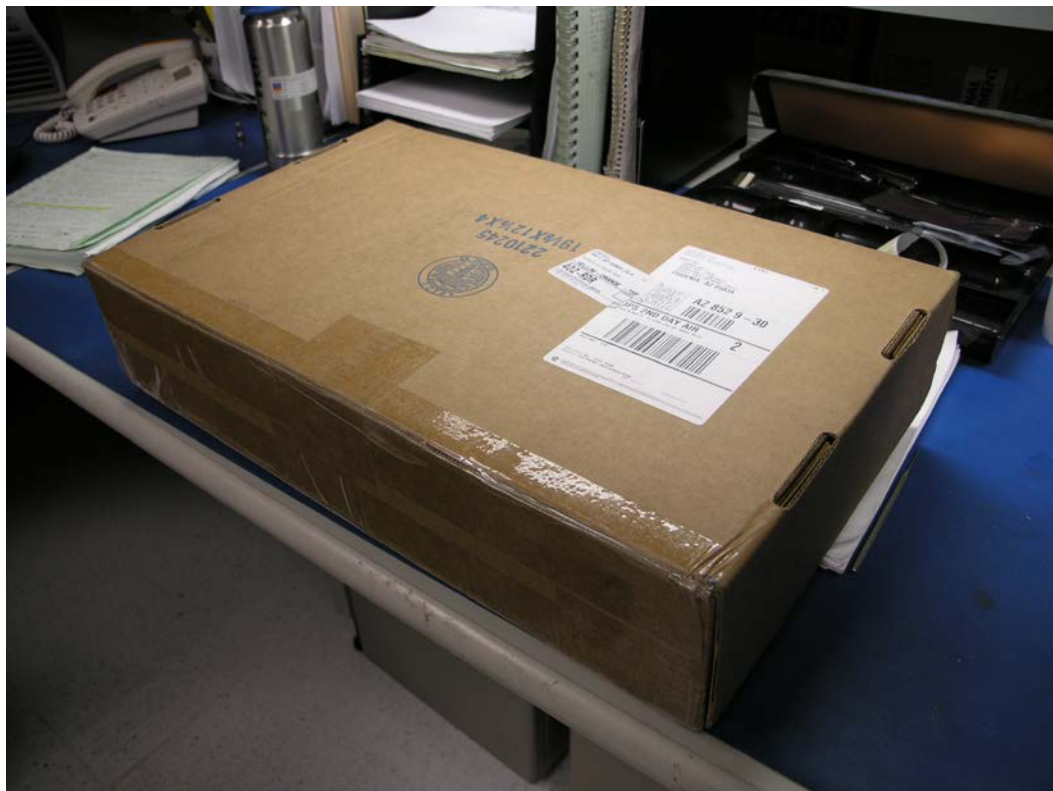
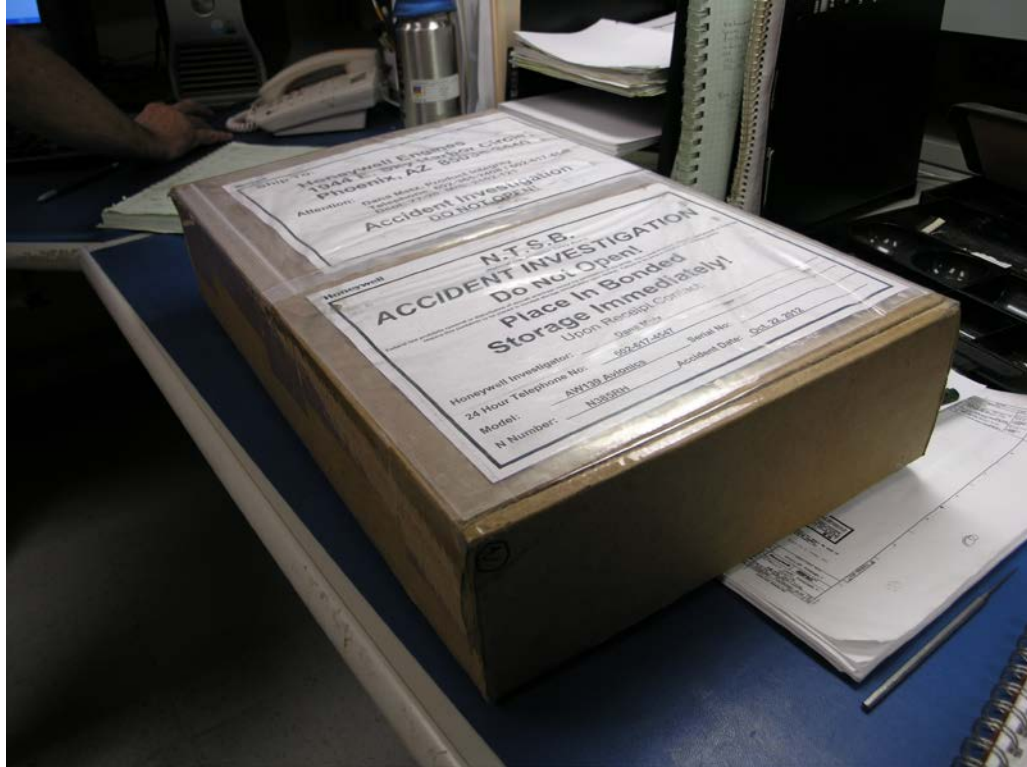
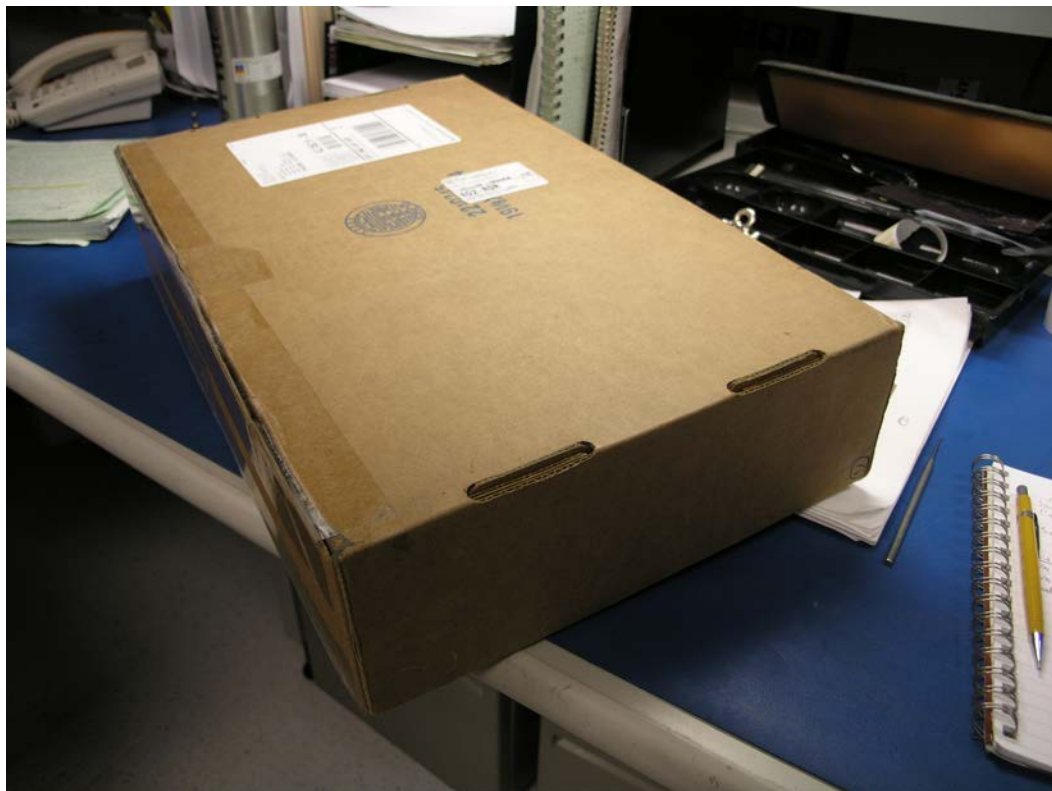
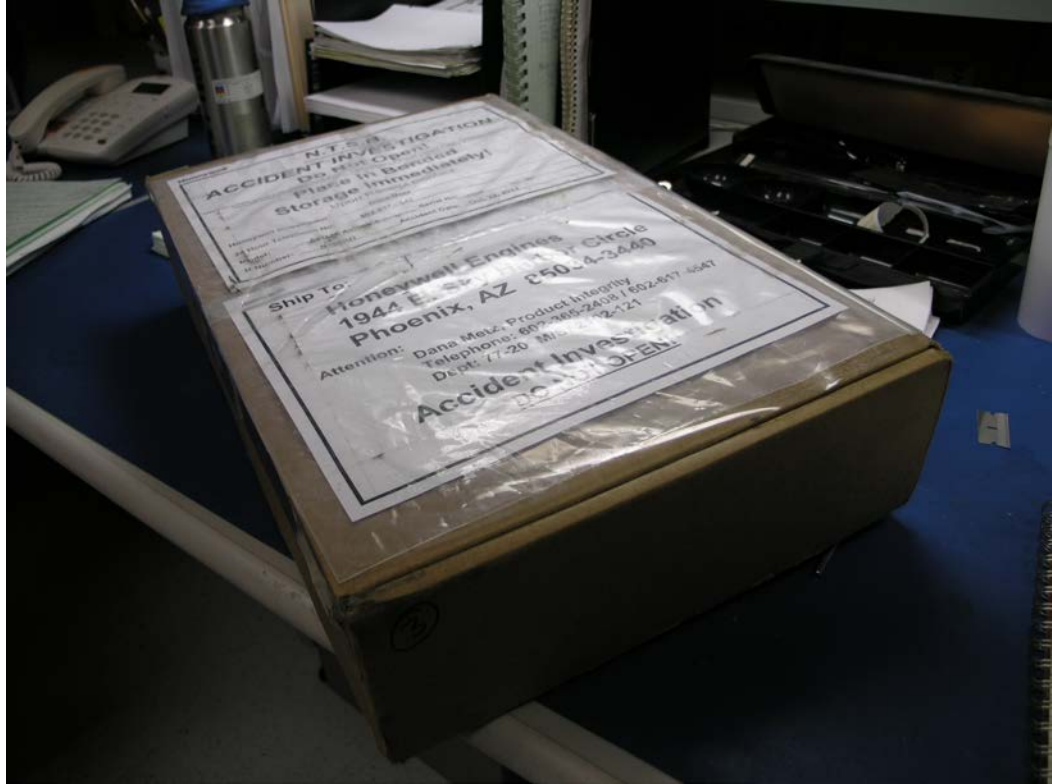
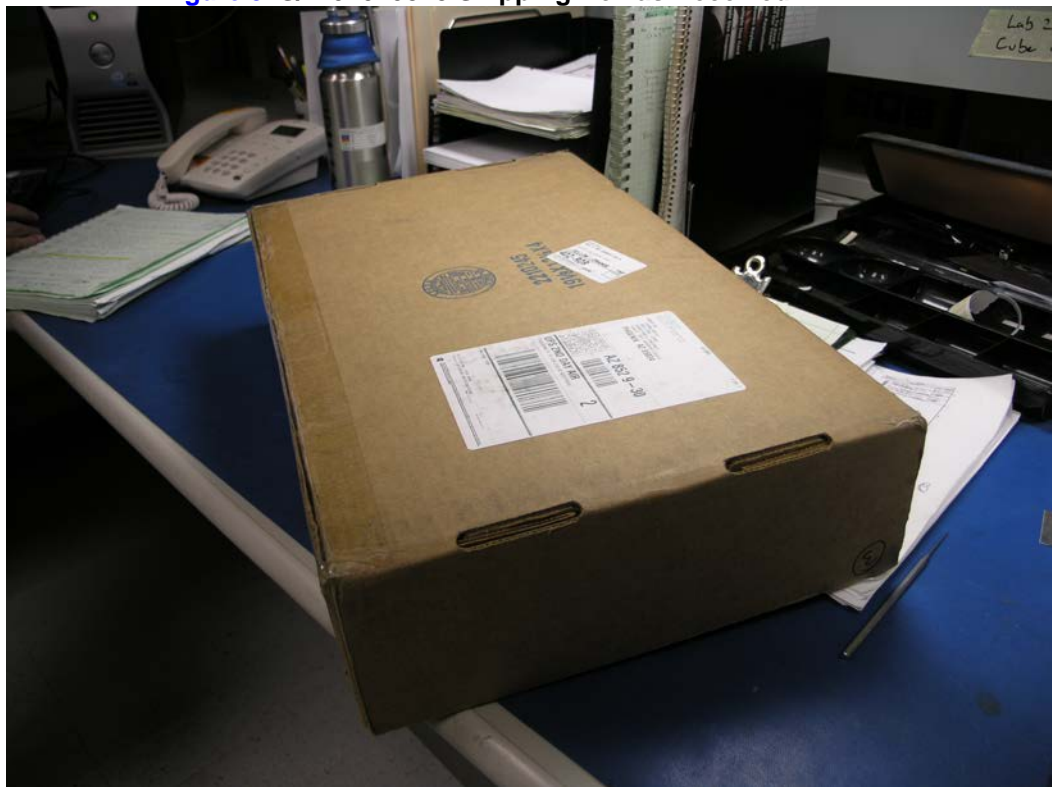
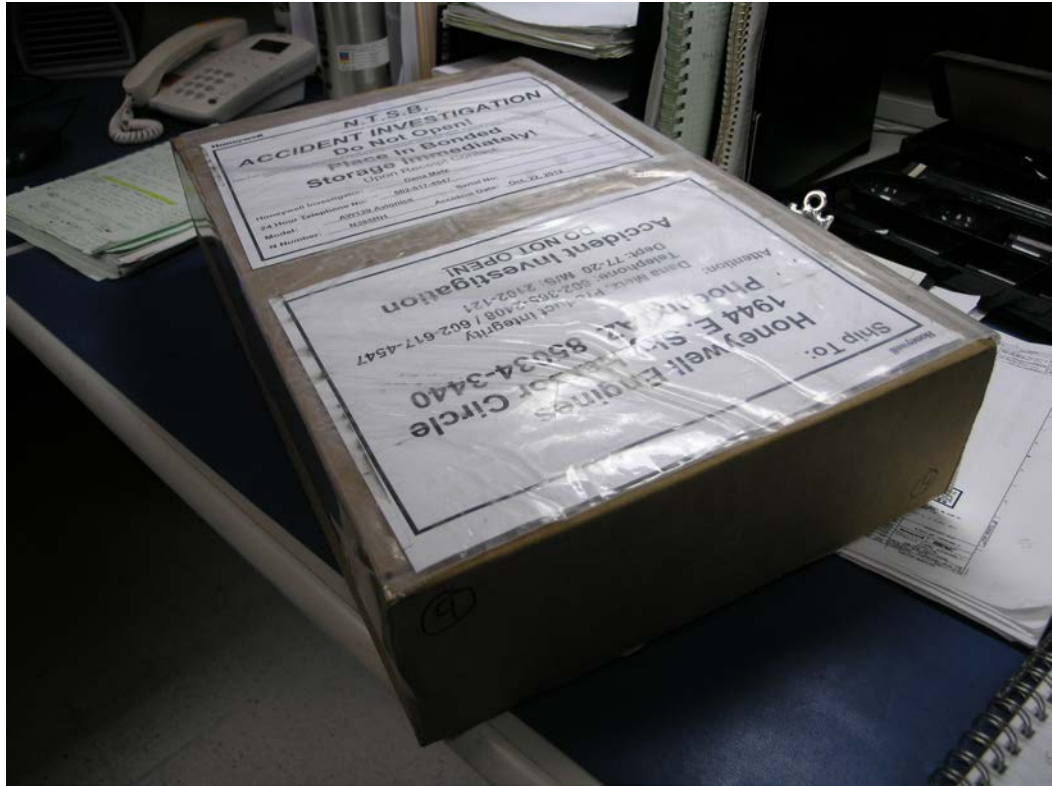
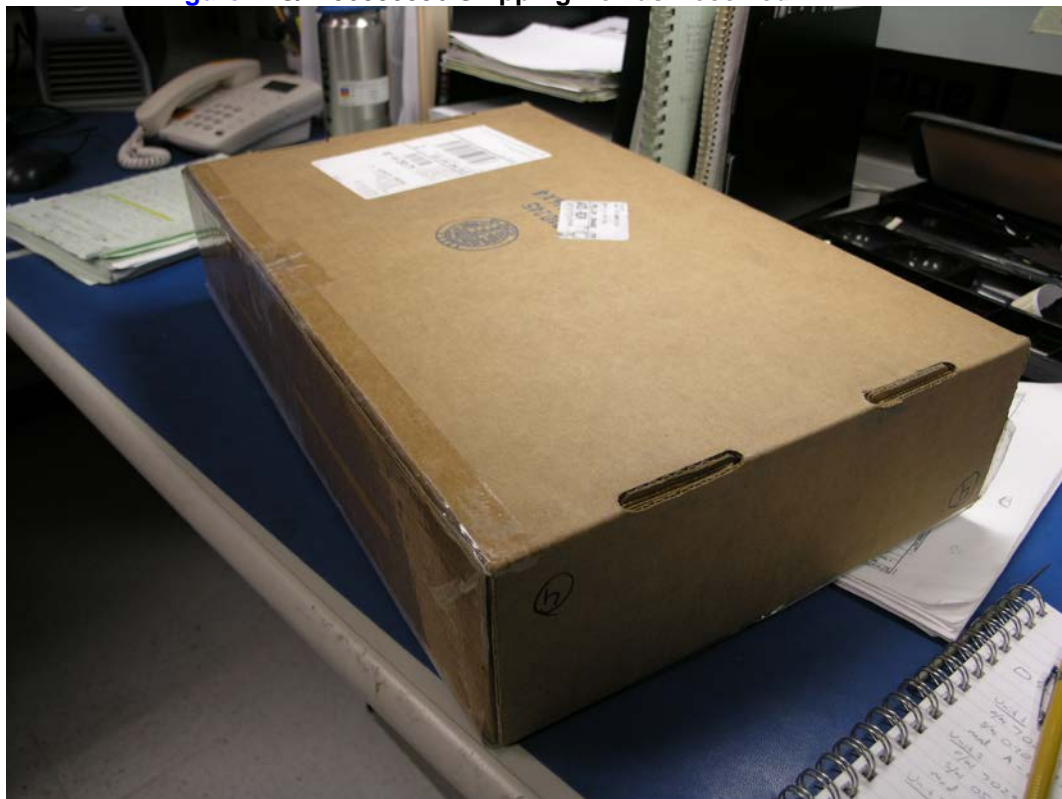
- The units were packaged in standard EPIC module shipping boxes. ([Figure 1](#) through [Figure 8](#))
- The shipping boxes appeared to be unopened and undamaged.
- After opening the shipping boxes, the AIOPs were found packaged within a standard Electro Static Discharge (ESD) safe bag. ([Figure 9](#) through [Figure 12](#))
- The AIOP modules appeared to be undamaged. ([Figure 13](#) through [Figure 20](#))
- One of the AIOP data plates identified the following information: ([Figure 21](#) and [Figure 22](#))
 - P/N: 7029194-1901
 - S/N: 07010735
 - Mod Status: A through L
- Another of the AIOP data plates identified the following information: ([Figure 23](#) and [Figure 24](#))
 - P/N: 7029194-1901
 - S/N: 05100394

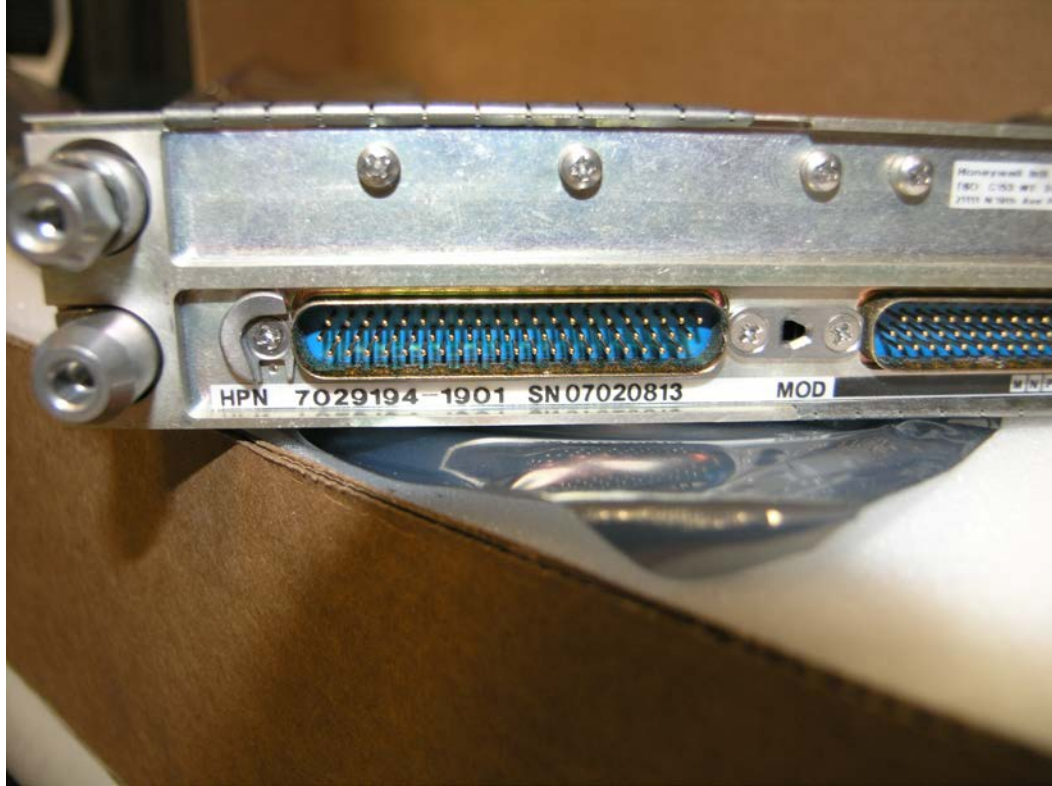
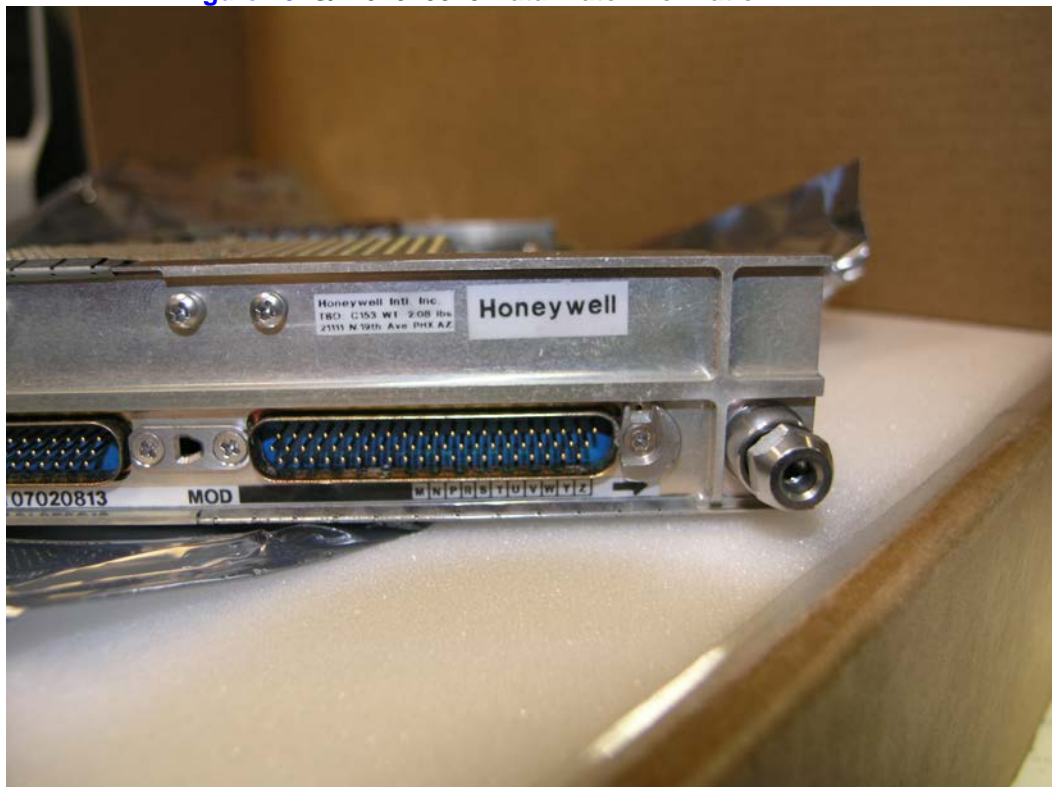
Figure 25. S/N 07020813 Data Plate Information

- Mod Status: A through L
- Another of the AIOB data plates identified the following information: (Figure 25 and Figure 26)
 - P/N: 7029194-1901
 - S/N: 07020813

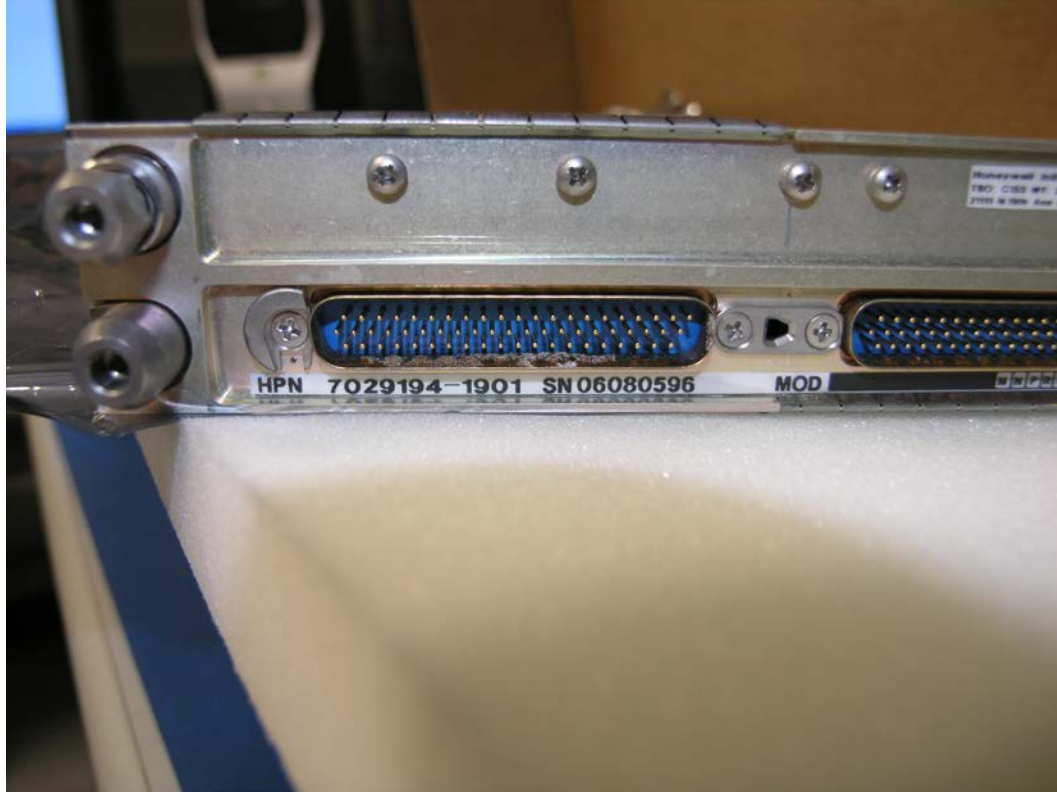
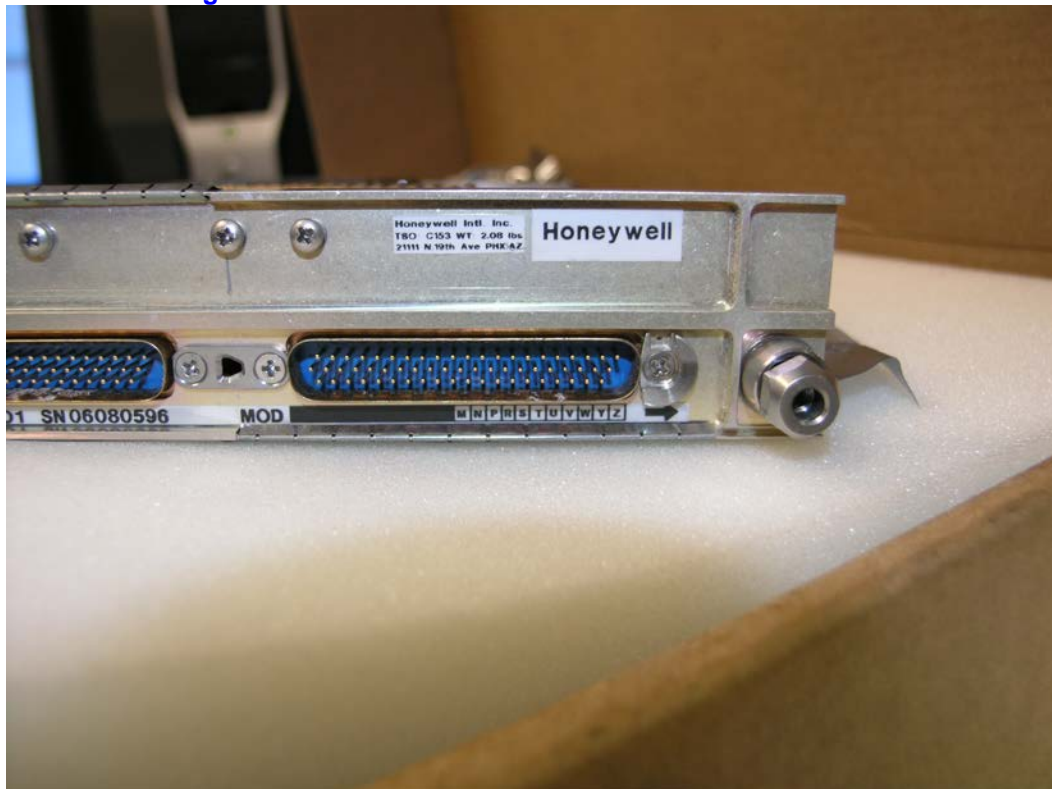
Figure 27. S/N 06080596 Data Plate Information

- Mod Status: A through L
- Another of the AIOB data plates identified the following information: (Figure 27 and Figure 28)
 - P/N: 7029194-1901
 - S/N: 06080596

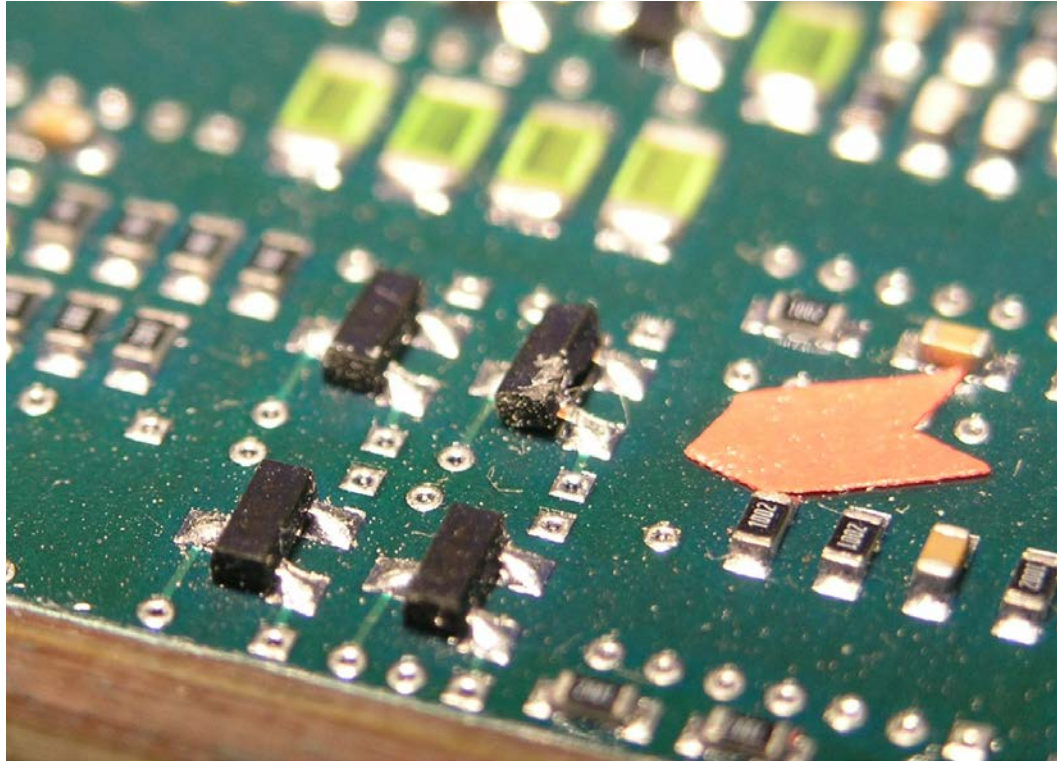
- A full Automated Acceptance Test Procedure (ATP) was run on each module. All modules passed ATP with the exception of S/N 07020813 which failed one test. An analysis of the failure led the team to identify a damaged diode (Figure 31) on the circuit card that is used in a 3.3V pull down circuit. This circuit is only used for ATP testing and has no impact on the functionality of the software.

Figure 31. SN 07020813 With Damaged Diode

- As a final check, the S/N 07020813 was reloaded with the TSO’d functional software and placed back onto the system bench. It powered up properly and behaved as expected.
