# ATTACHMENT 4

SYSTEMS GROUP CHAIRMAN'S FACTUAL  
REPORT

CEN17FA168

Non-destructive Evaluation of the KMH-820 Computer  
U28 Memory Chip

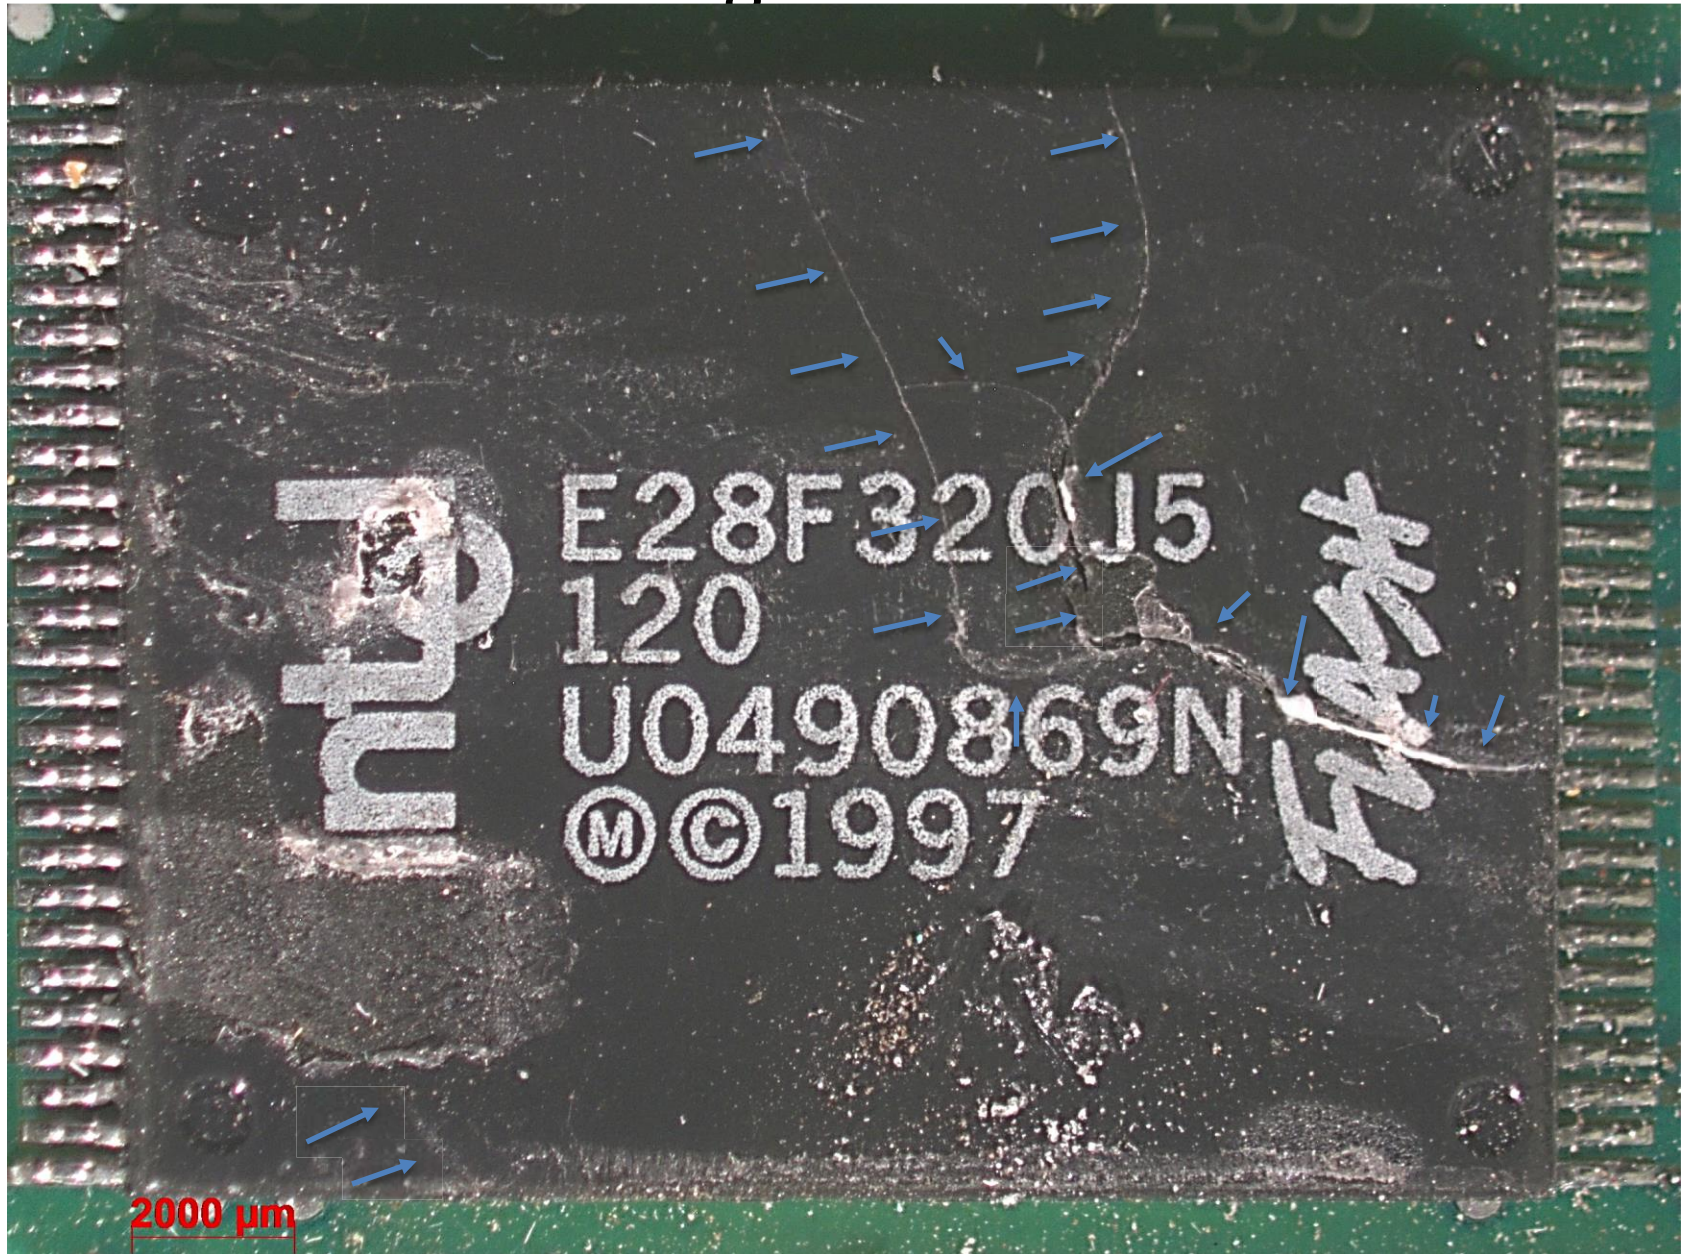
Optical image of the U28 memory package showing surface cracks

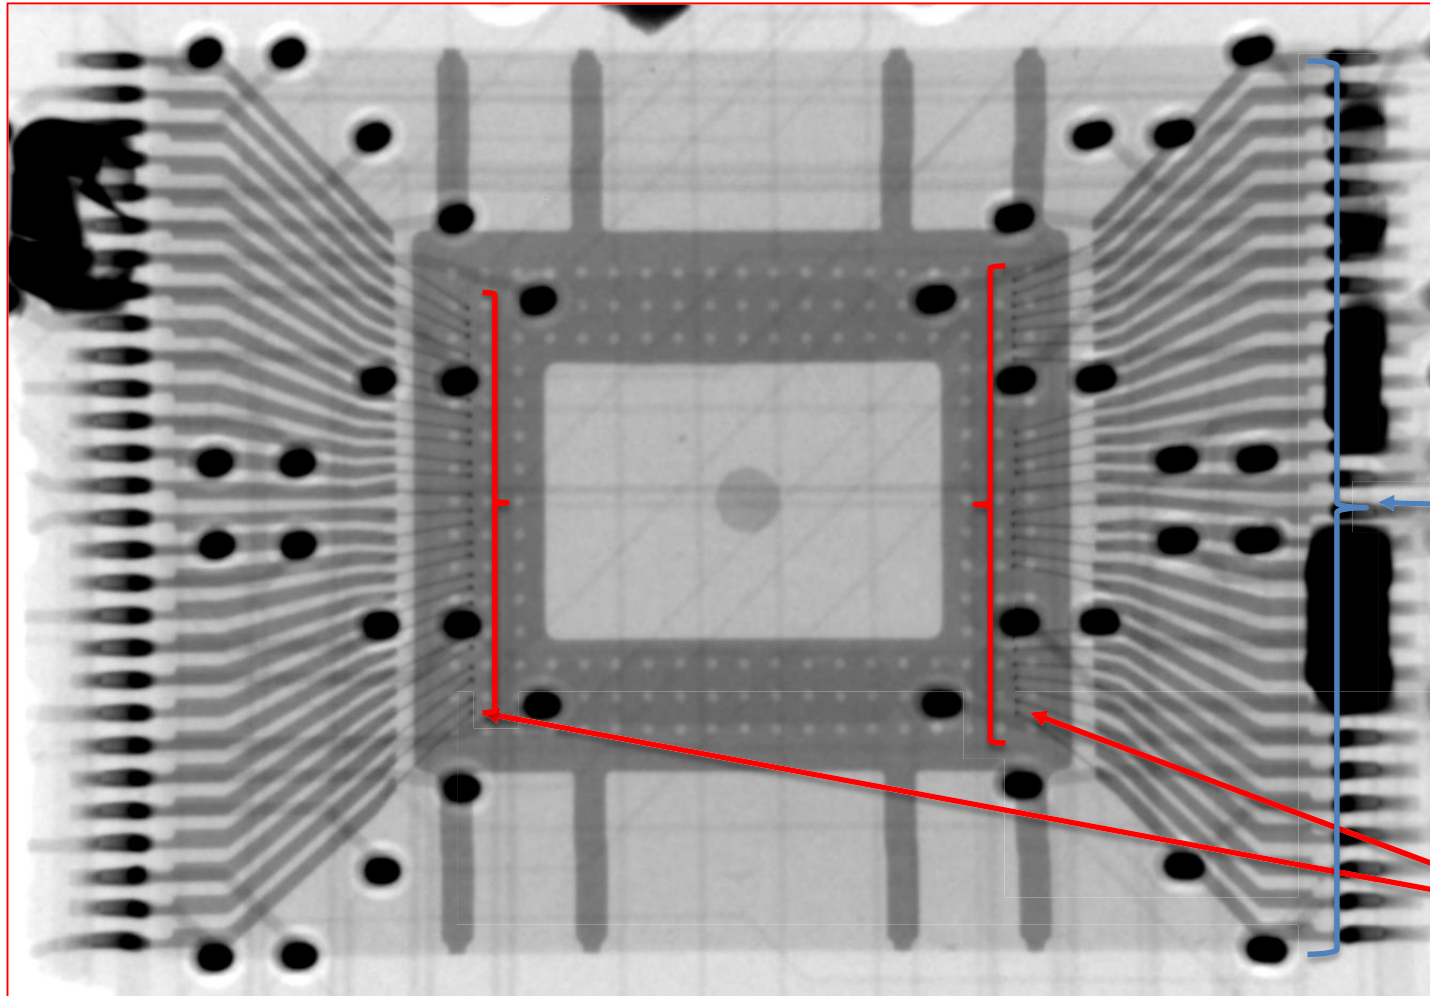
# X-ray image

The package contains wire bonded Si die

Wire bonds near the two edges of the die

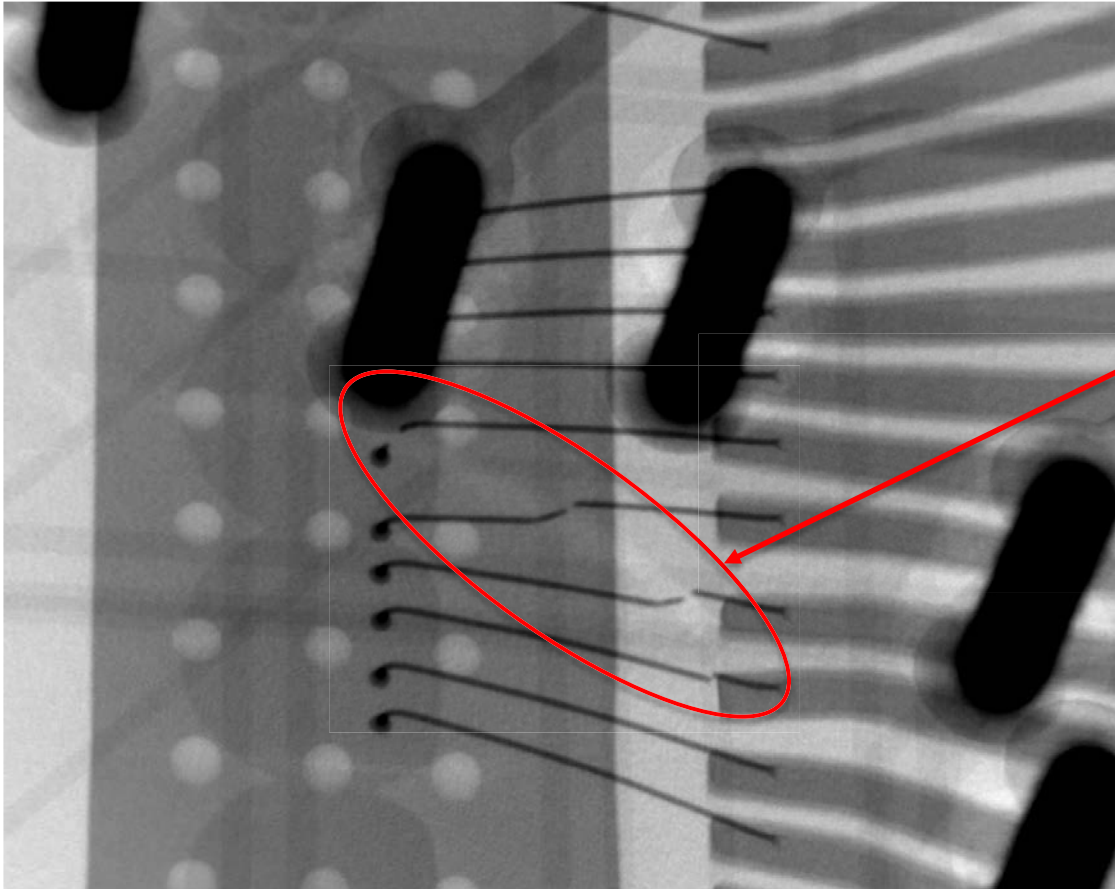
# X-ray image

Broken wire bonds along a crack line

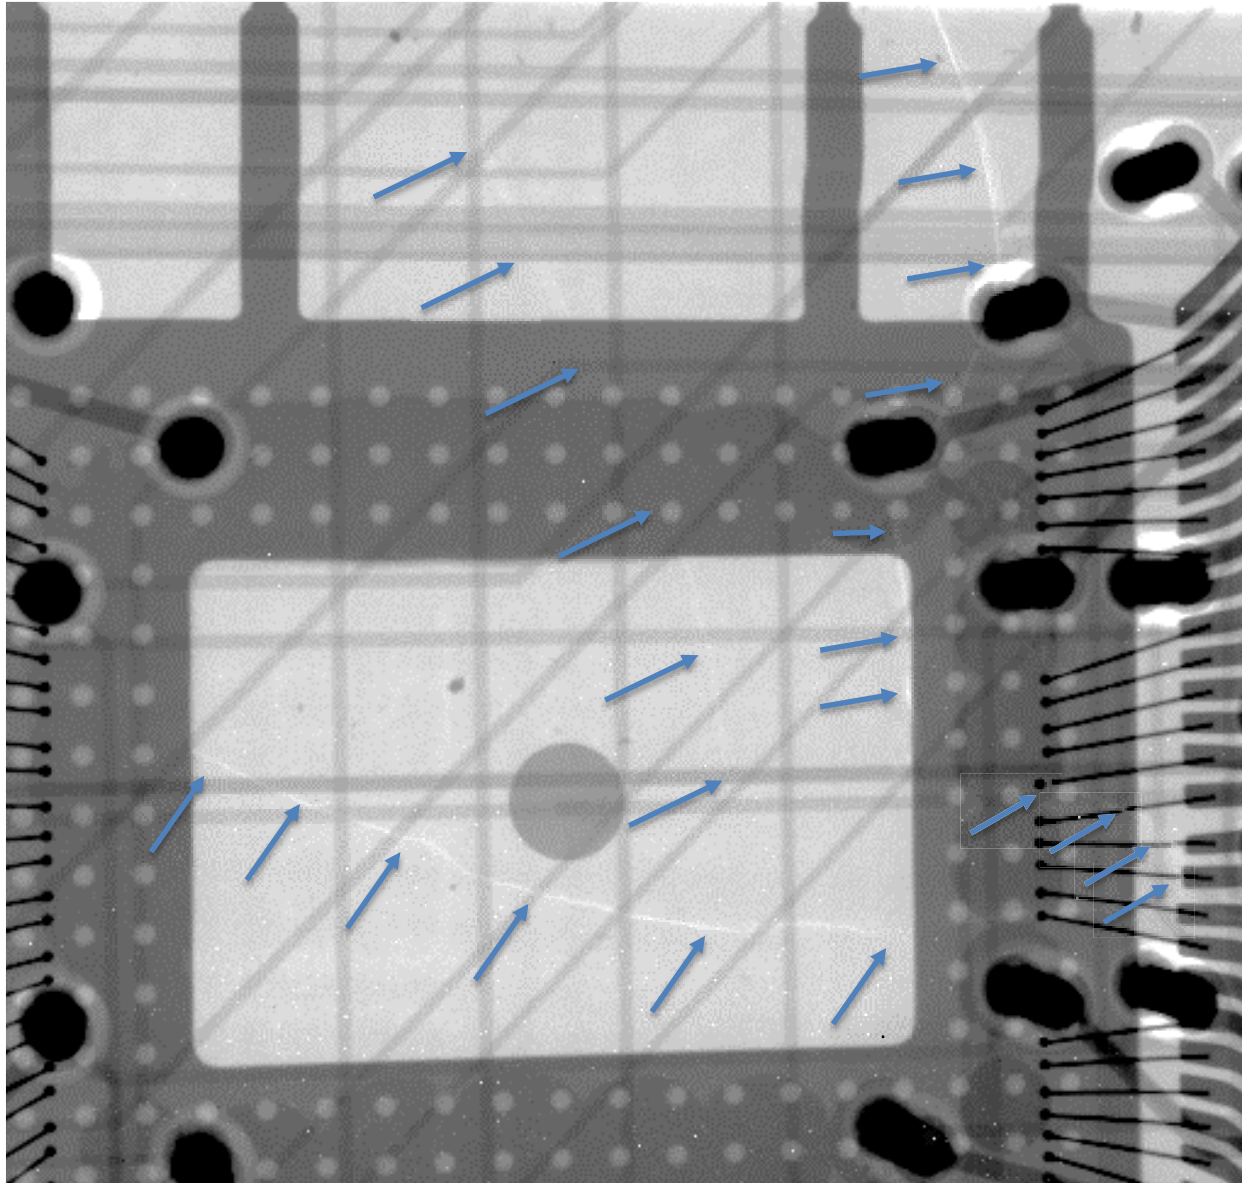
# Multiple Cracks in the memory package and possibly the silicon die

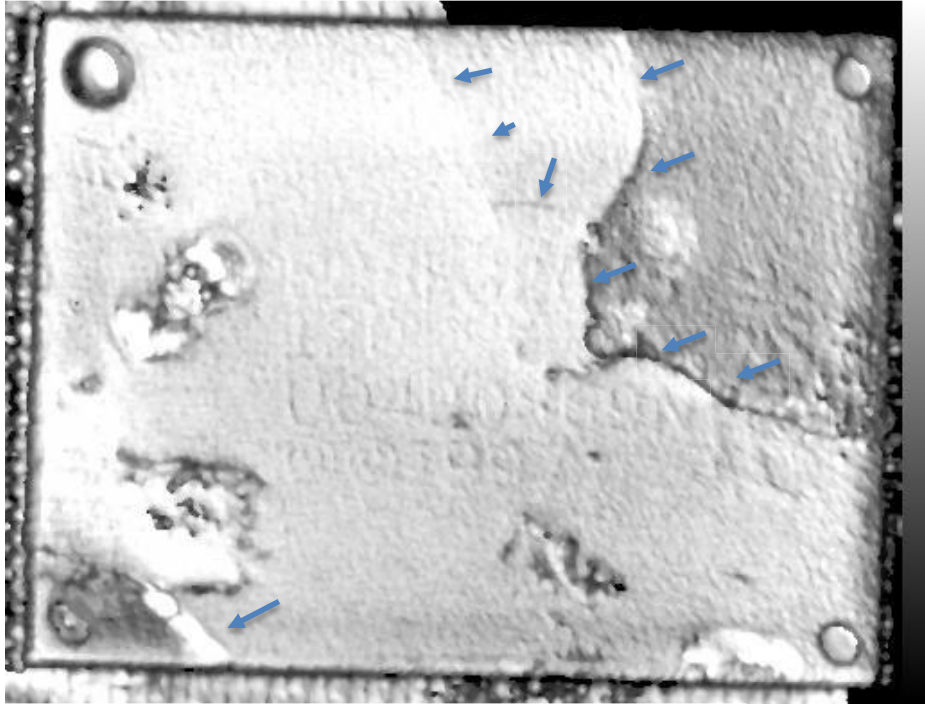
Acoustic image of the memory package top surface showing package surface cracks

Cracks or shadows of cracks from upper layer

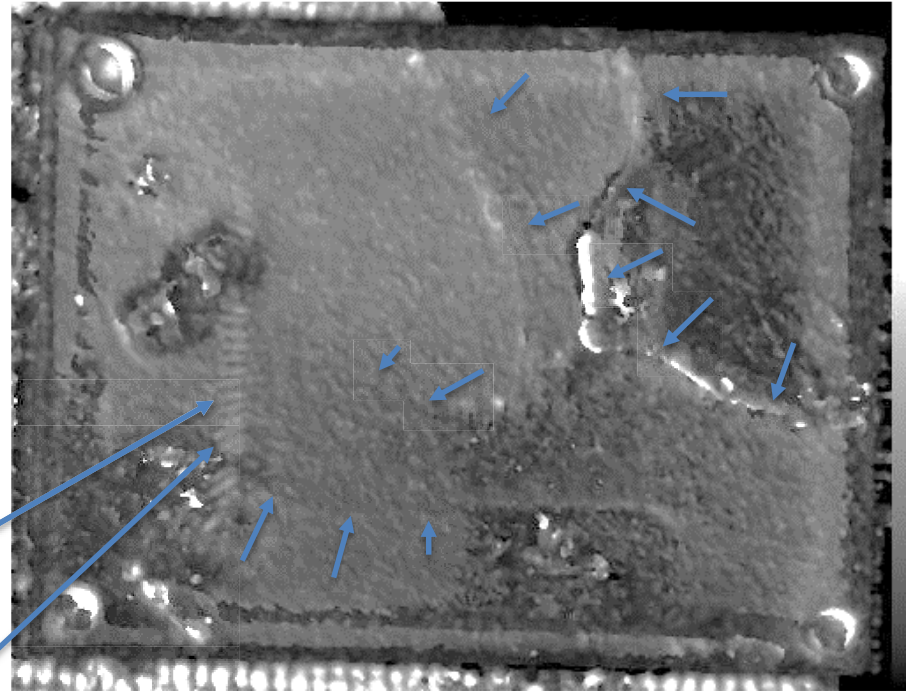
Wire bonds embedded within the mold

Acoustic image from within the package mold

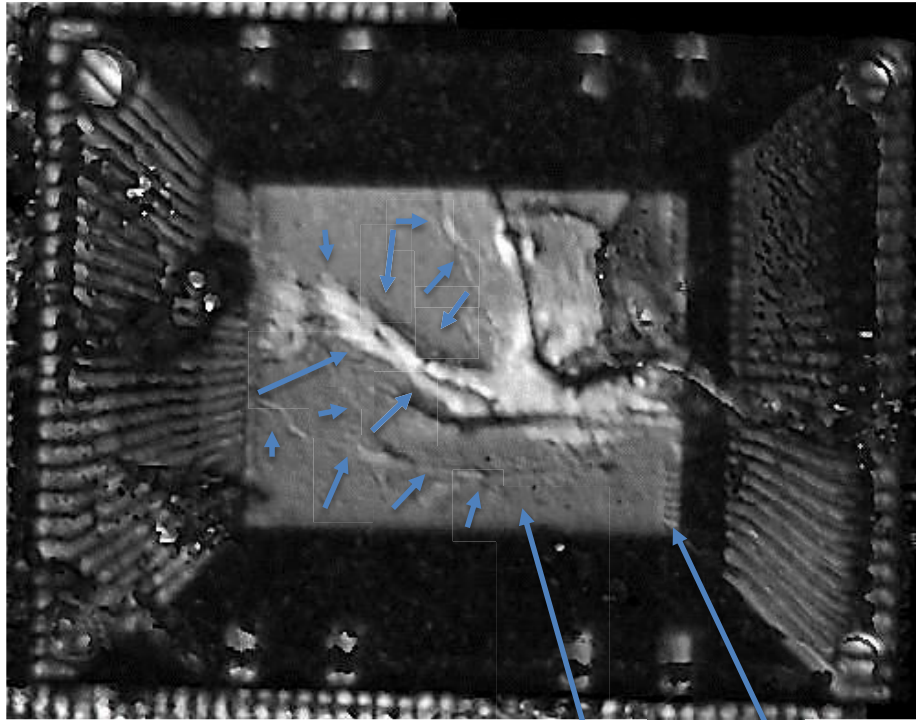
Die top      Wire bonds

Acoustic image from die surface showing severe cracks in the die

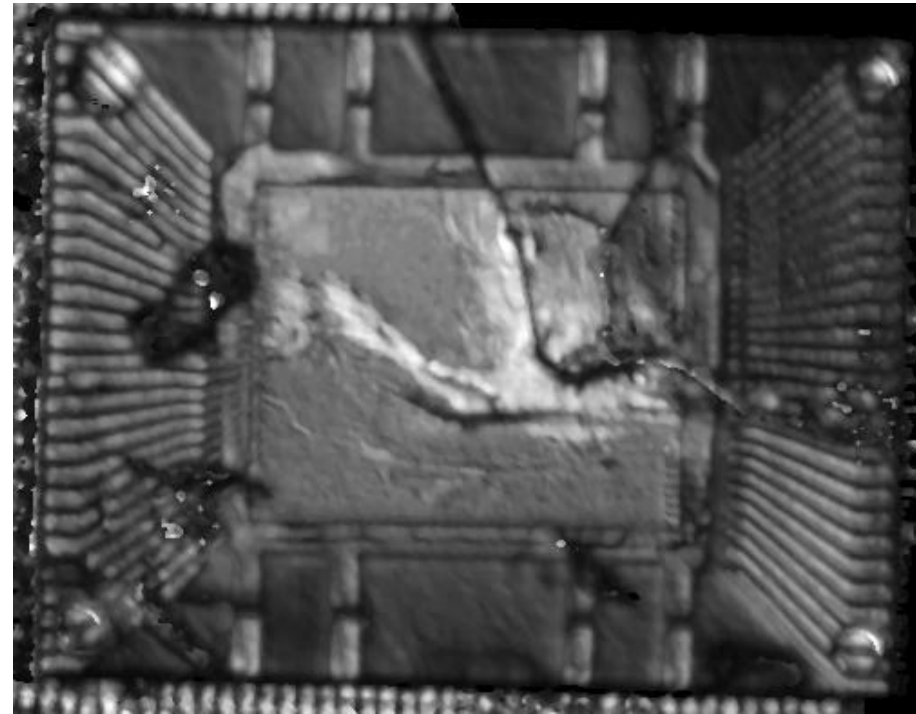
Composite acoustic image showing die, die paddle and lead frame in the package. Multiple cracks can be seen throughout the package.

Acoustic images shows that the memory die suffered severe crack damage from the impact.
