**Operations/Witness Group Chairman's Factual Report**  
**Attachment 5 - Immersive Witness Interview (IWI) Report**

**WPR12MA034**

***Immersive Witness Interview (IWI)®***  
***Accident: EC130 B4, S/N: 4909; N11QV; Blue Hawaiian Helicopters;***  
***Molokai, Hawaii; 10-10-2011; NTSB Ref: WPR12MA034***

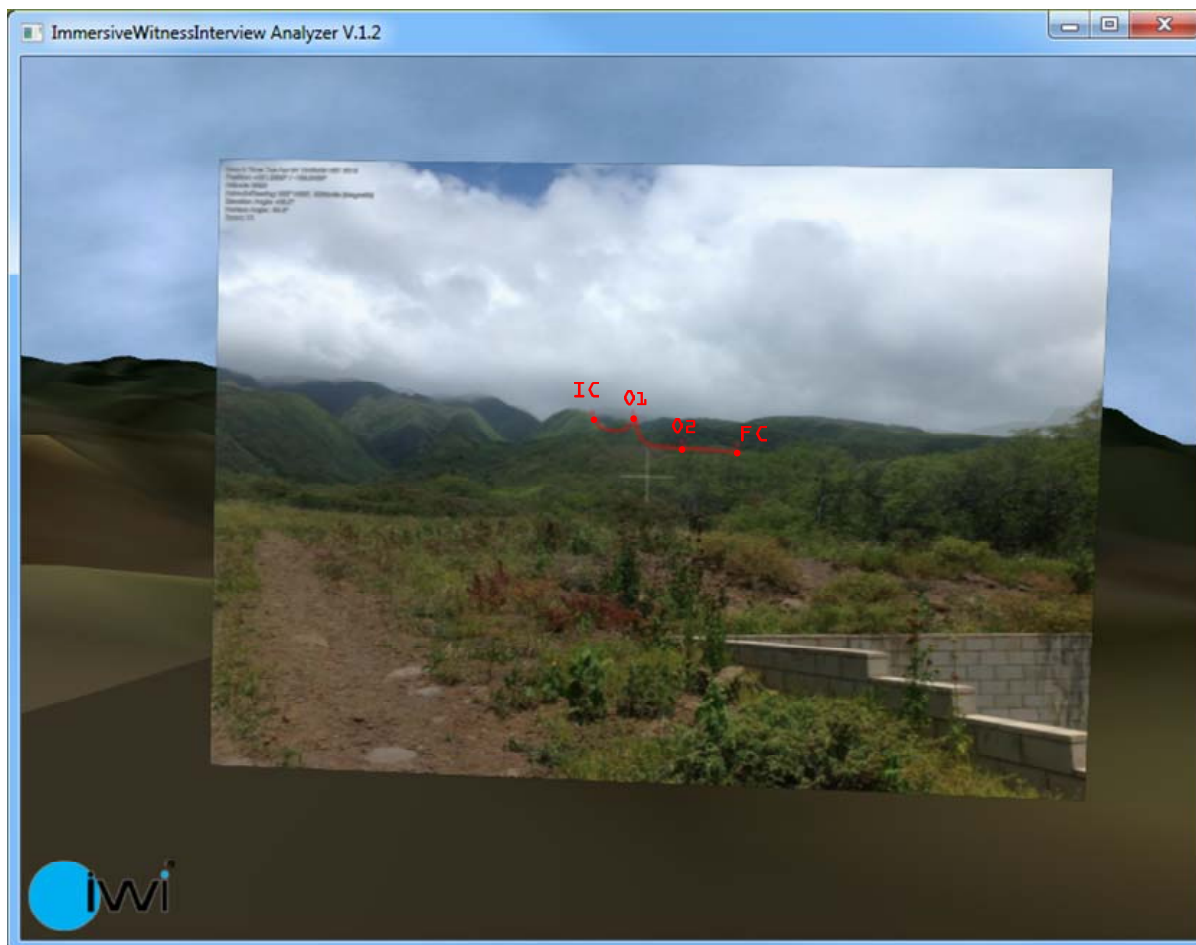
Figure 4: Witness #1 (Paleka) viewpoint with described flight path (red line)

At Mr. Paleka's initial observation of the aircraft (noted on the red line at IC), he described it as generally traveling at him, in his direction and hearing a "Whoop whoop whoop" sound. He further remembers seeing the cabin of the helicopter and then described it as going "belly up" (noted on the red line at O1). At this time he heard a "Pop" sound as the helicopter was moving up and before it began to "fall away". He said he noticed "something black fall off". He wasn't sure what it was but he also used words stating that the "tail fell." The last point he saw the aircraft was as it was travelling along the red line and ending at the location of FC, near the actual impact site. He stated that he saw the fire in the aircraft before the impact, as he moved and ran northwest approximately 50 feet to a 2nd location. This 2nd location "Position #2" is located at: N21° 3' 47.60" W156° 50' 38.04".

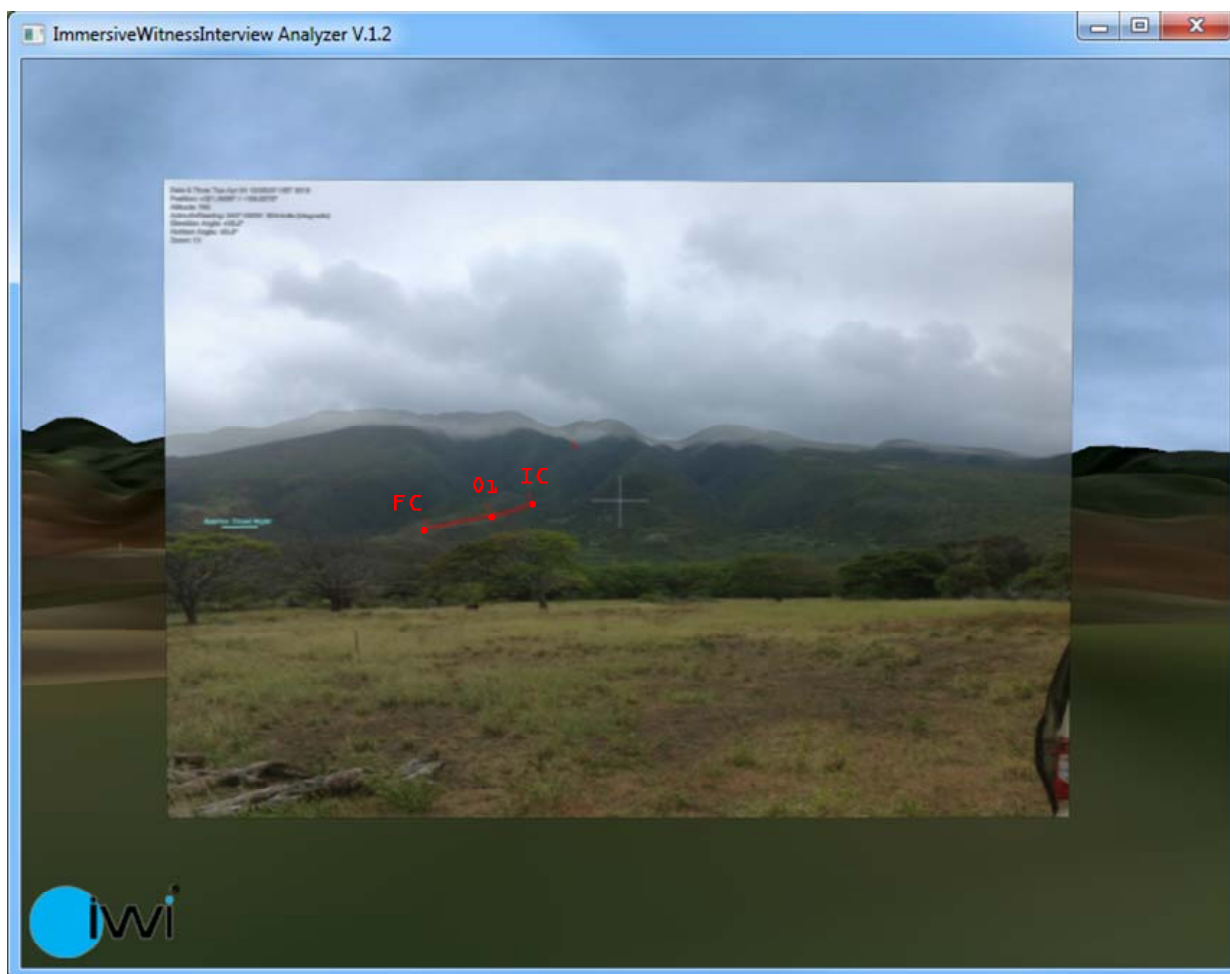
Figure 5: Witness #2 (Lopez), viewpoint with described flight path (red line) and cloud base in blue.

At Mr. Lopez's first observation of the aircraft (noted on the red line at IC), he described it as traveling generally from right to left in his field of view. He first noticed the aircraft's sound as he was driving in his pickup truck eastbound on Highway 450. He heard a sound that he said was similar to what he thought a 'Huey' helicopter would sound like, "Whoop whoop whoop". He said, he remembers hearing the sound and seeing the aircraft travel from approximately the point identified by IC to O1. At O1, he stated he could see it [helicopter] with the color blue moving down and to the southwest. Between, approximately O1 and FC, Mr. Lopez pulled off the road to get a better view. He stated that at the final contact (FC) of the flight path he saw the impact fire.

He identified the cloud base as being just above where the helicopter impacted the ground. He drew the cloud base on the photo identified by the blue line, next to "Approx. Cloud Height". Mr. Lopez additionally stated it "was foggy, and was very windy"; He said "it was rainy then shortly after it cleared up about  $\frac{3}{4}$  way up the mountain."

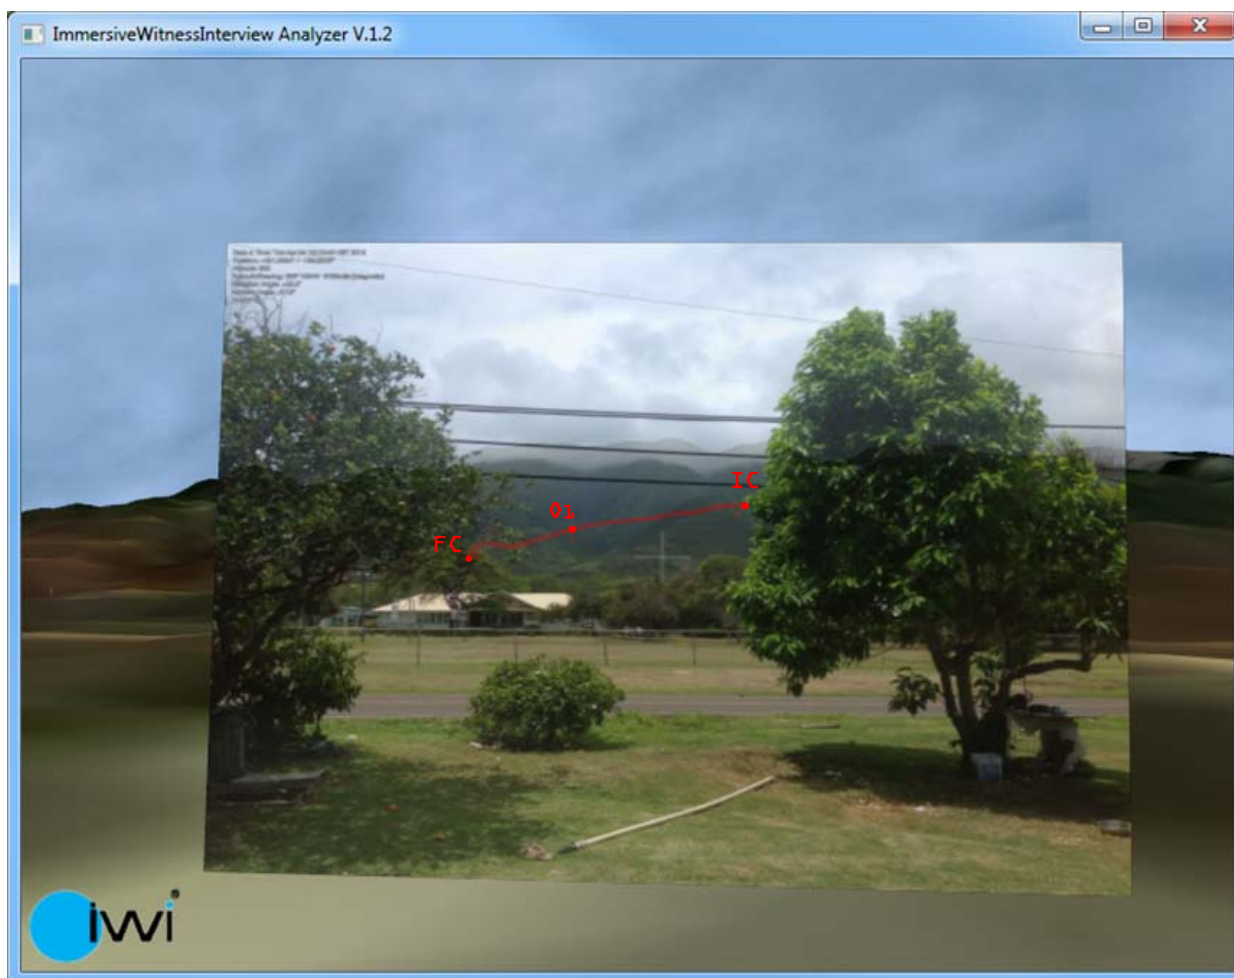
Figure 6: Witness #3 (Kapuni), viewpoint with described flight path (red line)

Mr. Kapuni's stated that his initial observation of the aircraft (noted on the red line at IC), was with a gray mist/smoke spiraling path, but that he wasn't sure what it was at first because of the rain front that had quickly moved into the area from the east. He said he was unable to make out the color of the object [aircraft] because of the dark clouds and rain. However, by the time it had reached the point that he depicted by O1, he saw a red type of light that he described as "like the back of jet engine" and it was here that he also heard the sound of engine power. He described the line of travel as relatively level, but drew a line that was on a slight decline from point IC to O1. During the interview he drew two slightly different line paths that changed the (O1) position slightly lower. At the point depicted by (FC) near the end of the path, he said he saw it nose over, followed by a large impact fire. He stated that from point O1 to FC it went slightly down, then up, then straight down to the ground.

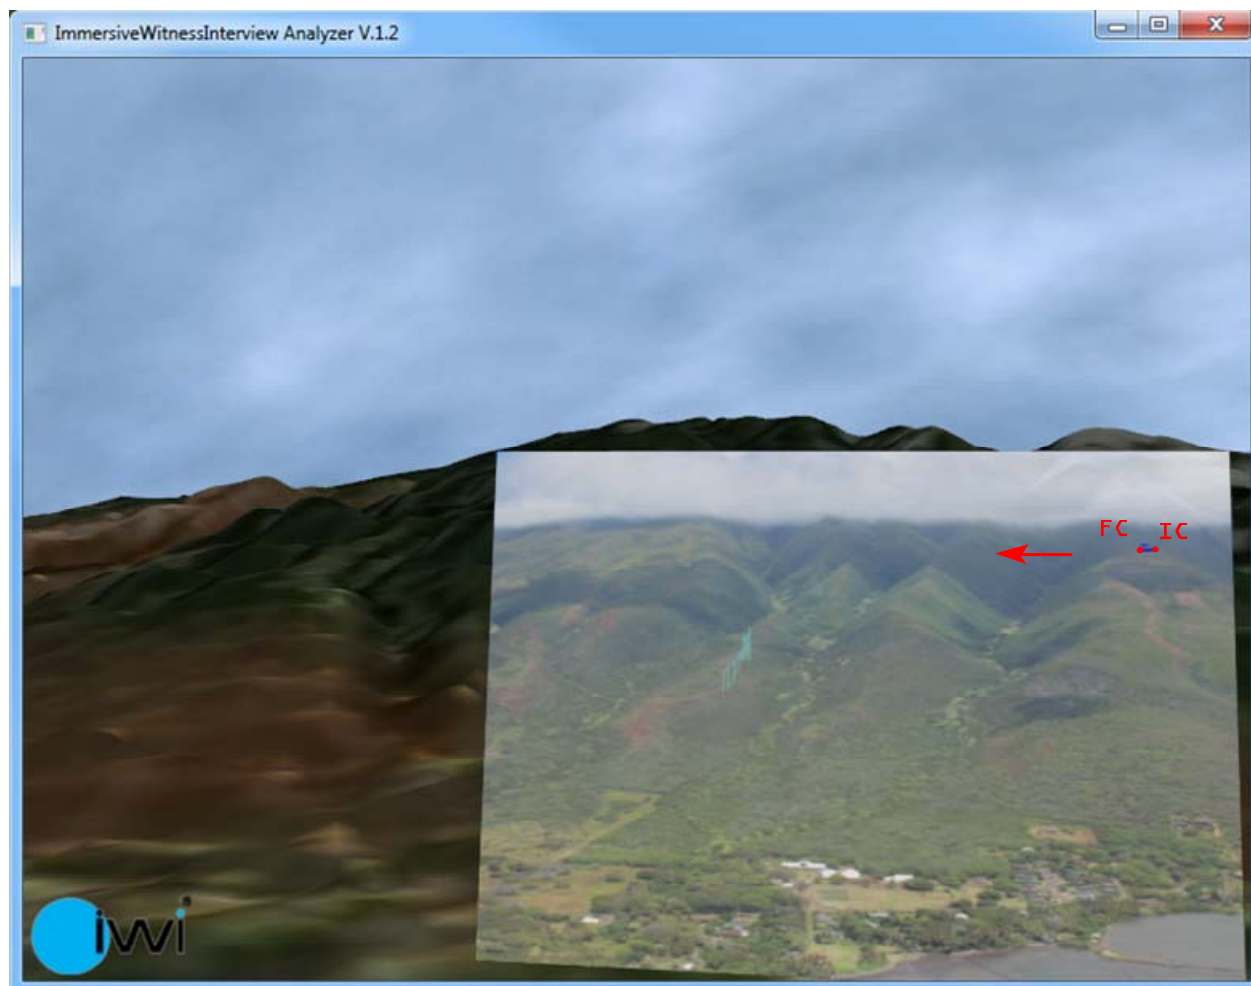
Figure 7: Witness #4 (Schneider), approximate viewpoint with observed point of helicopter (blue circle)

Mr. Schneider was flying a helicopter (an MD500 with the doors off) on a southwest heading over, or approximately just past Highway 450, heading out over the water when he looked up and briefly saw the subject aircraft heading westbound just below the cloud deck at approximately his 3 to 4 O'clock position. He mentioned that it was difficult to make out the company/color of aircraft due to dark clouds, as it was a dark colored aircraft against a dark background, but he was quite certain of the location at which he spotted the aircraft. He said he saw the subject aircraft just below the clouds, and he estimated them to be approximately 2,200 – 2,400 feet MSL. He additionally mentioned that he remembers it was windy that flight and that the winds were out of NE, and that it was a "little bumpy".

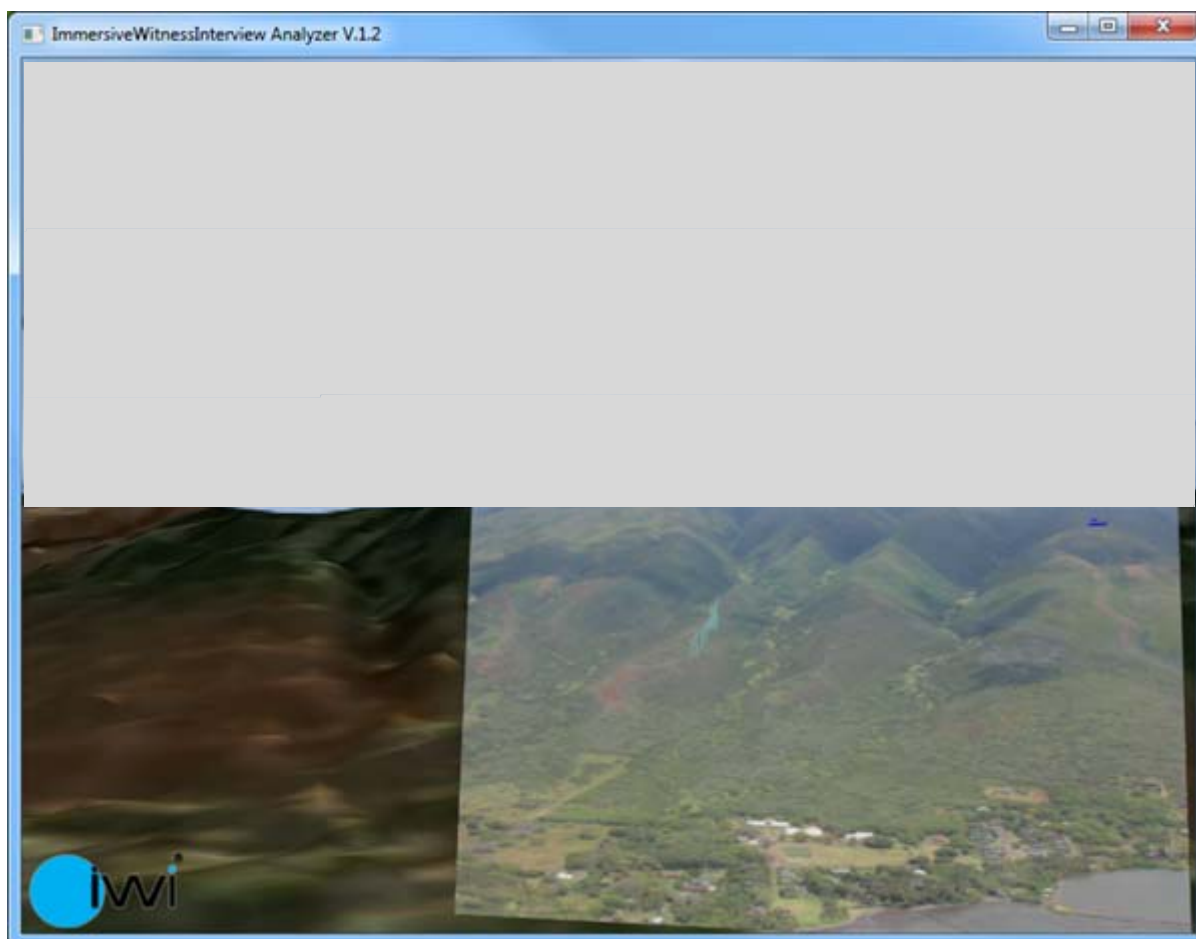
The meteorological conditions described by witnesses Schneider and Lopez suggest that the top of the mountain was obscured by the clouds at the time of the event. These witnesses also depicted the approximate base of the clouds as being just above the aircraft, as seen from their viewpoints and at the time they each made their initial contact (IC) of the aircraft. According to Mr. Schneider, he estimated the cloud base to begin at approximately 2,200 to 2,400 feet MSL (see figure 8). Mr. Lopez estimated the cloud base beginning at a level which was later estimated to be approximately 700 to 800 feet MSL. The difference in the cloud base altitudes reported by these two witnesses could be accounted for by the time and distance from which these two witnesses observed the event. Still, the metrological phenomena in the areas of this event are reportedly capable to change both quickly and differently depending on the time and terrain. A full metrological examination performed by the NTSB, of the weather in this area has not been completed at the time of this report.

Figure 8: Witness #4 (Schneider) IWI viewpoint, with a cloud base line showing cloud layer at approximately 2,200 feet

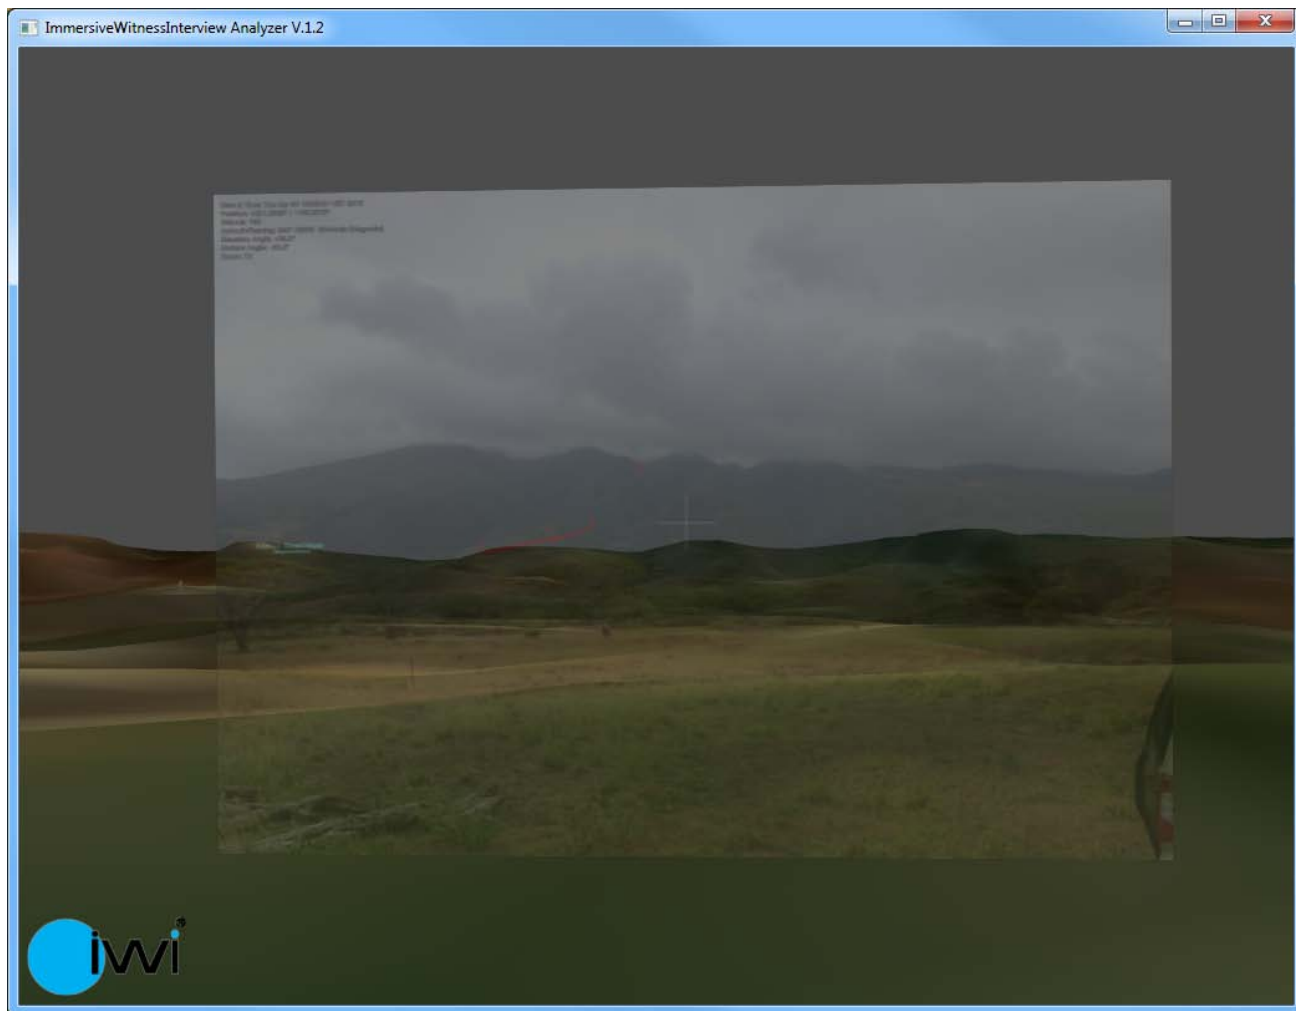
Figure 9: Witness #2 (Lopez), with IWI viewpoint showing a progressive cloud coverage with altitude that begins at approximately 800 feet, where he identified it began with the blue mark on the left of the IWI app rendering.

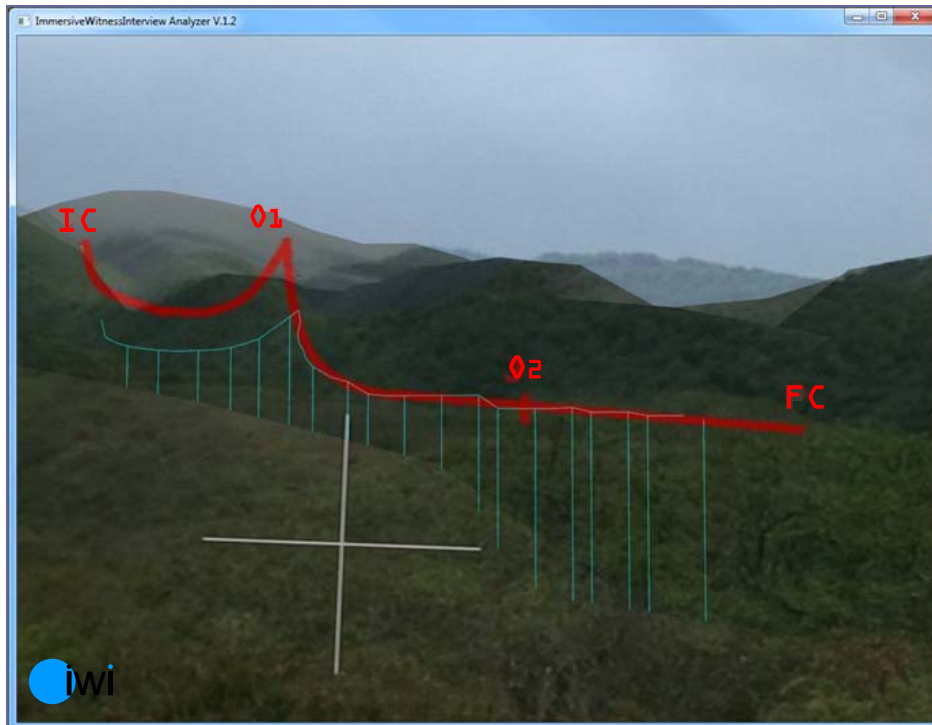
Figure 10 (Paleka – Lopez): Paleka’s 2D description (Red) combined with the IWI reconstructed flight path (blue) of Lopez

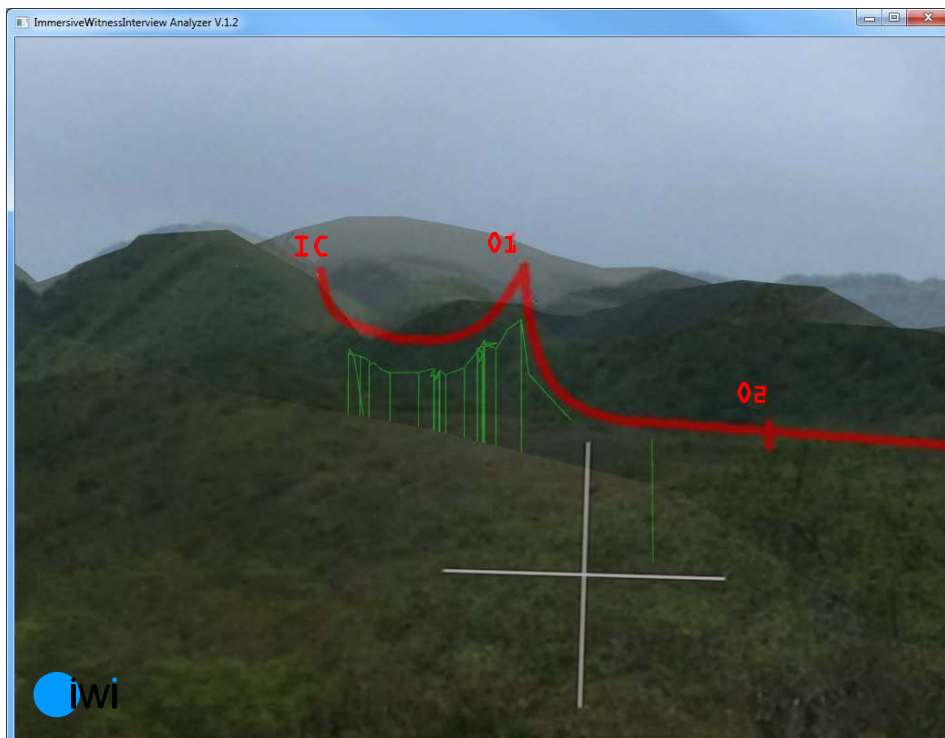
Figure 11 (Paleka – Kapuni): Paleka’s 2D description (Red) combined with the IWI reconstructed flight path (green) of Kapuni

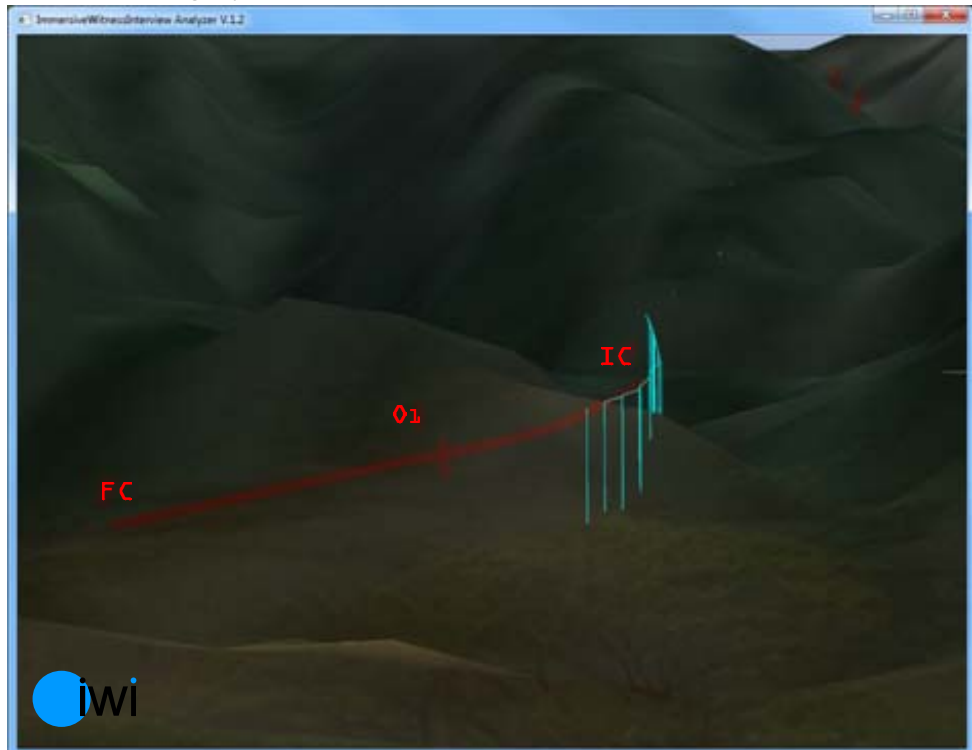
Figure 14 (Lopez - Paleka): Lopez's 2D description (red) combined with the IWI reconstructed flight path (Blue) of Paleka

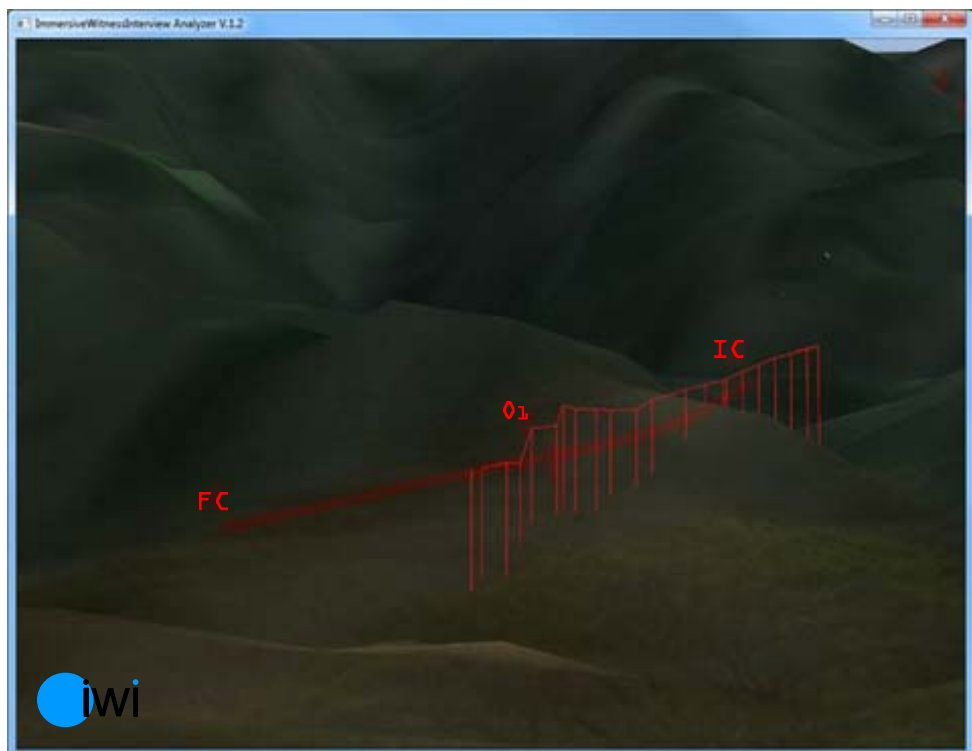
Figure 15 (Lopez - Kapuni): Lopez's 2D description (red) combined with the IWI reconstructed flight path (red) of Kapuni

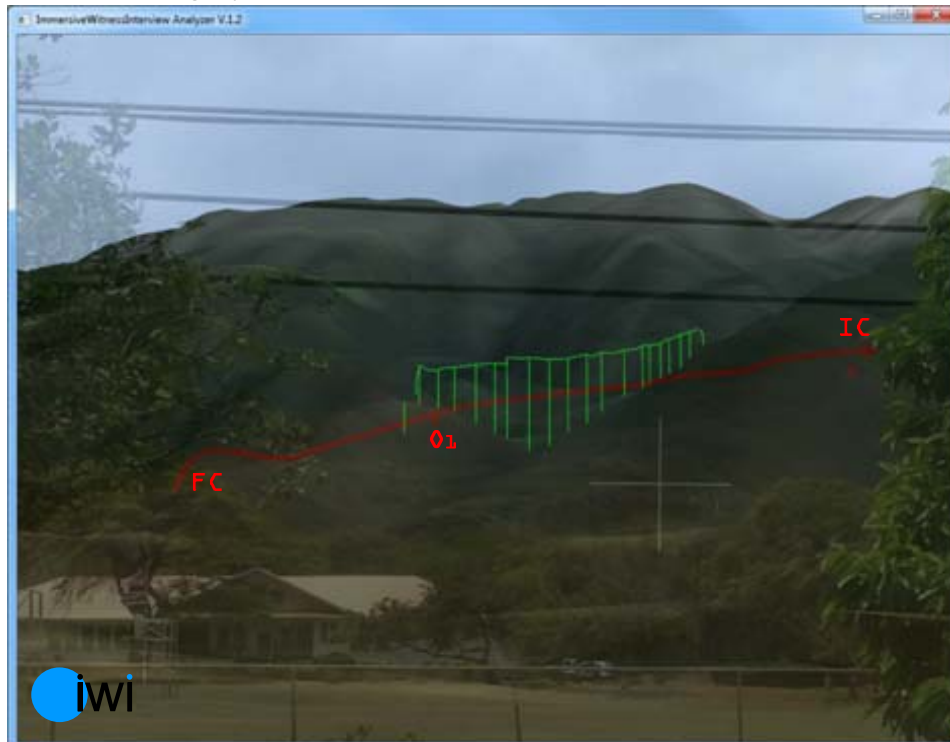
Figure 12: (Kapuni - Paleka): Kapuni's 2D description (red) combined with the IWI reconstructed flight path (green) of Paleka

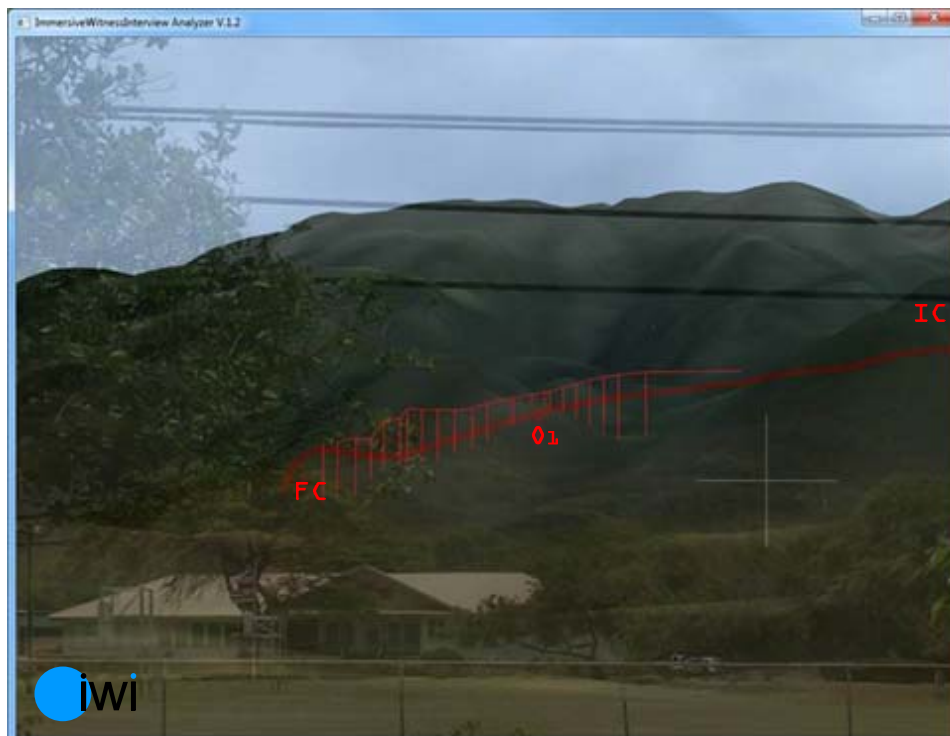
Figure 13 (Kapuni - Lopez): Kapuni's 2D description (red) combined with the IWI reconstructed flight path (red) of Lopez

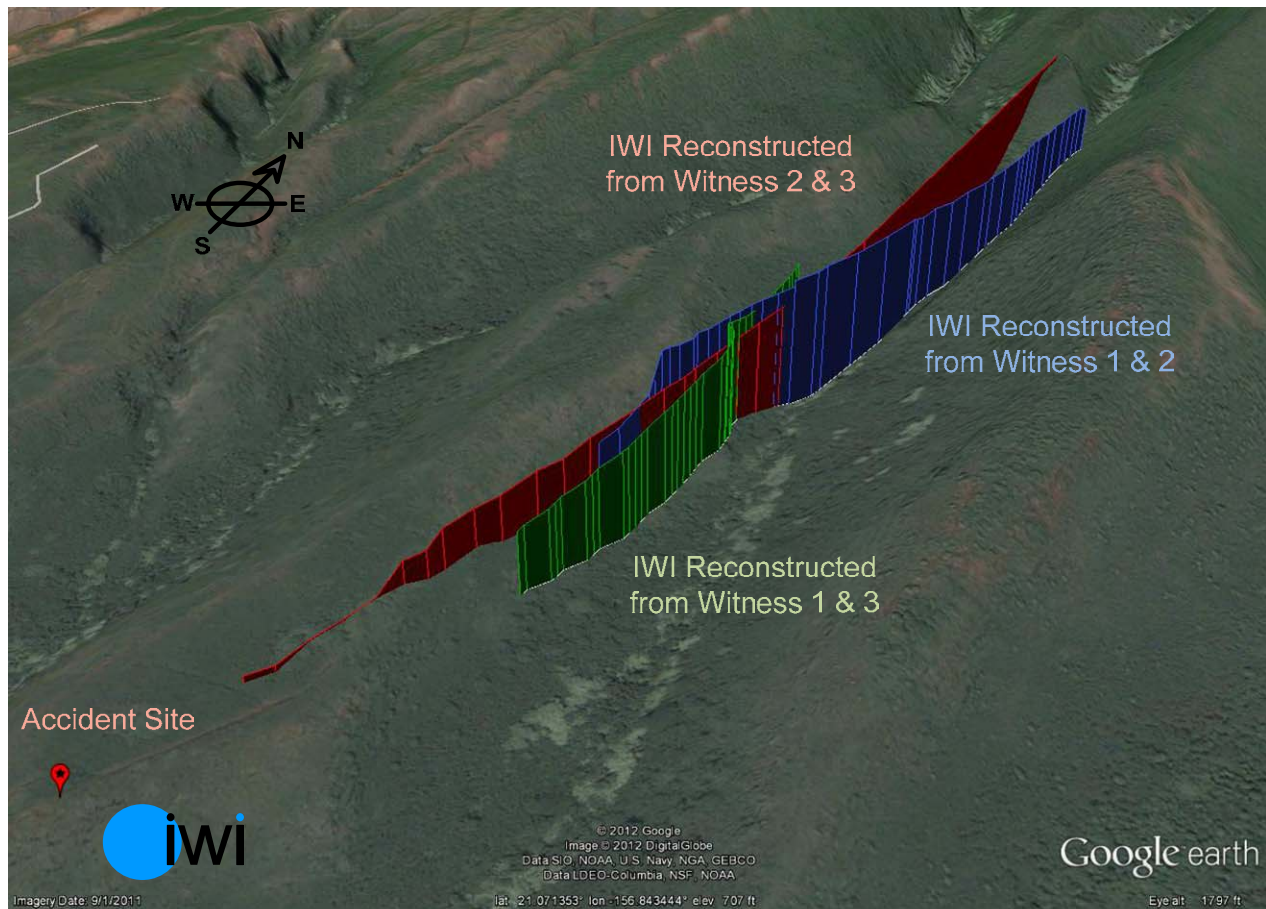
The three flight paths illustrated by witnesses Mr. Paleka, Mr. Lopez, and Mr. Kapuni are plotted for consideration from the IWI-Analyzer software, which depicts the following reconstructed flight paths as calculated (see Figures 16, 17, 18 and 19). The light red points shown in the figure below depict the location of the accident site and the debris. Based on the IWI witness statements and the reconstructed flight paths (Red, Blue and Green lines), the subject helicopter came down the mountain range on a heading of approximately 170 degrees.

Figure 16: Overview - Looking northwest at the three reconstructed flight paths from the IWI-Analyzer Constructed from the following witness combinations (Blue = 1 & 2, Green = 1 & 3, Red = 2 & 3).

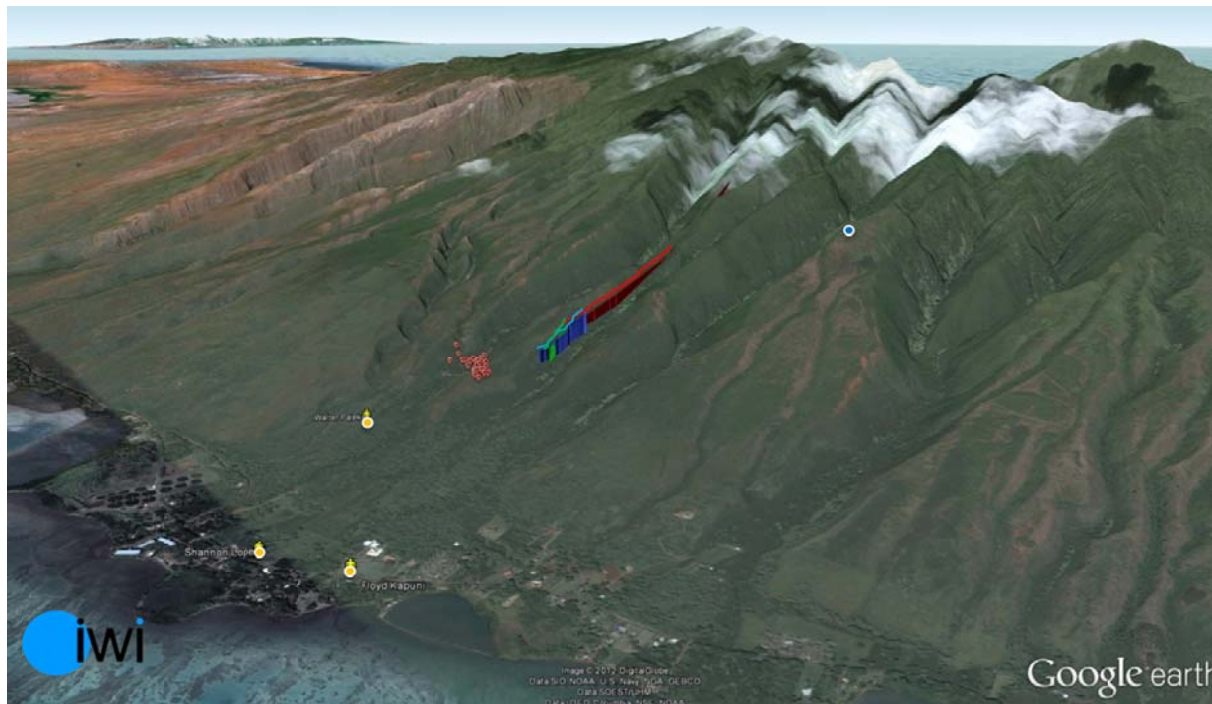
Figure 17: Overview looking northwest at three land witness locations (Yellow) and Reconstructed Flight Paths the main wreckage site (Red dots). Last observed position by witness David Schneider (Blue dot)

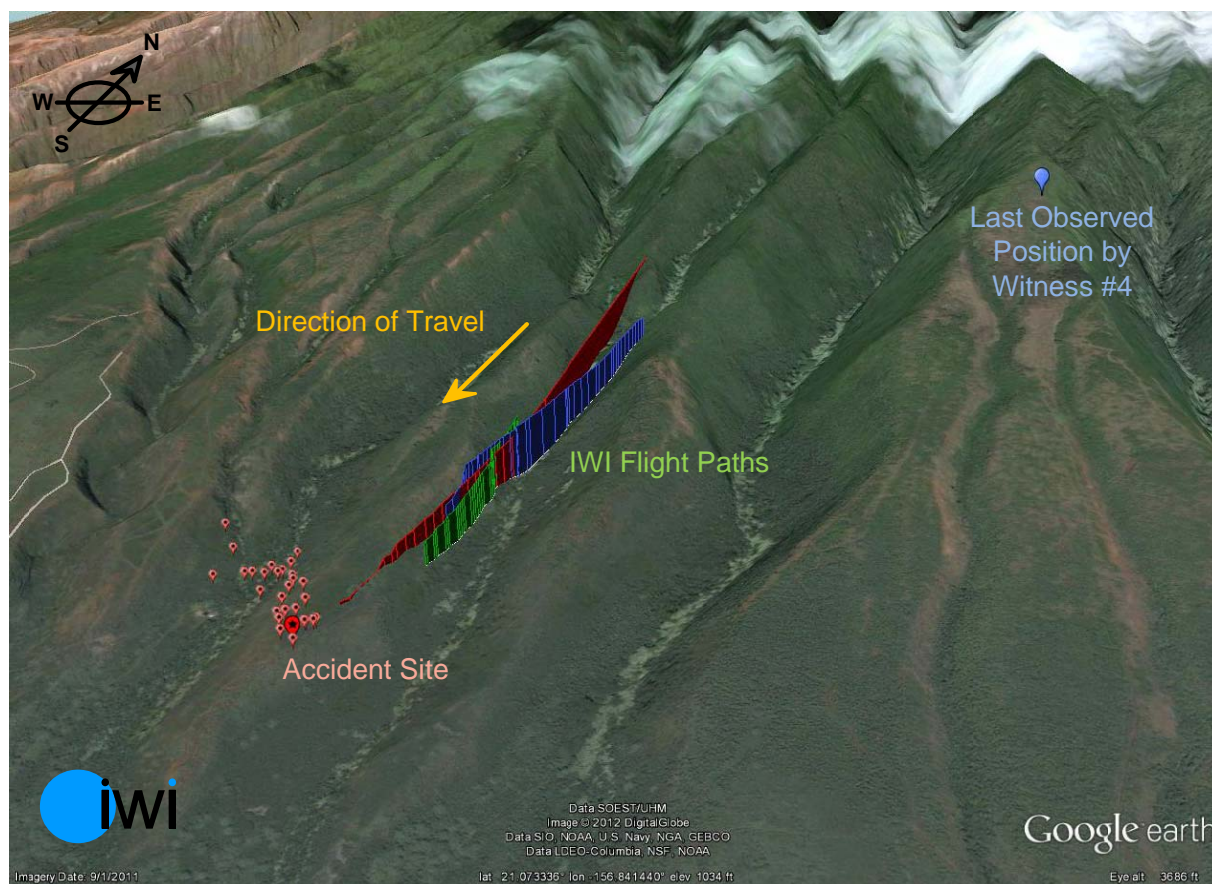
Figure 18: IWI reconstructed flight paths with direction of travel, accident site, and last observed site. Reconstructed flight paths (Blue = witness 1 & 2, Green =1 & 3, Red = 2 & 3),

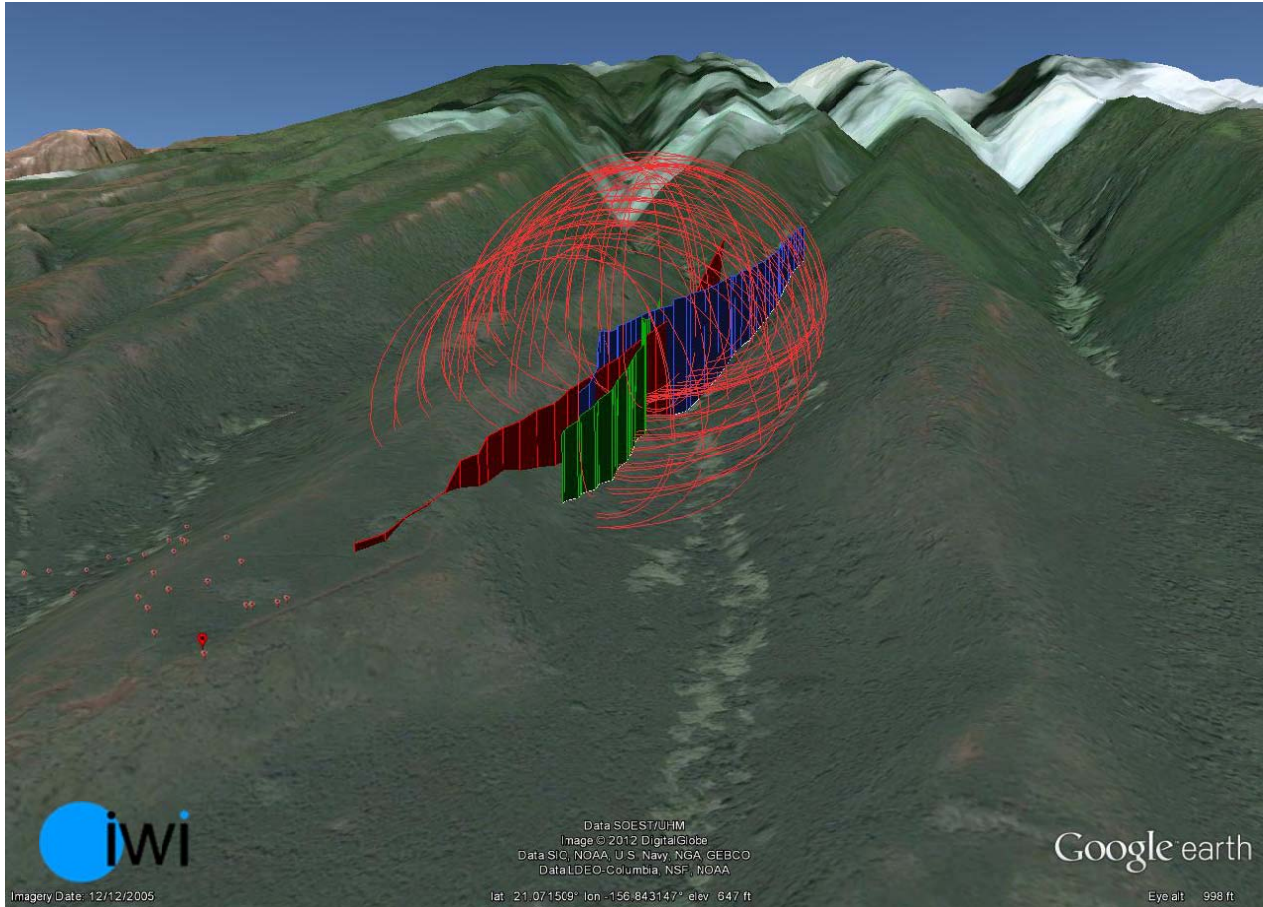
Figure 19: Calculated error tunnel around three reconstructed flight paths (red) looking north from accident site.

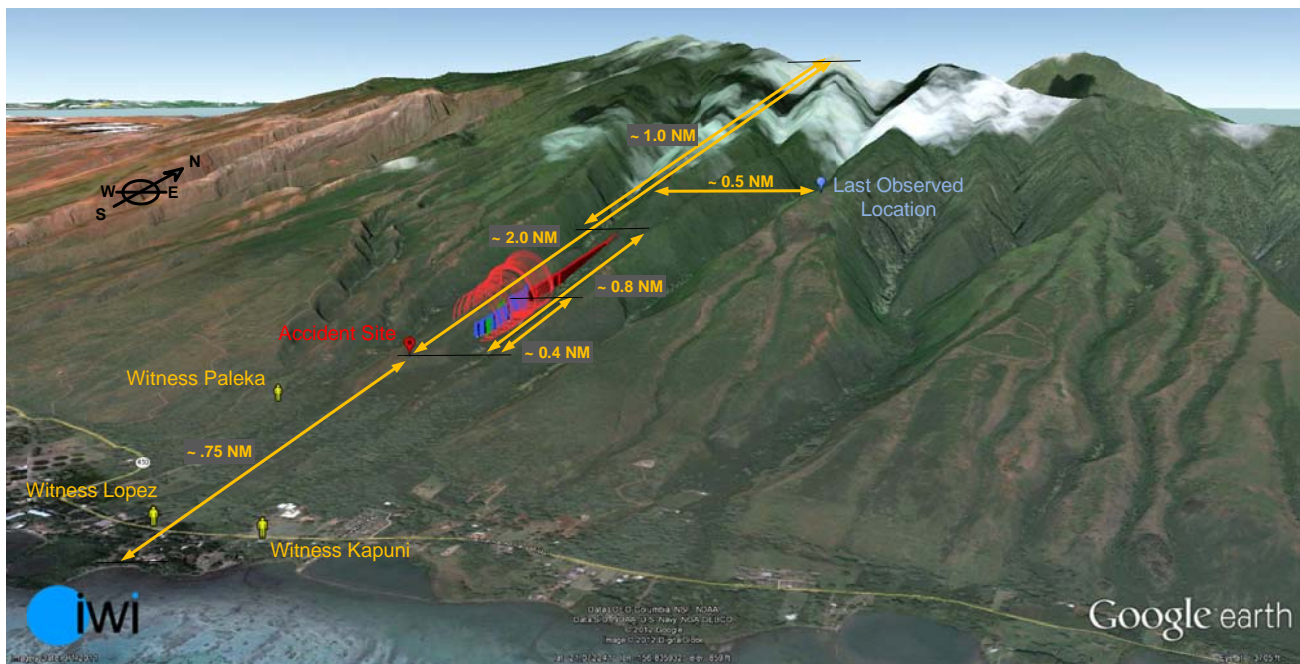
Figure 20: Three Reconstructed Flight Paths with Error Tunnel and descriptive dimensions.

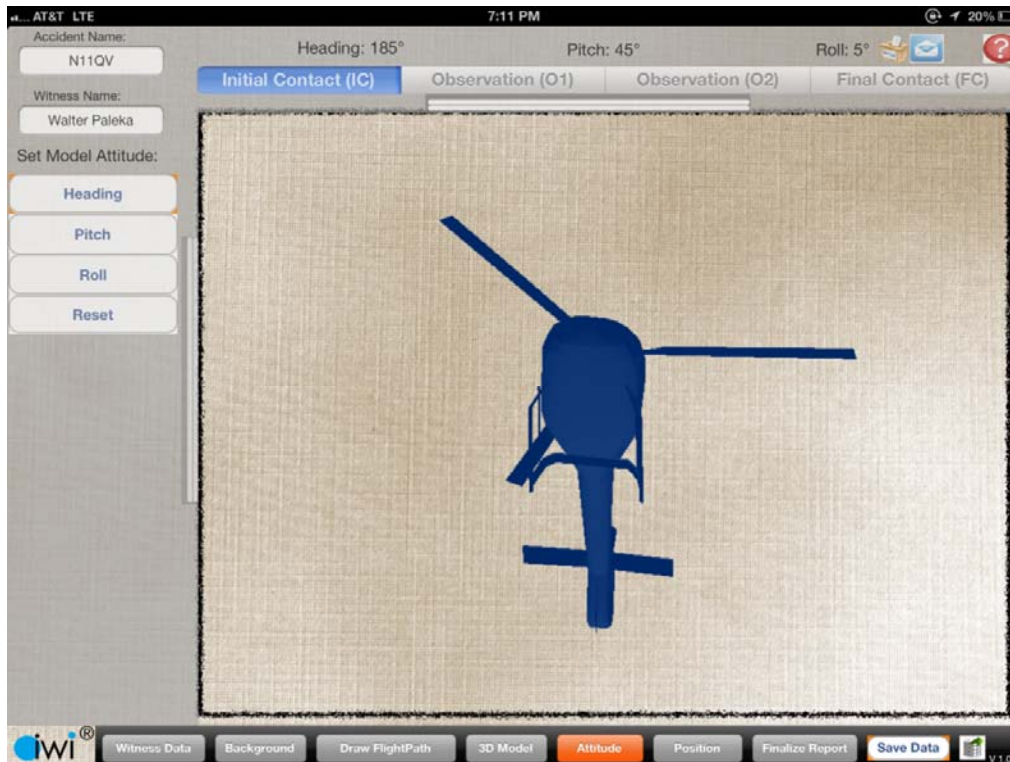
Figure 21: Screenshot of IWI app with Paleka's attitude description of the helicopter at position IC

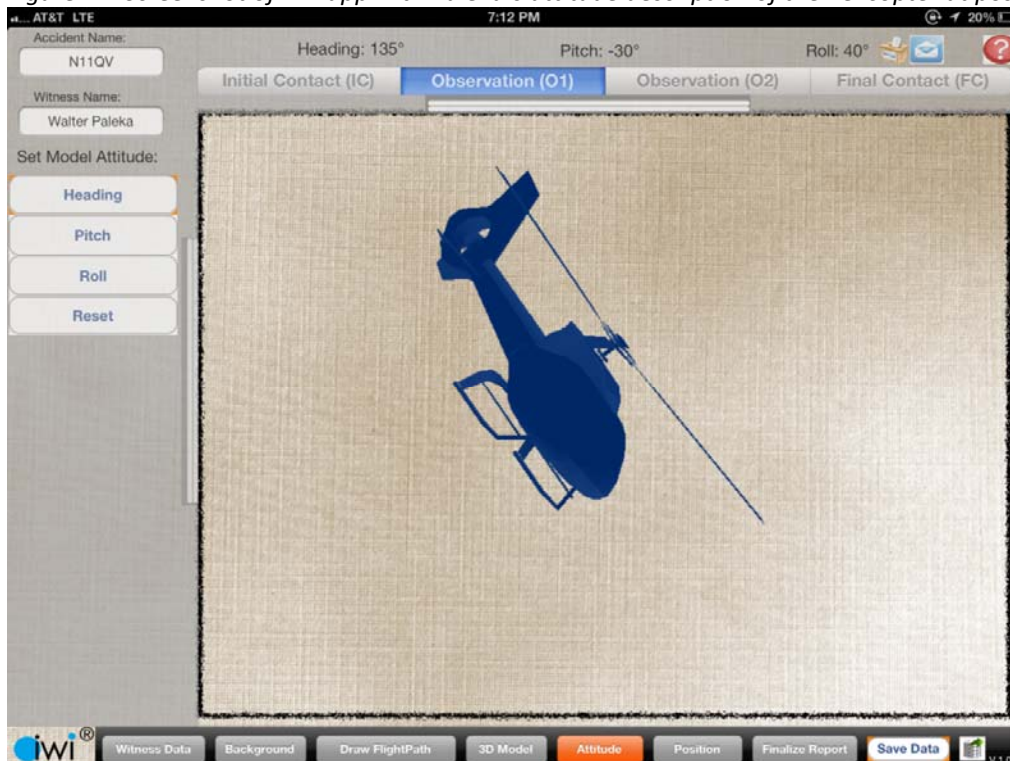
Figure 22: Screenshot of IWI app with Paleka's attitude description of the helicopter at position O1

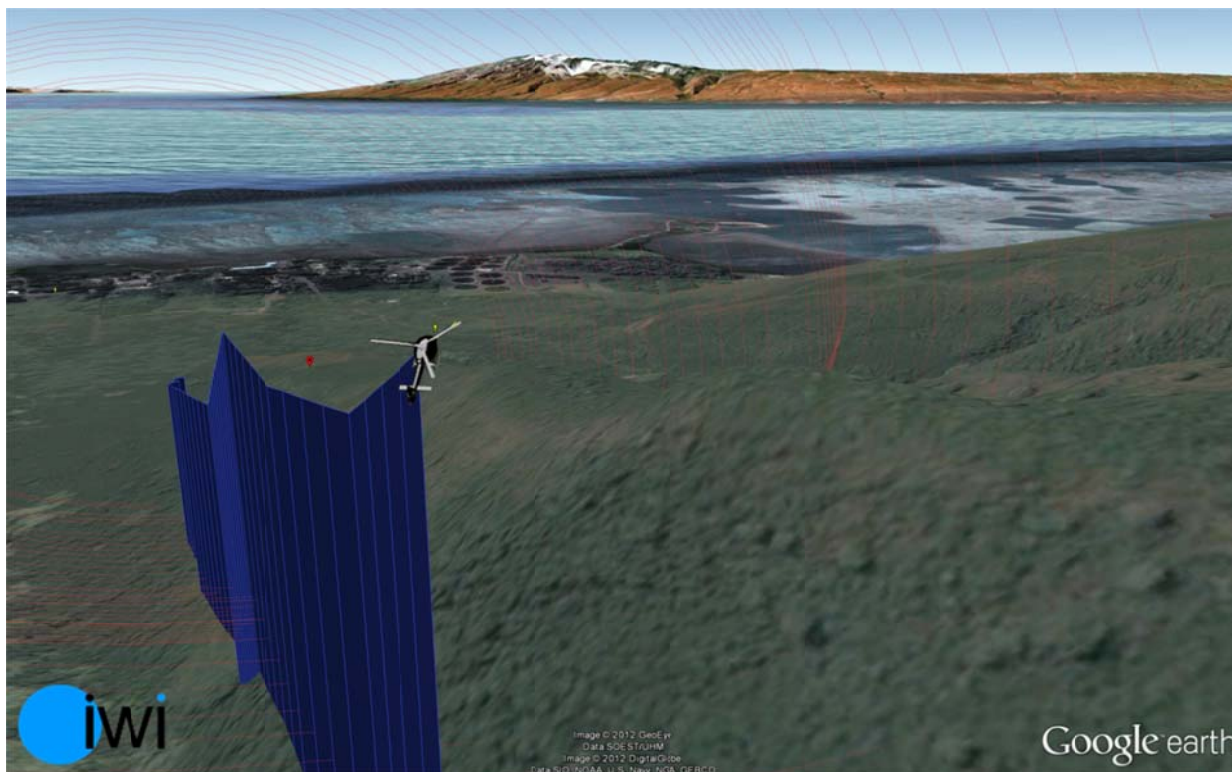
Figure 23: Witness #1 of helicopter's attitude at observed point IC on the IWI reconstructed flight path looking south.

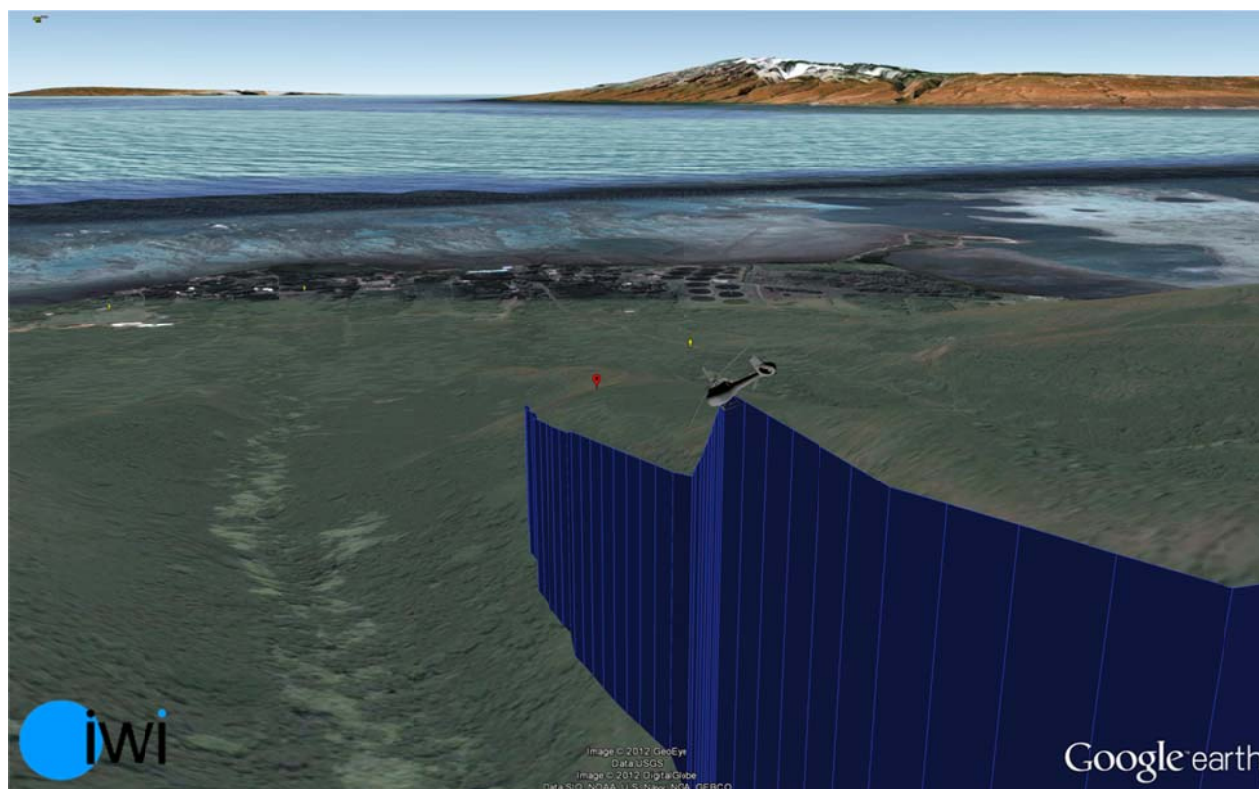
Figure 24: Witness #1 of helicopter's attitude at observed point O1 on the IWI reconstructed flight path looking south.
