DCA16MR011
NJT
Collision of Train 1614
Hoboken Station
Hoboken, NJ
September 29, 2016

Attachment 6
Cab Car 6036 Master Controller Test Report

| | Report Type: | <i>Master Controller Functional Test Report</i> |
| | Subject: | <i>Cab Car 6036</i> |

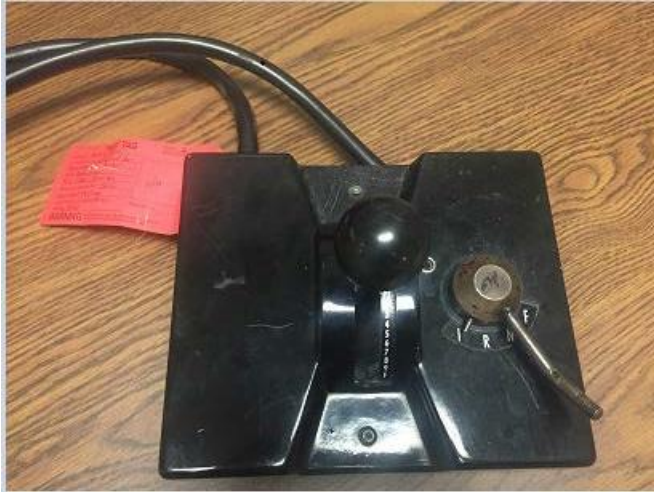
Master Controller from the 6036

The Master Controller was tested thoroughly and passed both functionality tests. No abnormalities or exceptions were noted during testing. It should be noted that the consist test was conducted on a dead locomotive because of the environmental and safety concerns with starting a locomotive inside of a shop. Also, the test was carried out in End Door and Center Door bypass as the damage to the doors on the consist was too severe to allow them to be closed completely. In addition, the bench test carried out on the Bench Test Equipment (BTE) at the MMC passed all tests with no abnormalities noted. Representatives from NJT Technical Services as well as a representative from the FRA were present. The NTSB as well as the FRA and NJT deemed the above procedures acceptable and the Master Controller was deemed to be working as intended.
