DCA16MR011
NJT
Collision of Train 1614
Hoboken Station
Hoboken, NJ
September 29, 2016

Attachment 7
Cab Car 6036 Translator Test Report

Technical Services	Report Type:	<i>Translator Functionality Testing Report</i>
	Subject:	<i>Cab Car 6036</i>
	Location:	<i>S&I Shop</i>
	Date:	<i>10/08/2016</i>

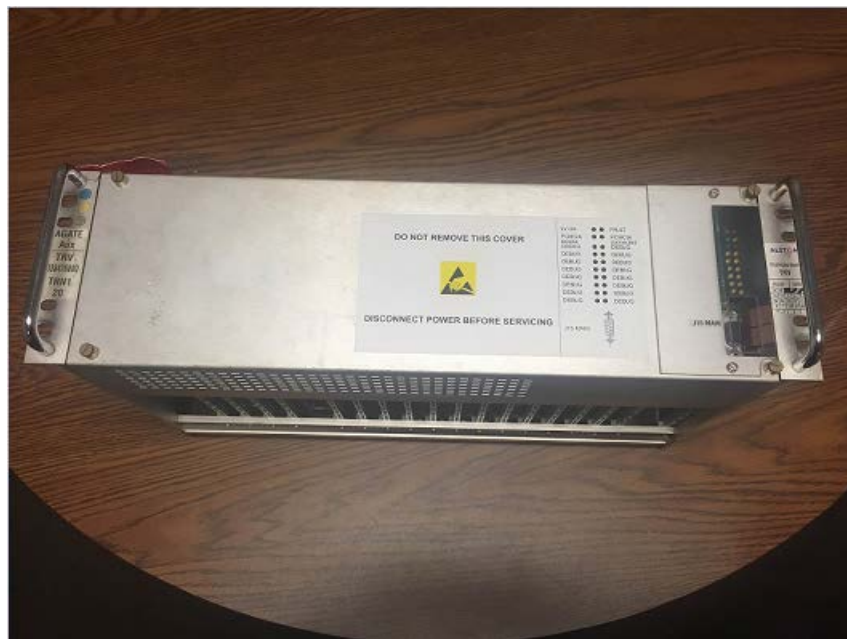
Translator removed from the 6036

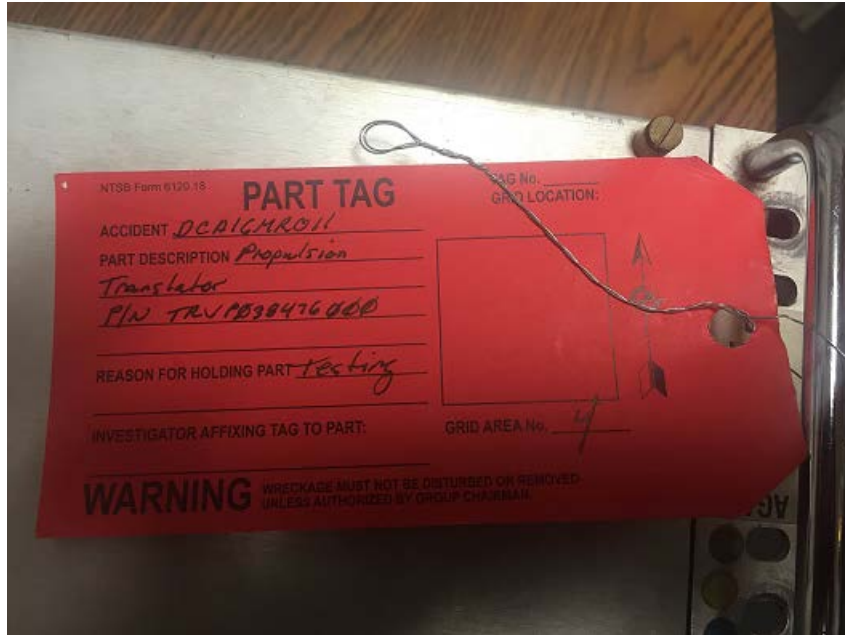
Translator ID Tag
