ATTACHMENT A

ADDENDUM A POWERPLANT FACTUAL REPORT

DCA-95-MA-054

The following attachment includes all the documents distributed during the Powerplant Group meeting of September 13 and 14 at Hamilton Standard, Windsor Locks, Connecticut.

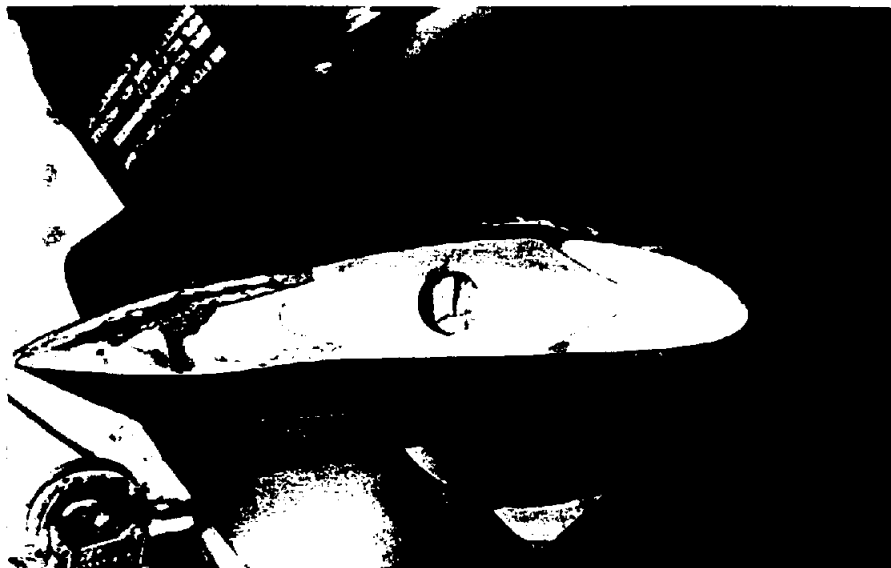
a.) Overall view of the chordal fracture plane as it was found at the site on the frozen lake.

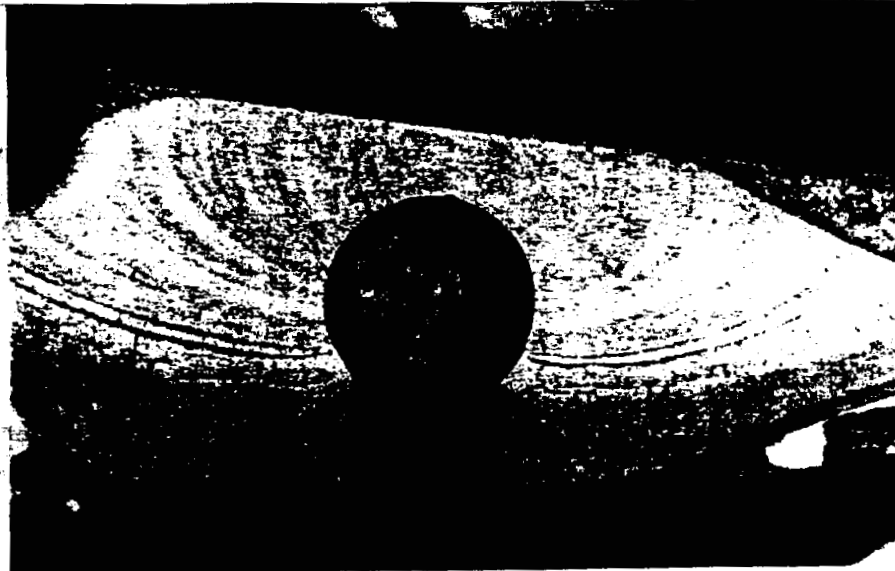
c.) The fracture surface of the spar showing a series of semi-elliptical crack arrest fronts and a dark elongated pit at the crack origin in the surface of the taper bore.

- The fracture occurred at the 22.3 inch station and propagated generally in the chordal plane.
- The crack origin was located at a cavity pit in the surface of the taperbore in line with the minimum stock thickness alignment on the face side of the airfoil.
- The dimensions of the cavity were approximately:
 - $A = 0.031$
 - $2C = 0.058$
 - $B/2 = 0.050$ (the outboard end of the pit is missing)
- Four other cavities of similar size were found in the surface of the taperbore on the camber side. No chordwise cracks were apparent at these locations.
- No material abnormalities were found.
- Traces of chlorine were found by TSBC at the cavity site.

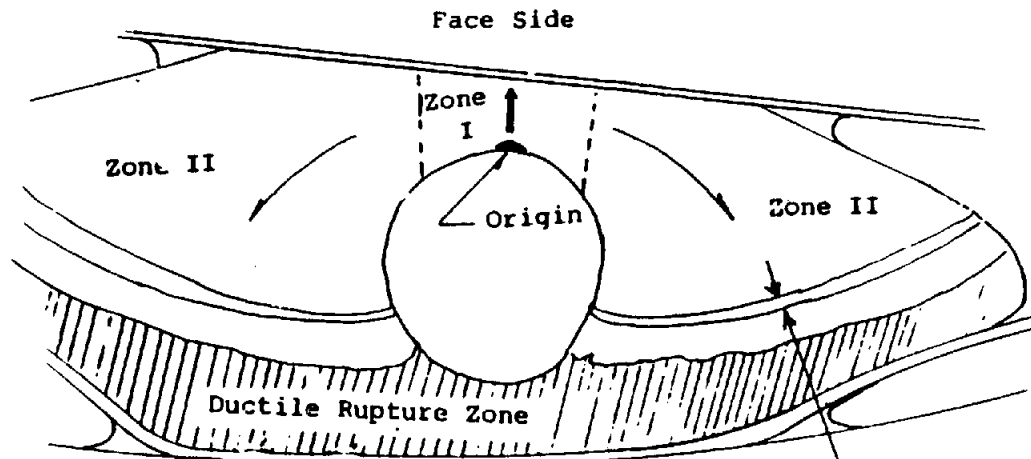
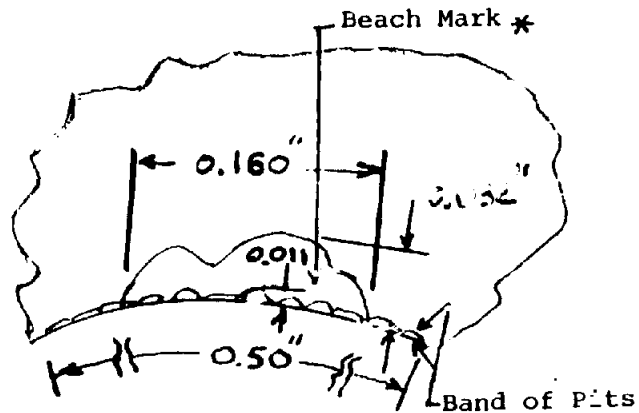
EMB-120/14RF-9 Blade Spar Fracture

* (Indicative of Interrupted Fatigue Cycling)

- The fracture occurred at the 17.9 inch station and propagated in the chordal plane.
- The crack origin was located at a series of multiple pits on the surface of the taperbore in line with the minimum stock thickness ligament of the face side of the blade
- The dimensions of the pitted area was an .011-inch x 0.500 with a stained fracture surface .032-inch x 0.160-inch
- Cavities of smaller size were found elsewhere in the taperbore. No chordwise cracks were apparent at these locations
- Chlorine was found in the origin pit, as well as areas in the vicinity of the fracture.

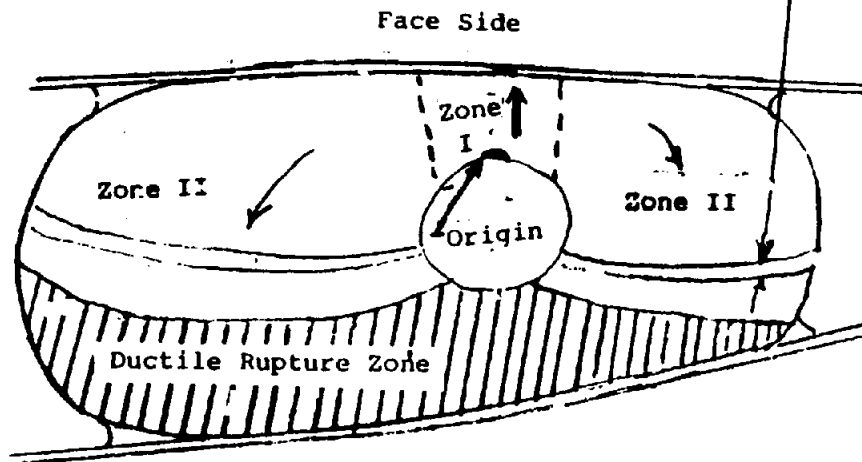
Visually apparent band of fatigue crack propagation
