Attitude Indicator and Directional Gyro Examination Notes
N5714W
NTSB Case # ERA13FA088
Parkton, North Carolina
December 16, 2012

Location: Parkton, North Carolina
Date: December 16, 2012
Time: About 1532 EST/2032 UTC
Aircraft: Piper PA-28-160
Registration: N5714W

Chairman: Timothy W. Monville
National Transportation Safety Board
Doral, Florida

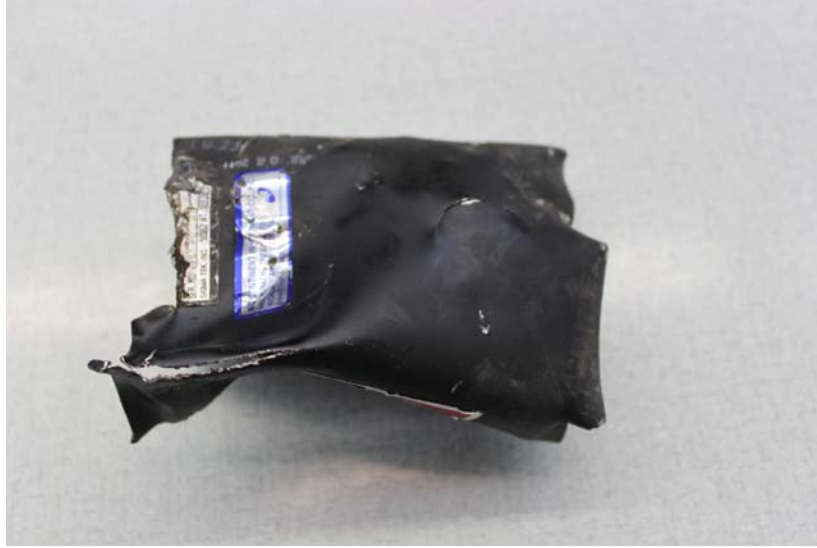
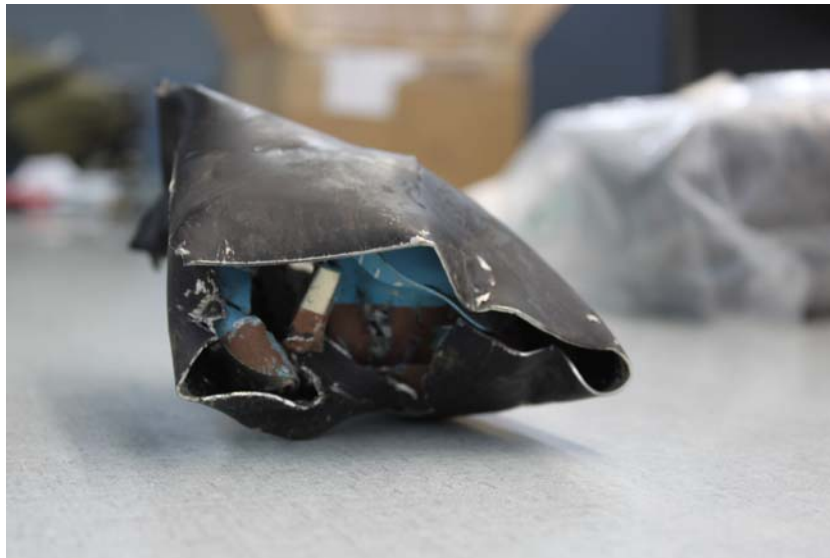
Photographs of the attitude indicator were taken and are pictures IMG_5674.jpg thru IMG_5688.jpg. The initial inspection of the component revealed extreme crushing and tearing of the case.

Figure 1: Photograph depicting crushing of the instrument case.

Figure 2: Photograph depicting crushing of the instrument case.

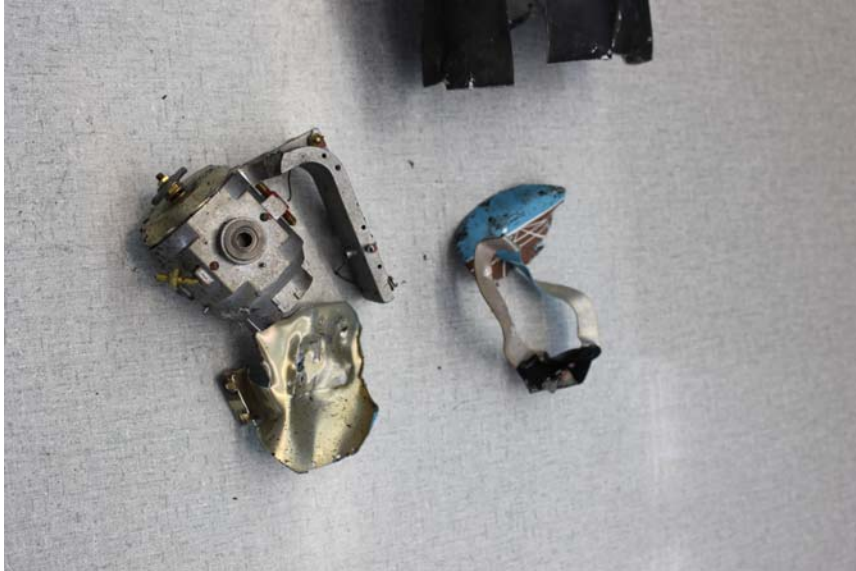
The instrument case was cut in order to remove the rotor housing. The gimball ring support was fractured, and a portion was missing. The silhouette was missing, and a rotor shaft screw was broken.

Figure 3: Photograph depicting the rotor housing, fractured and only remaining portion of the gimball ring support.

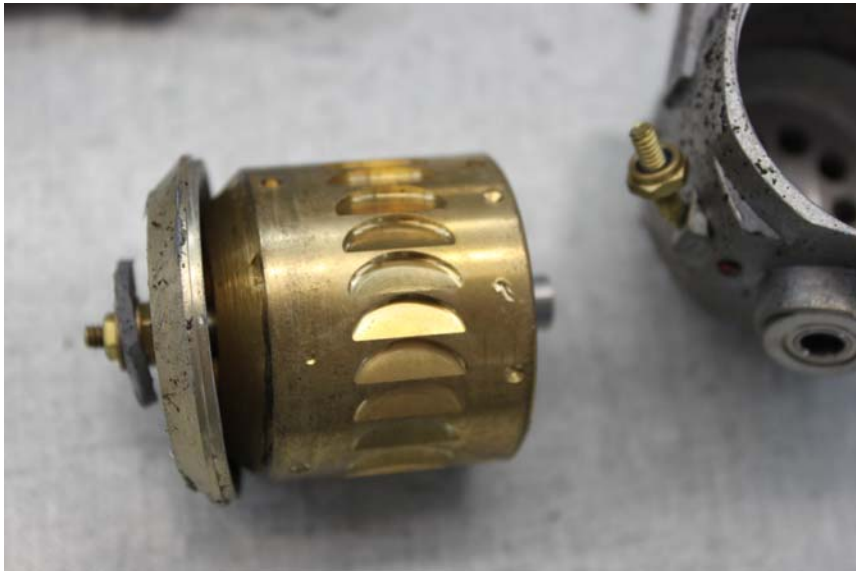
The rotor was removed from the rotor housing and no scoring was noted on the rotor.

Figure 4: Photograph depicting the rotor.

Further inspection of the rotor revealed the end with the broken screw exhibited a rough feel to the bearing during rotation of the rotor.

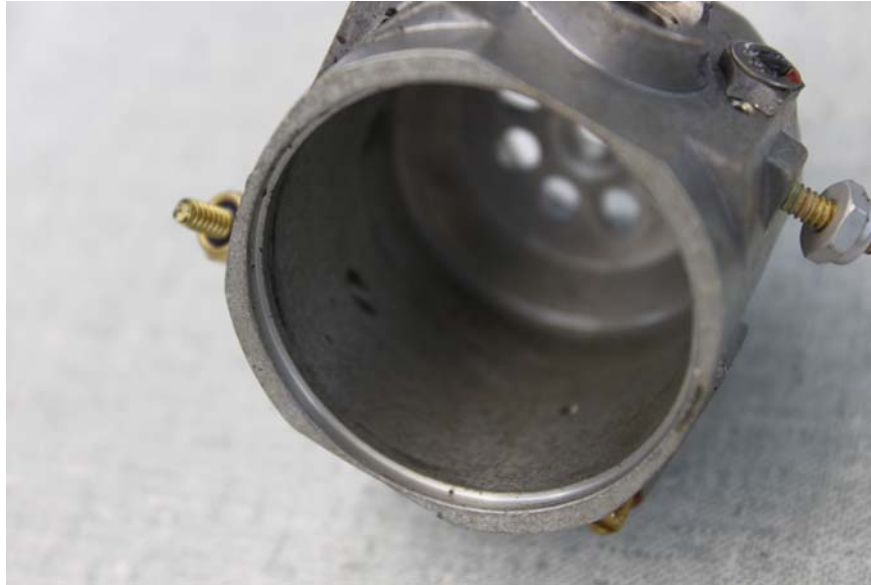
Inspection of the rotor housing revealed light rotational scoring at an area between the 4 and 7 o'clock positions; but no corresponding scoring of the rotor was noted.

Figure 5: Photograph depicting the interior surface of the rotor housing.

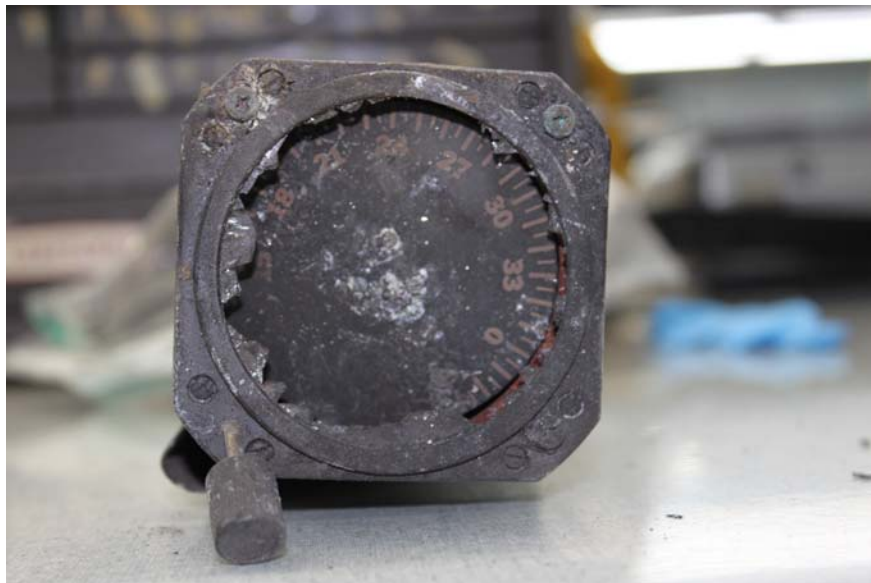
Photographs of the directional gyro were taken and are pictures IMG_5689.jpg thru IMG_5706.jpg. The initial inspection of the component revealed fire and impact damage.

Figure 6: Photograph depicts the front portion of the directional gyro.

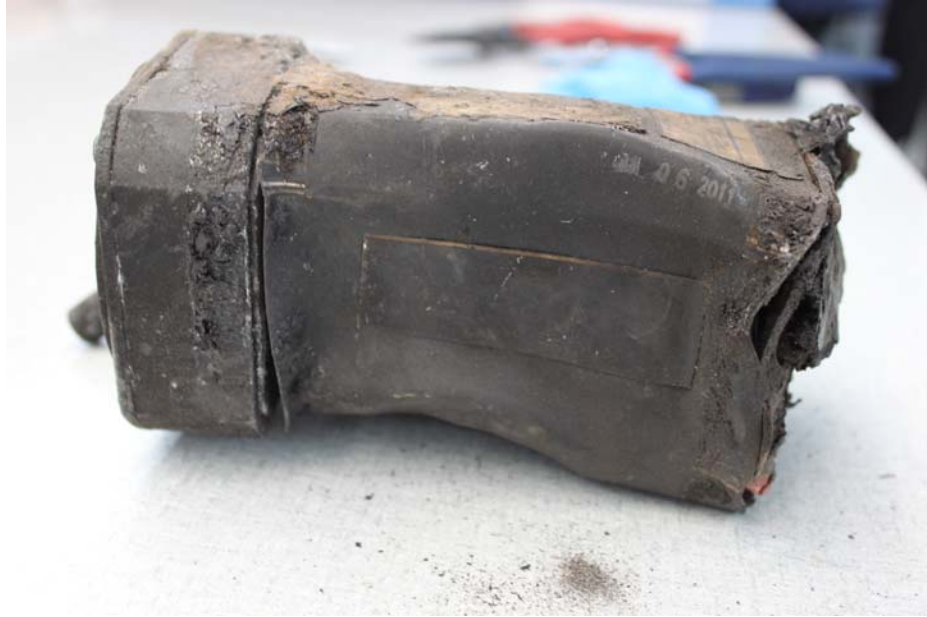
Figure 7: Photograph depicts the impact damage to the side of the directional gyro.

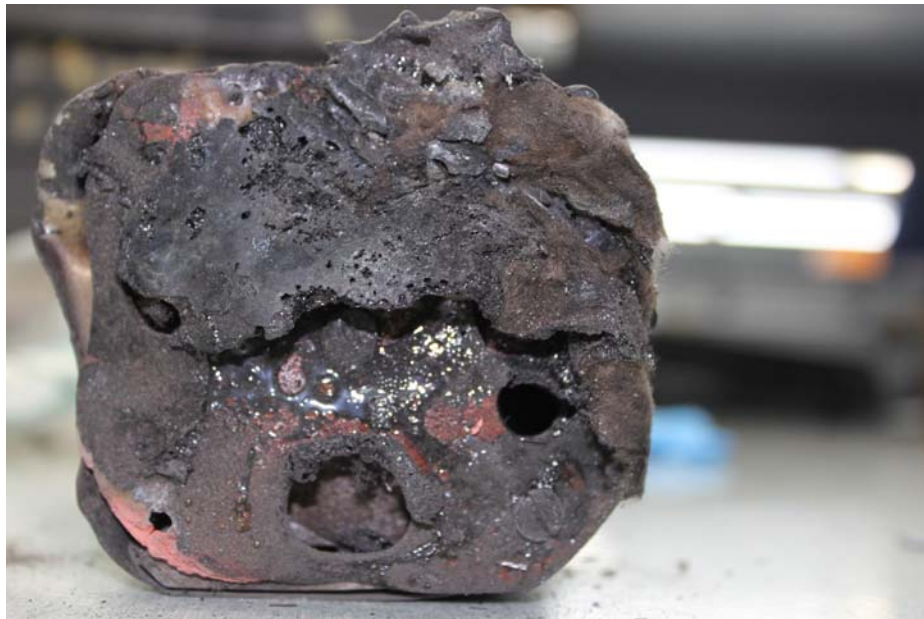
Figure 8: Photograph depicts the back portion of the directional gyro.

The glass bezel was broken, the knob shaft was bent down, and the rear plate exhibited extensive heat damage. The compass card was on heading 240 degrees. The housing was cut open to facilitate access to the rotor housing.

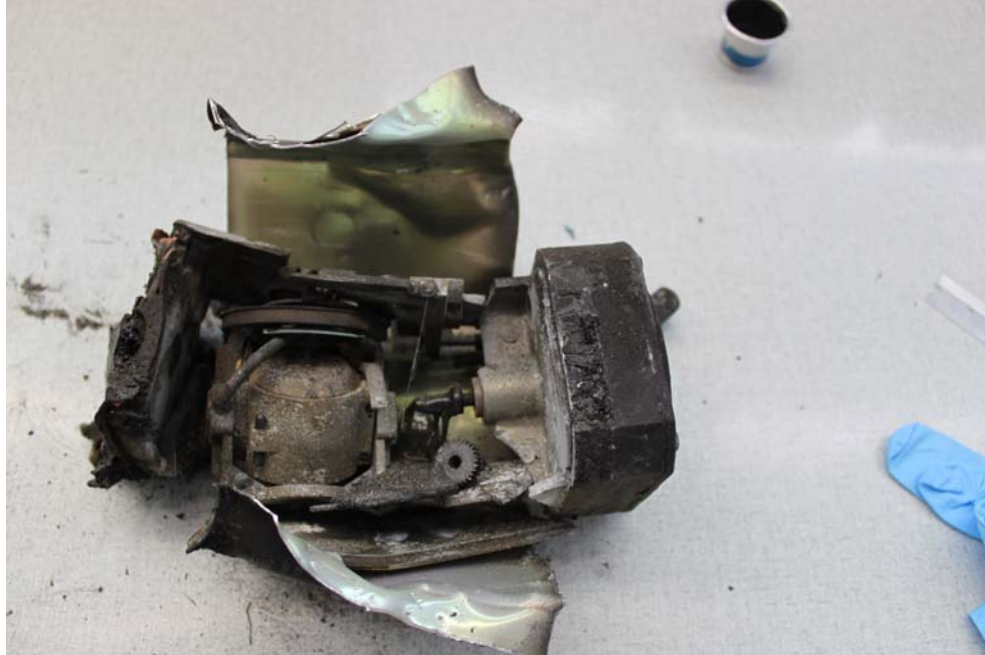
Figure 9: Photograph depicts the instrument following cutting of the housing.

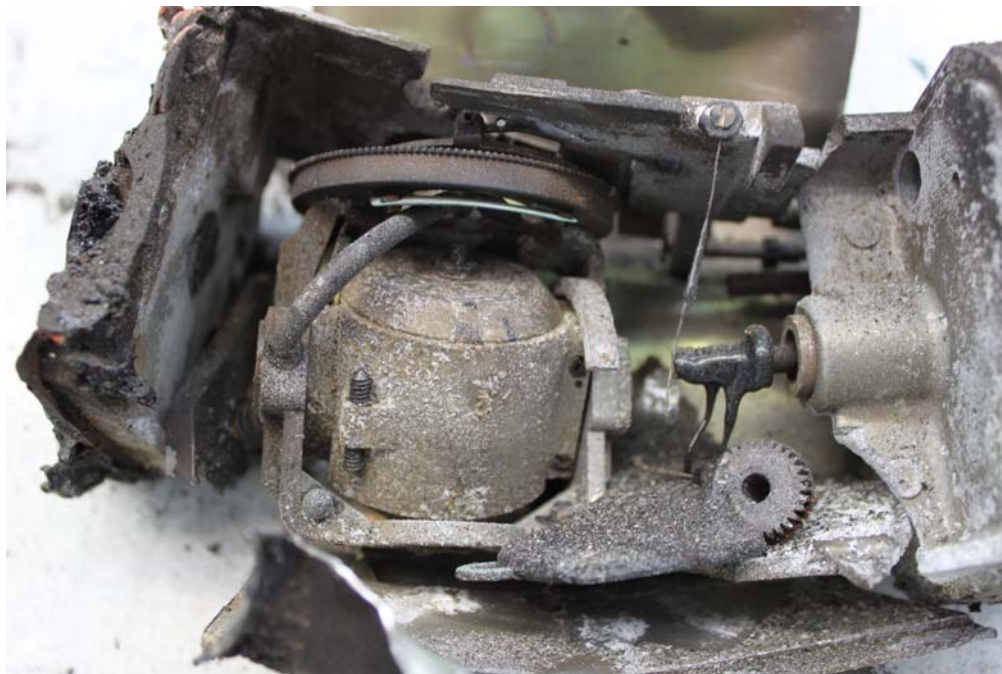
The frame was fractured in multiple locations, but the rotor housing remained installed in the gimball ring. The rotor housing was noted to rotate freely in the gimball ring.

Figure 10: Photograph depicts the rotor housing installed in the gimball ring.

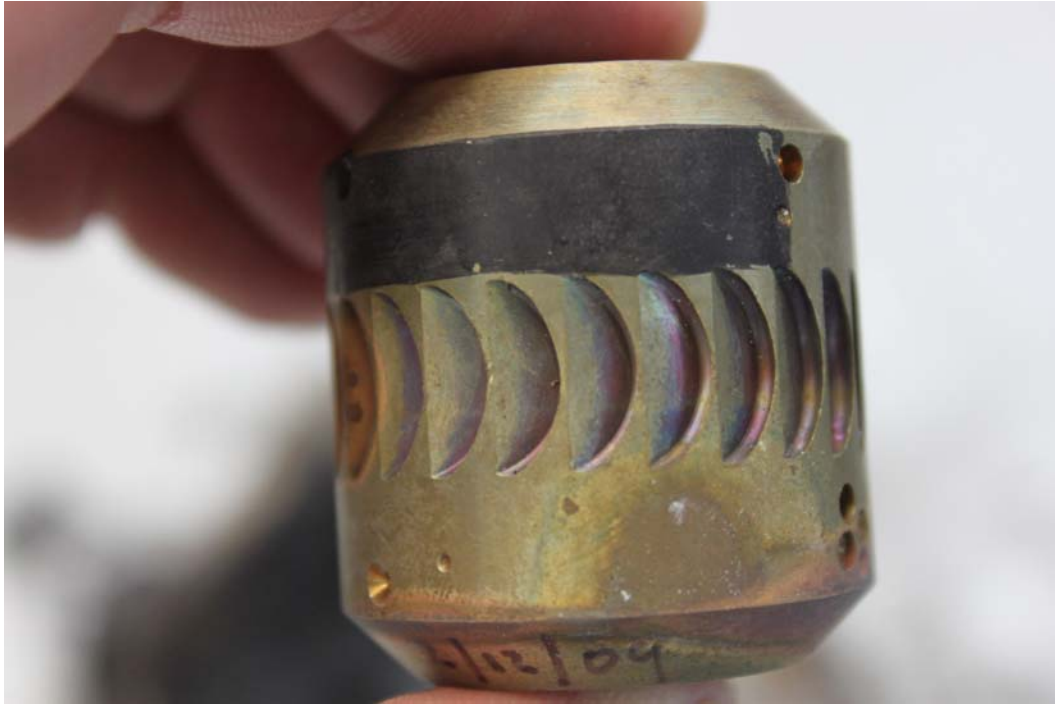
The rotor was removed from the rotor housing and both were inspected for signs of rotational scoring; none was noted. An ink mark on the end of the rotor depicted

“2/12/09”. The rotor bearings felt OK. Heat damage was noted to the rotor. One rotor assembly axis support was broken, and the phenolic gear train was melted.

Figure 11: Photograph depicting the rotor.
