**WCB MD-82/JT8D-217A/C Venezuela Event**  
**Analysis of Engine EPR and ATS Modes - Subframes 10000 to 11200**  
**Based on NTSB FDR processed data from 27Oct 2005 (EPR2 data “cleaned up”)**

# West Caribbean Airways, MD-82, HK-4374X

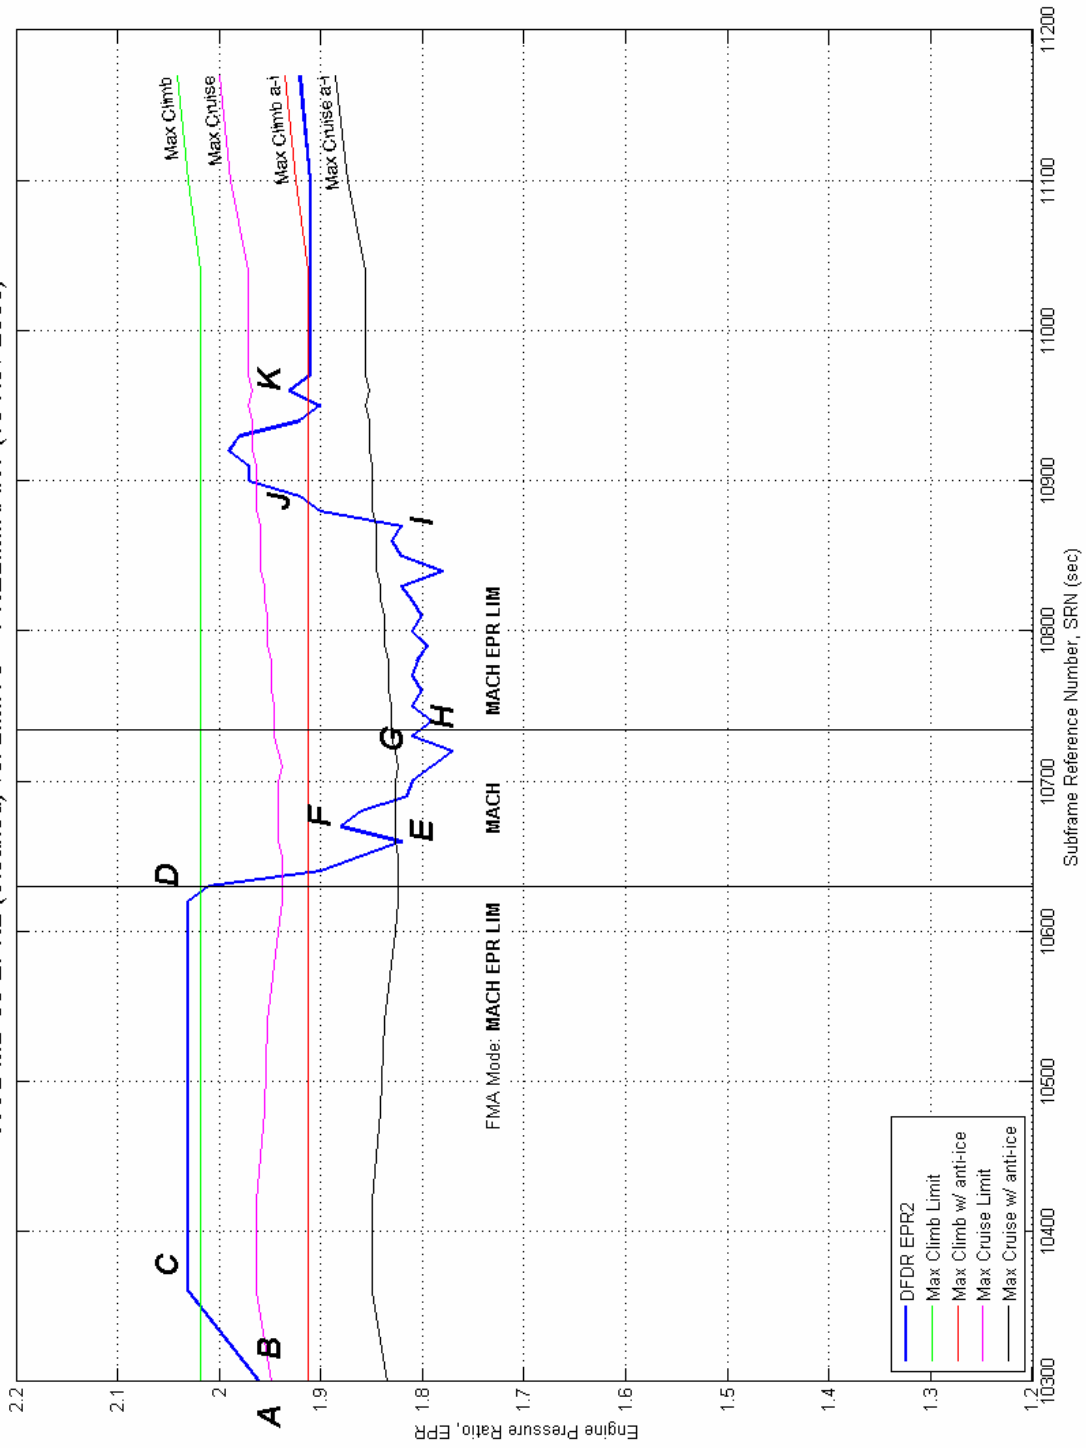
WCB MD-80 EPR2 (Cleaned) vs. LIMITS -- PRELIMINARY (15-Nov-2005)

Marker	Subframe Ref Number	Commentary
A	10270	<p>During the step climb from FL310 to FL330, the Auto Throttle System (ATS) mode automatically changed from <i>EPR Limit (Climb)</i> to <i>Mach EPR Limited</i>.</p> <p>The airplane could not maintain the selected target Mach (in climb) within the existing EPR limit constraint. Prior to the mode switch, the EPR limit corresponded to Max Climb (MCL) with engine ice protection on.</p>
B	10315	<p>It appears that Engine Anti-Ice (EAI) was switched off (~45 seconds after mode change) which resulted in the observed EPR increasing to MCL (no anti-ice).</p>
C	10370	<p>The ATS would normally automatically revert from <i>EPR Limit (Climb)</i> to <i>Speed</i> or <i>Mach</i> mode as a pre-selected target altitude is reached. At the FL330 level-off, since the airspeed was below target Mach (~ 0.76, as determined by the PMS), the thrust remained at MCL until the target Mach was attained.</p>

D	10630	<p>The ATS reverted to <i>Mach</i> mode. The throttles maintained an EPR sufficient to sustain the target Mach in level flight. At this time, the Max Cruise (MCR) EPR limit is typically manually selected on the Thrust Rating Panel (TRP).</p>
E	10660	<p>This initial undershoot (to 1.82) of the apparent desired EPR of 1.85 to 1.90 is not unusual during mode changes in similar conditions.</p>
F	10670	<p>Over the next 30 seconds, EPR rose back to 1.88 EPR, then reduced to a level at or below the MCR limit with both engine and airfoil ice protection (EAI and AAI) on.</p> <p>It is possible that the engine and airfoil ice protection was switched on near this time and would account for the initial large EPR fluctuation.</p>
G	10720	<p>The airplane maintained the target Mach for roughly 90 seconds then the airspeed began to decrease.</p>
H	10735	<p>The ATS mode changed to <i>Mach EPR Limited</i>, meaning that the current selected EPR limit (on the TRP) was insufficient to maintain the target Mach number. The EPR appears to have been constrained to the MCR (EAI+AAI) limit. The airspeed continued to decrease.</p>

Marker	Subframe Ref Number	Commentary
I	10870	<p>The MCR (EAI+AAI) limit increased slowly as the airspeed dropped, allowing a marginal amount of extra thrust. Mach number had dropped to 0.70.</p> <p>Since the <i>Mach EPR Limited</i> mode was still active, presumably at the MCR (EAI+AAI) limit, the ATS should not have been able to accelerate the engines at this point without additional crew actions. These might have included a combination of: 1) pilot pushing the throttles forward manually, or 2) pilot turning off ice protection (providing an additional 0.115 cruise EPR), or 3) pilot selecting MCL or MCT on the TRP (presumably while leaving all ice protection on).</p>
J	10880	<p>During the engine accel, the EPR is seen to hesitate at the MCL (EAI+AAI) limit on the way to an EPR above MCR (no AI). The hesitation is <b>not</b> typical of an ATS accel directly to the MCR (no AI) EPR limit, suggesting crew action of some sort at this point.</p>

K	10960	<p>The EPR level is observed to retreat to a level consistent with MCL (EAI+AAI), and this EPR limit was maintained as airspeed (and TAT) continued to decline.</p>
L	11220	<p>The airplane continued to slow down with thrust constrained by the MCL (EAI+AAI) EPR limit, until dual engine rollbacks occurred as the airplane descended through FL320.</p> <p>The engines do not appear to go sub-idle. They maintained an above-idle EPR, in the 1.0 to 1.2 range.</p>
