PII
 Engineer 1 Lab & Testing Services
 Technical Research & Development

Project ID: 2010100401 (revised UT section)

Subject: Number-3 wheelset off of BN 534967 involved in a derailment at Crawford, NE on 9/25/2010, Accident ID: PR-0910-106

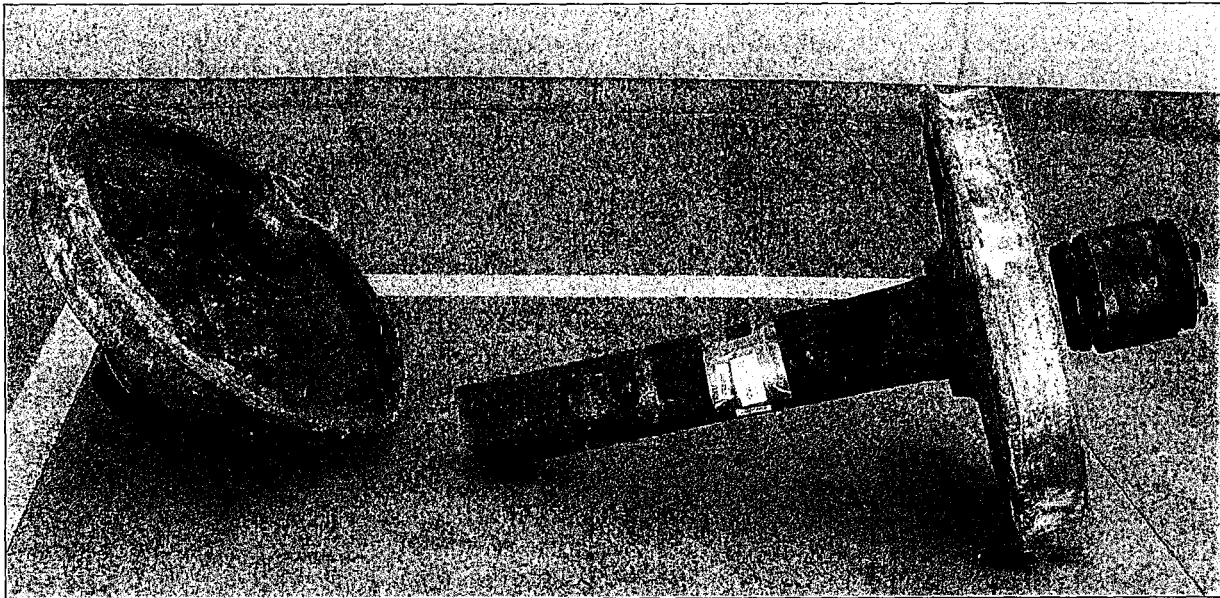
The number-3 wheelset off of BN 534967 with a broken axle between the wheels was received, see Figure 1. The following information was taken from the wheelset:

Figure 1: Number-3 axle off of BN 534967 as received.

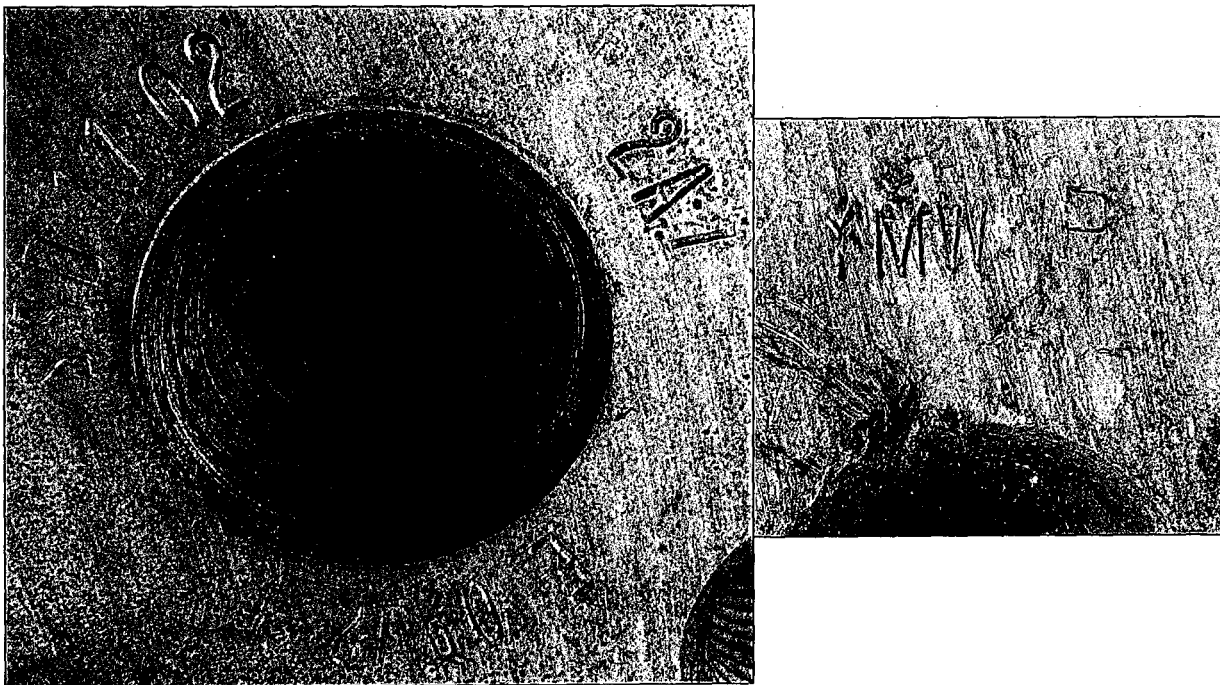
The axle was manufactured by Standard Steel Division in November 2002, see Figure 2. The current wheels and bearings were mounted on the axle by BNSF Railway in May 2009 and installed under BN 534967 in June 2009.

Figure 2: Stamped information taken from the axle ends.

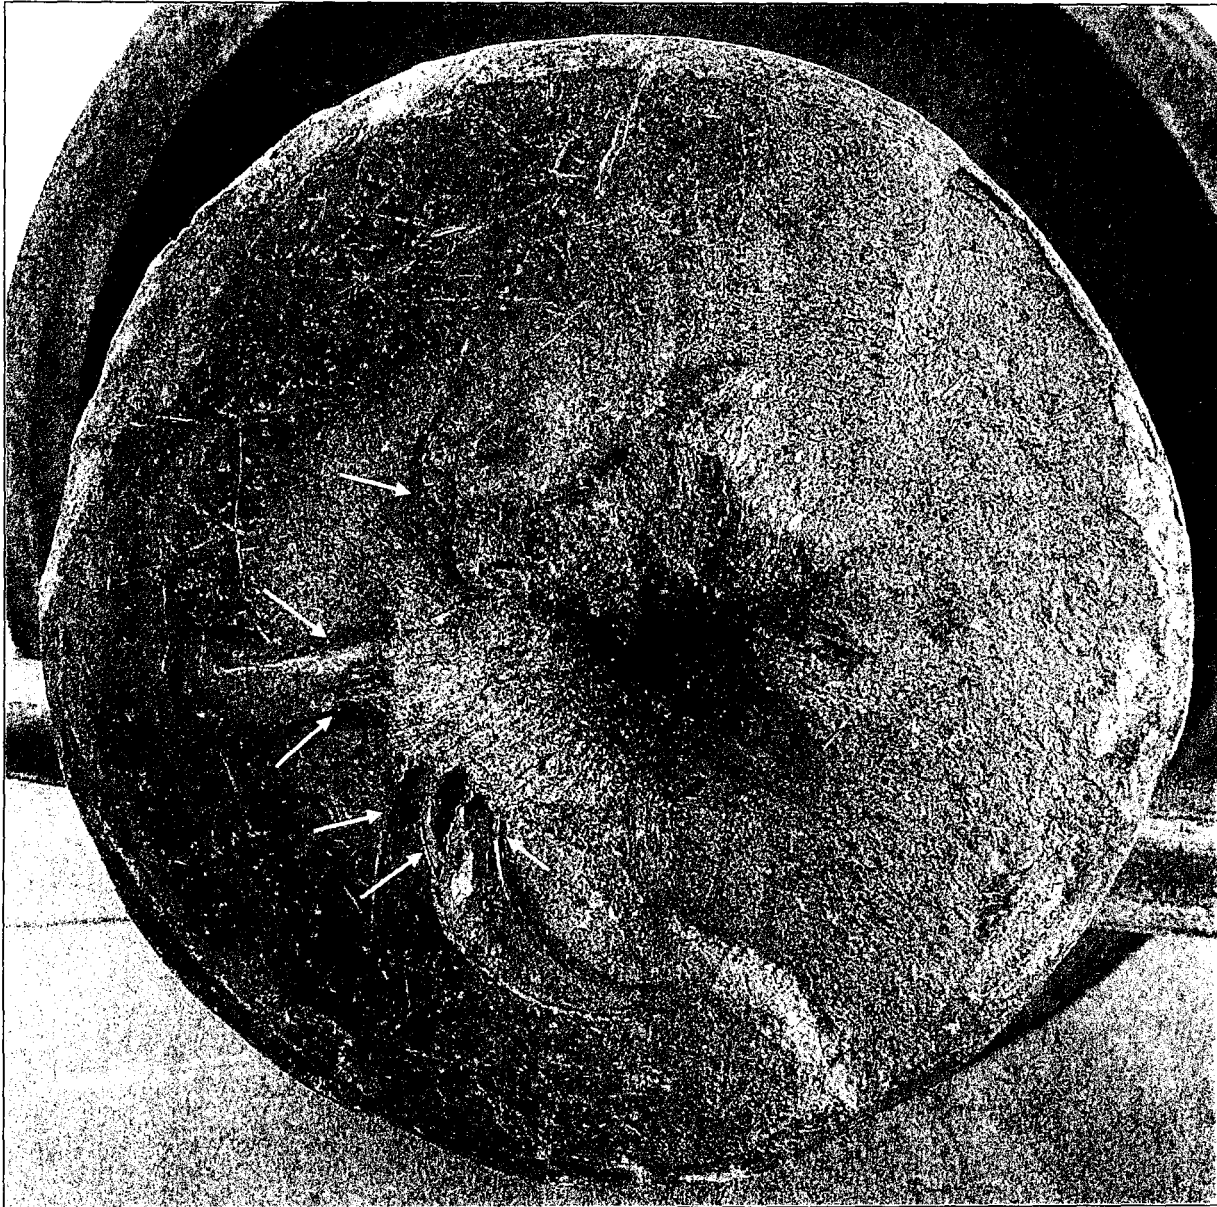
Examination of the fracture faces revealed a large void, which originated during the manufacturing process, in the center of the axle, see Figures 3 and 4. The void covered approximately 15 percent of the fracture face and was located approximately 27-inches from the end of the axle. Multiple fatigue origins (ratchet marks) grew from the void, indicating the void was the cause of the axle failure. The fatigue grew to 60 percent of the cross section before rapid brittle fracture of the remaining 25 percent.

The void in this axle should have been detected at the time that it was ultrasonically tested and the axle should not have been placed in service.

This axle failed due to the large void in the axle body. This void was a manufacturing defect which should have been detected during the ultrasonic inspection at the manufacturing plant.

Figure 3: Fracture face view taken from the long axle end. Ratchet marks pointing to the void as the failure origin (yellow arrows).

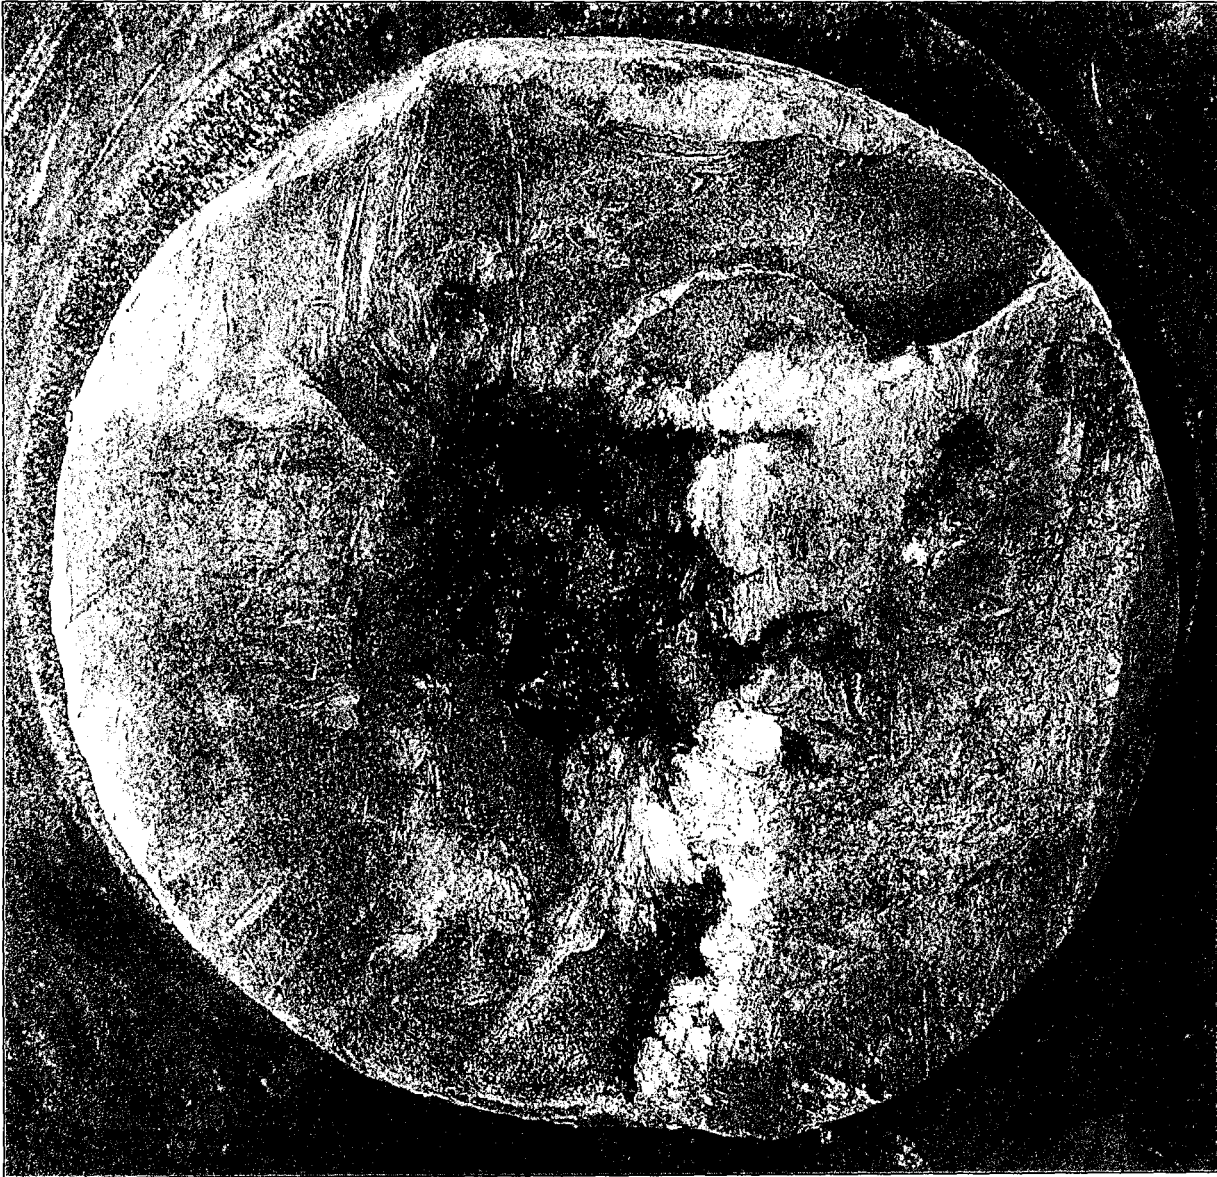
Figure 4: Fracture face view taken from the short axle end.

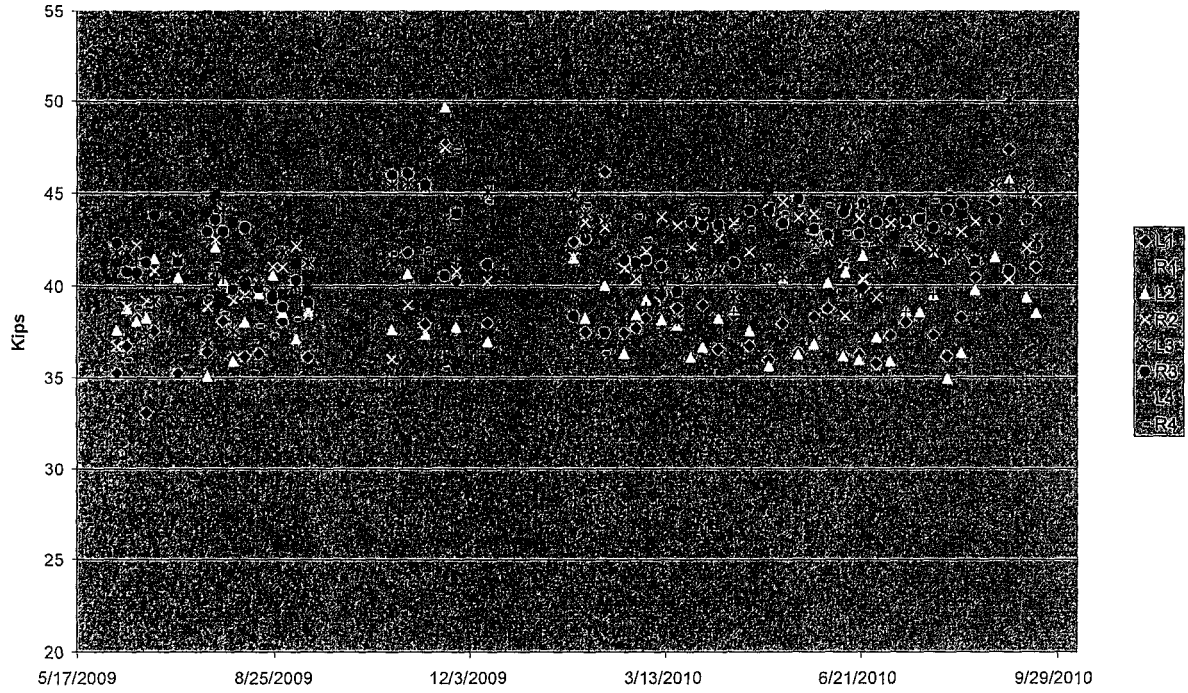
The wheel history of the car was researched using the wheel impact load detector (WILD) data. No impacts exceeding 90 kips were found for car BN 534967 from the time when the wheelset was installed under BN 534967 in June 2009 until the failure on September 25, 2010. The impact history for this time period was graphed and can be seen in Figure 5.

Figure 5: Loaded wheel impact data for BN 435967 from June 2009 to September 25, 2010
