## DERAILMENT General Report

Reference Description: **Broken Axle - Derailment- South Morrill Yard, NE-MP 162- COEH 6962- L3, CNAOV-19**

Project History Number (PH#): **36-2010-012**

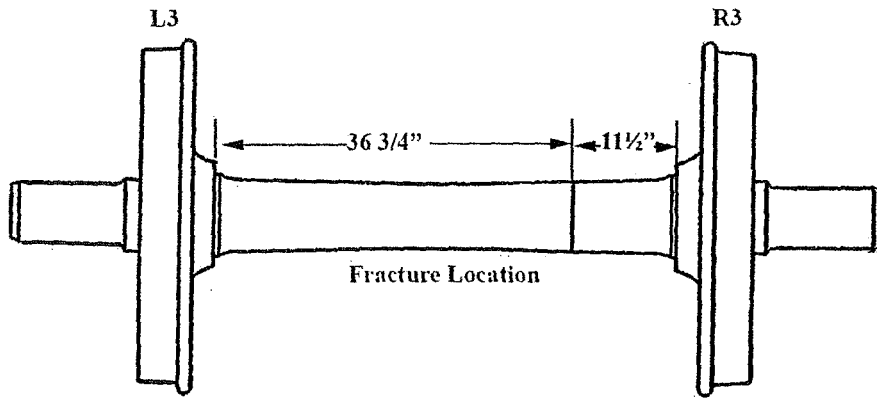
A visual inspection of the wheel set revealed that the fracture occurred approximately one quarter of the distance between the back wheel hubs, as shown in Figure 1. The two sections of the broken wheel set are shown in Photographs 1 and 2. Photograph 3, shows that the origin of the axle failure is a forging burst located on the center line of the axle. The forging burst originated the fatigue cracking, which grew around the void until approximately 60% of the axle was fractured, at which time the axle failed due to overload fracture.

Figure 1: Drawing of wheel set showing the location of the axle defect.

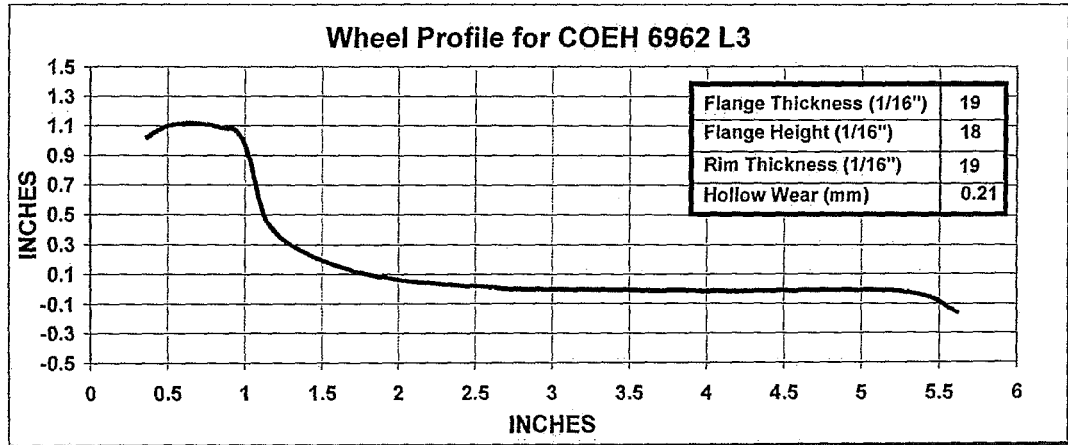
The wheel profiles for both the failed and mate wheels were captured using a LazerView digital gage. The profiles are shown below in Figures 2 and 3. No exception is taken with the wheel profiles.

Figure 2: Wheel profile for the wheel in the L3 position.

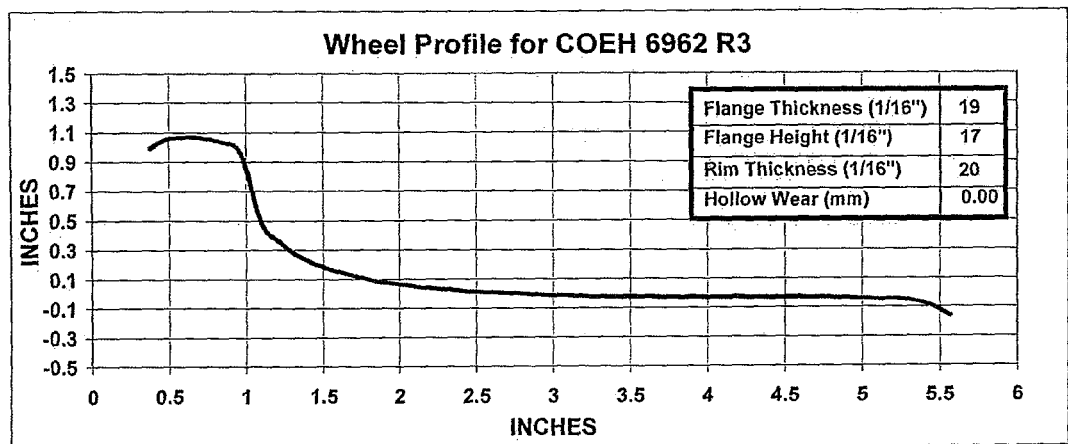
Figure 3: Wheel profile for the wheel in the R3 position.

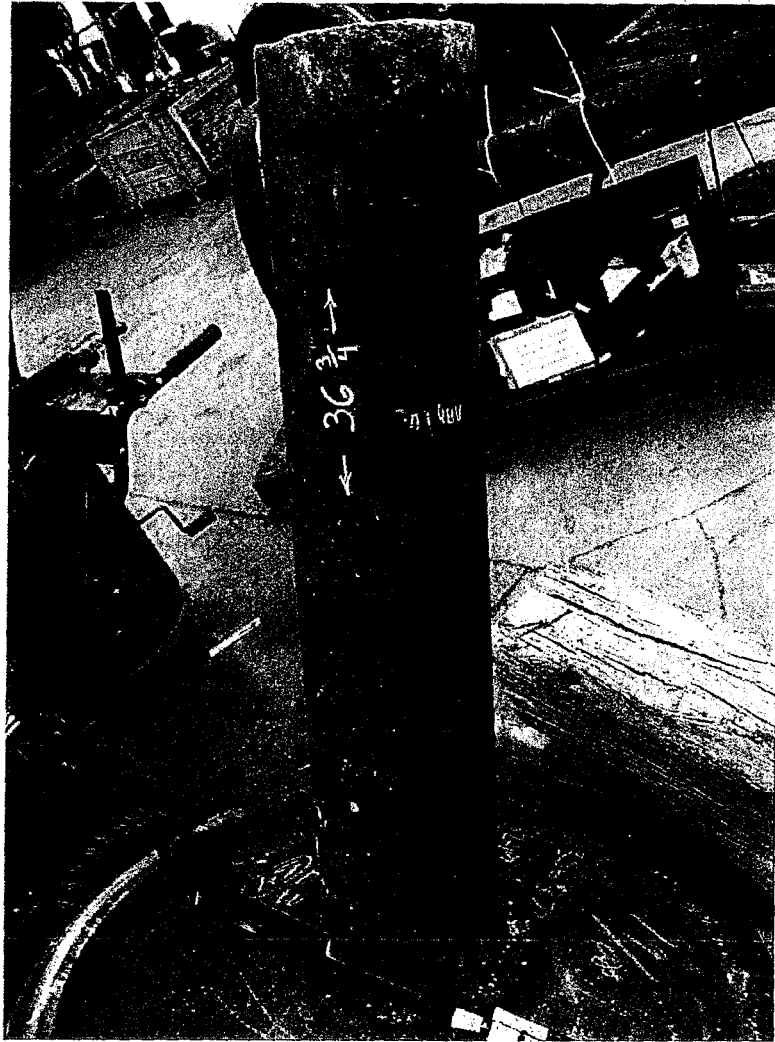
Photograph 1: The L3 side of the broken axle as received at the Laboratory.

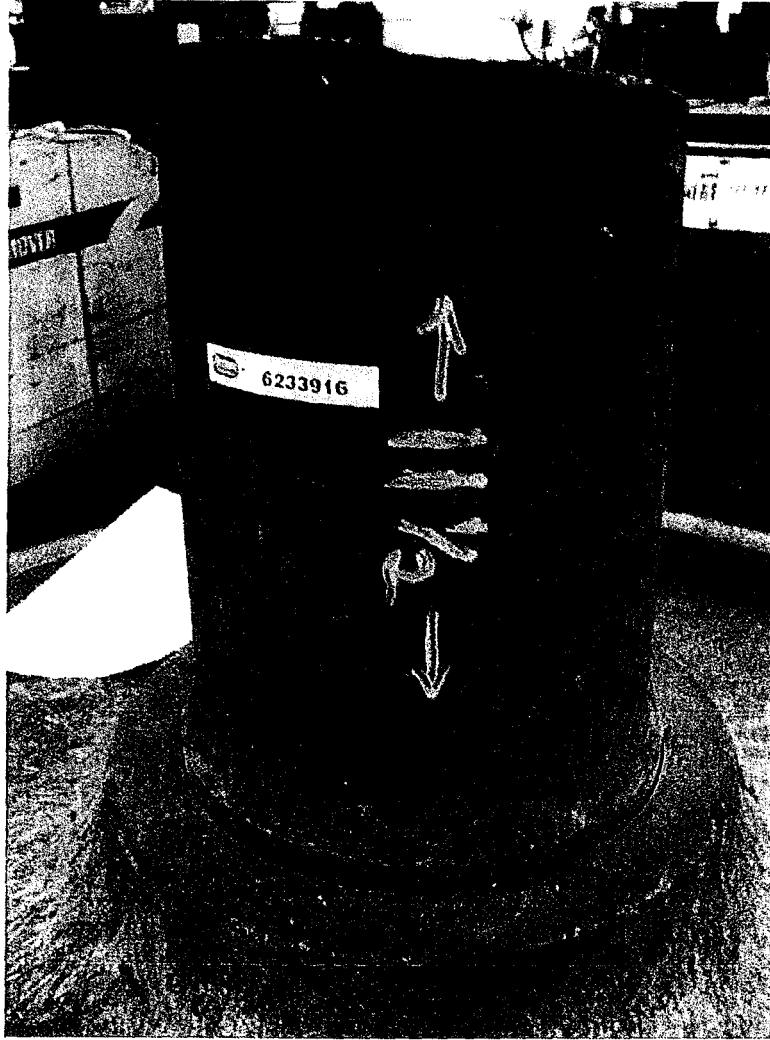
Photograph 2: The R3 side of the broken axle as received at the Laboratory.

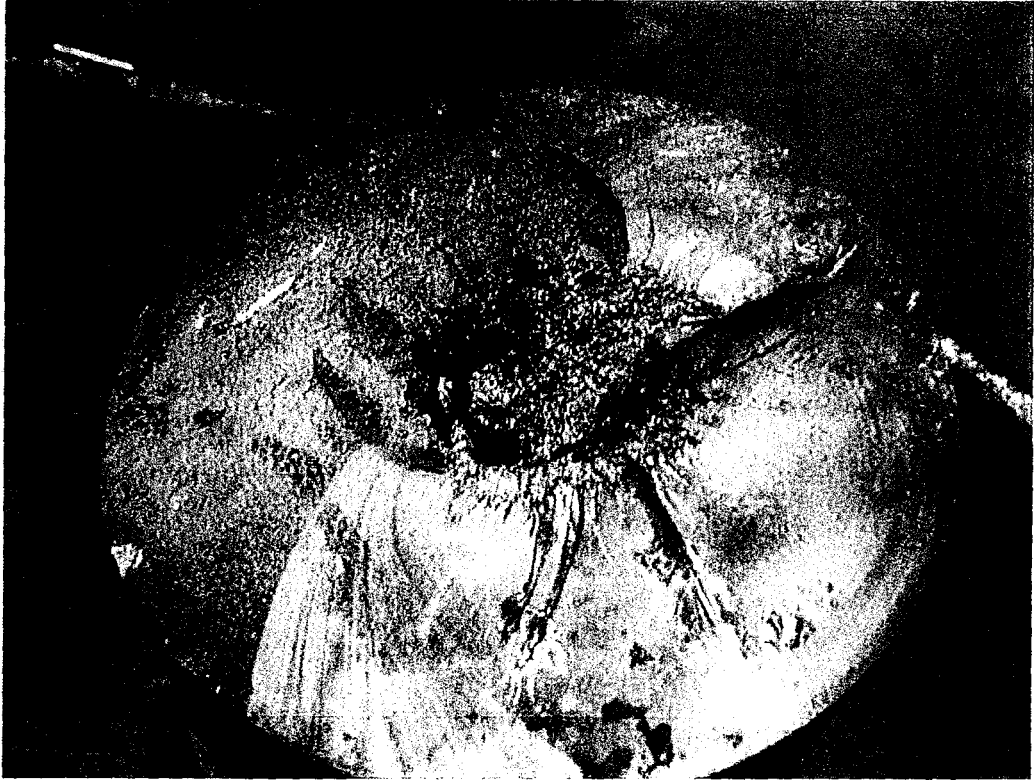
**Photograph 3: View of the forging burst in the center of the axle on the R3 side.**

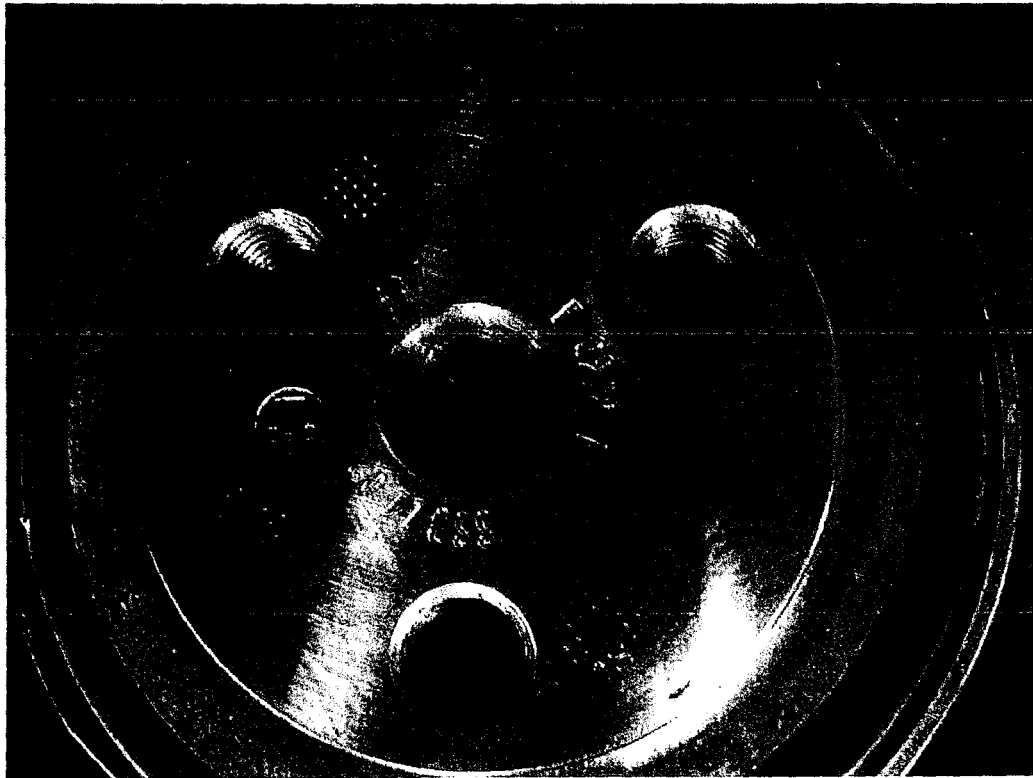
This forging burst should be detectable by ultrasonic inspection as detailed in the AAR Wheels & Axles manual, sections 16 through 20. As shown in Photograph 4, this axle was stamped with a circle "T", indicating that it was ultrasonically inspected.
