ALERT SERVICE BULLETIN

Bell Helicopter **TELEXTRON**

SUBJECT: ALERT SERVICE BULLETIN 206L-87-47, REV. "C", TAIL-BOOMS, P/N 206-033-004-3/-11/-103/-45, INSPECTION AND MODIFICATION OF

MODEL AFFECTED: 206L, 206L-I, 206L-III
SUBJECT: TAILBOOMS, P/N 206-033-004-3/-11/-103/-45 PERIODIC INSPECTION OF, MODIFICATION OF

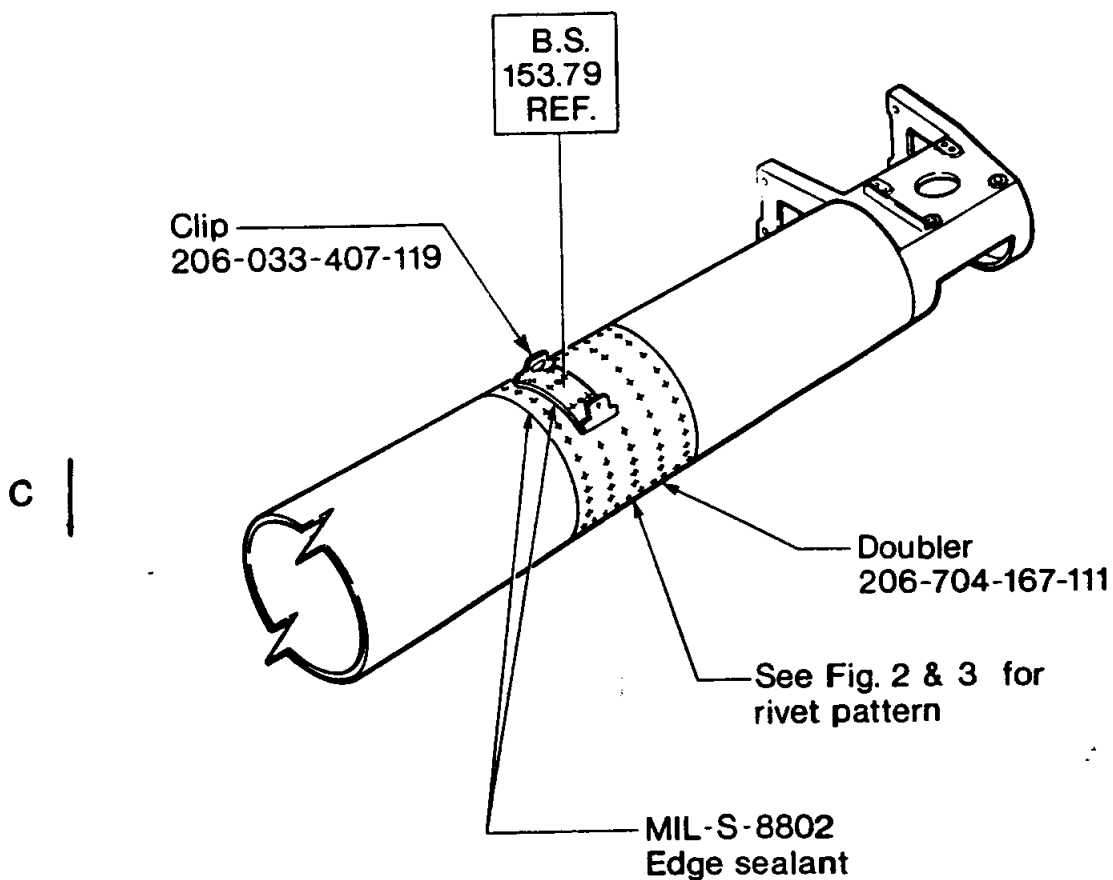
FIGURE I

206L SERIES TAILBOOM
CLIP MODIFICATION
B.S. 153.79

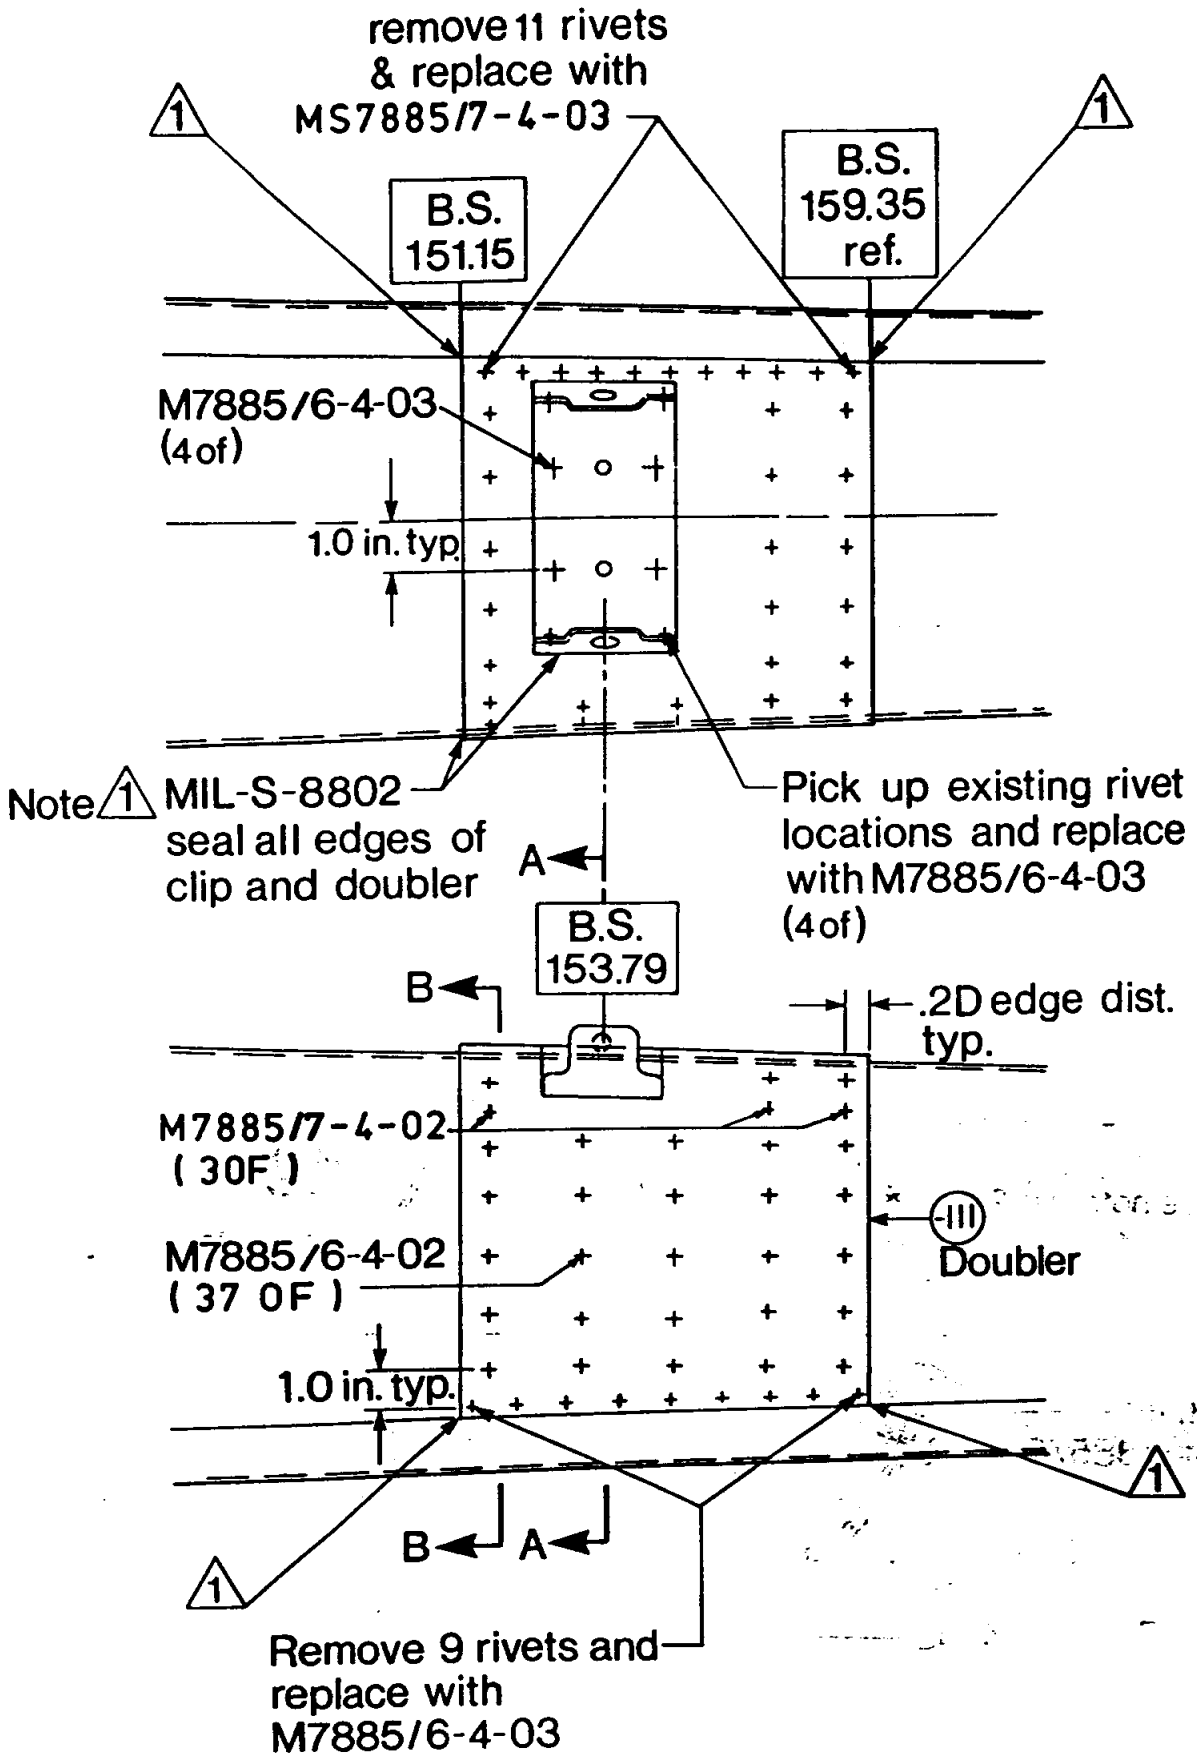
FIGURE 2

- 4) Remove rivets along upper and lower skin seams between B.S. 151.15 and B.S. 159.35. (Approx. 11 rivets on upper and 9 rivets on lower.) See Fig. 2.
- 5) Strip paint from area of top skin between B.S. 151.15 and B.S. 159.35 and from new clip faying surface.
- 6) Fit doubler P/N 206-704-167-111 to tailboom such that leading edge of doubler is at B.S. 151.15 and drill to match existing holes along seams and 4 existing clip rivet holes.

- 13) With adhesive applied to faying surfaces of doubler and tailboom, position doubler and secure using appropriate rivets, per Figure 2.
- 14) Apply adhesive to top of doubler and to clip faying surfaces, position clip on doubler and secure to tailboom using 8 M7885/6-4-03 rivets.

- 17) Apply a brush coat of alodine to bare aluminum areas and to rivet heads.
- 18) Seal all edges of doubler and clip using MILS8802. (See Fig. 2.)
- 19) Prime using polyamide epoxy primer and repaint affected area. | "C"

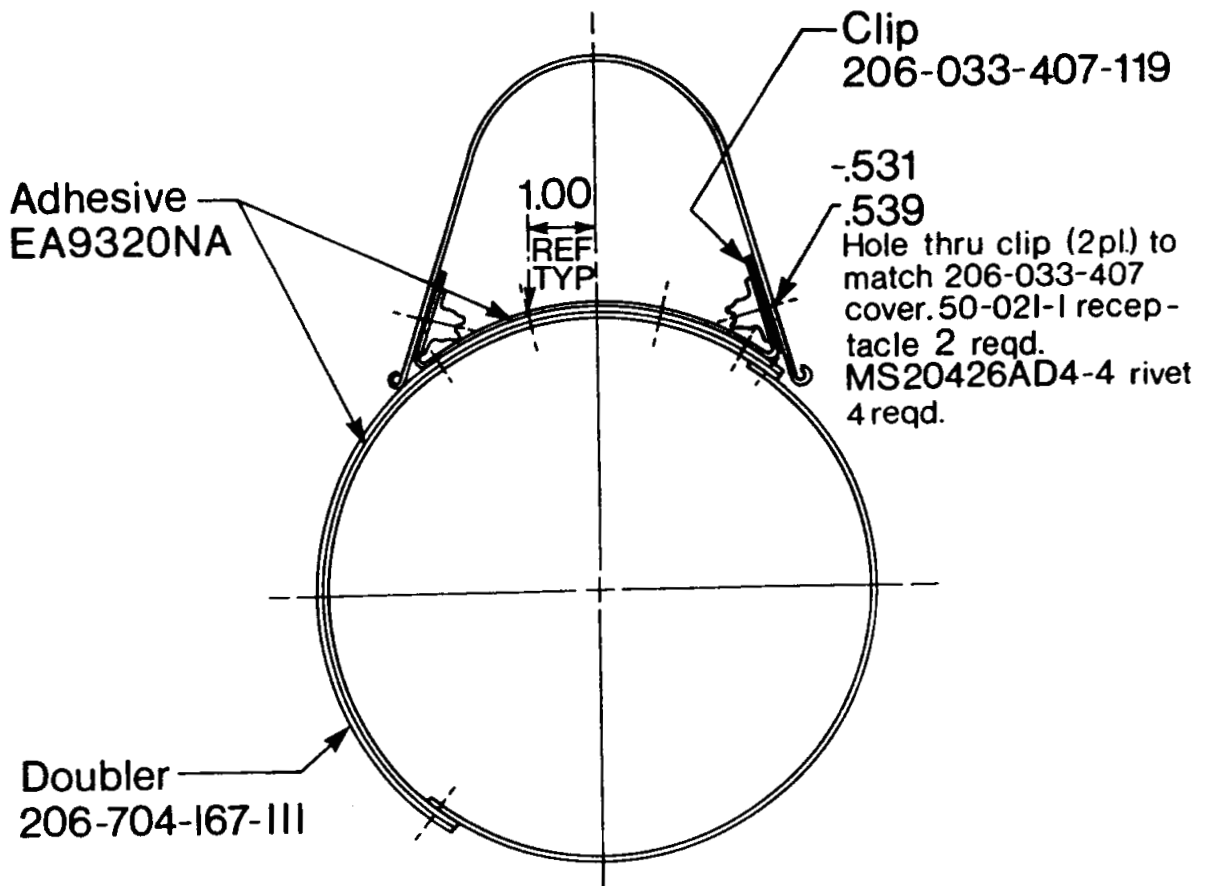
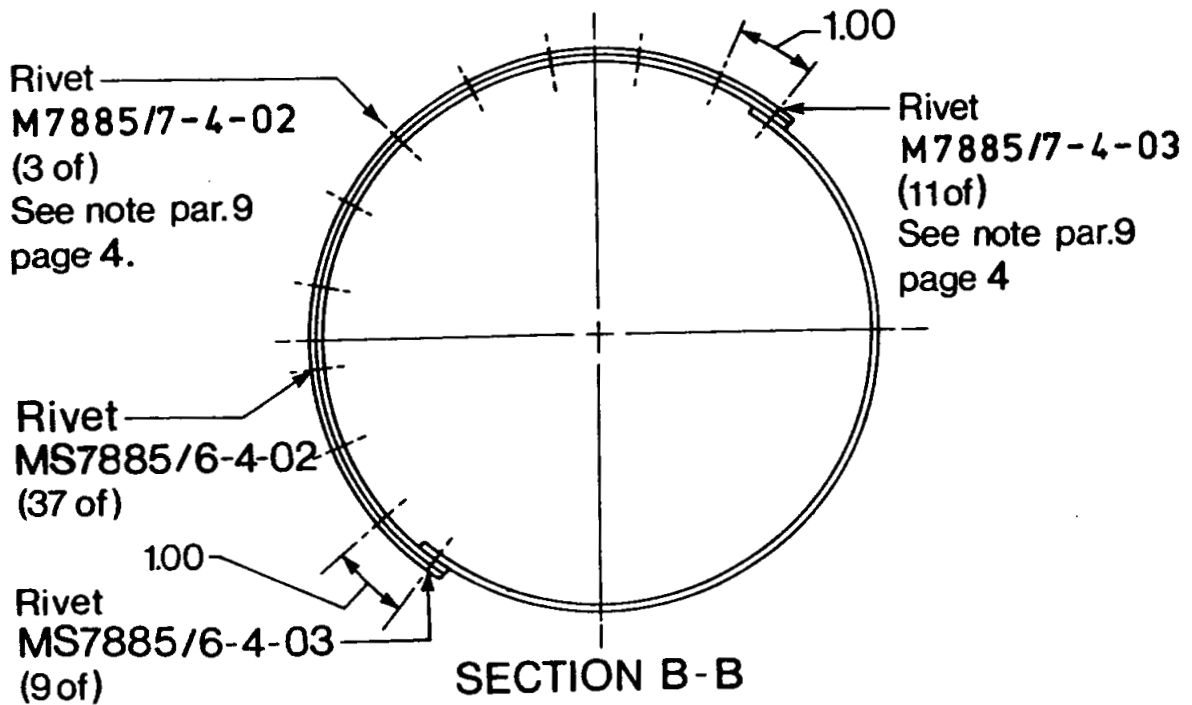
FIGURE 3

- 1) Doubler rivet rows are spaced 1.0 inch from seam rivet lines. See Figure 3, Sec. B-B.
- 2) Five (5) rows of rivets are equally spaced from front to back of doubler. Maintain a 2D edge distance. See Figure 2.
- 8) With doubler held in place, position saddle clip, P/N 206-033-407-119, at B.S. 153.79 to align with T/R drive shaft cover and pickup on 4 existing clip rivet holes. In addition, drill two rivet holes 1.0 inch each side of the longitudinal C/L of tailboom. Maintain 2D edge distance. See Figures 2 and 3, Sec. A-A.
- 9) Drill all holes in tailboom, doubler and clip to proper rivet hole size. Countersink to a max. depth of .038 inch in 14 places for M7885/7 or NAS1739B4 rivets (see Figure 2 and 3 for locations). Remove clip and doubler and deburr holes both sides including tailboom skin.

- 16) Install receptacle P/N 50-021-1 on clip. Position to match P/N 206-033-407 cover and secure using MS20426AD4-4 rivets. (See Fig. 3), Sec. A-A. Ensure that fastener stud does not come into contact with clip saddle when secured.

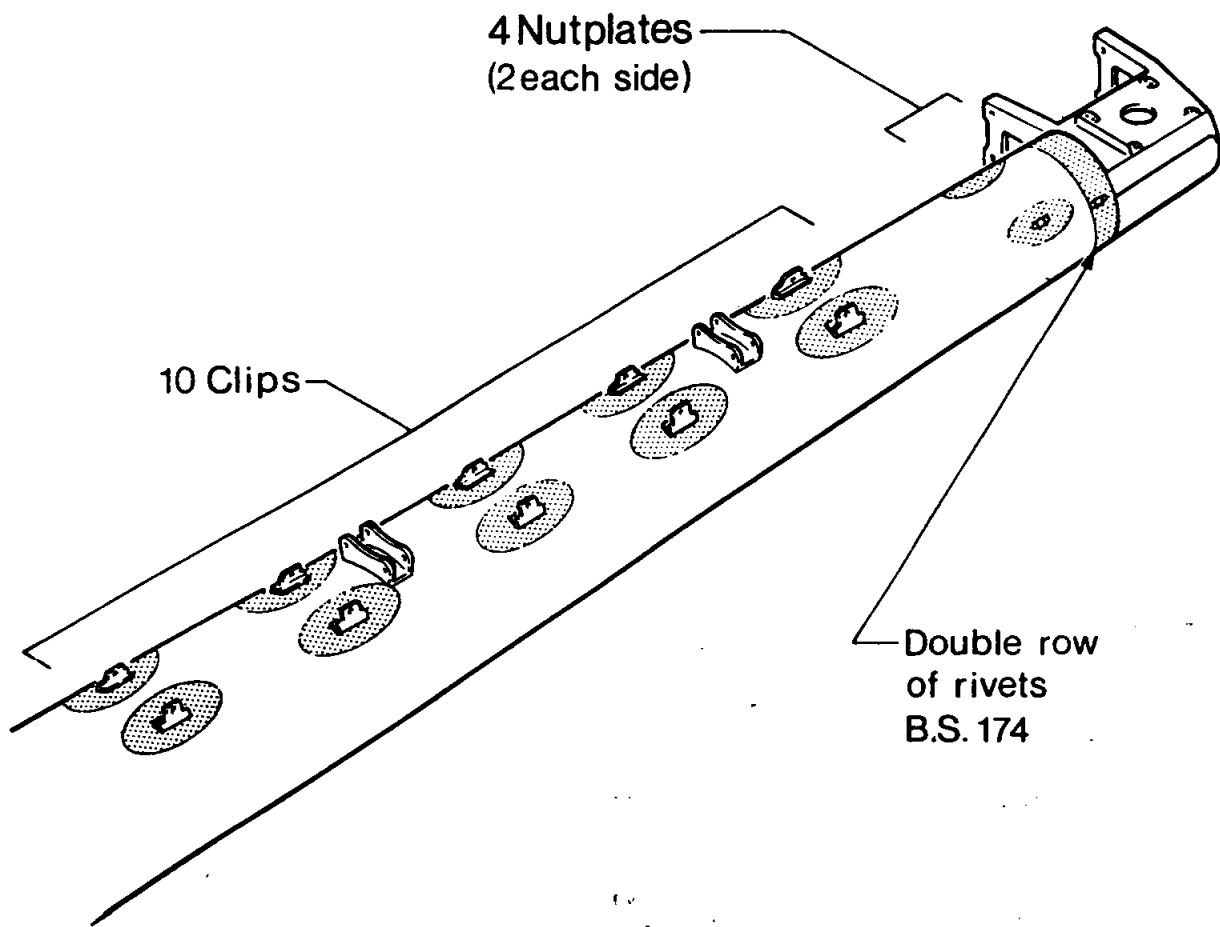
FIGURE 4

- 3) Prior to cleaning, use a min. 5 power magnifying glass to inspect for cracks and signs of developing cracks at the following locations: (See Fig. 4)

- A) Aft of stabilizer assy, around rivets which attach the tail rotor drive shaft cover retention clips to the tailboom.
 - B) Area of tail rotor gearbox fairing attachment nut plate rivets.

- C) area of double row of rivets which attach the tail rotor gearbox support fitting to the tailboom (B.S. 174).
- 4) Clean entire tailboom taking particular care to remove all grime and dirt in specified area of inspection and repeat min. 5 power inspection as per sub-paragraph 3.

- 5) Visually inspect entire tailboom in accordance with maintenance manual.
- 6) Replace any loose or working rivets found.
- 7) Replace anti-chafing tape removed as required.

- 8) In the event that cracks are found, you are requested to contact:

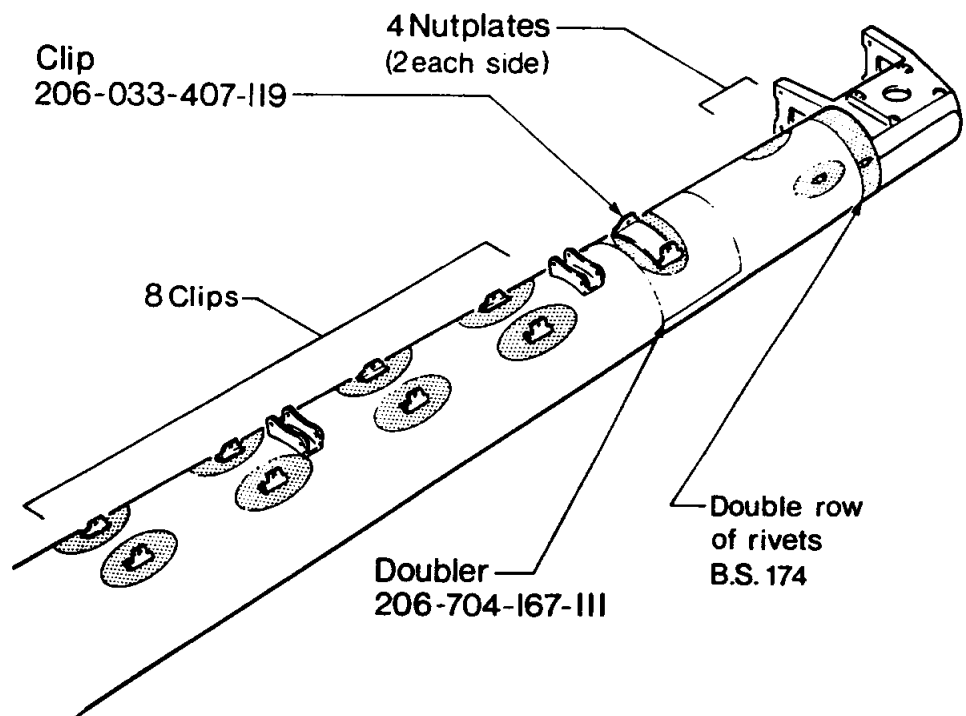
FIGURE 5

- 1) Inspect as per PART II. (Refer to Fig. 5)
- 2) Inspect doubler and clip edge sealant for integrity. Reseal as required. (See Fig. 2)
