Brotherhood of Locomotive Engineers and Trainmen

Before the National Transportation Safety Board

NTSB Accident Number: DCA-15-MR-010

Proposed findings, probable cause, and safety recommendations, in connection with the derailment of National Railroad Passenger Corporation (“Amtrak”) train No. 188 on May 12, 2015 in Philadelphia, Pennsylvania.

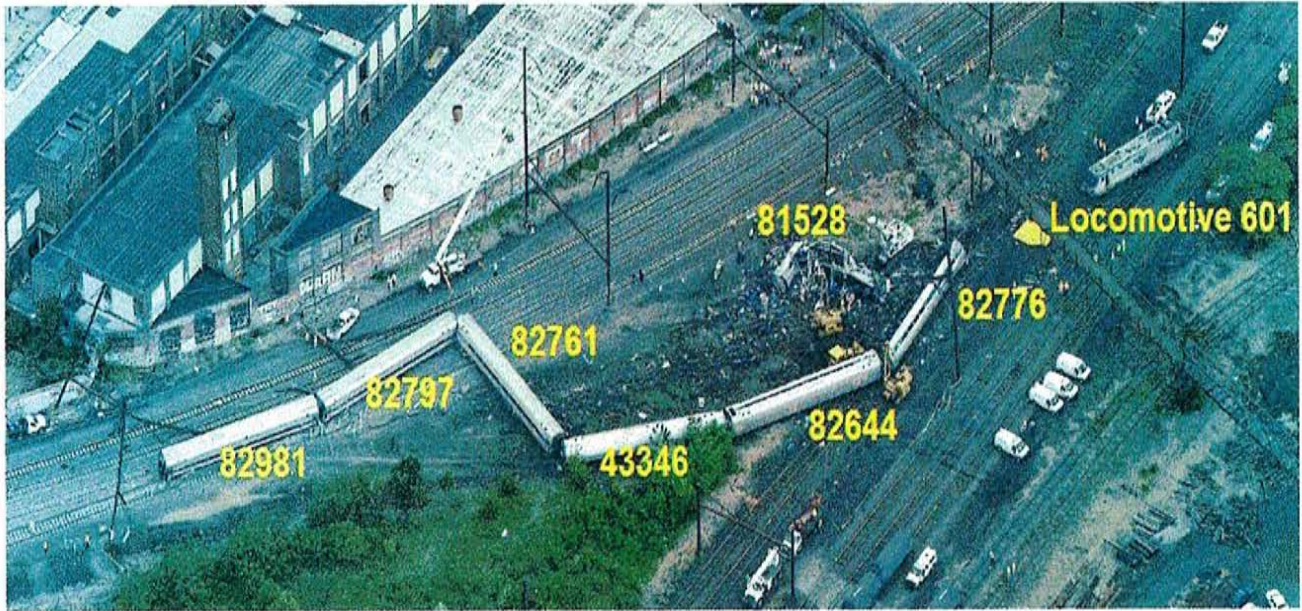
ATK 188 train entered a maximum authorized speed (“MAS”) curve of fifty (50) miles per hour (“MPH”) at an estimated speed of 106 MPH,³ derailing at a speed of approximately 102 MPH. The derailment resulted in eight (8) passenger fatalities and over 200 injuries.

Figure 1 aerial photo of derailment
