**BROTHERHOOD OF LOCOMOTIVE ENGINEERS
AND TRAINMEN**

BEFORE THE NATIONAL TRANSPORTATION SAFETY BOARD

NTSB Accident Number: DCA-13-MR-004
Class: MAJOR

Final Submission

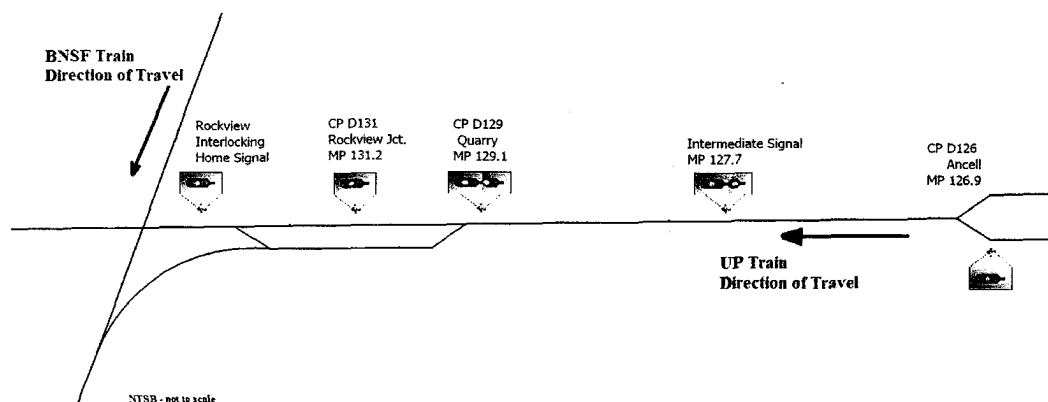
Figure 2: Signals Encountered by Union Pacific Train.

Based upon data obtained from the signal log, the UP lead locomotive’s Track Image Recorder, and the UP conductors written signal log book, the UP train encountered an Advance Approach³ signal (flashing yellow aspect) at Mile Post (MP) 127.7. The next signal, at MP 129.0, was displaying an Approach⁴ aspect (continuous yellow). At MP 131.1 the signal displayed a Restricting⁵ indication (flashing red aspect). The last signal the UP crew encountered before striking the BNSF train was the home signal at the Rockview Interlocking (MP 131.4), which was displaying Stop⁶ (continuous Red aspect).

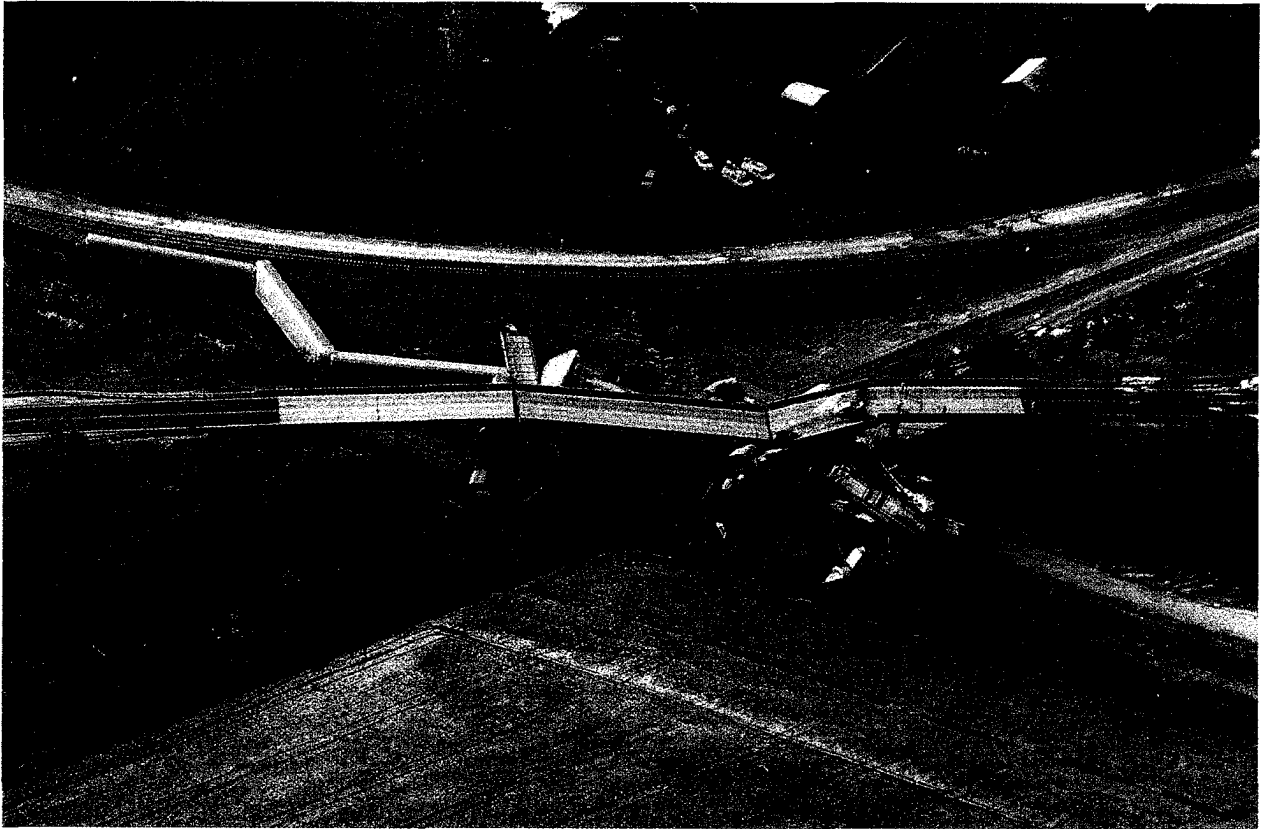
Figure 3: Aerial view of accident scene

UP train No. 2-ASMAR-25 entered the interlocking at a speed of forty-three (43) miles per hour (UP timetable maximum authorized speed of forty (40) mph). The UP train collided with the twelfth (12th) car of the BNSF train, resulting in the subsequent derailment of both trains. Both locomotives of the UP train rolled onto their sides after hitting the freight cars of the BNSF train.
