Brotherhood of Locomotive Engineers and Trainmen

Before the National Transportation Safety Board

NTSB Accident Number: DCA-17-FR-009

Proposed findings, probable cause, and safety recommendations, in connection with Long Island Rail Road (“LIRR”) commuter Train No. 7623 fatally striking a LIRR Maintenance of Way Track Foreman in Queens, New York on June 10, 2017.

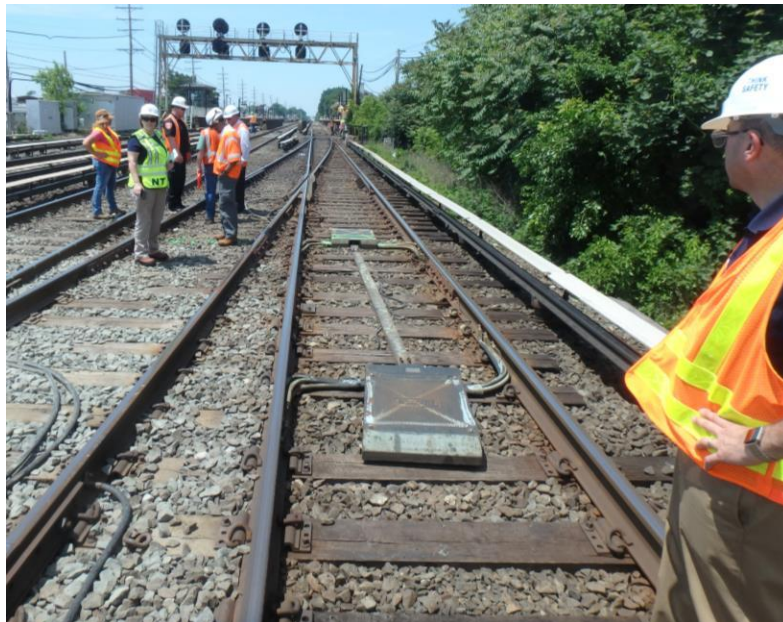
At approximately 10:13 a.m., the MOW west Track Foreman walked towards Main Track No. 3 just prior to the lead cab control car of train No. 7623 approached him, which struck him at 78 MPH at MP 13.3 .

Figure 1. *See photo below of approximate location of where Foreman was struck (MP 13.3):*
