BROTHERHOOD OF LOCOMOTIVE ENGINEERS AND TRAINMEN

BEFORE THE NATIONAL TRANSPORTATION SAFETY BOARD

NTSB Accident Number: DCA17FR004

Proposed findings, probable cause, and safety recommendations, in connection with the BNSF Railway Roadway Worker Fatalities at Edgemont, South Dakota January 17, 2017

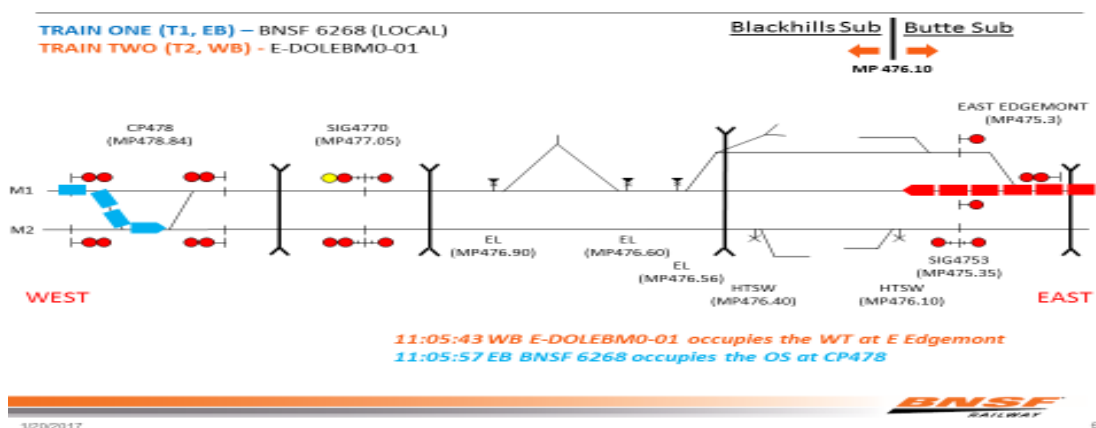
Figure 3. Signal Aspect and Train Movement. (Graphic courtesy of BNSF Railway).

Figure 3 shows the westbound accident train, E-DOLEBM0-01, on Main Track No. 1 occupying the WT track circuit at CP East Edgemont. It also shows the eastbound local train, BNSF 6268, crossing over from Main Track No. 1 to Main Track No. 2 at CP478.

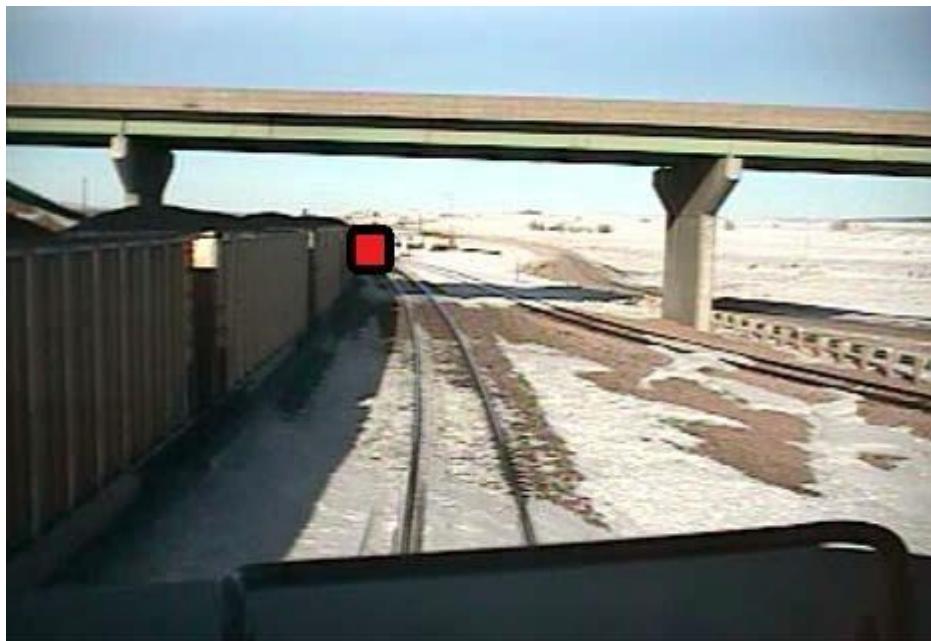
See photo below for the track image recorder from the E-DOLEBM0-01E lead locomotive as the train approached the worksite (workers are blocked out in red—photo courtesy of NTSB). Note the eastbound loaded coal train traveling east on Main Track No. 2.
