# **Brotherhood of Locomotive Engineers and Trainmen**

**NTSB Accident Number: DCA-11-FR-004**

**Proposed findings, probable cause, and safety recommendations, in connection with the rear end collision of a northbound CSXT Railway freight train (Q19423) striking a standing northbound CSXT Railway freight train (Q61822) in Mineral Springs, North Carolina, resulting in two fatalities , a derailment, and subsequent fire.**

**FINAL SUBMISSION**

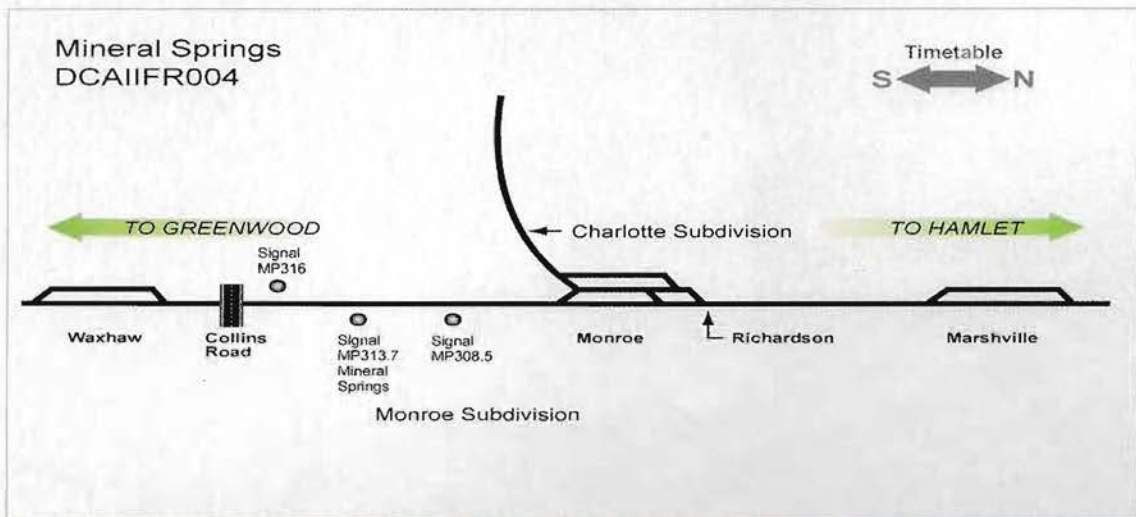
Moments after passing Collins Road (MP 316.2) the engineer manipulated the throttle from throttle position 8. The speed of the train – due, in part, to the topography - continued to increase from about 31 mph and reached a maximum speed of 48 mph. Data indicates that during the 78 seconds before the accident the engineer made throttle control manipulations, applied the dynamic brakes, and activated the bell and horn. Data also indicated that there was an emergency brake application after the collision had occurred.

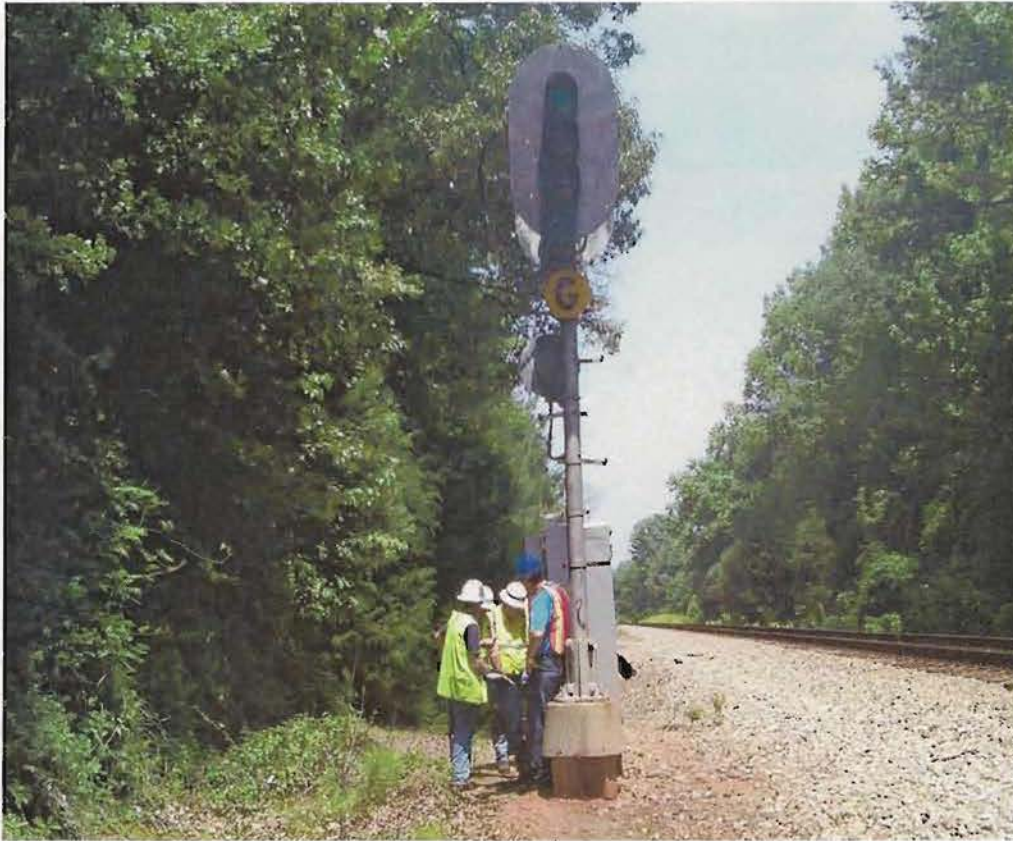
(Signal SG 316.0 revealed it was dark during post-accident investigation)

The signal testing reviewed it had a burnt out bulb and was not displaying any signal aspect when it should have been displaying a red aspect.

The burnt out bulb in the signal aspect of SG 316.0 is a contributing factor in this accident. The photograph of the signal demonstrates that there was no ambient lighting in the area, and raises a question whether the crew of the striking train realized they had passed the signal governing entrance to the block in which the struck train was stopped. Had the signal been performing as designed, it should have heightened the awareness of the operating crew as they passed it.
