# Babcock & Wilcox

Plant Service Bulletin

SAFETY ALERT WARNING

## Corrosion-Fatigue Failures of Riser Tube Bends

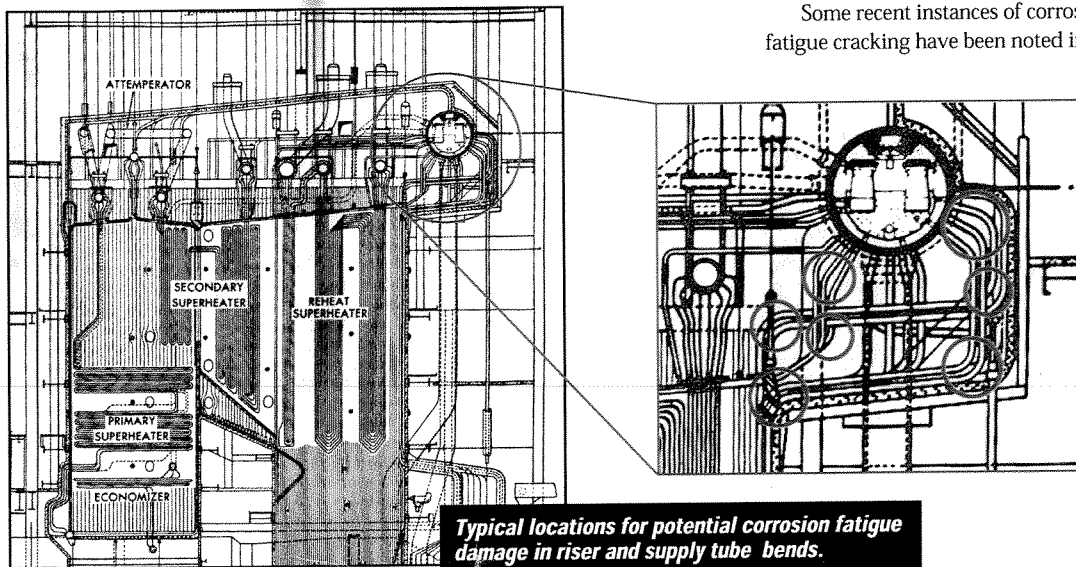
Corrosion fatigue damage has been found on the inside of bends in riser tubes. The damage appears as crack-like indications parallel to the tube axis, predominantly aligned along the neutral axes of these bends, and limited to the bend area. These "cracks" often initiate at internal pitting attack locations and then propagate through the tube wall. In time, pinhole leaks occur that could steam wash and damage nearby tubing and boiler parts. In addition, the leaking tube could catastrophically rupture as a window blowout, ripping along the inside diameter (ID) cracking at the neutral axes. Anyone in the area during such an event could be severely burned or killed.

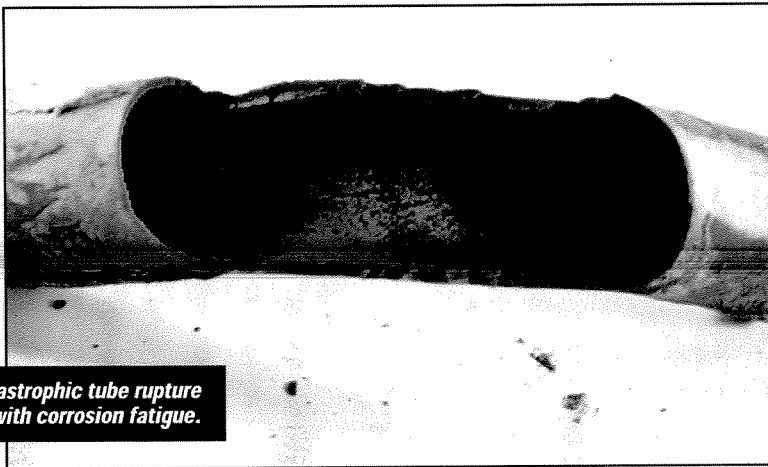
**Photo shows catastrophic tube rupture that is possible with corrosion fatigue.**

4. Review pressure part failure history that may indicate increasing susceptibility to corrosion-fatigue failures and revise tube inspection procedures and frequencies accordingly.
5. Replace any tubing that shows any evidence of cracking as soon as possible.
