**Factual Observations of Helicopter Mishap**  
**Bell 407; S/N 53498, N503MT**  
**Date of Accident: July 13, 2004**  
**Operator: Med-Trans Corporation**  
**Location: 14 miles NW of Newberry, SC**

**SUBJECT: EXAMINATION OF A MODEL 407 CAUTION AND WARNING PANEL FROM  
MED TRANS IN NEWBERRY, SOUTH CAROLINA**

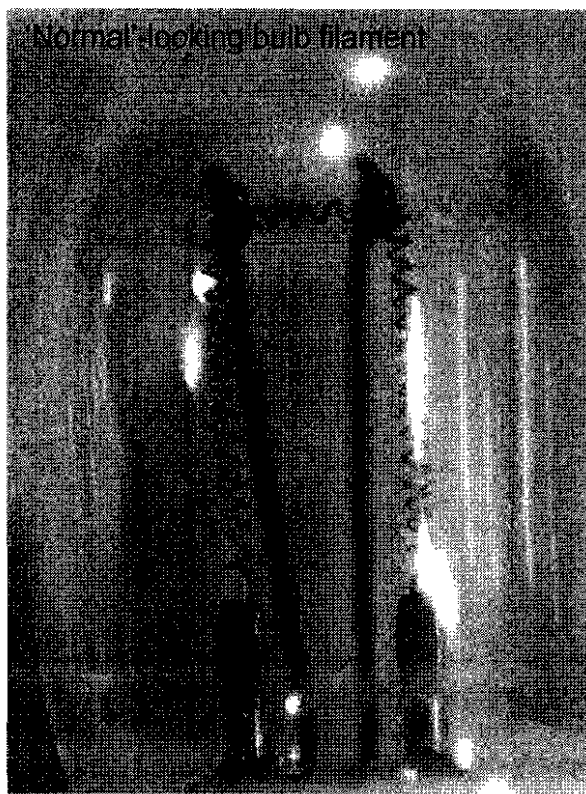
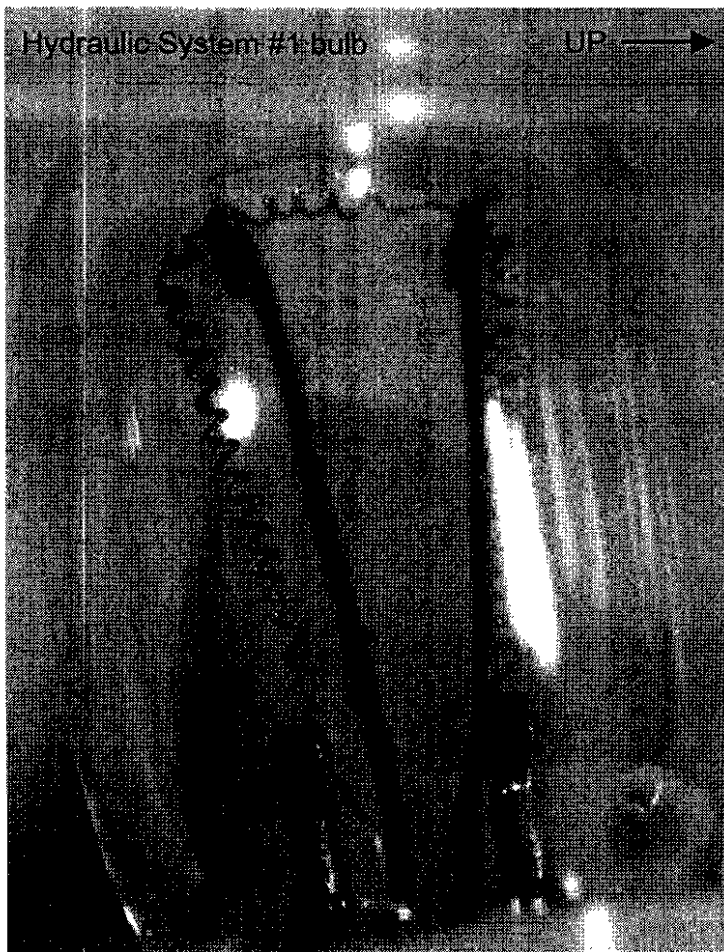
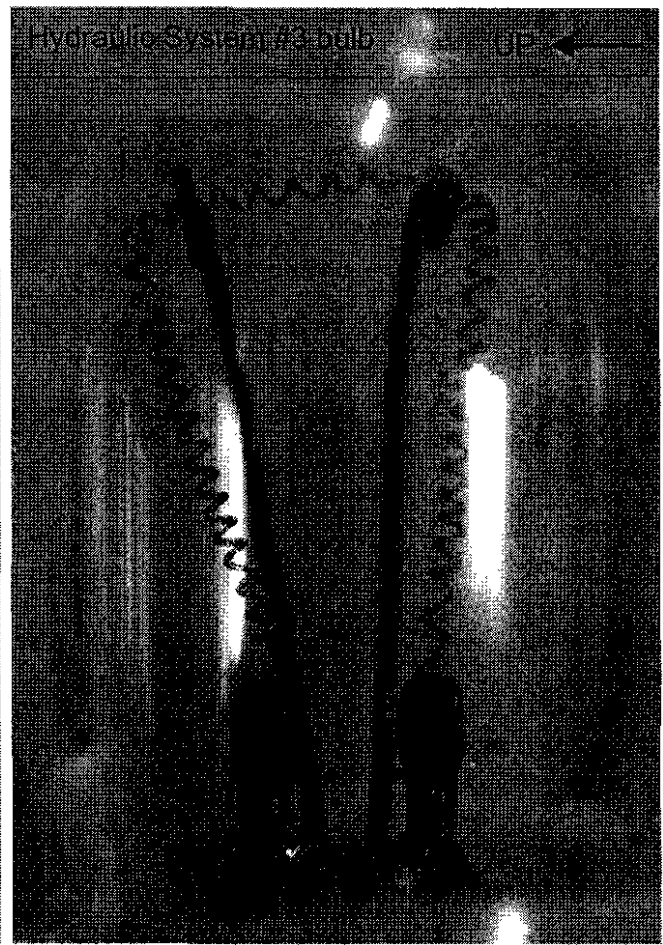
There were 108 bulbs in the 36 caution and warning indicators, three to each indicator. None of the bulb filaments was broken. None of the bulb filaments was stretched a large amount. Two bulb filaments from the Hydraulic System indicator had a small amount of stretch from an undetermined origin.

Figure 2: Closeup views of a 'normal'-looking bulb filament and the two Hydraulic System bulbs with slightly stretched filaments.

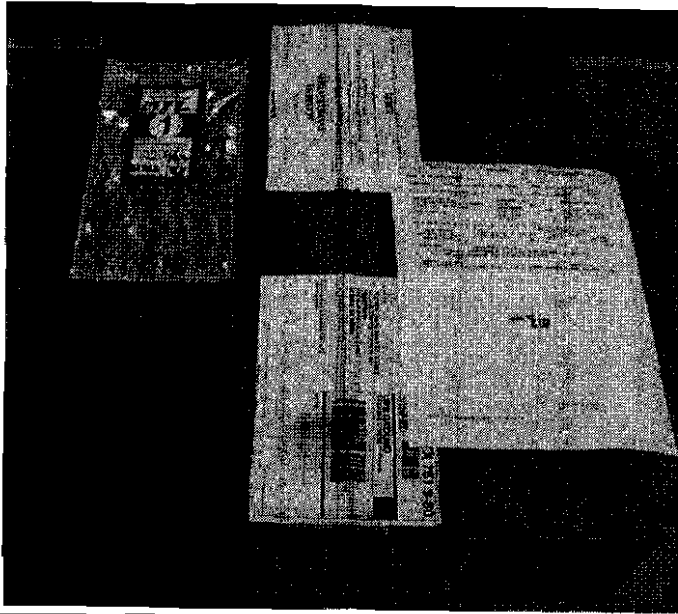
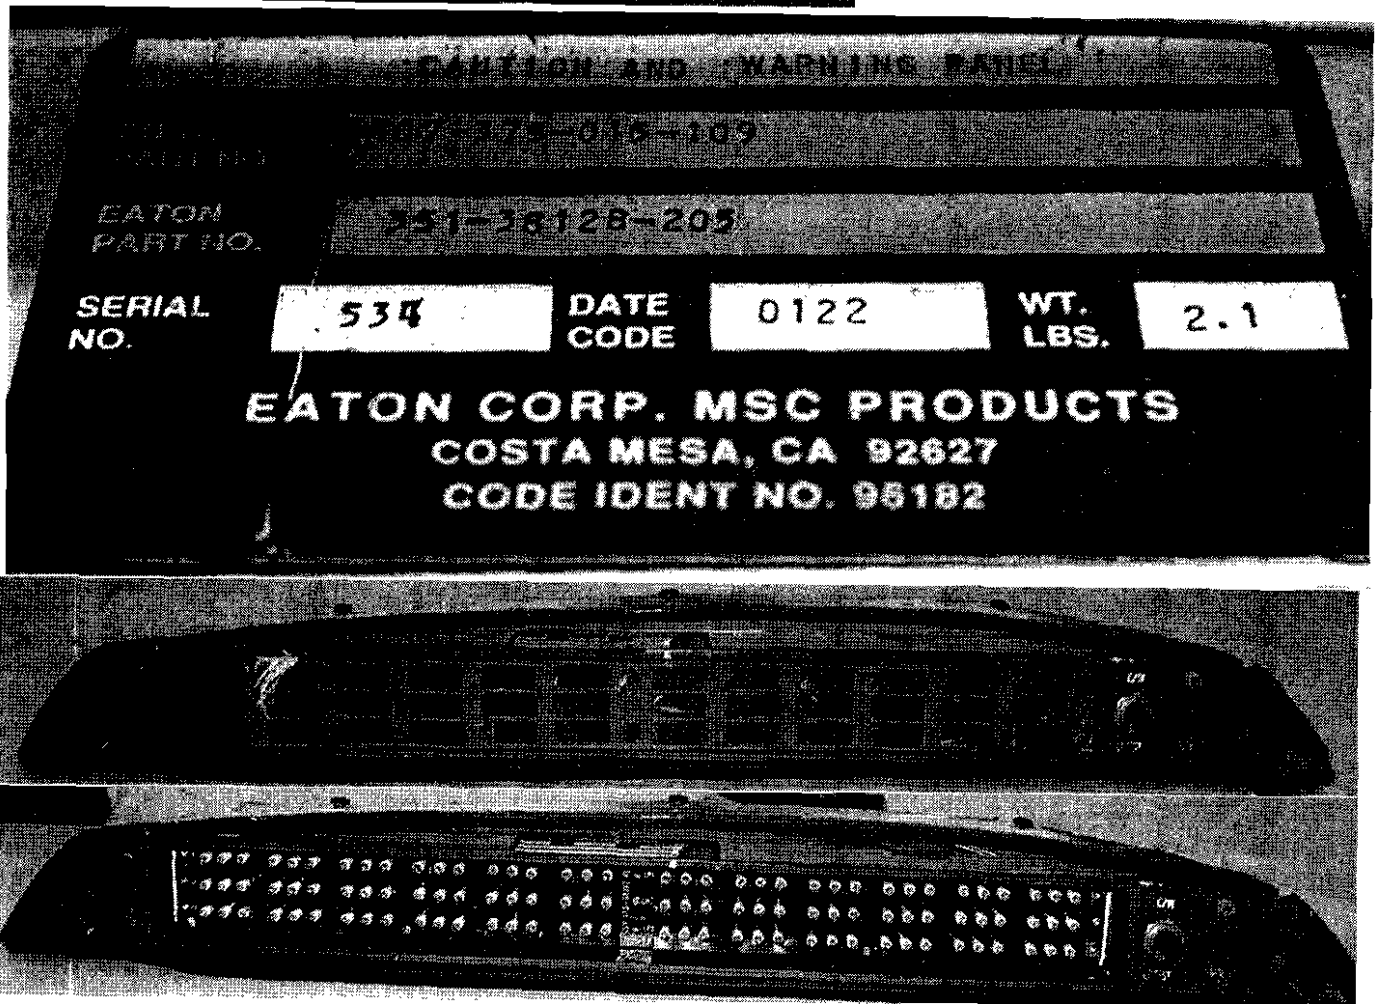
Figure 1: Overall views of the caution and warning panel as received, and with the front indicator panel removed.
