Subject: **EXAMINATION OF A 206L1 HELICOPTER TAILBOOM  
AT WASHINGTON D.C.**

Model: 206L1  
Registration: N79SP  
Serial number: 45540  
Total time: 2898 hours

Name: Tailboom  
Part Number: 206-033-004-045A  
Serial Number: AOKP 01058

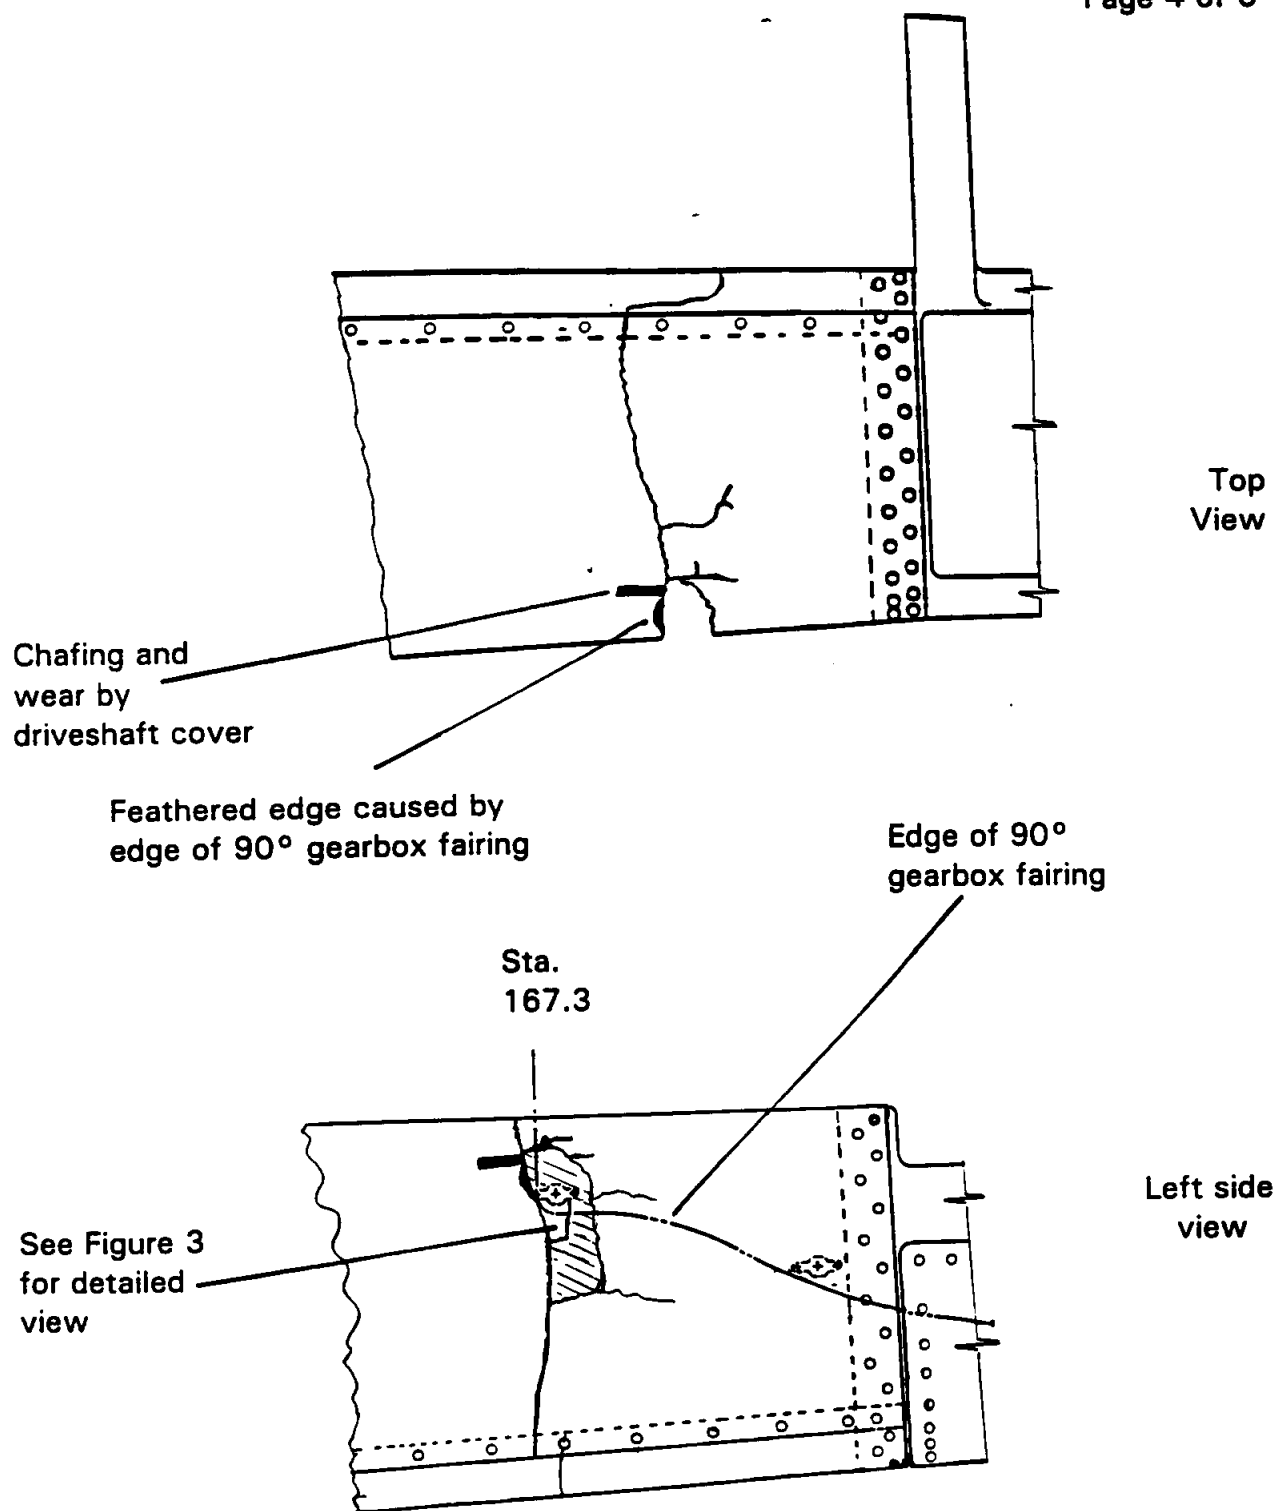
Examination of the fractured tailboom revealed evidence that fatigue cracking had been present prior to the accident. The cracking was centered near a nutplate attachment rivet hole on the upper left side at boom station 167. The nutplate was used as an attachment for the 90° gearbox fairing. No material discrepancies and/or deficiencies were found which would have caused the fatigue cracking to occur.

Inspection of the tailboom fracture revealed a circumferential fracture had occurred between boom stations 167 and 170. The forward side of the fracture was relatively intact. The aft side of the tailboom fracture had been buckled and torn or "mushroomed" after the fracture occurred. It could be seen that the lower skin had fractured as a result of overstress. However, portions of the fracture surface of the upper skin had been worn smooth and fracture features were no longer visible. Sections which had mated with the forward side of the fracture were missing from the aft side of the fracture in the area around the 90° gearbox fairing retention bolt nut plate at boom station 167 (see Figure 1).

**Figure 1**  
View showing fracture in tailboom.

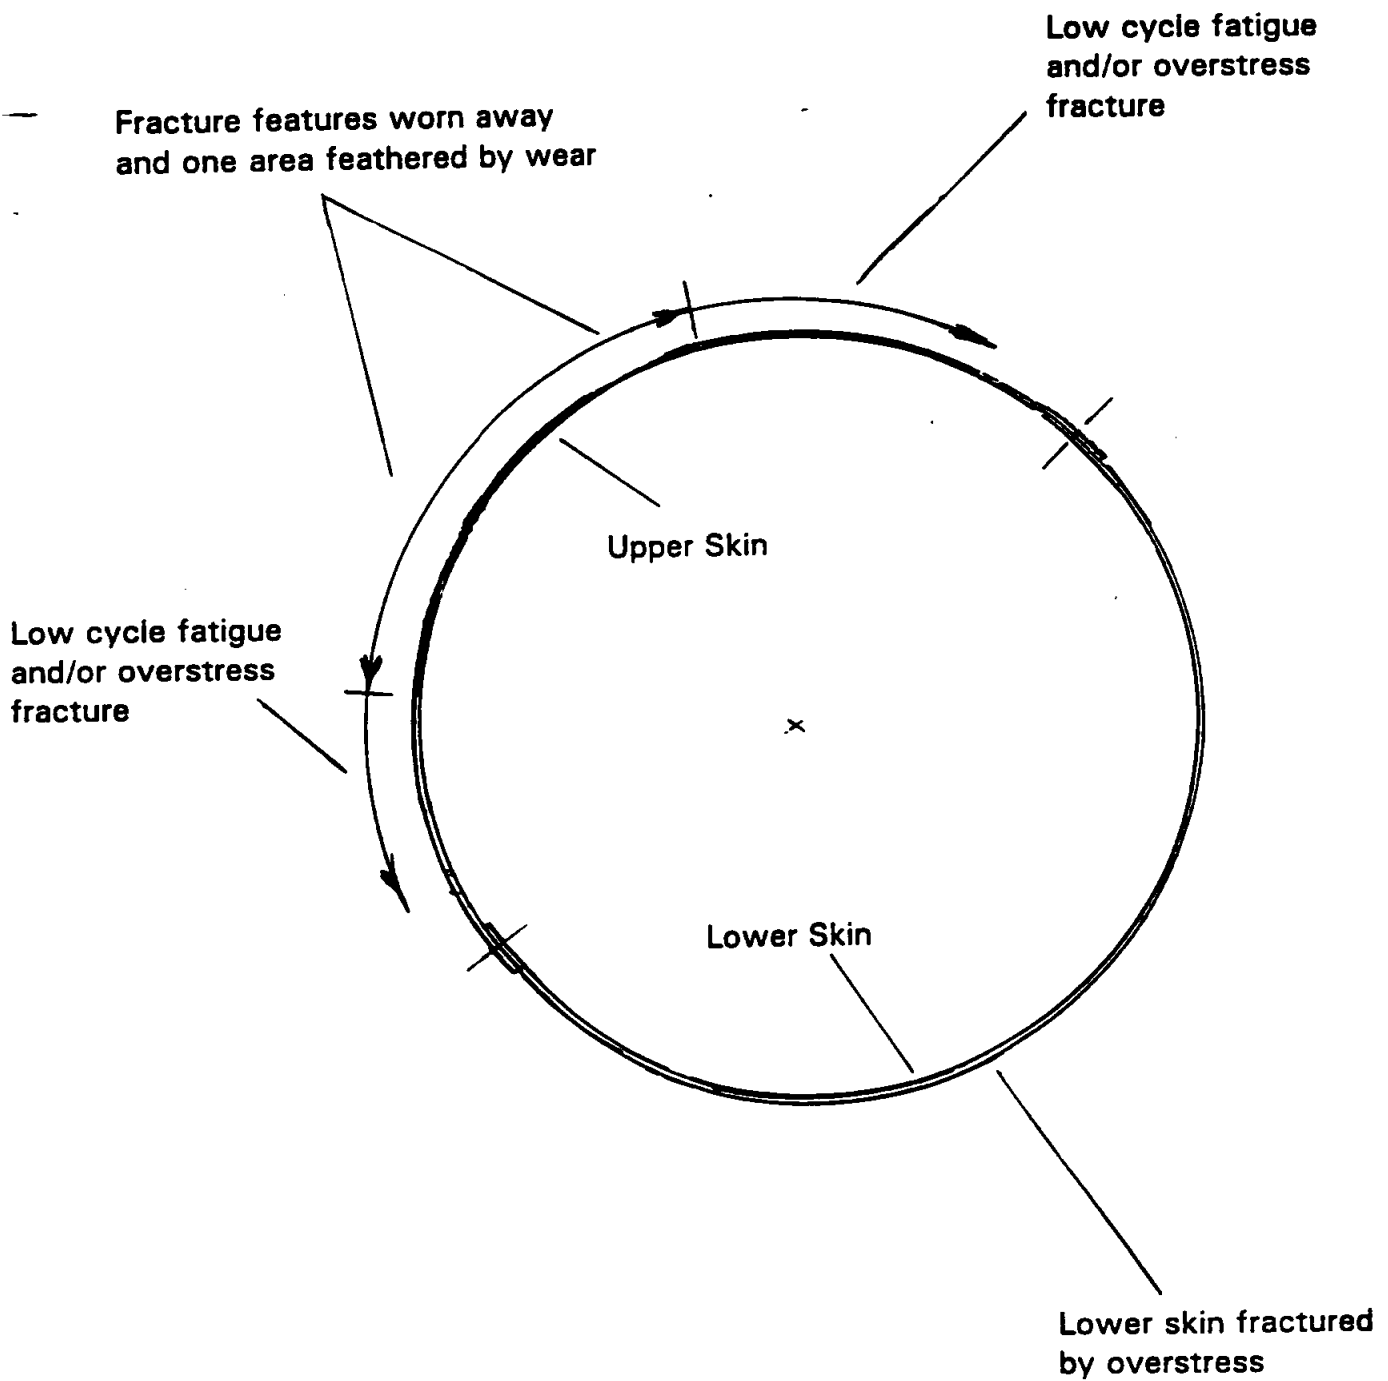
The forward portion of the fracture near the area of the 90° gearbox fairing retention bolt nut plate at boom station 167 had been worn and chafed to a feathered edge by the forward corner of the 90° gearbox fairing. Wear had also occurred where the reinforcement doubler on the inside surface of the driveshaft cover had chafed the upper tailboom skin. Other portions of the upper skin fracture surfaces in that area had been worn smooth and/or damaged so that fracture features were no longer visible. Figure 2 shows the forward side of the tailboom fracture.

Figure 2  
View of forward side of fracture.

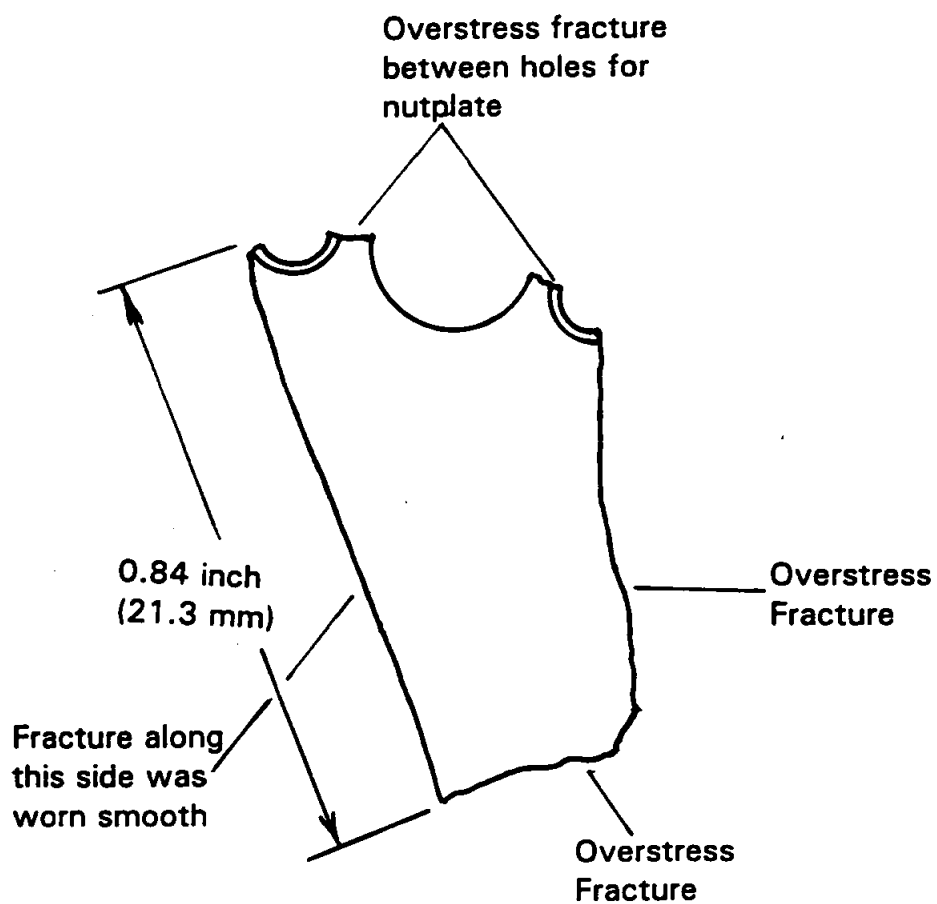
One portion of the aft fracture in the tail boom skin was retained at the 90° gearbox fairing retention bolt nut plate and is shown in Figure 3. The forward side of this piece of tailboom skin was flat and worn smooth with no remaining fracture features. The fractures between the holes and the other two edges on this piece were overstress.

**Figure 3**  
Fragment of tailboom skin from aft side of fracture at the forward 90° gearbox fairing retention bolt nut plate.
