Subject: Boeing Performance Analysis – Southwest (SWA) 737-700 N753SW Nose
Landing Gear Collapse on Landing, LaGuardia, New York, 22 July 2013

Enclosure: FDR Analysis for SWA N753SW NLG Collapse

Boeing Performance Analysis – Southwest (SWA) 737-700 N753SW
Nose Landing Gear Collapse on Landing. LaGuardia. New York. 22 July 2013

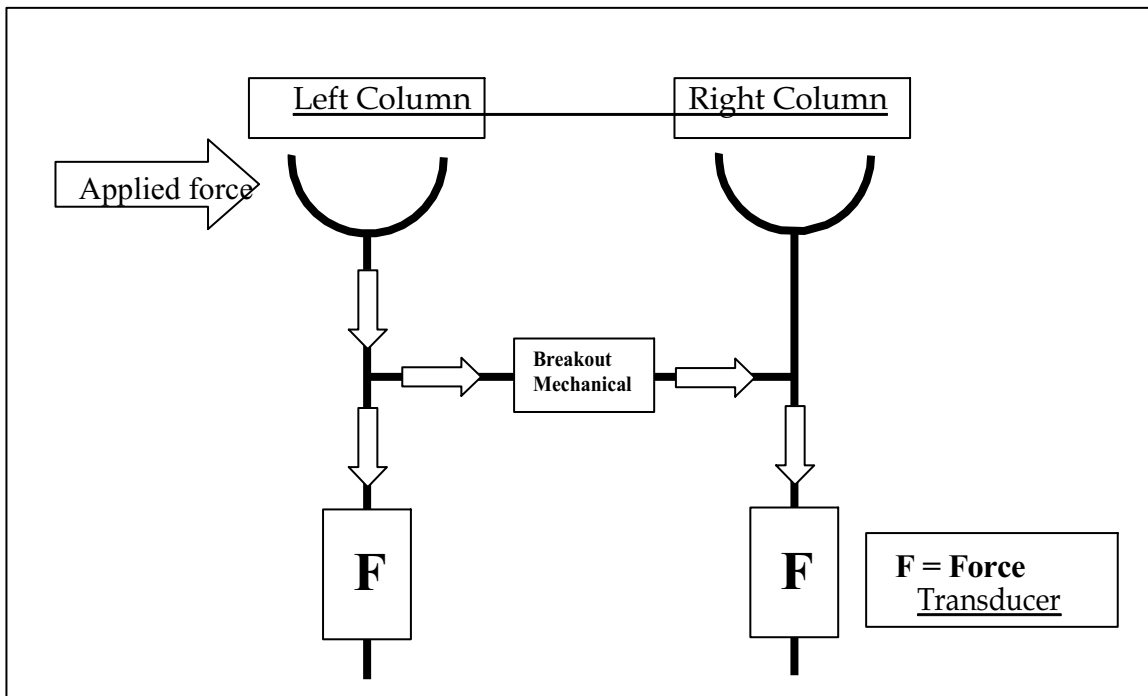
Control Column Force Measurement System Diagram

On 737NG aircraft, there are two control column force transducers (one on each side). Applied column force is transmitted along two linkages that connect the control columns to these two transducers, as shown in the simplified system diagram below.

Because of compliance in the system, the transducer that is closest to the applied force will reflect larger forces in the recorded data and, therefore, indicate which column is being used to make inputs to the elevator.

The FDR data were evaluated to determine the pilot flying during the approach and landing segments of the flight. Figure 7 shows the column force data from the left and right seat, Captain and First Officer's, respectively. When the autopilot is engaged, the column force parameter will record a value near zero; when the autopilot is disengaged, the column force parameter will record the force applied to the column. The column force recorded on the side of the pilot flying will have slightly higher forces due to compliance in the system. Before evaluating the data to determine Pilot Flying (PF), biases were removed from both force parameters. The biases in the parameters were determined from pre-flight values, just after the control sweeps but before the takeoff roll, when the column was in the neutral position. After removing the biases, the column force data show that after the autopilot was disengaged, the forces on the right side (the First Officer's side) were slightly higher in the pull and push directions. This indicates that the First Officer took control of the column after autopilot disengagement at approximately 360 feet RA (time 7753.5 seconds). The First Officer remained in control of the column throughout the final approach, until approximately time 7786.5 seconds, when the control column forces decrease to near zero at 25 feet RA. The last recorded commanded column force data point was 14.8 pounds at 30 feet RA (time 7785.6 seconds) before the data decreased towards neutral.
