Boeing FDR data analysis and observations

Content of Boeing email dated November 17, 2016

EKV 737-700 RUNWAY OVERRUN
 27OCT2016 -- TIME-ALIGNED FDR DATA
 LONGITUDINAL PARAMETERS

YA203/N278EA

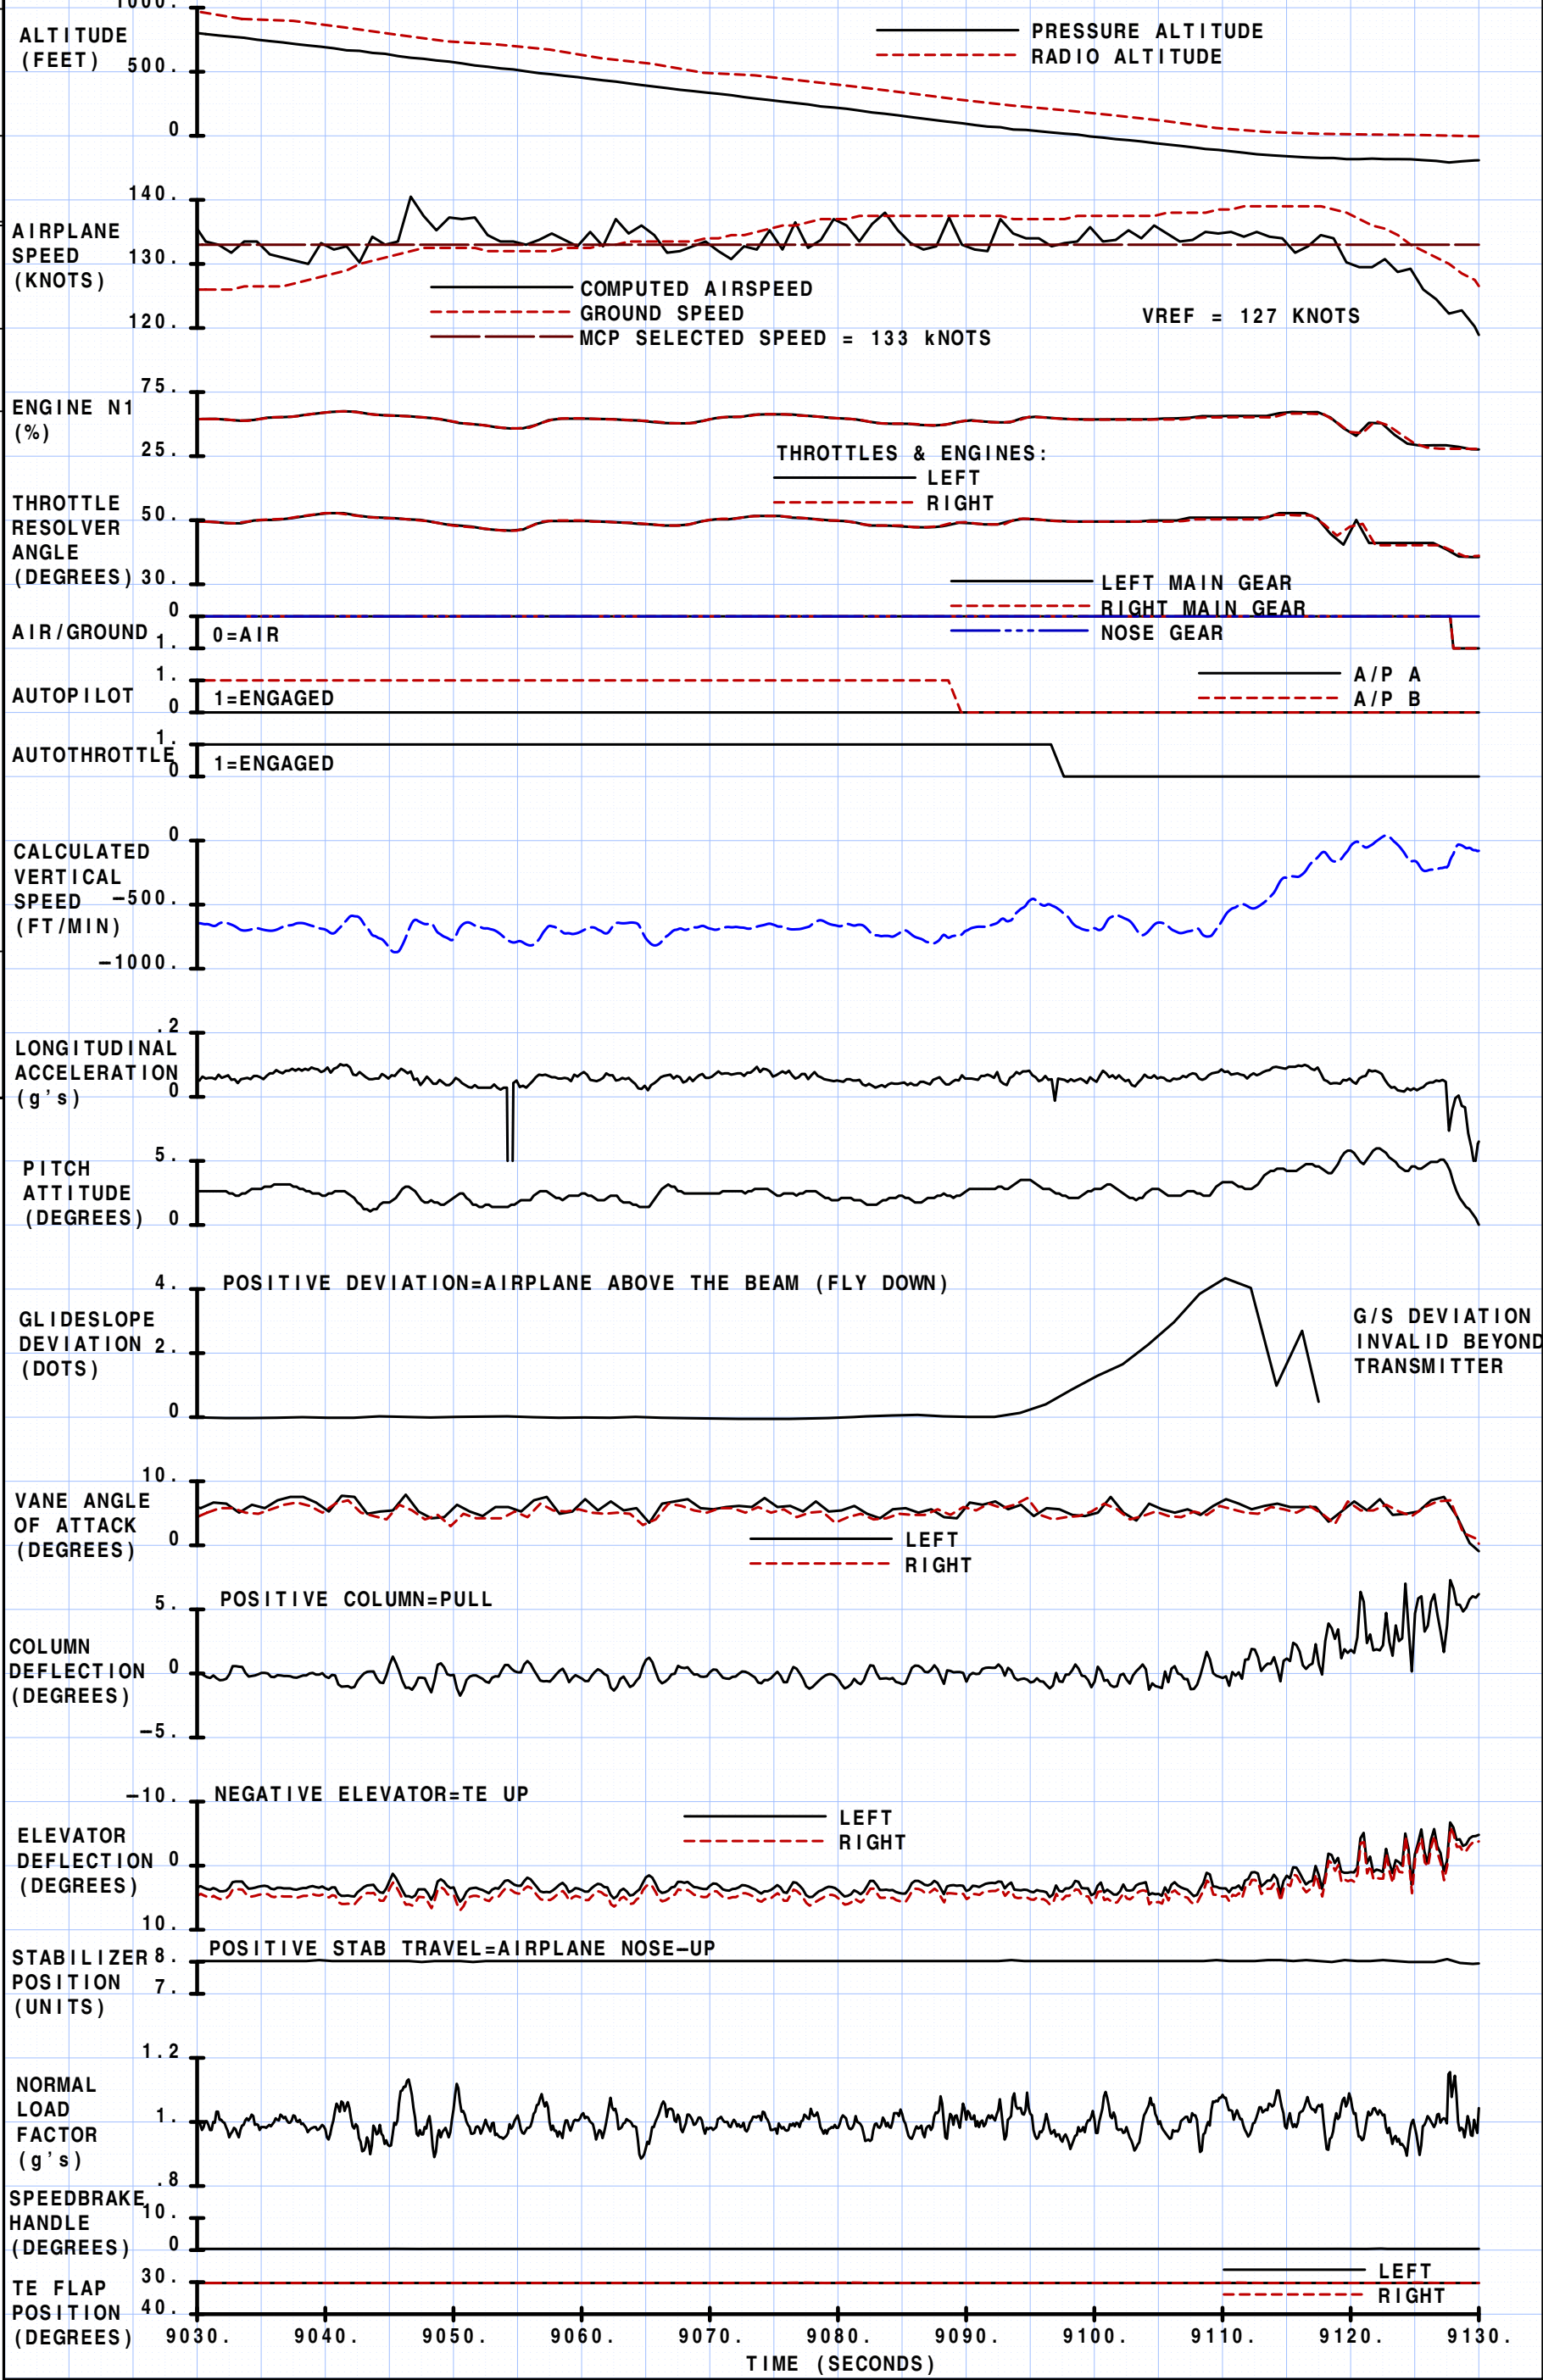
- F30 approach to Runway 22 at LaGuardia (LGA) with a runway length of 7001 feet, at a gross weight of 116,560 lb. at landing (Max Landing Weight [MLW]=129,200 lb.).

- Turbulent atmosphere with an increasing tailwind as the airplane approached the runway. At touchdown, the tailwind was approximately 10 knots.
- Autopilot was disconnected at approximately 300 feet radio altitude, with the autothrottle disconnected approximately 7 seconds later at 200 feet radio altitude

- Shortly after autopilot disconnect, the glideslope deviation began to increase indicating the airplane was deviating above the glideslope beam.
- The airplane crossed the runway threshold at a radio altitude of 66 feet with the glideslope deviation increasing beyond 4 dots and a descent rate (negative vertical speed) of approximately 750 ft/min.

- The descent rate was reduced to near zero by 2500 feet beyond the runway threshold, resulting in the airplane floating down the runway.

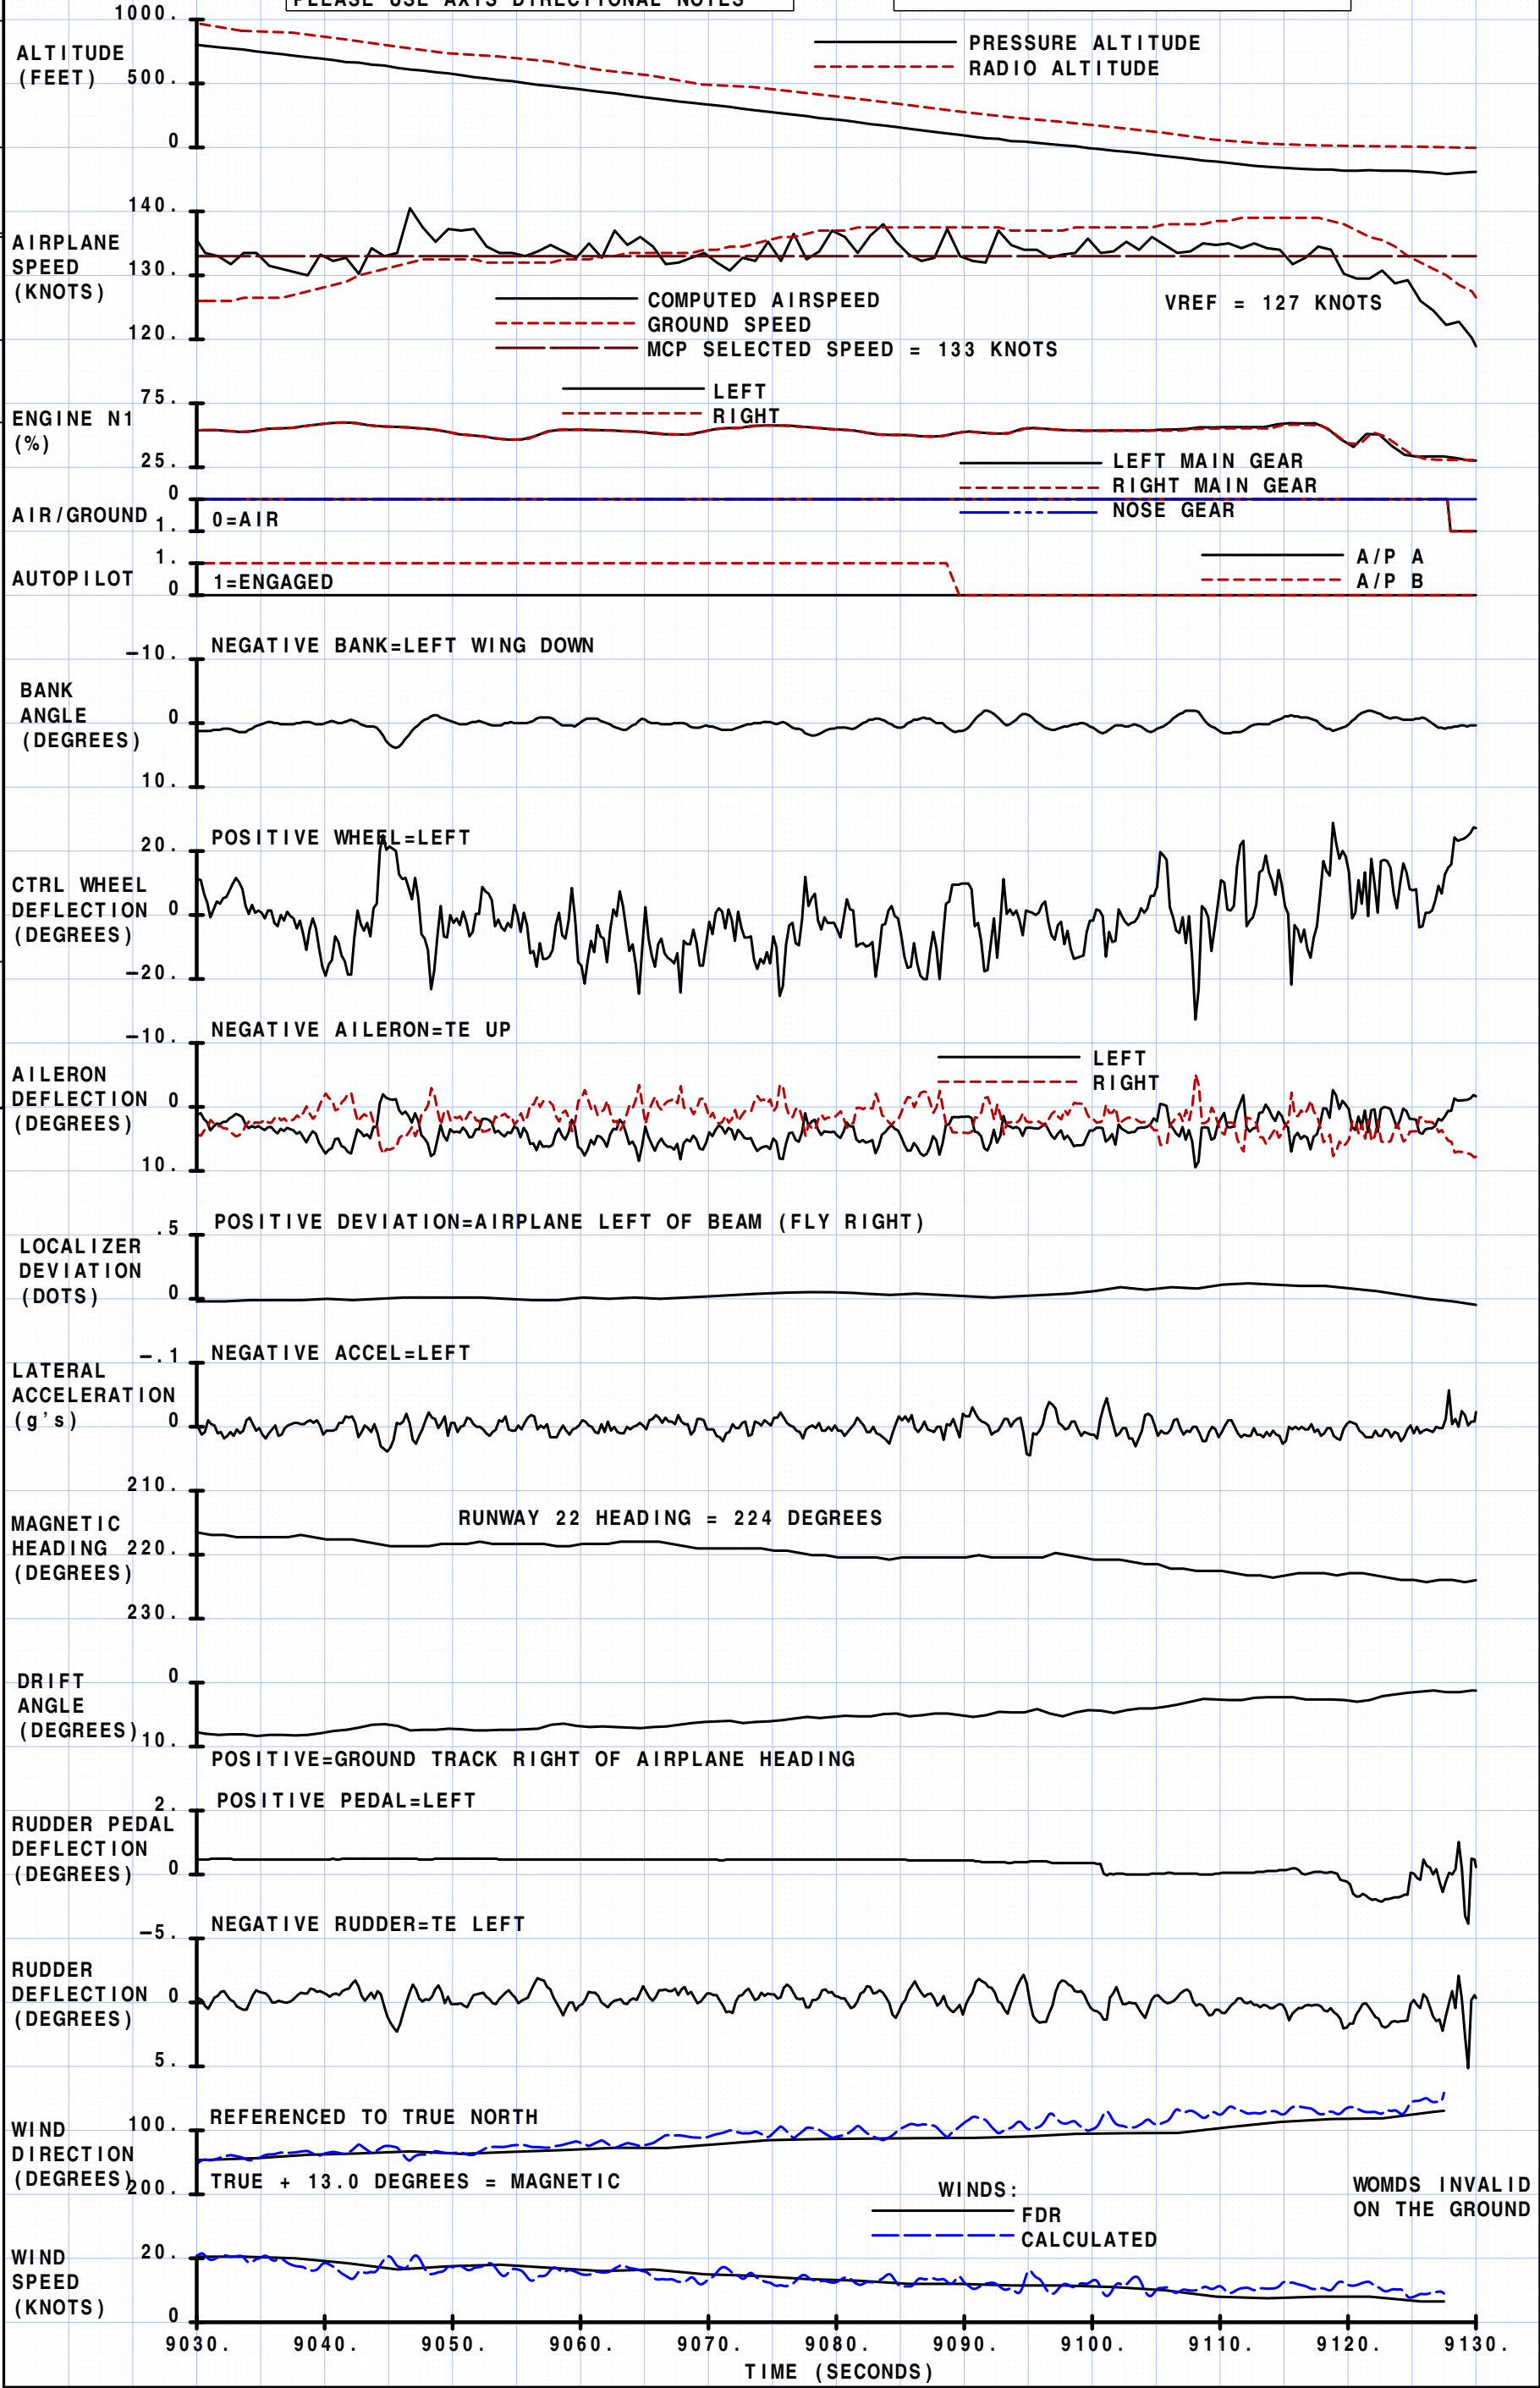
PAGE 2

- The calculated in-air crosswind component indicated there was a left crosswind of 7 to 8 knots, reducing to 3 to 5 knots before touchdown. The winds that were present while the airplane was on the ground could not be calculated, but a left crosswind would typically result in a right rudder pedal input to maintain centerline (and left control wheel if the crosswind magnitude was large enough).

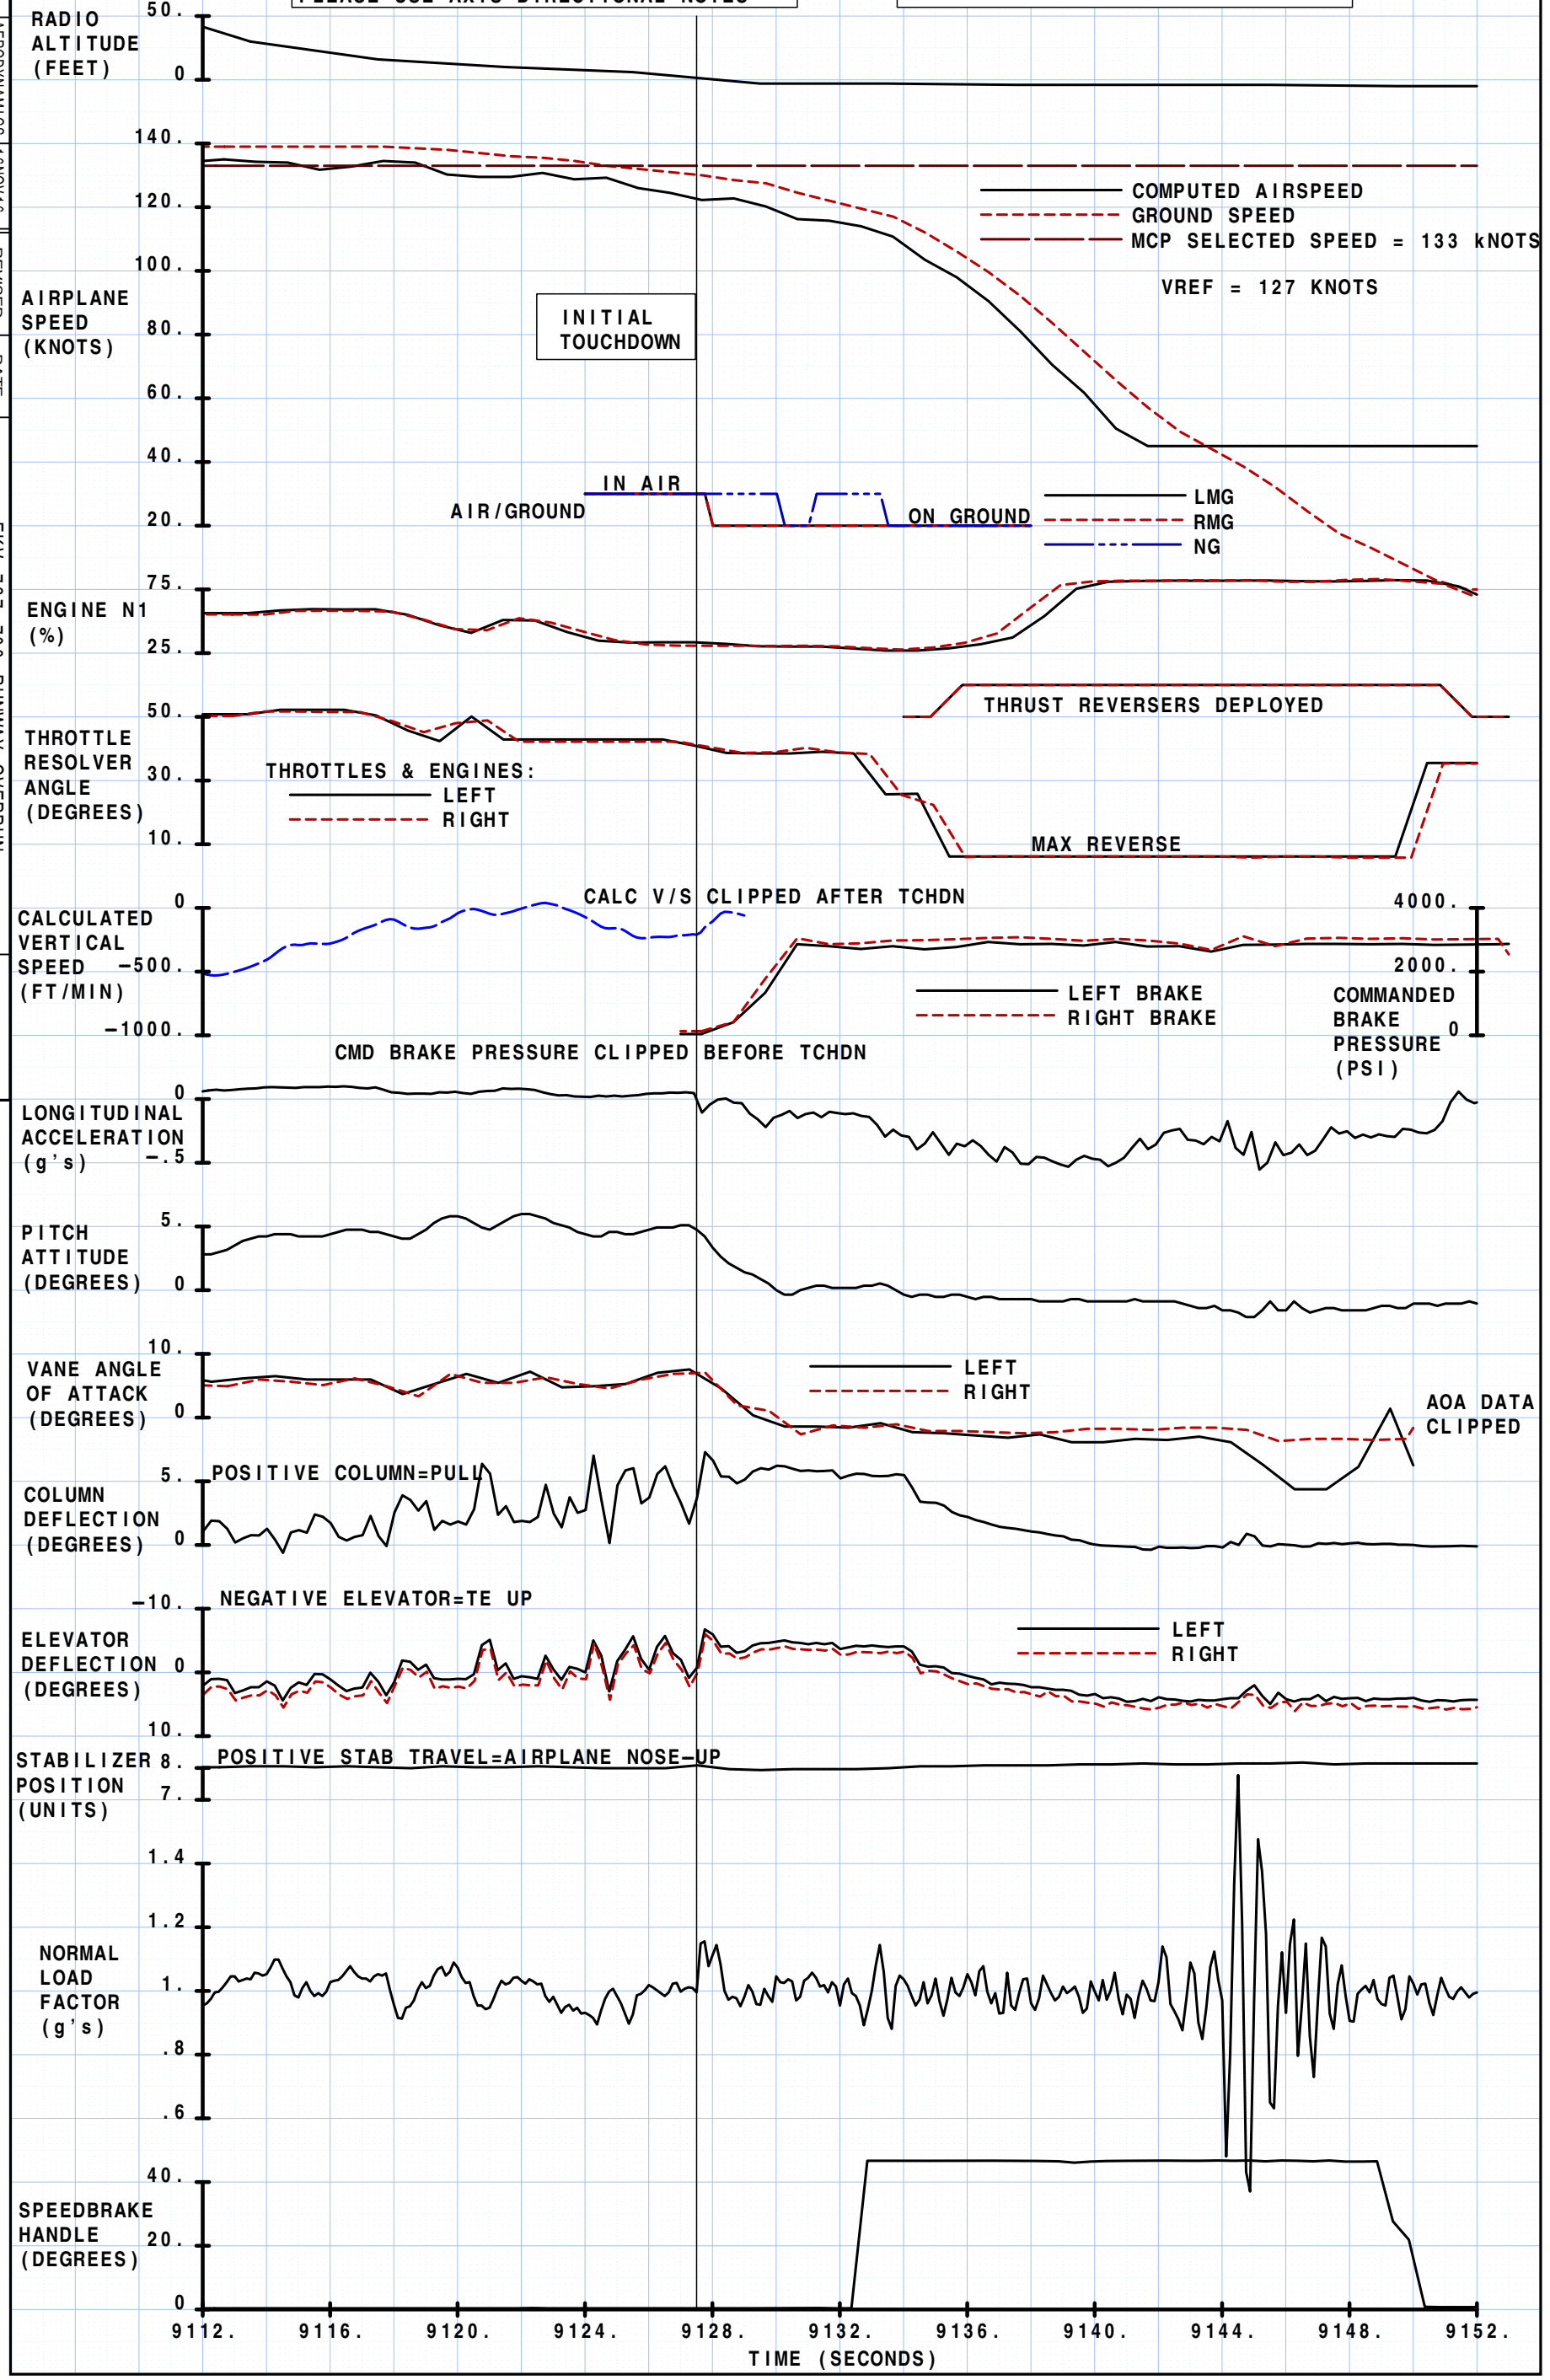
FIGURE 3

- The initial touchdown occurred at: 1) approximately time 9127.5 seconds, 2) a distance of 4242 feet beyond the runway threshold (~1900 feet beyond the recommended touchdown zone), 3) an airspeed of 123 knots (V_{ref-4}), 4) a ground speed of 130 knots, 5) a sink rate of 3.3 ft/sec.

- Upon main gear touchdown, maximum manual wheel brakes were commanded.
- The nose gear touched down approximately 2 seconds after main gear touchdown, but then rebounded back into the air due to commanded aft control column. The nose gear was held off the ground until it touched down a second and final time approximately 5 seconds after main gear touchdown.

- Speedbrakes were manually extended to full approximately 4.5 seconds after main gear touchdown (the speedbrakes were not armed for automatic extension upon landing). After initial touchdown, the airplane traveled approximately 1250 feet down the runway before the speedbrakes were extended to full deflection.

- Max reverse thrust was commanded by time 9135.5 seconds (8 seconds after initial touchdown). From initial touchdown to max reverse command, the airplane had traveled approximately 1650 feet down the runway.

- The airplane achieved good deceleration with speedbrake extension, maximum wheel brakes, and maximum reverse thrust, reaching 0.5 g's of deceleration (negative longitudinal acceleration).

- Preliminary calculation of airplane braking coefficient indicates that during the period of friction-limited braking (beginning when the nose gear touched down at time 9133.5 seconds, 5520 feet beyond the threshold and ending as the airplane entered the EMAS) the calculated airplane braking coefficient varied between 0.2 and 0.4.

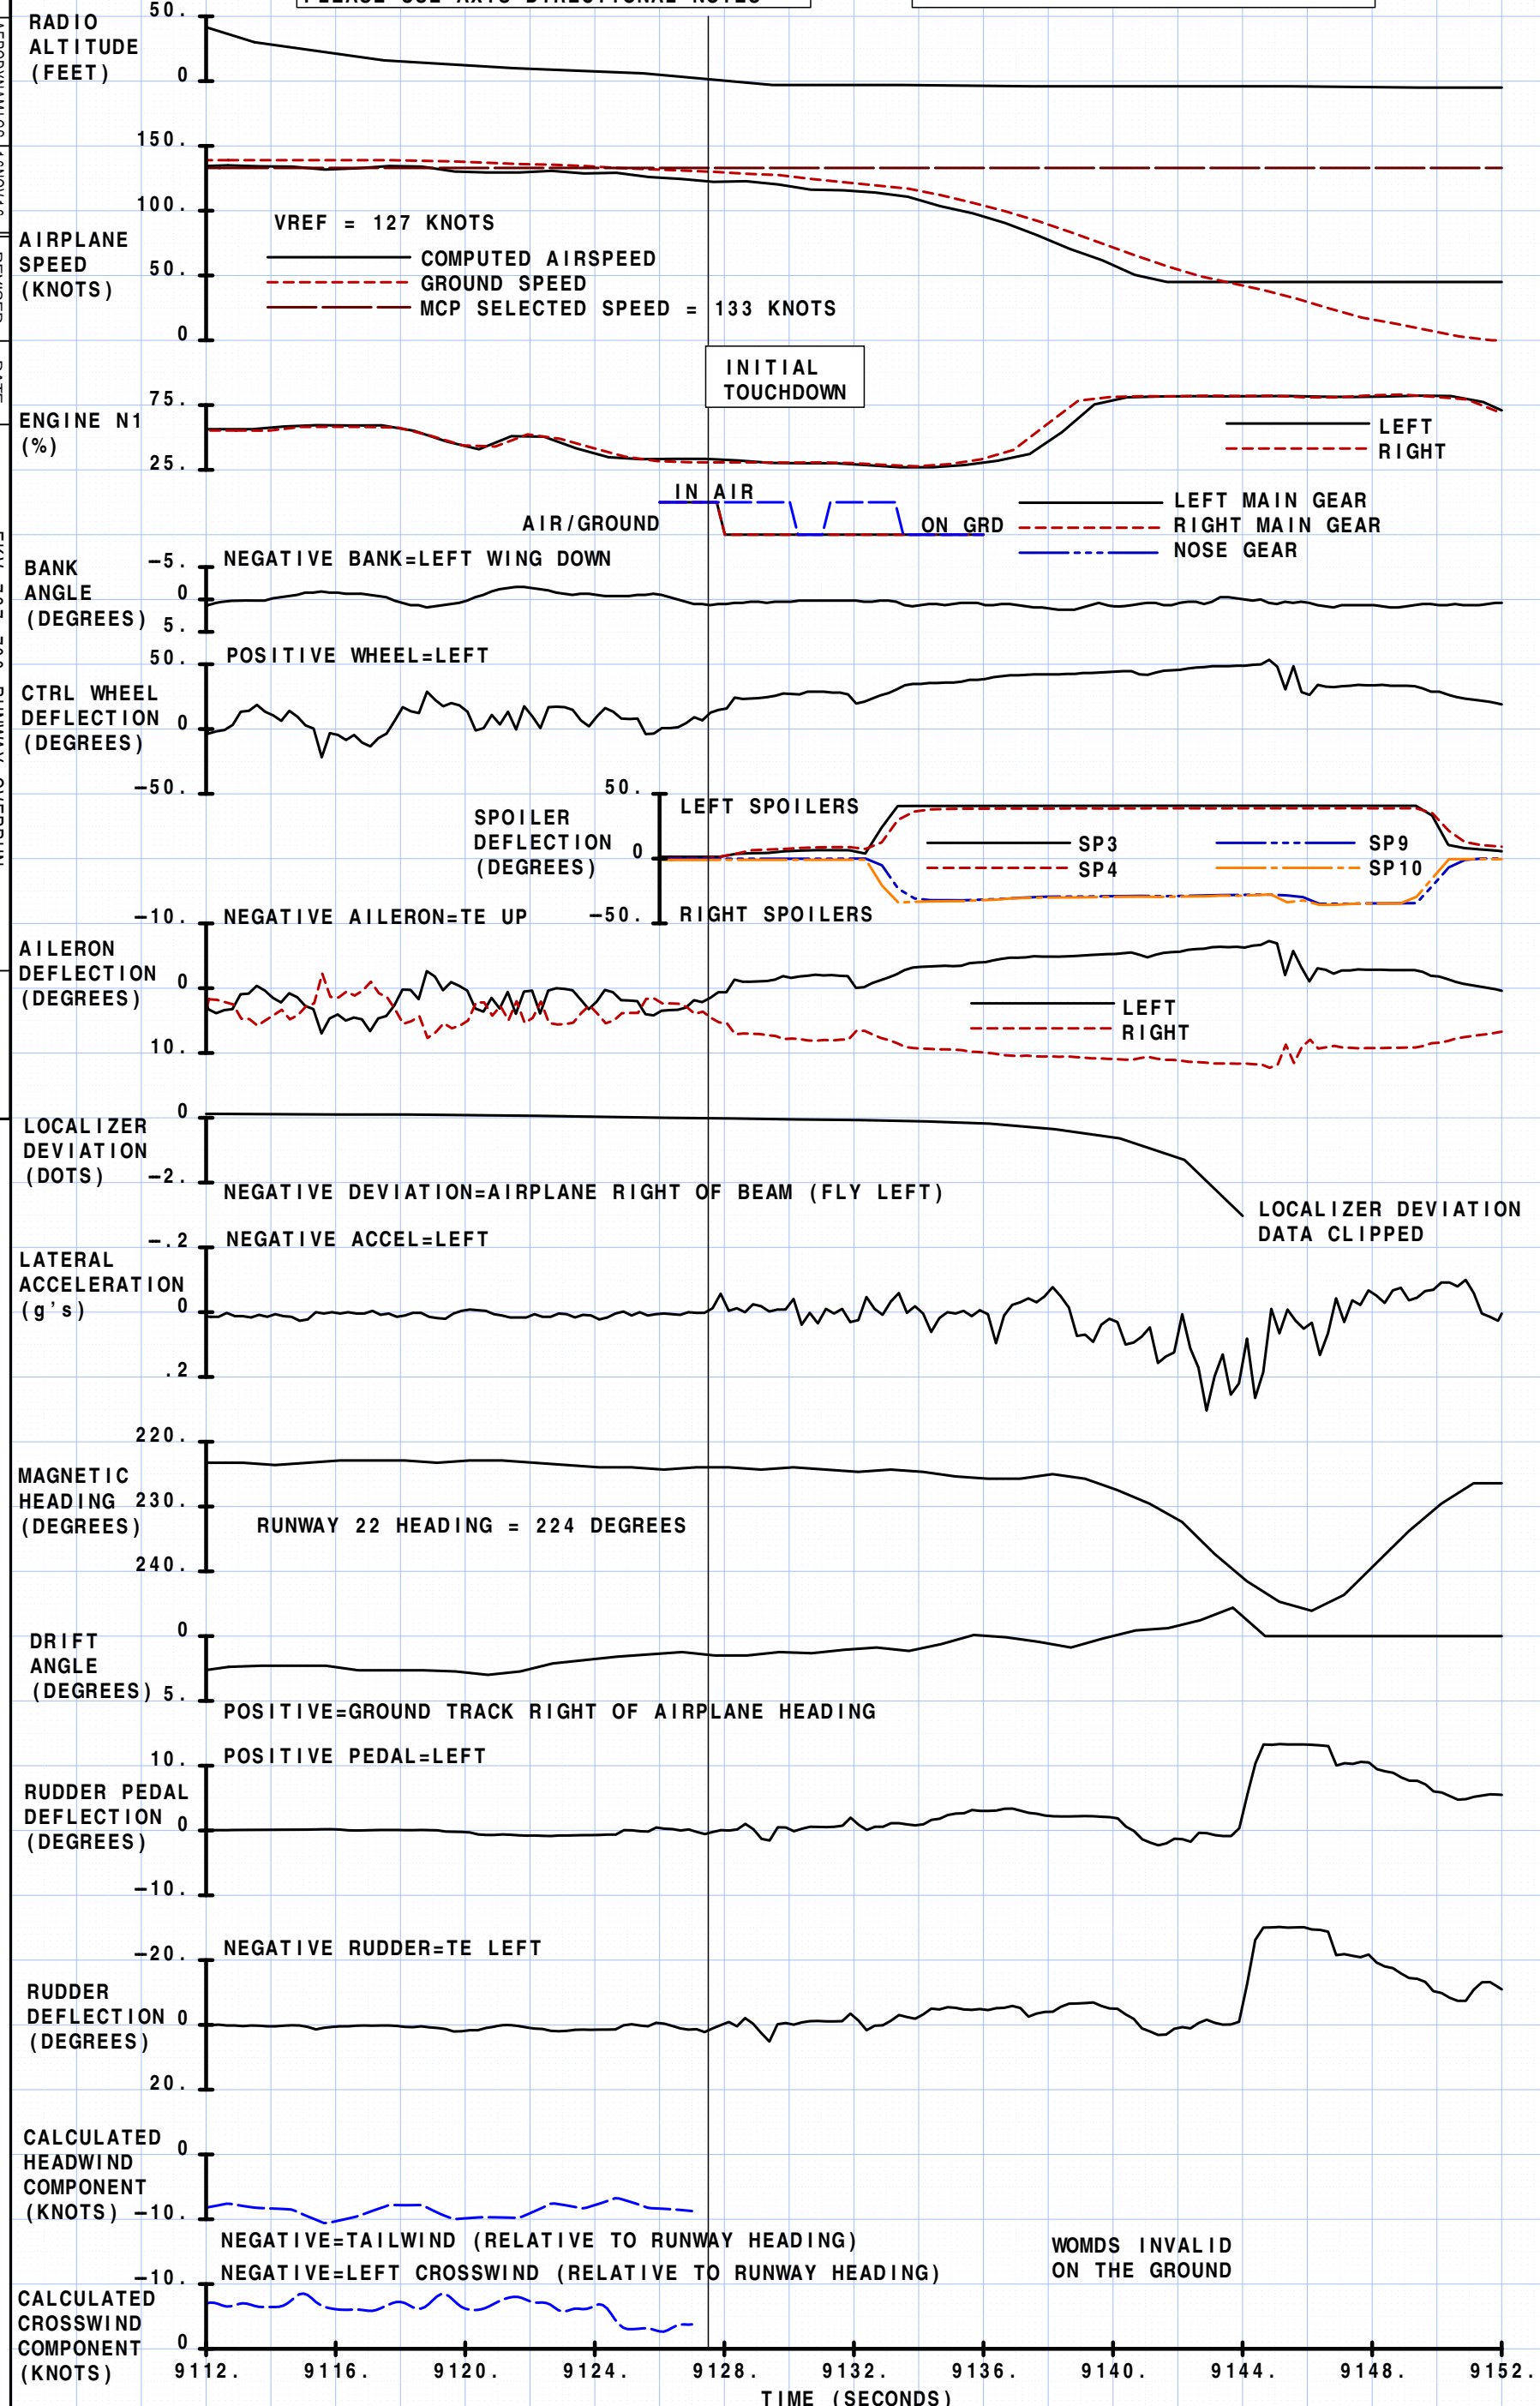
PAGE 4

- As the airplane decelerated, increasing left control wheel was commanded, reaching 50 degrees of left control wheel by time 9145 seconds. The increasing left control wheel reduced the spoiler deflections on the right wing, per design.

- Some left rudder pedal was commanded as the airplane rolled down the runway, until it was removed and right rudder pedal was commanded at 6650 feet beyond the threshold. The airplane responded to the right pedal by deviating right of the runway centerline.

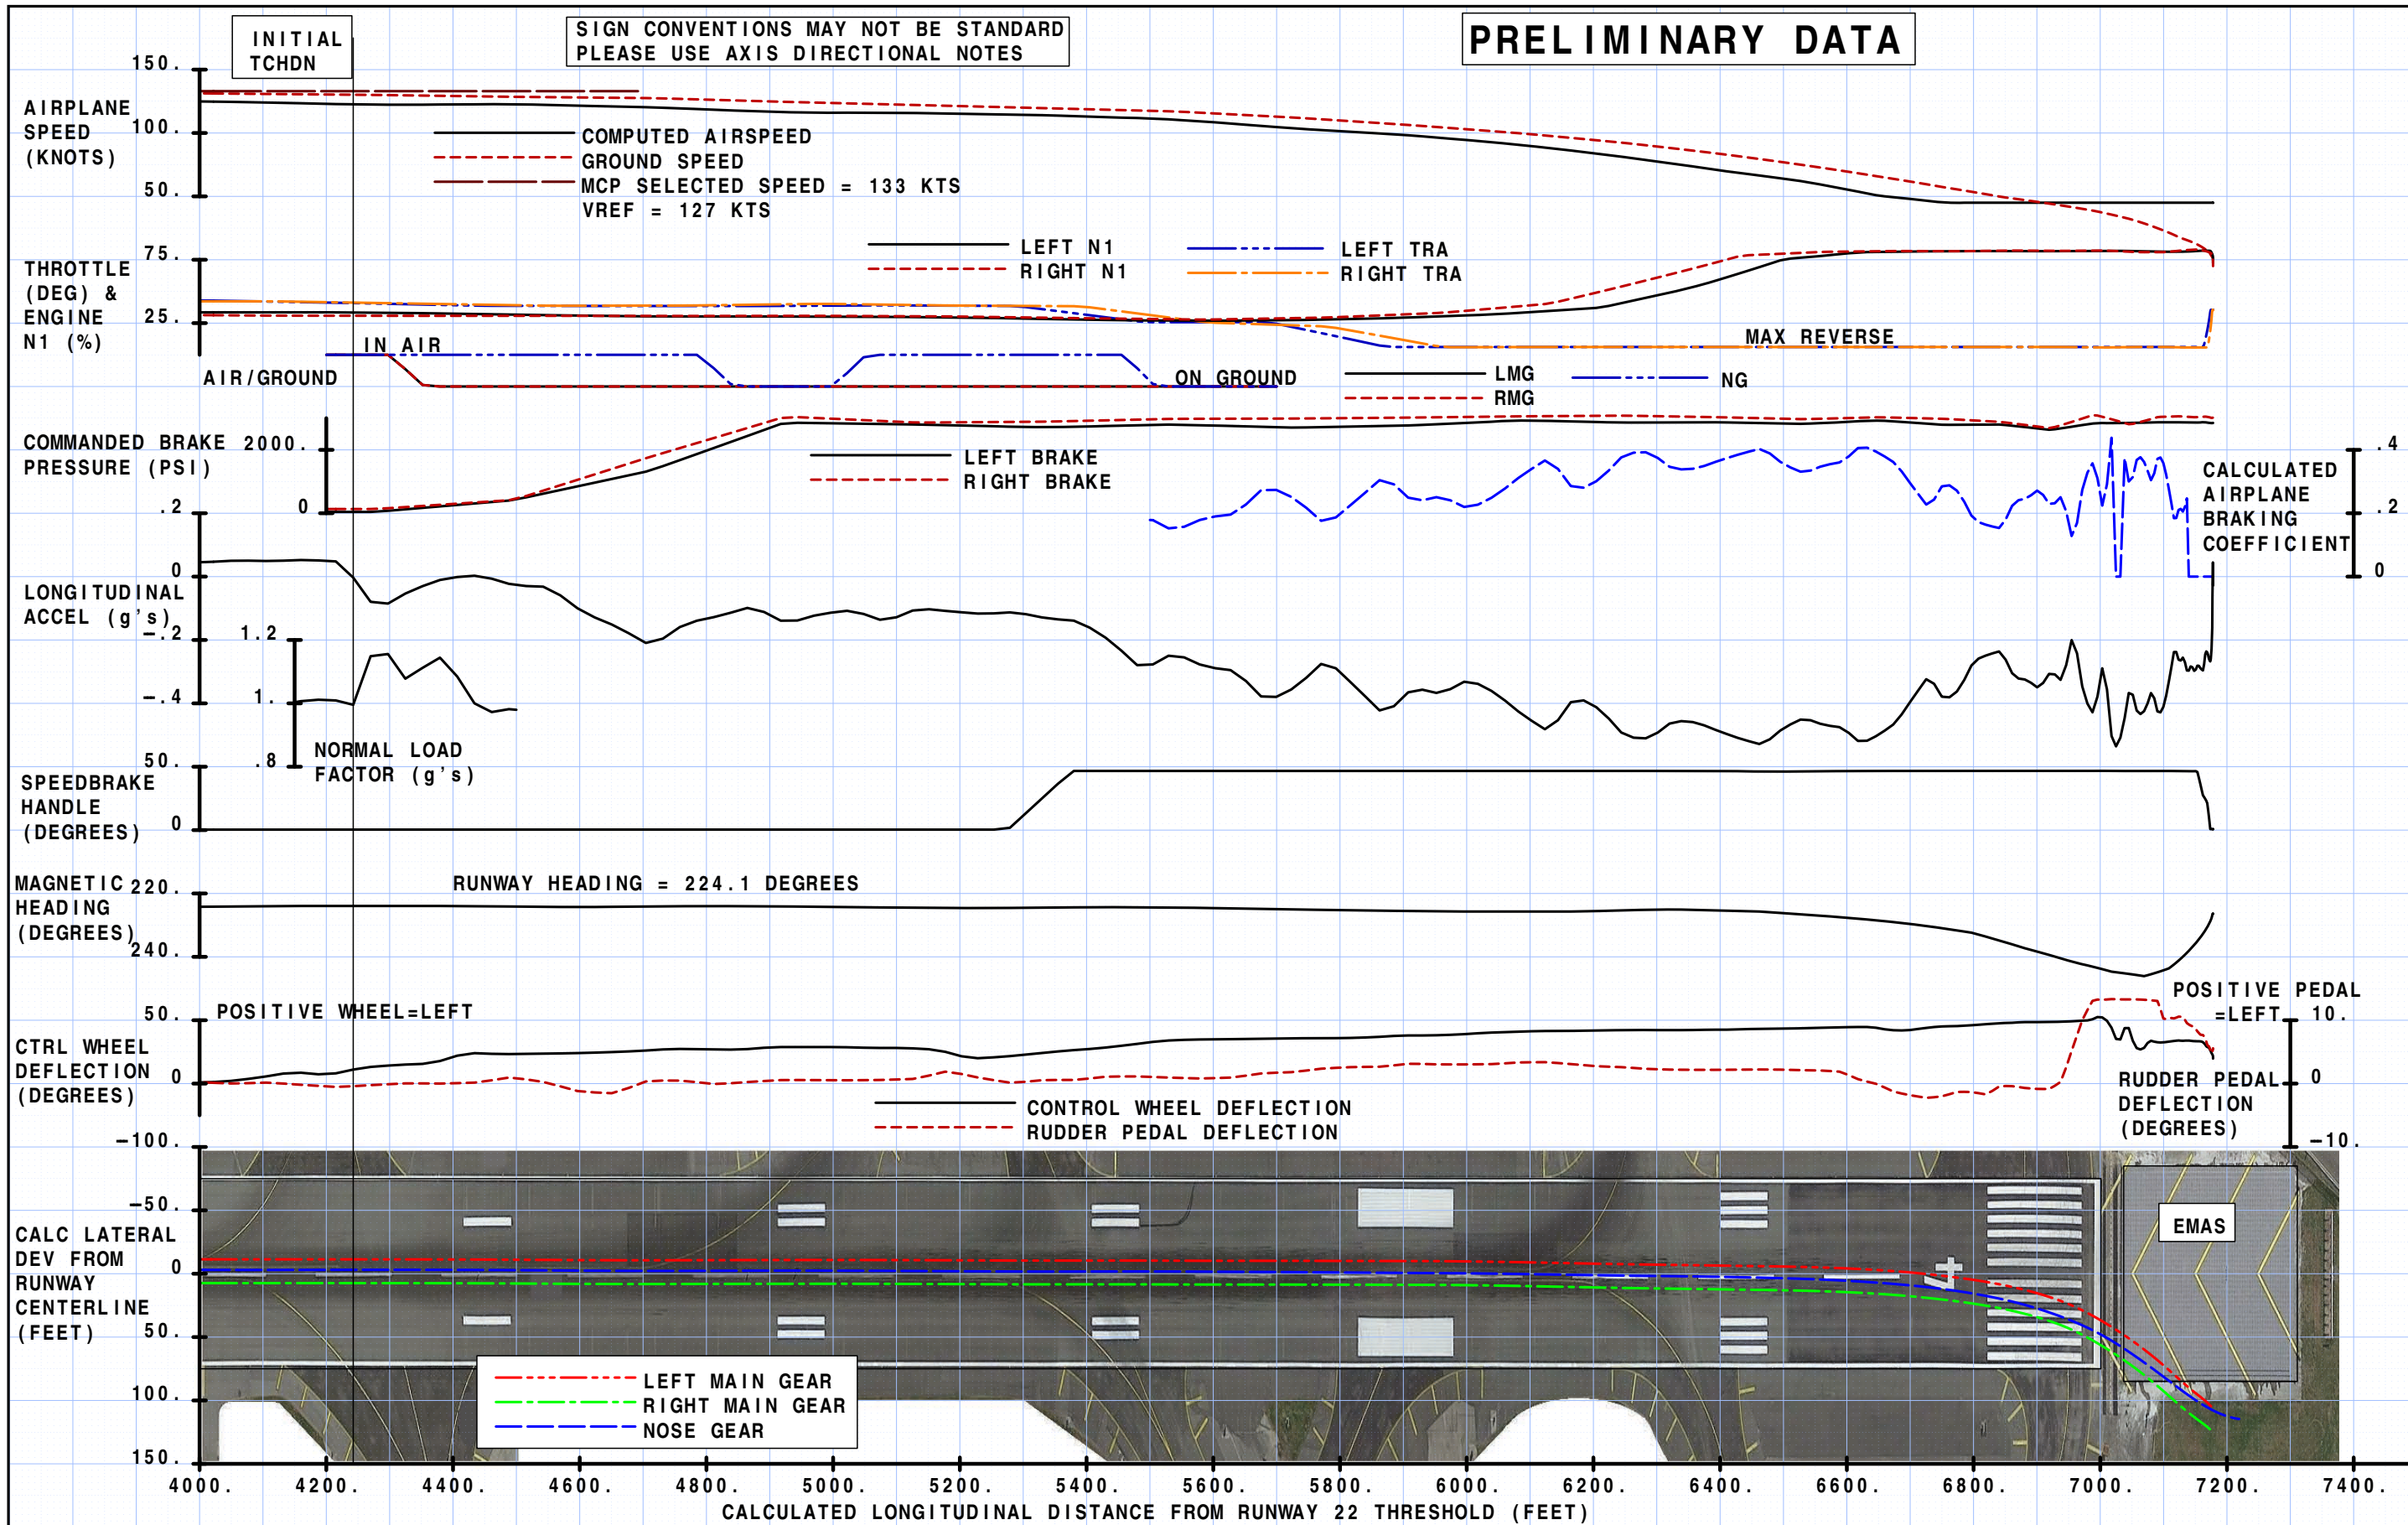
CALC	AERODYNAMICS	16NOV16	REVISED	DATE	EKV 737-700 RUNWAY OVERRUN 27OCT2016 -- TIME-ALIGNED FDR DATA GROUND TRACK ANALYSIS - LANDING ROLLOUT	YA203/N278EA
CHECK						FIGURE
APPD						6
APPD

- The airplane departed the end of Runway 22 while deviating right of centerline at a ground speed of approximately 40 knots.
- The airplane crossed through the right corner of the EMAS and came to rest to the right of the EMAS, approximately 7180 feet beyond the runway threshold, and 114 feet right of centerline.
