## II. Description of Accident Flight

USAir Flight 427, a Boeing 737-3B7, crashed while maneuvering to land at Pittsburgh International Airport on September 8, 1994. The 737 was flying at 190 knots, and leveling off at approximately 6,000 feet following a descent from 11,000 feet. The weather was good; sky clear, visibility 15 miles, with the wind from 250 degrees at 7 knots. The flaps were at 1 and the landing gear was retracted. The autopilot and autothrottle systems were engaged. As the accident sequence began, the airplane was rolling out of a 15 degree left turn toward wings level at a roll rate of about 2 deg/sec.

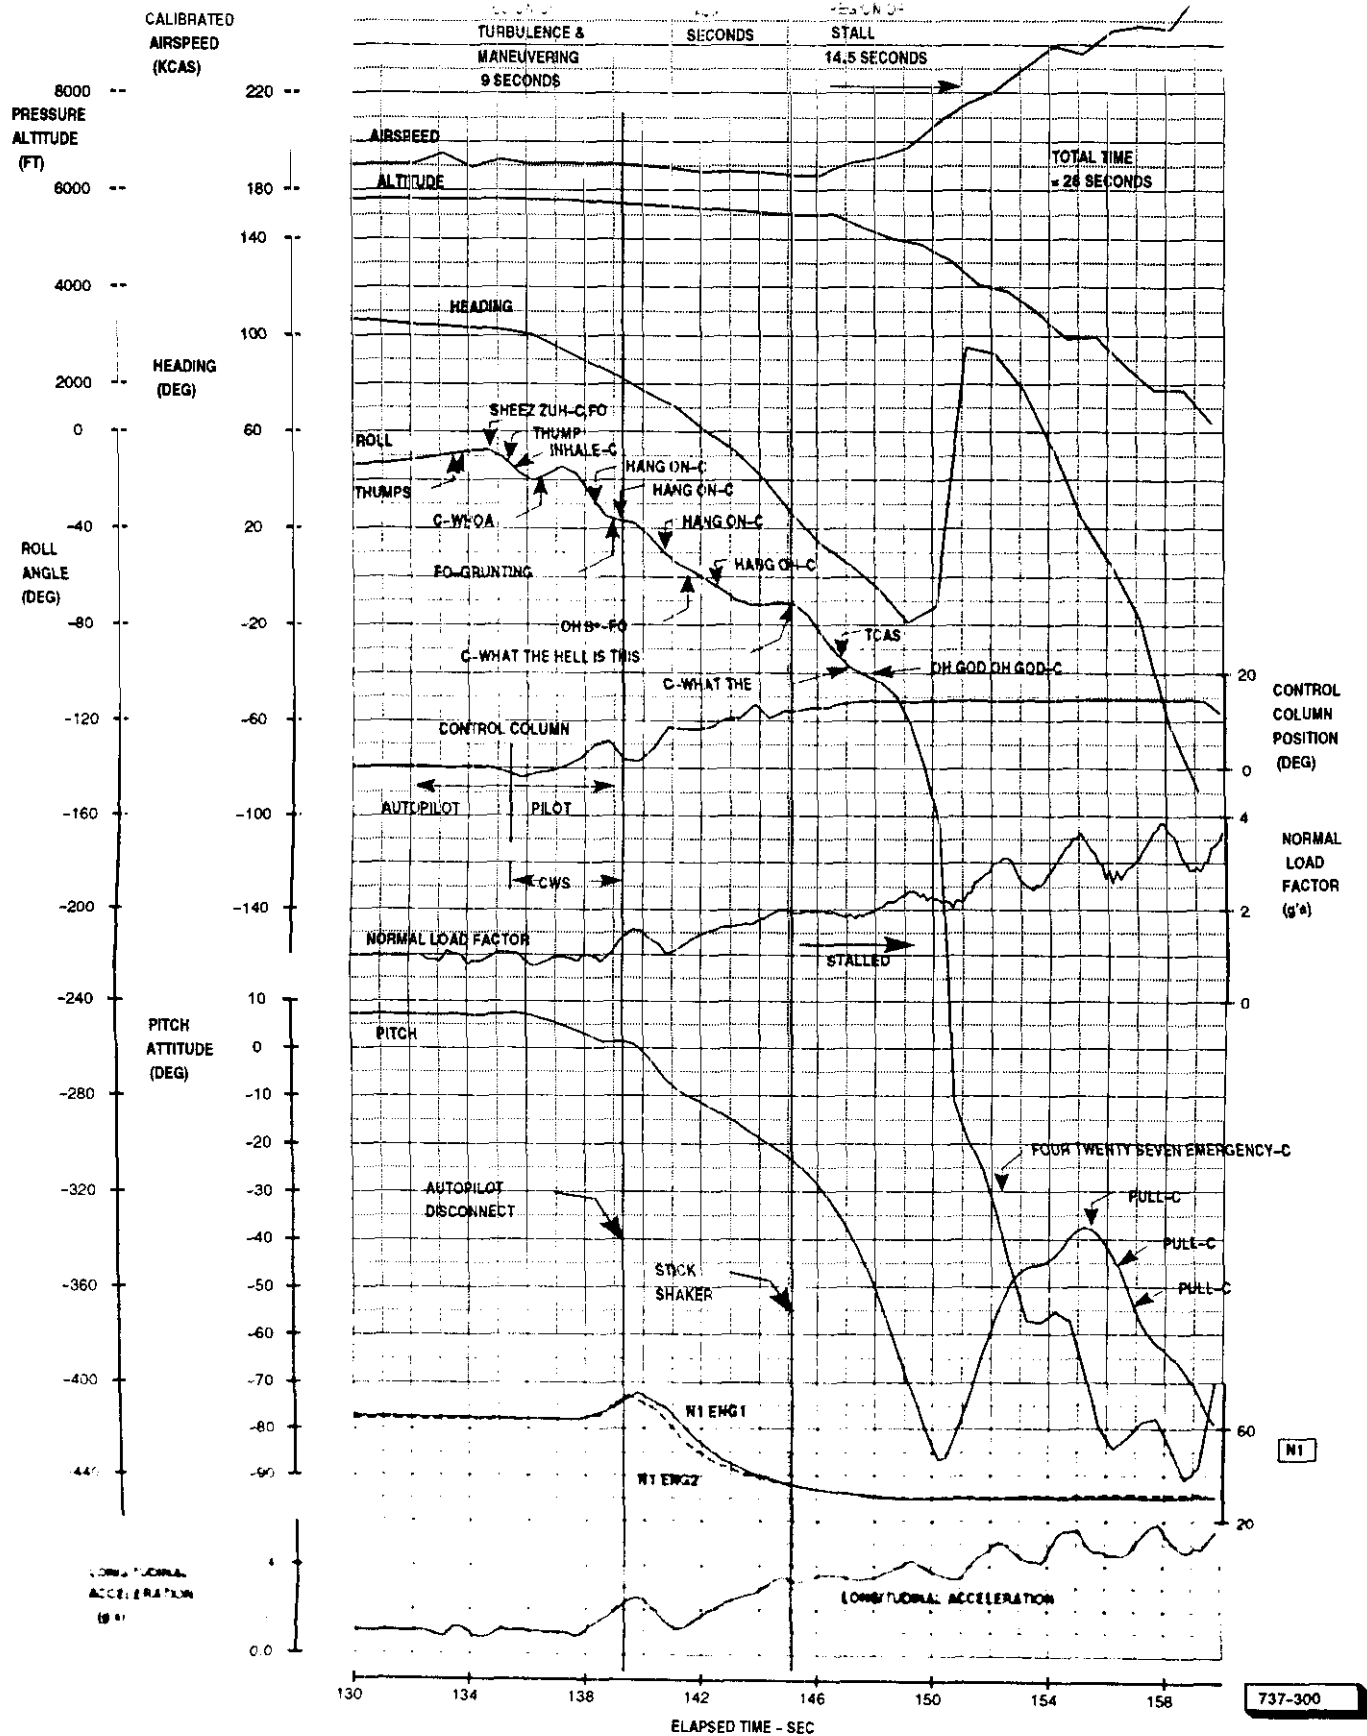
Figure 1: Flight 427 DFDR Annotated Plot

Figure 1 shows the parameters recorded on the digital flight data recorder (DFDR), annotated with the crew comments and other sounds from the cockpit voice recorder (CVR) for the final 30 seconds of the flight. The captain's and the F/O's comments are designated "C" and "F/O" respectively in Figure 1.

The following summarizes facts significant to the investigation that were obtained from the DFDR, CVR, and radar recordings:

1. A Delta 727 passed the area of the accident approximately 69 seconds prior to the start of the accident sequence.
2. Flight 427 encountered the 727's wake, passing directly through the center of the right core.

3. Both crew members made verbal utterances of surprise when startled by the effects of the wake vortex.
4. Prior to any rapid change in yaw rate, Flight 427 rolled to the left, followed by an unusually large roll acceleration<sup>2</sup> to the right.

5. The captain uttered the comment, "Whoa," just as the maximum roll rate to the right was reached.
6. The roll to the left was arrested three times during the accident sequence.

7. The autopilot was disconnected at time 139.4, but the horn continued to sound.
8. The control column had been pulled essentially full aft by time 144, by which time the airplane had reached a 70 degree left bank and a 19 degree nose down pitch attitude.

9. Flight 427 stalled during the accident sequence, which was caused by the aft-column input recorded on the DFDR.
10. The captain commanded, "Pull," several times just prior to impact.

11. The control column remained essentially full aft from time 144 until impact.

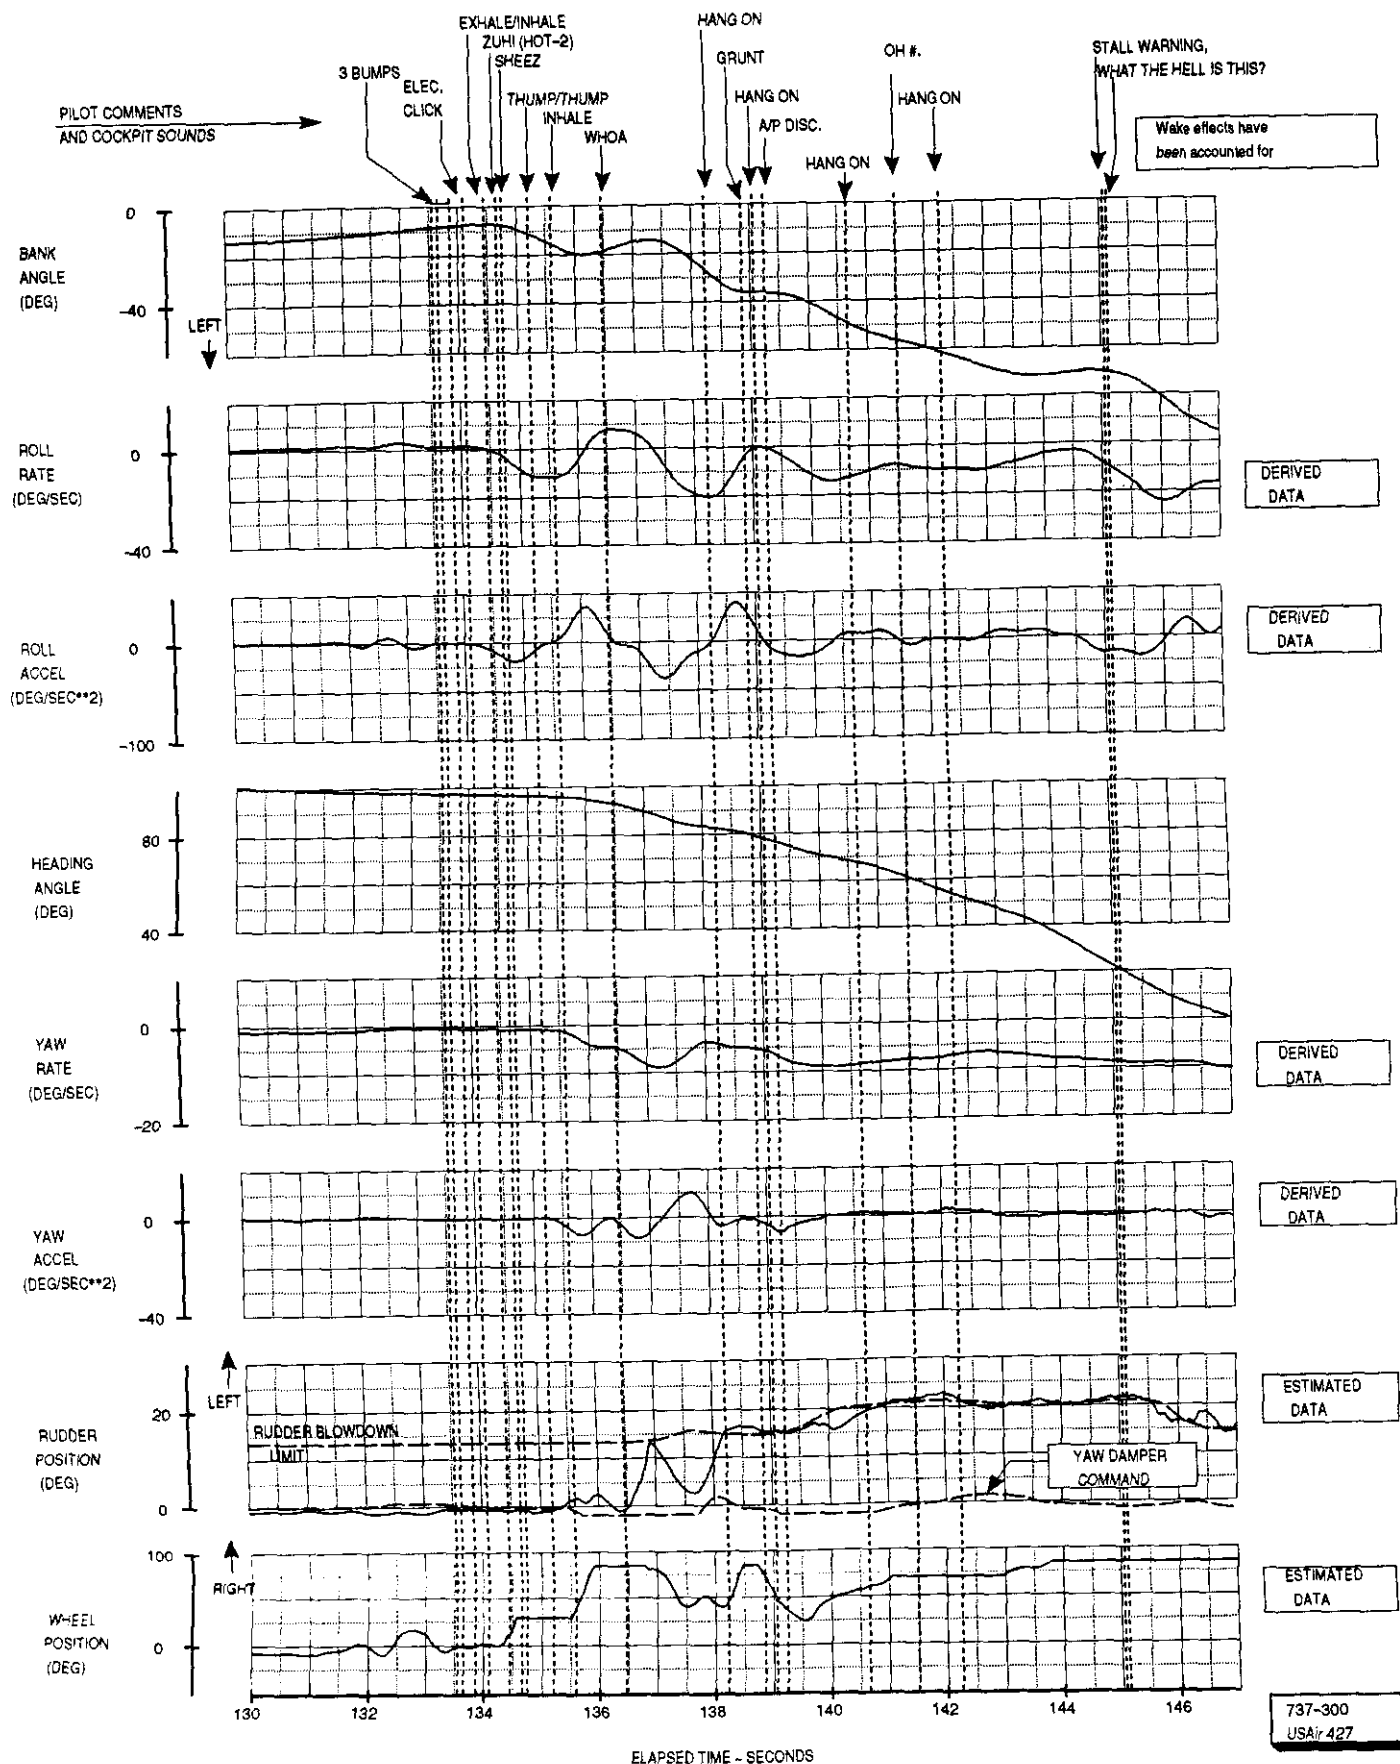
Figure 2: Flight 427 Accident Sequence Time Histories

The results of the kinematic analysis provide significant information as to the control activity during the accident sequence. Figure 2 provides time histories of the roll angle, rate, and acceleration; and of the yaw angle (heading), rate, and acceleration; along with the estimated wheel and rudder angles. Significant pilot comments and cockpit sounds are superimposed on this plot. In Figure 2, comments by the F/O are designated "HOT2." All other comments are by the captain

Note that the roll accelerations induced by the wake and wheel, before any rudder activity, are dramatically higher than would typically be experienced by a line pilot during normal flight

with the autopilot engaged. Normal autopilot roll accelerations are in the region of 2 deg/sec<sup>2</sup>. By contrast, the initial left roll acceleration due to the wake was approximately 19 deg/sec<sup>2</sup>, followed by a roll acceleration to the right due to pilot commands of approximately 36 deg/sec<sup>2</sup>. It is also important to observe that the wheel time history, shown in Figure 2, is consistent with that derived during the NTSB validation of the Boeing kinematic process.

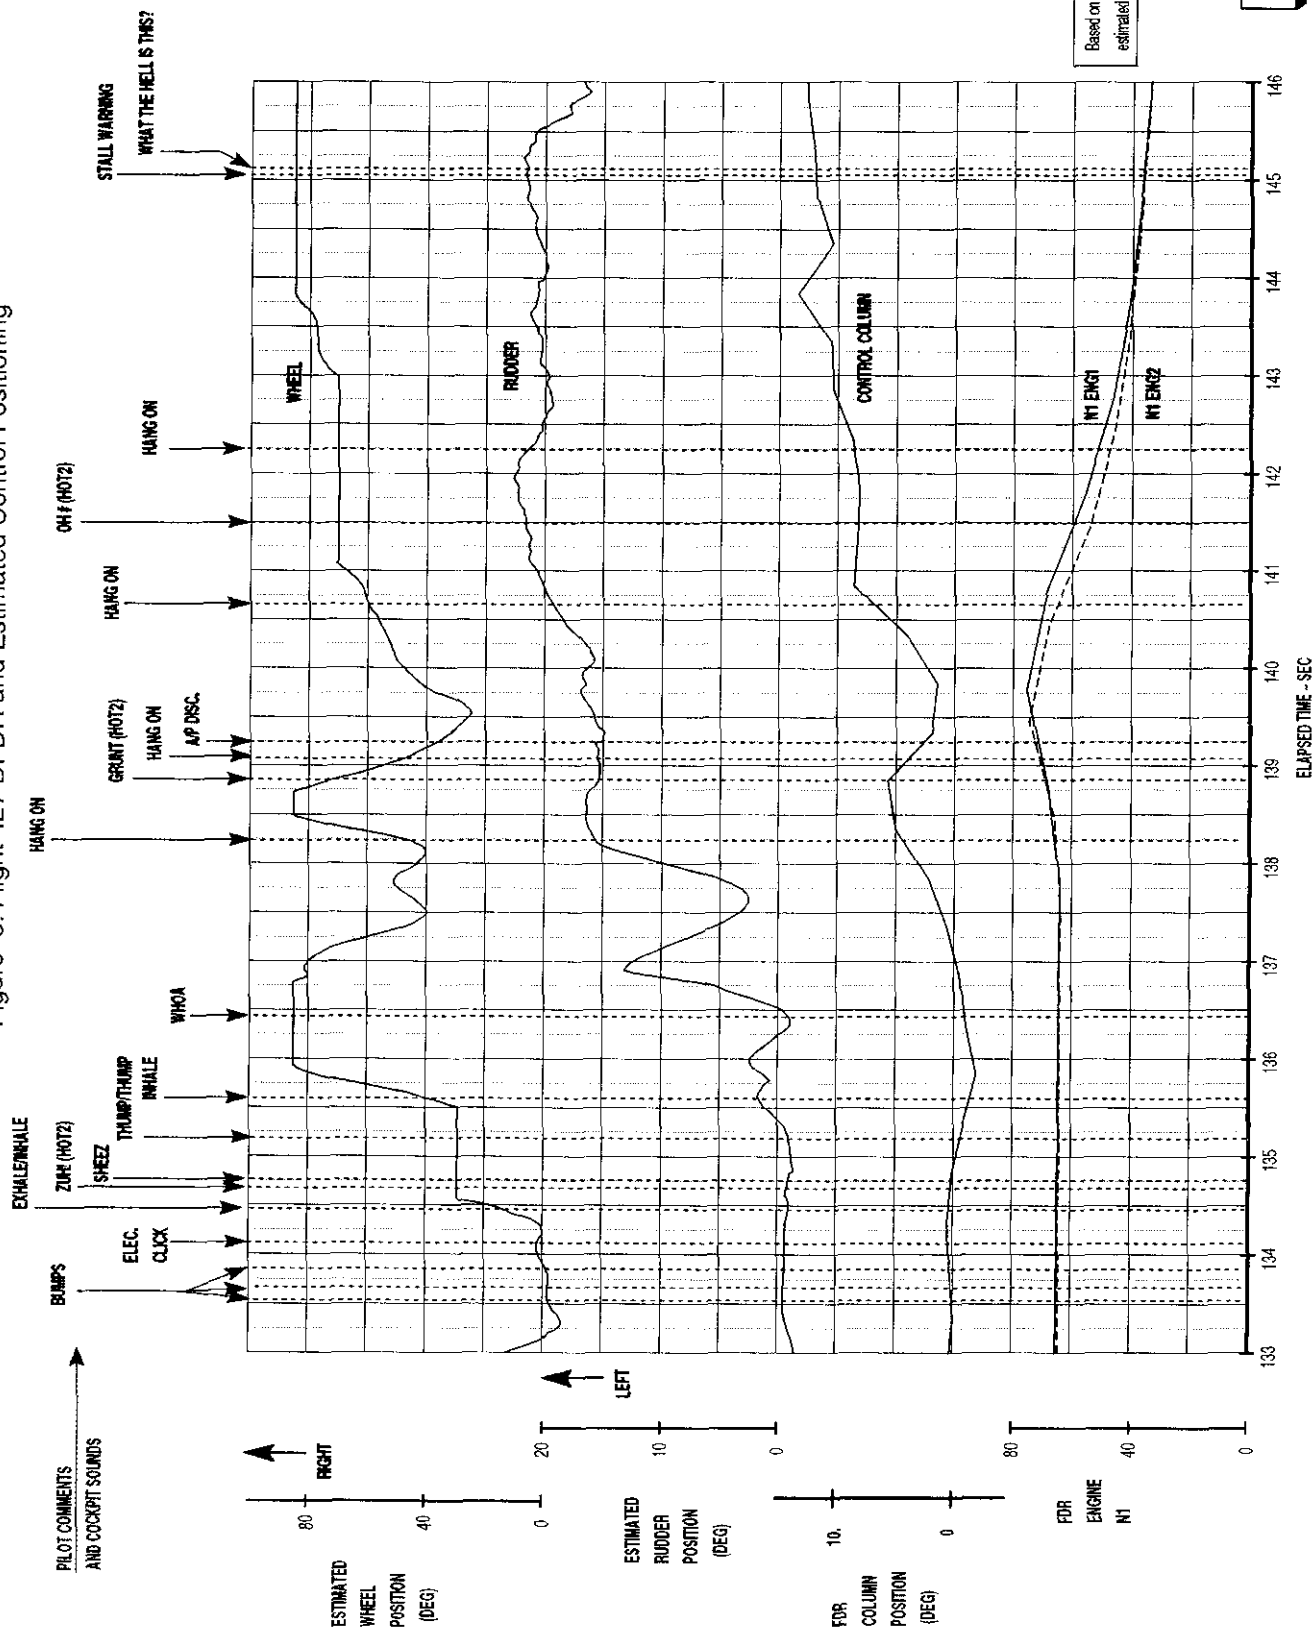
Figure 3: Flight 427 DFDR and Estimated Control Positioning

Obtaining the rudder time history is more challenging because airplane heading—the primary parameter for determining rudder position—was recorded on the DFDR only once every second, whereas roll angle—the primary parameter for determining wheel position—was recorded twice a second. The Boeing interpolation of heading resulted in the rudder position shown in Figure 2. The derived wheel and rudder positions are also shown using an expanded time scale in Figure 3, along with the column position from the DFDR and the engine RPM. Pilot comments and cockpit sounds are shown for reference.

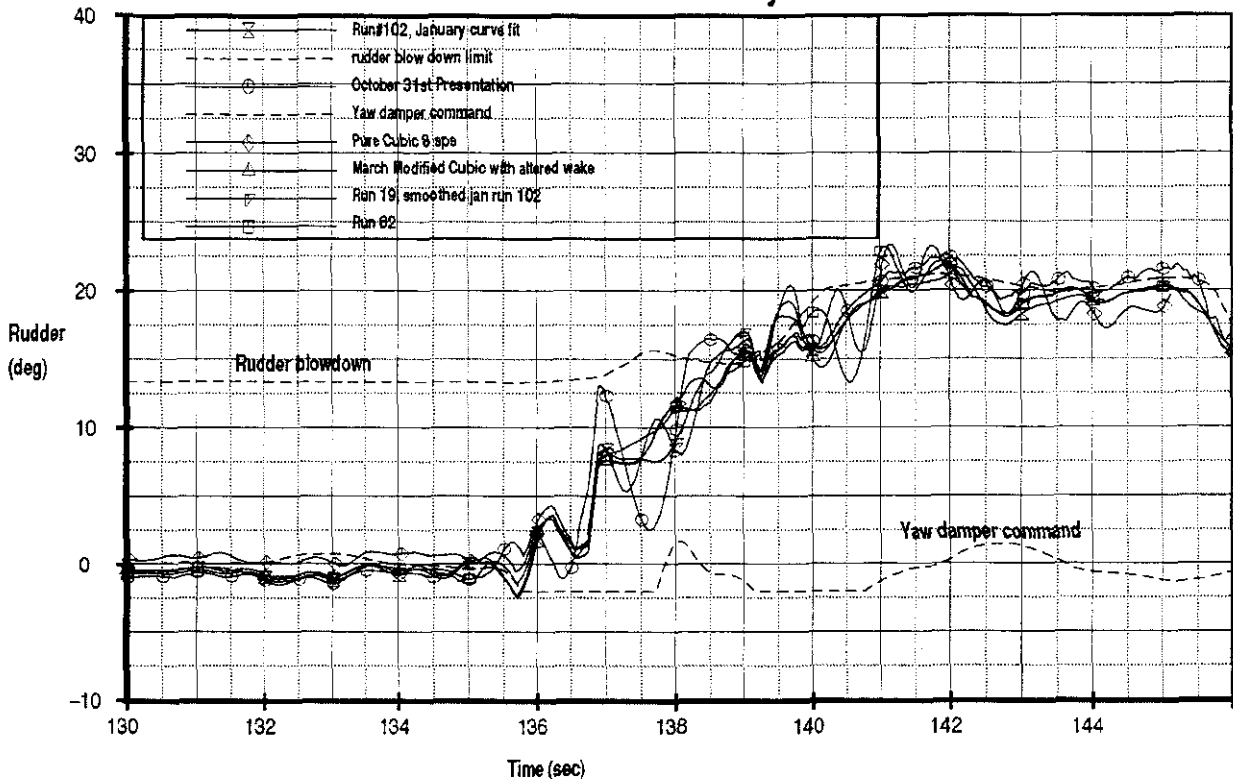
Figure 4: Results of Different Methods of Interpolating Heading Data

The NTSB Performance Group looked at several other methods of interpolating the heading data. All of the results are shown in Figure 4, and are discussed in the NTSB study. Examination of the various resulting rudder traces shows that the derived rudder before time 136.8, and after time 138.8, are essentially the same. The only difference is the rudder position time history as it transitioned from near neutral to its blowdown limit. The rudder time histories that evolved from the various analyses will be used in later analysis to evaluate pilot response and rudder system failure scenarios.
