BOEING COMMERCIAL AIRPLANE COMPANY

June 1979
M-7020-4877
ATA: 0211

Subject: Operations, Flight Perform, Approach,
Roll Maneuver, Model 737

APPROACH ROLL INCIDENT FLIGHT RECORDER TRACES

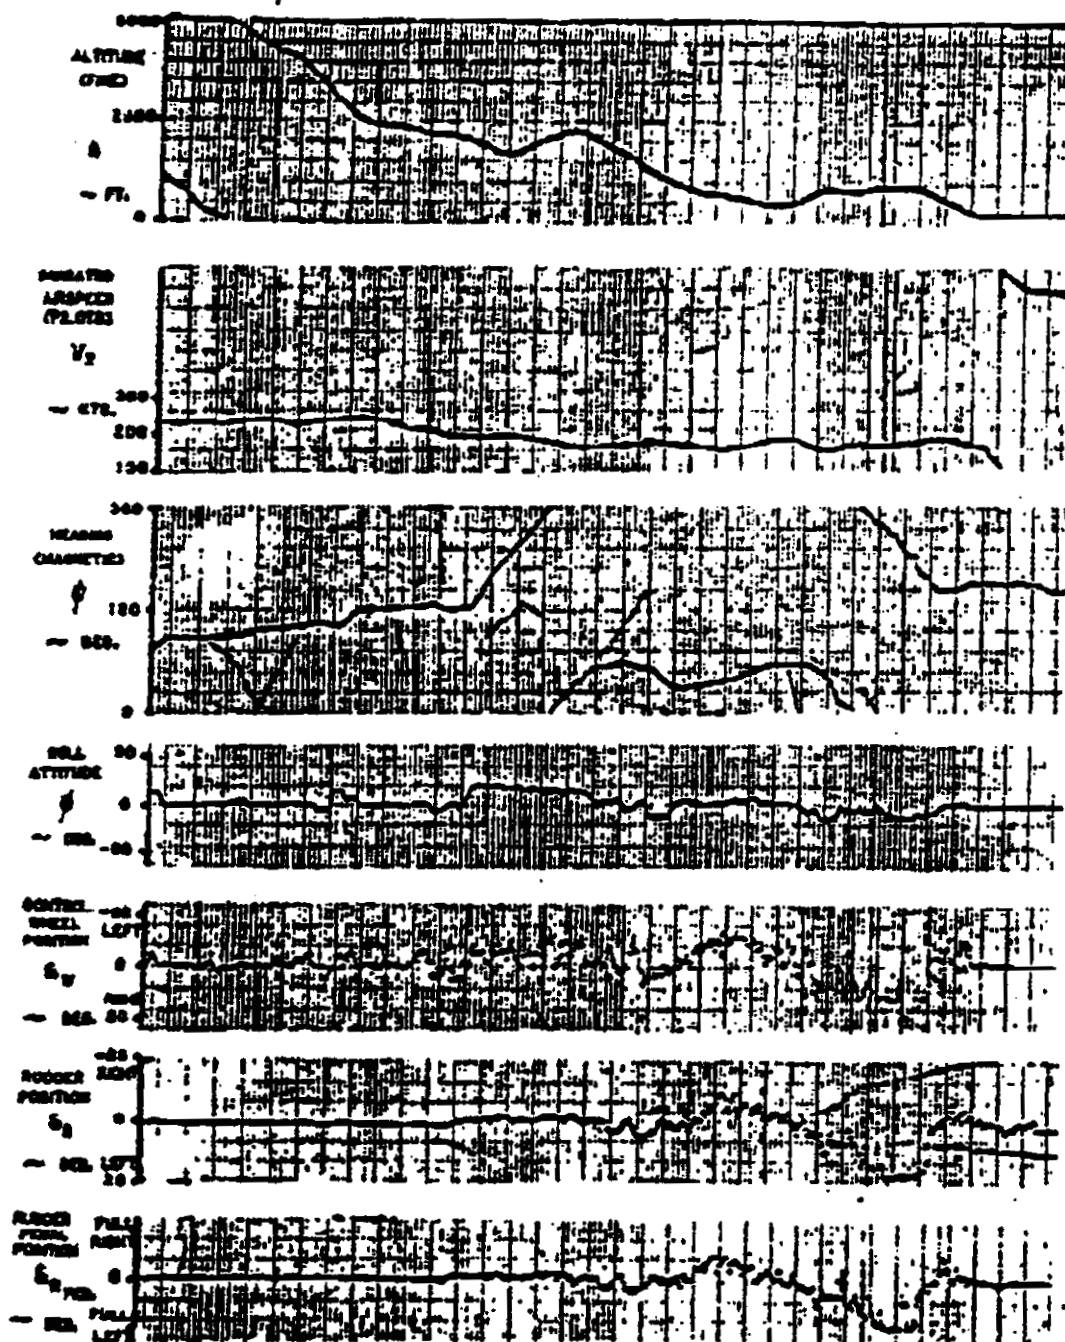
Our analysis of the flight data recorder traces substantiates a normal approach until the initiation of the procedural turn required to position the aircraft for the downwind leg of the final approach to . Specifically, airplane was directed on a heading of 180 degrees and began a right turn to position for the downwind leg heading of 040 degrees for approach to Runway 22. This turn began at approximately 185 knots indicated airspeed with trailing edge flaps at 25 and the landing gear down. During this relatively steep 35 degree right turn, indicated airspeed reduced to 150 knots and the trailing edge flaps were reportedly raised to the flaps 15 position. Presumably in an attempt to coordinate this turn, the flight crew applied and continued to

maintain small but excessive amounts of right rudder control, approximately 3 to 5 degrees. This in turn required excessive left control wheel input, approximately 30 degrees, to hold the 35 degree right bank. Typically, very little rudder control is required to coordinate turns of this magnitude on 737 aircraft in similar situations.

When positioning the airplane for the downwind leg, several rudder control and lateral control oscillations occurred. Two rapid left and right roll maneuvers appear to have resulted primarily from several sudden left rudder control inputs. The rudder control and lateral control inputs shifted to an out of phase condition during the attempt to establish a 10 degree right bank. Control inputs increased in magnitude while holding this bank until 15 degrees of right rudder control and 40 to 50 degrees left control wheel were applied. Several small amplitude sudden roll maneuvers also occurred during the downwind leg as these control inputs oscillated.

As the airplane turned to final approach, the right rudder sideslip condition, resulting from cross control, was gradually changed to a full left rudder and full right control wheel sideslip. Several additional small amplitude, roll maneuvers occurred as control inputs were rapidly oscillating. This cross control continued to exist to a lesser extent until the airplane landed.

In conclusion, it would appear that the reported roll maneuvers were caused by rudder control and lateral control oscillations which were introduced by the flight crew. We believe that these oscillations were the result of the cross controlled situation which existed during the final approach to
