Flight Safety Dept.
May 6, 1996

UNCOMMANDED ROLL
FEBRUARY 1996
DATA NOT TIME ALIGNED
737-500
FIGURE 1
PAGE

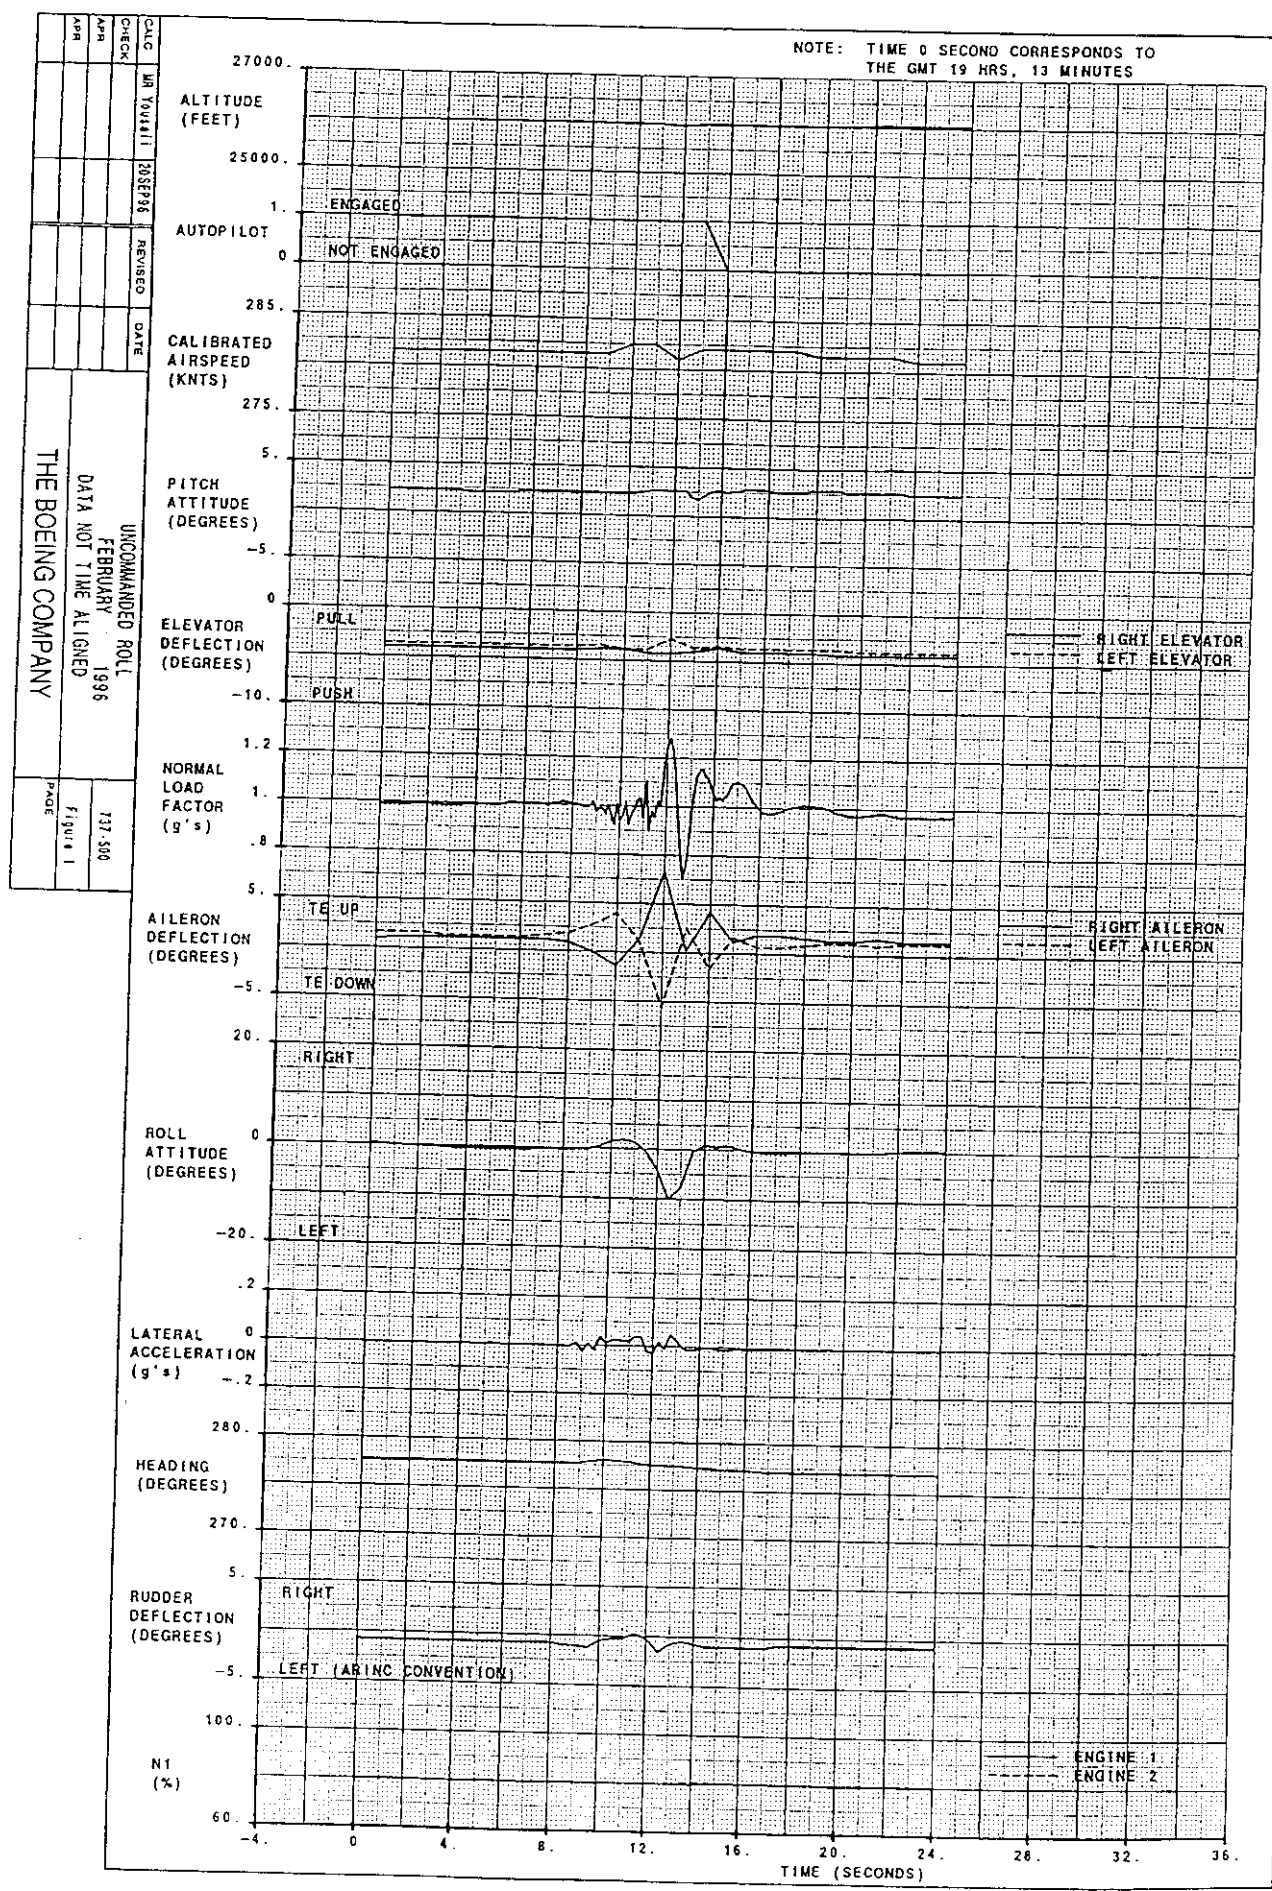
Just before the incident, the captain, that was the pilot flying, felt two jolts, like if someone had kicked the belly of the aircraft. Suddenly, the aircraft started a left roll. The captain disengaged the autopilot and manually corrected roll attitude. He was unable to remember the control wheel and yaw damper indicator position during the event.

The 25° roll was controlled with A/P disengagement only. It was not necessary turn the yaw damper off. After few minutes, the A/P was reengaged, first on CWS and after on CMD mode again without further incident. Since then, the subject aircraft has been flying normaly.
