FROM: John Purvis
Boeing Air Safety Investigation
Phone - [REDACTED]
Fax - [REDACTED]

SUBJECT: Upset During Approach

REFERENCE: Feb 95

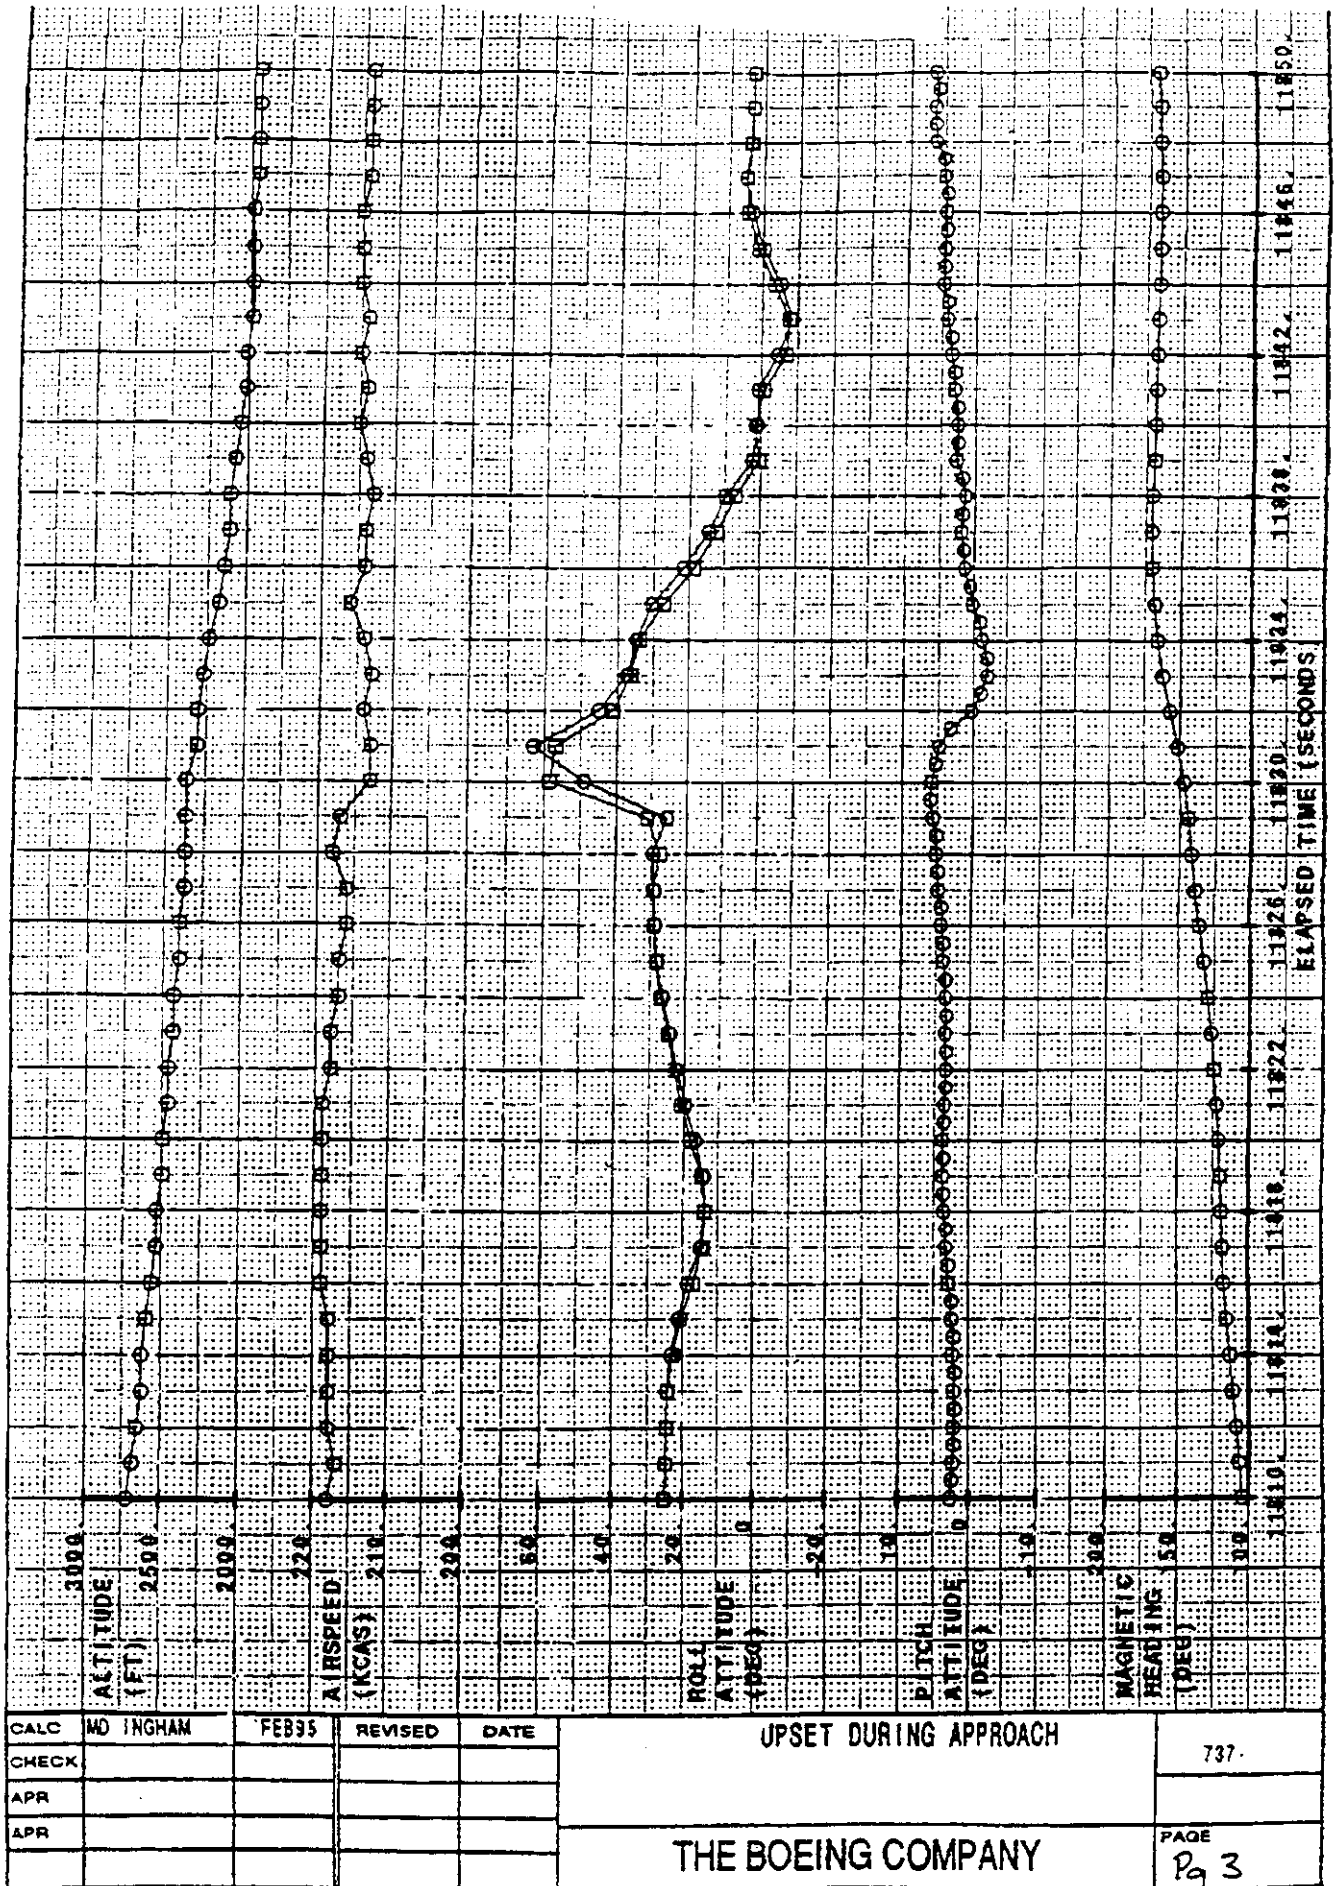
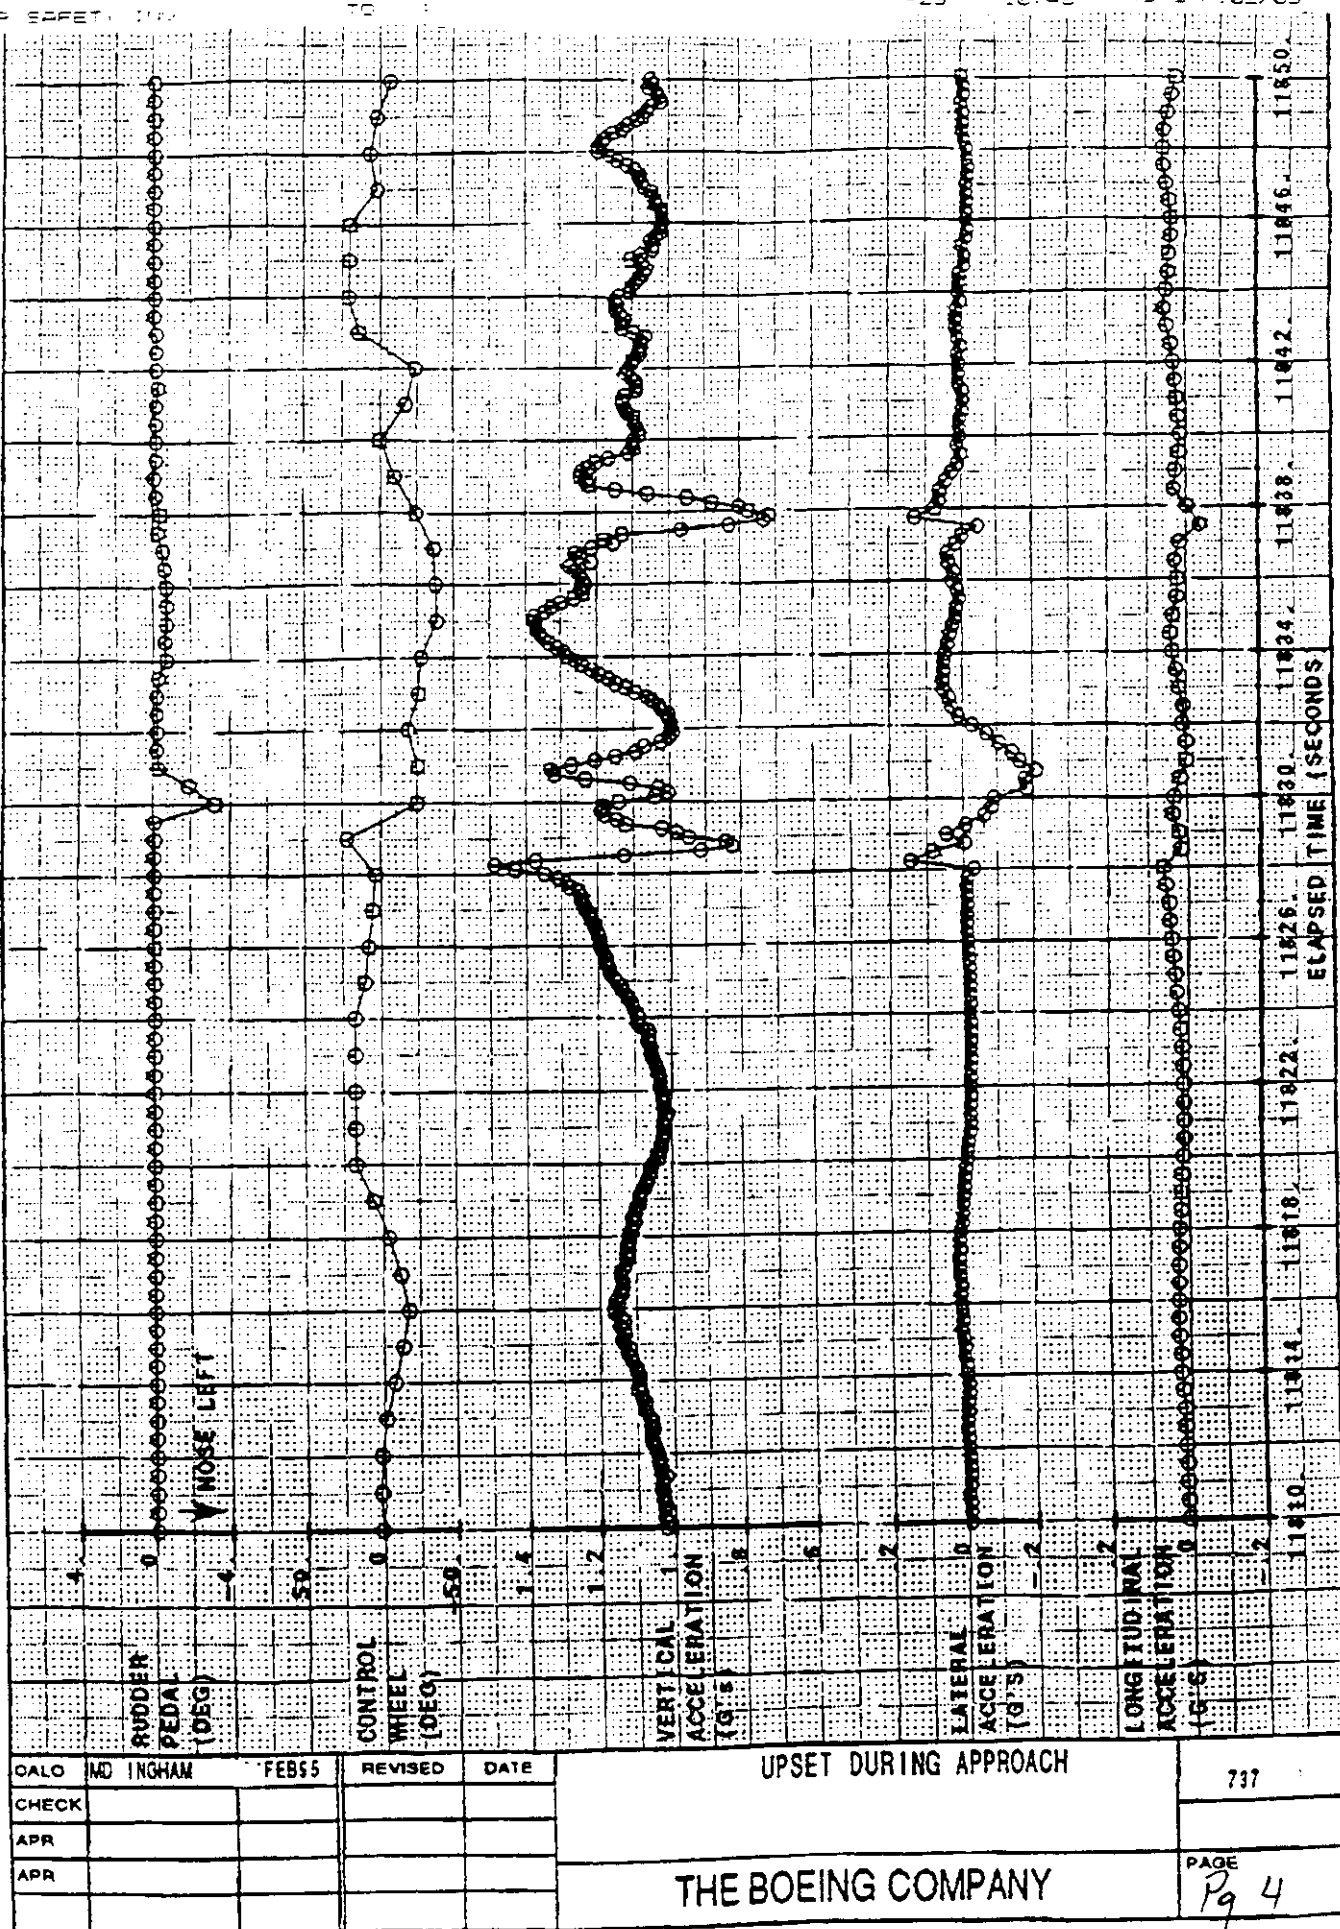
The DFDR data from the [REDACTED] has been examined and key parameters are shown on the two attached time-history plots. 48

The roll upset was identified as having occurred between the elapsed times of 11829 and 11830. However, just prior to the roll upset a disturbance can be clearly seen in both vertical and lateral accelerations beginning at elapsed time of 11828. This disturbance precedes the roll upset, and is characteristic of an external disturbance (atmospheric or wake) acting on the aircraft. It is clear that these changes in acceleration and the resulting roll upset are not due to any control input from the aircraft.

While it was reported that the aircraft was on autopilot at the beginning of the upset, data show the pilot applied appropriate wheel and rudder to counter the roll beginning at an elapsed time of 11830.

The one control wheel data point at 11929 may be the autopilot attempting to maintain heading / lateral navigation, as this is within the flaps 1 autopilot wheel authority limit. This wheel input occurs after the initiation of this event, and could not have induced this roll and acceleration upset.

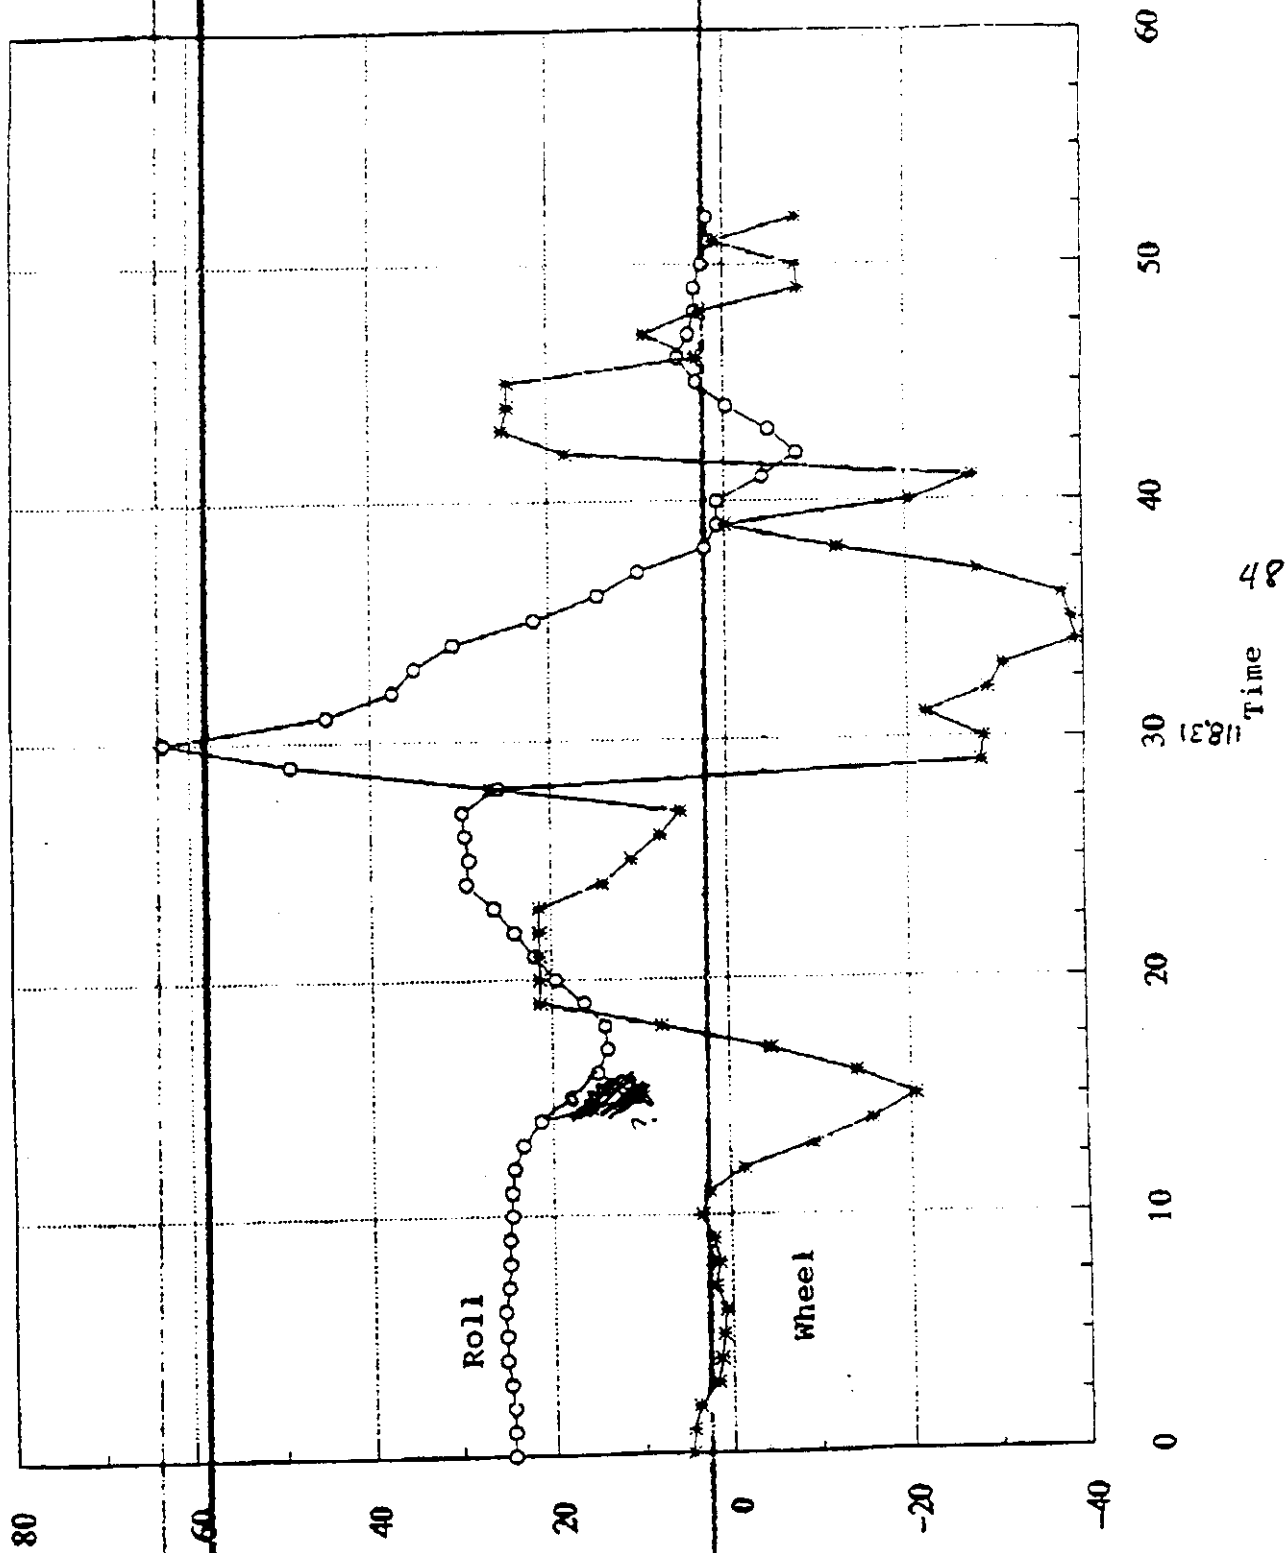
The attached plot is of wheel position and roll from the original faxed data. Subsequent to this another set of roll data was sent which included a column identical to the original and another column which was taken to be offset from the first by one half second but was not added to this plot.

The time at 30 seconds on this plot is equivalent to 118.31 on the aero plots. All further references to time will be with respect to this plot.

In response to LOC capture the autopilot banked the airplane up to 30 degrees while the flaps were still up. This is indicated by the wheel limiting at 21 degrees between 19 and 23 seconds. As the bank angle approached 30 degrees (24 to 27 seconds) the autopilot brought the wheel back to approx. 5 degrees. During this time the flaps were lowered to 1 degree.

Between 27 and 28 seconds a sharp lateral accel was felt by the airplane and the bank angle was driven off the 30 degree limit to approx. 25 degrees. This change in bank command from the desired bank angle of 30 degrees resulted in an autopilot wheel command of approx 26 degrees which is the flaps 1 autopilot limit. Between 28 and 29 seconds the airplane banked to 50 degrees and the wheel responded by reversing direction to the approx autopilot flaps down limit in the other direction, which it held for one more data frame as the airplane continued to roll to 60 degrees. Somewhere between 28 and 30 seconds the autopilot dropped to Roll CWS and disconnect occurred between 38 and 40 seconds.

The autopilot can move the wheel at approx 60 deg/sec within the limits of the aileron force limiter. The wheel rates and wheel directions which occur between 27 and 29 seconds are those to be expected from the autopilot responding to the externally induced roll rates.
