ACCESSION NO. : 314668  
 DATE OF OCCURRENCE : 9508  
 REPORTED BY : FLC  
 PERSONS FUNCTIONS : FLC, PIC. CAPT;  
 FLIGHT CONDITIONS : VMC  
 REFERENCE FACILITY ID : CLE  
 FACILITY STATE : OH  
 FACILITY TYPE : ARPT  
 FACILITY IDENTIFIER : CLE  
 AIRCRAFT TYPE : B737-300  
 ANOMALY DESCRIPTIONS : LOSS OF ACFT CTL

15  
PRELIMINARY INFORMATION  
B737-300 Uncommanded Roll  
B7 / 195

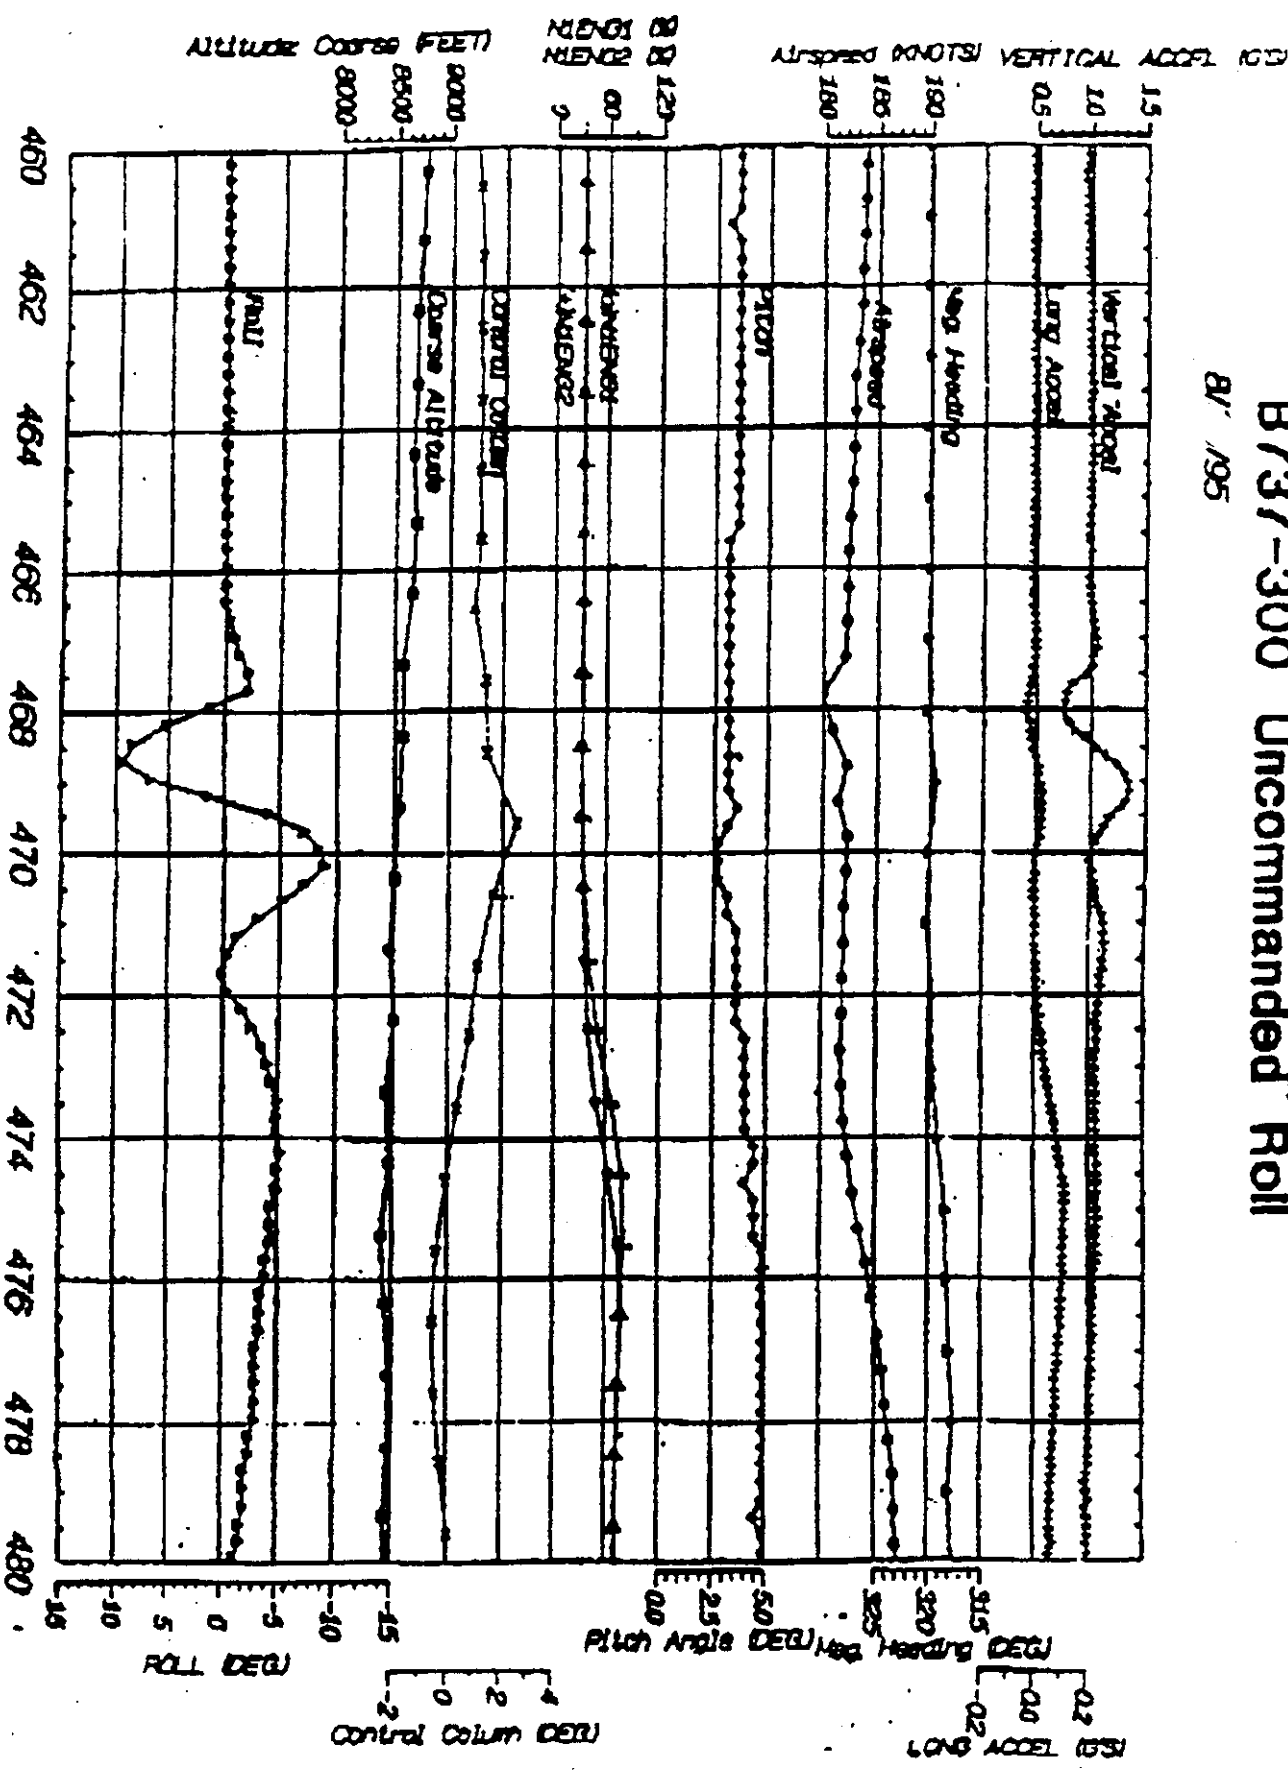
Preliminary Data, D11  
Facts

FDR Subframe Reference Number (sec)
