**Submission to the  
National Transportation Safety Board  
for the**

**Alaska Airlines Flight 261  
Accident Investigation**

**The Boeing Company**

**23 August 2002**

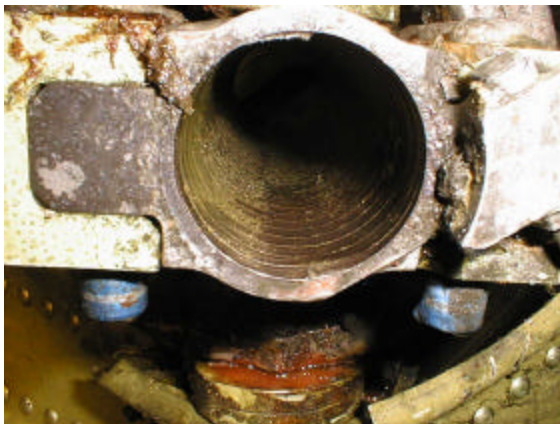
**Figure 4. Accident Airplane's Acme Nut Bore**

Following recovery of the accident airplane's acme screw and nut from the ocean floor, examination revealed that the threads were missing from the nut's inner bore (fig. 4). The screw was found with many spirals of thin metal ribbon wrapped around its threads. They were later identified as being of aluminum-bronze nut material and denoted as *thread remnants* (fig. 5). This evidence indicates that the acme nut threads wore down to such an extreme point that the normal operating load deflected them into the screw and they subsequently jammed the mechanism. Further attempts to activate the trim resulted in large rotational forces being applied to the system.<sup>36</sup> Eventually, these large rotational forces led to the acme screw threads shearing the acme nut threads from the interior of the nut element itself, which allowed axial/vertical movement of the acme screw.

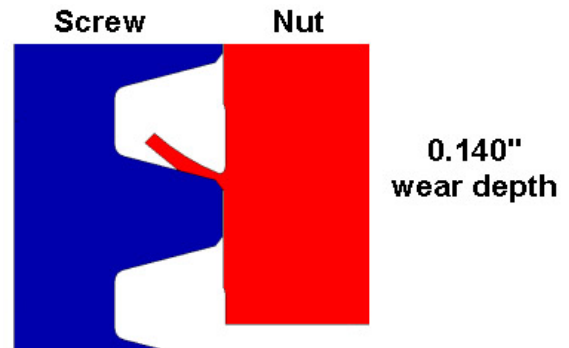
Figure 10 shows an acme nut thread that has now worn to a depth 0.140 in., or more than 4.5 times the amount of wear that is permitted by the replacement threshold of 0.040 in.

The nut threads of the accident airplane appeared very similar to this immediately before they stripped out of the acme nut.<sup>41</sup>

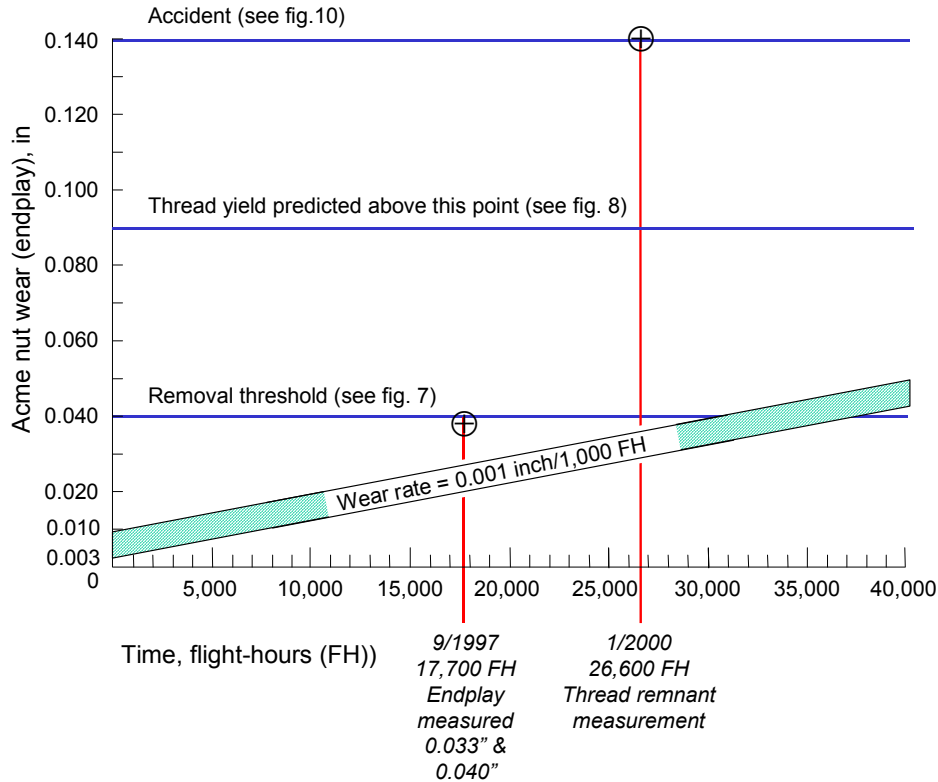
**Figure 11. Wear vs. Flight-Hours, Accident Airplane**

From the time of its delivery to its last endplay check inspection in September 1997,<sup>42</sup> the accident airplane had accumulated approximately 17,700 flight-hours. As noted previously, the operator reportedly obtained measurements of 0.040 and 0.033 inches in two sets of endplay checks. Approximately 8,900 flight-hours later, the threads of the acme nut sheared at a wear depth of 0.140 in. or greater. Figure 11 summarizes these two points and shows a typical comparative average-wear-rate band (0.001 in. per 1,000 flight-hours), the width of which reflects the initial new-jackscrew-unit endplay measurement range of 0.003 to 0.010 in.

The amount of wear experienced by the accident airplane over its first 17,700 flight-hours of operation was greater than the nominal jackscrew wear behavior. However, subsequent to its last endplay inspection check, a drastic change in the wear behavior of the acme nut occurred. The *average* wear rate from September 1997 to January 2000 was approximately 0.010 in. per 1,000 flight-hours,<sup>43</sup> or ten times the nominal wear rate of 0.001 in. per 1,000 flight-hours.<sup>44</sup>

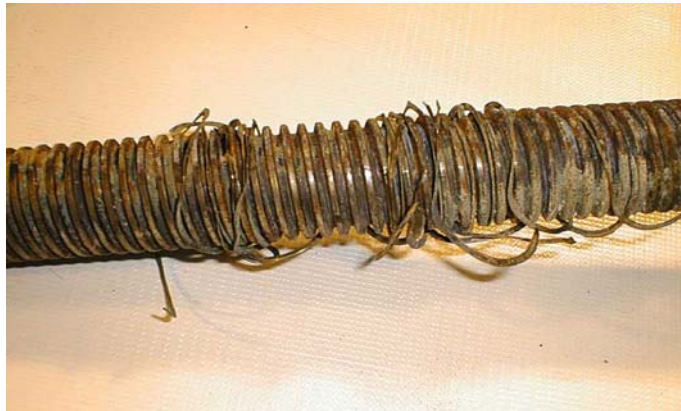
**Figure 12. N963AS Jackscrew With Acme-Nut Thread Remnants, Photographed at Recovery Site, 10 February 2000**

Based on examination of jackscrew assembly components at the recovery site, the NTSB observed that “Visual and tactile inspections of the threaded regions of the acme screw found no evidence of grease or other lubricant in the central ‘working’ region of the screw threads.”<sup>46</sup> Figure 9 shows a portion of this area.

Likewise, the interior of the nut showed no visual indications of grease on the surface where the threads would normally be.<sup>48</sup> Furthermore, the grease passage connecting the acme nut’s Zerk grease fitting to the interior of the nut was plugged with hardened-grease residue,<sup>49</sup> indicating an absence of successful grease application via this fitting. Relatively fresh lubricant that had been applied at least four to five months before the accident<sup>50</sup> was found in the Zerk fitting, blocked by the clog. The freshness of this grease and the condition of the clog residue suggest that the clog was present for a prolonged period.
