**Submission to the  
National Transportation Safety Board  
for the**

**Emery Worldwide Airlines Flight 17  
Accident Investigation**

**The Boeing Company  
19 December 2002**

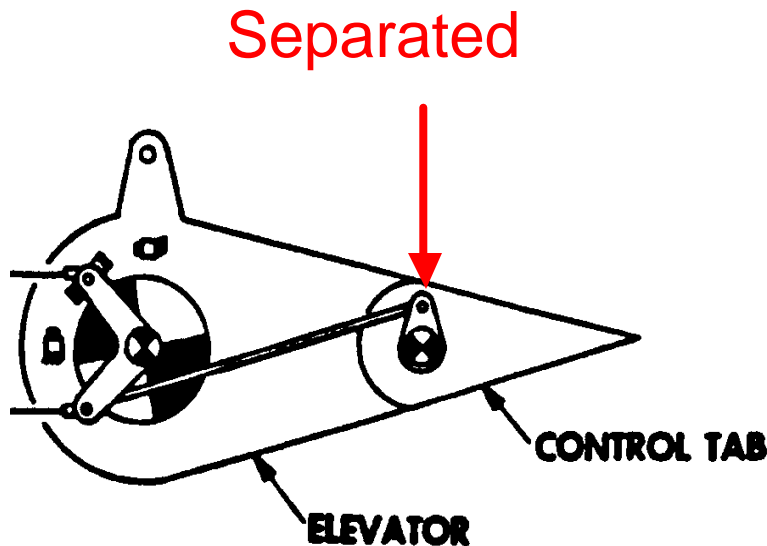
Examination of the recovered horizontal stabilizer and elevator control components revealed evidence consistent with a right elevator tab crank that was not attached to the right control tab pushrod at impact. See Figure 3 below.

The control rod end and the control tab crank clevis lugs were intact, with no evidence of internal damage or deformation that would have been expected had the bolt been in place at impact. The bolt that normally secures the rod end to the control tab crank was not recovered.<sup>1</sup> However, an intact castellated nut that appeared to match the nut installed at the forward end of the control rod was recovered from inside the right elevator. The nut was in good condition, and the threads were not stripped.<sup>2</sup> Further, the NTSB confirmed that the recovered nut

was a 5/16-inch nut (the correct size for the control-rod-to-control-tab-crank joint).<sup>3</sup>

1. Issued revisions to the DC-8 AMM to state that proper connection of the control tab pushrod to the control tab crank (and the geared tab drive rod to the geared tab crank) requires that the bolt, washer and nut are installed and then the nut is tightened and safetied with the cotter pin. The revisions also included illustrations of the bolt, nut, washer and cotter pin.

4. Begun developing an enhanced design of the control tab pushrod that will prevent the pushrod from dropping or otherwise moving in front of the control tab crank should the bolt migrate out of the connecting joint. The front end of the pushrod is also being reviewed for consequences should it become disconnected.
